Tropical Knitex Ltd.

Chandra, Kaliakoir, Gazipur-1751, Bangladesh

24th September 2019 , 6th October 2019 & 15th October 2019

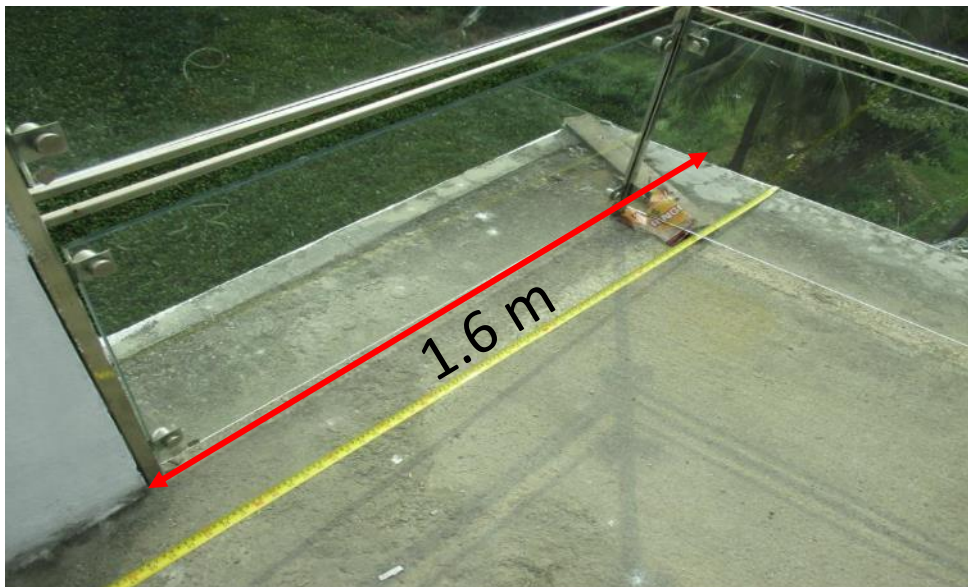
Cantilever slab

1.6 m cantilever slab was found at west side of the building. The slab details has not been added in as-built structural drawing. Factory engineer is required to develop accurate as-built drawing and assess the load bearing capacity of the cantilever slab.

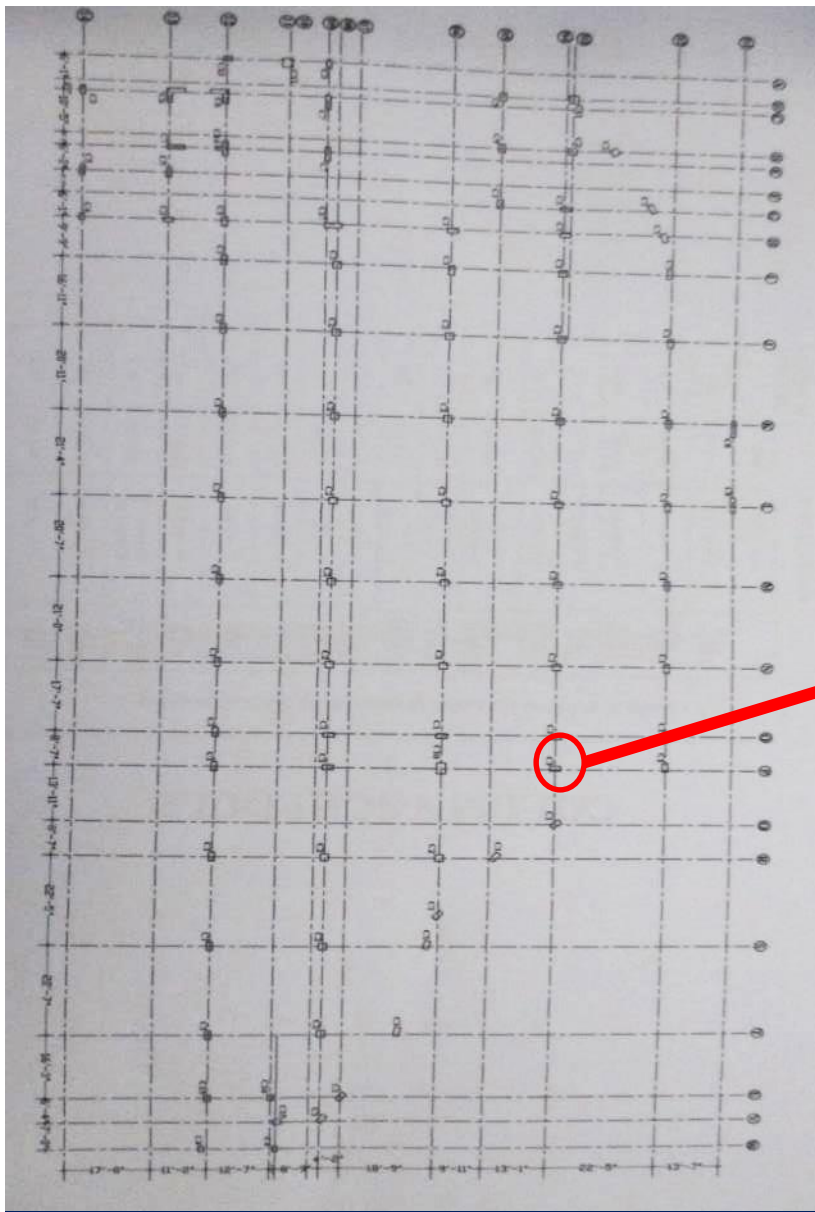
Column Layout plan

Hole was found in column due to electricity outlet purpose at marked column in figure. Factory engineer is required to investigate the hole and suggest repair methodology.

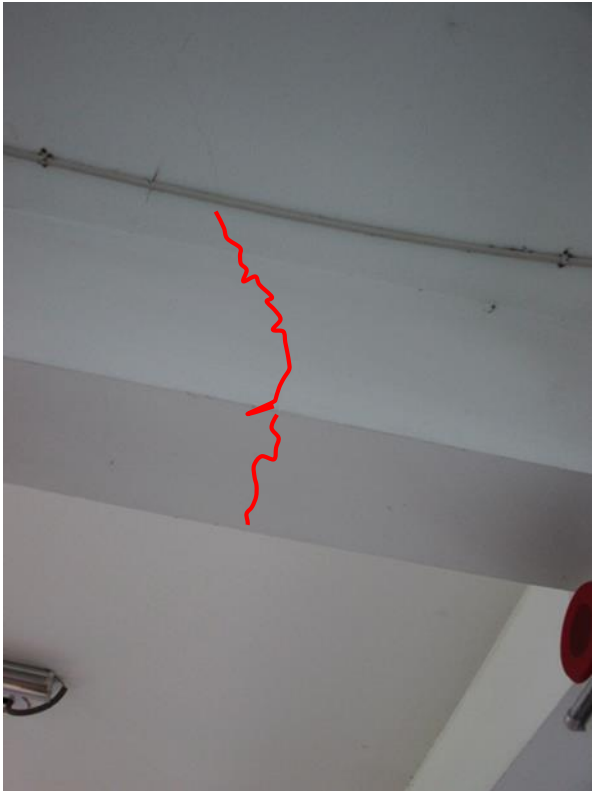
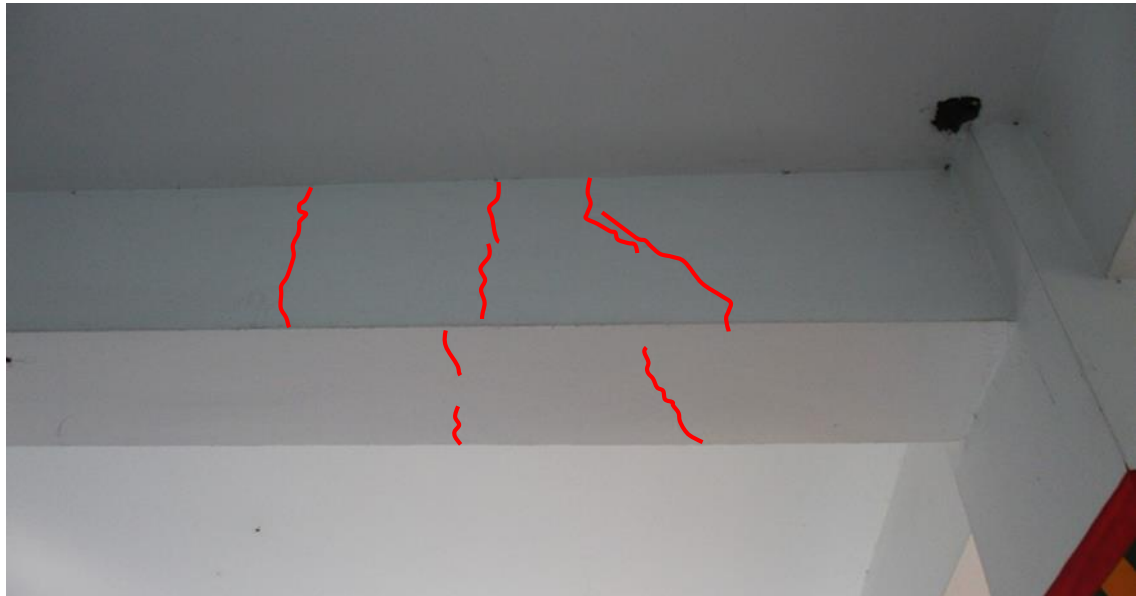
Hairline crack was found in beam at several locations of the structure. Factory engineer is required to investigate the cracks and produce a crack investigation report including the reason, extend of crack and recommendation for the repair of the cracks.

34	Building-11: Hairline Crack in beam	Complete remedial works arising from investigation report.	6-months
35	Building-13: Discrepancies between provided as-built drawings and on-site condition	Building Engineer to survey the structure and prepare accurate as-built drawings.	6-weeks

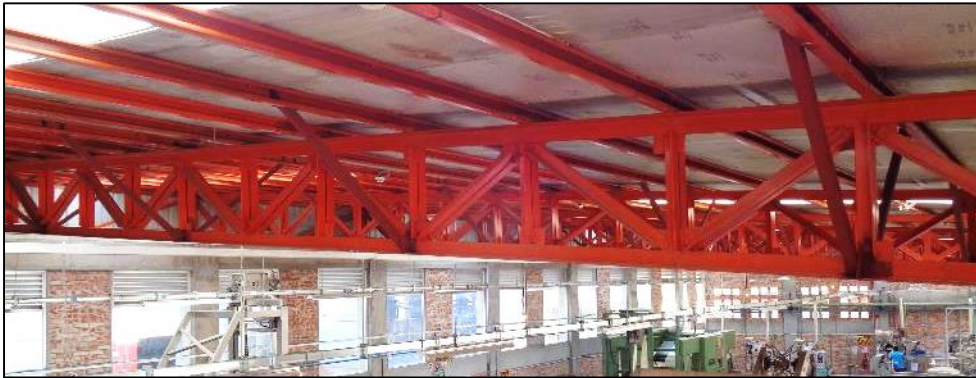
As built condition.

Number of vertical members in the truss were found less than the number shown in as built drawings. In as built drawings, 14 vertical members are shown but on site 12 were found.

Also on site the heights from floor to truss top were found greater than the height value mentioned in the as built drawings.
