Mondol Fashion Ltd

Rashid Tower, Tongabari, Asulia, Savar
(23.90585, 90.32248)

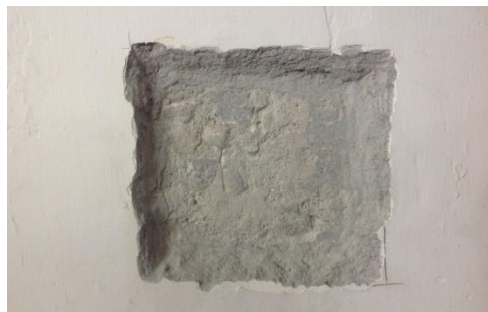
Tested Column C/3 (Stone)

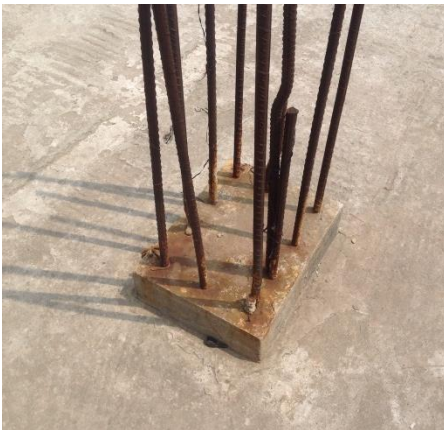
High strength reinforcement steel bars were observed at Roof level. The number of bars observed at Roof level is comparable with observations at basement level using the ferros scanner, but is inconsistent with what is indicated in the Structural Drawings.

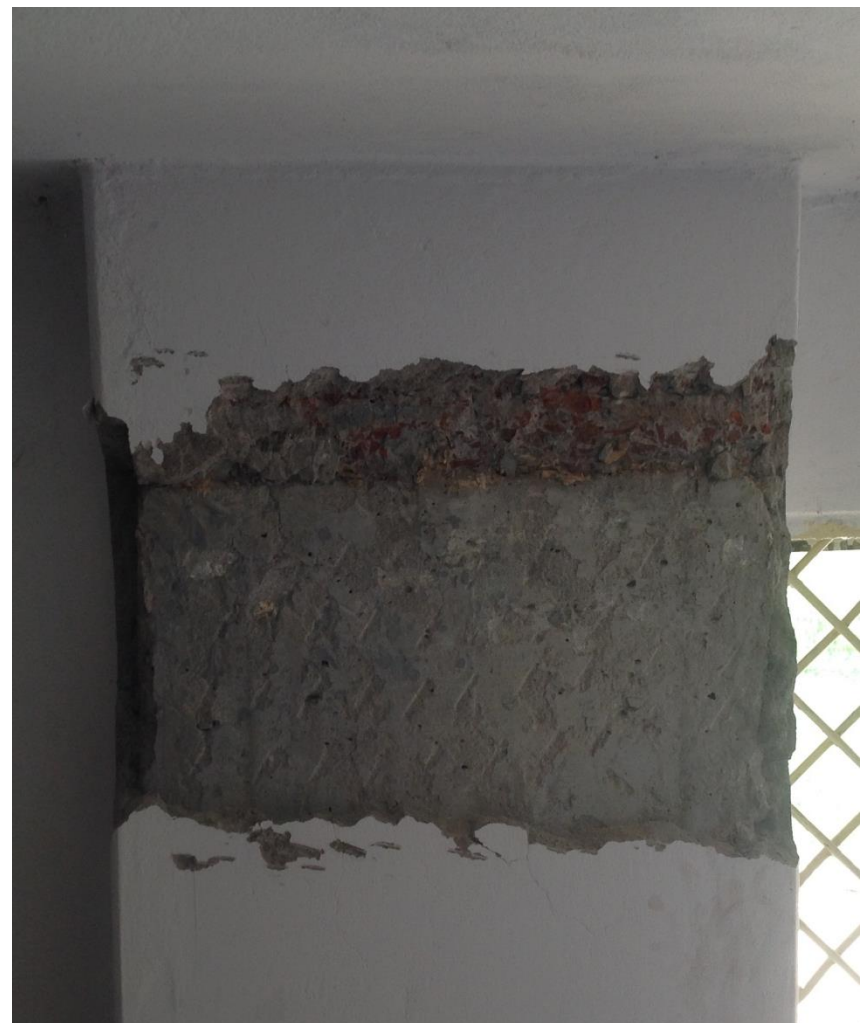
Exposed Column A/2
Hairline cracks were noted to column head. This prompted the removal of plaster, which revealed different aggregate types used in distinct concrete pours for the same column.

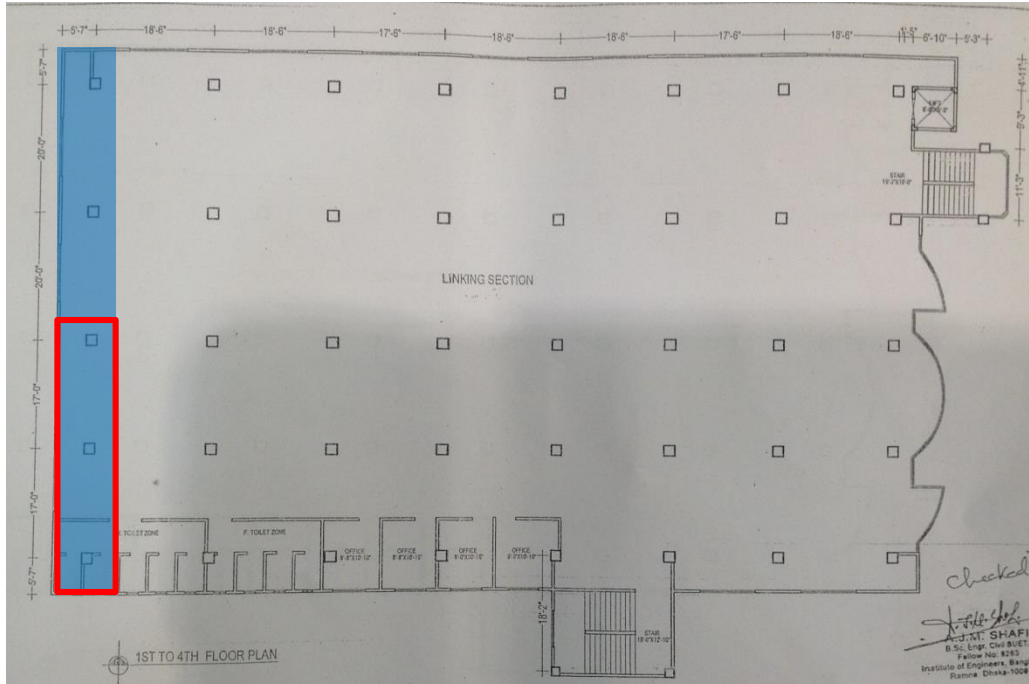
Areas of high super dead loading were noted in the toilets along the West elevation of the building at the cantilever location, in the form of plinths, suspended slabs and walls. Building Engineer to check that the cantilevers have been adequately designed to accommodate this loading.

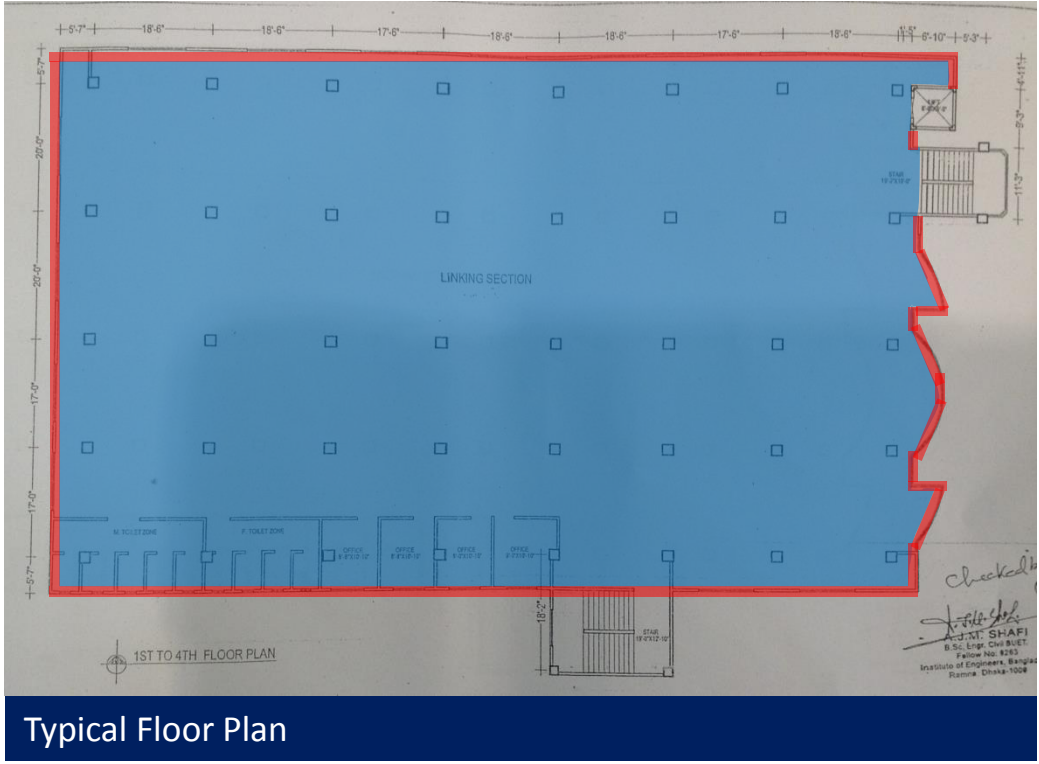
There is no edge protection at Roof level where works are ongoing. Handrails are also missing to stairs. Building Engineer to install adequate fall barrier / guarding with immediately effect.

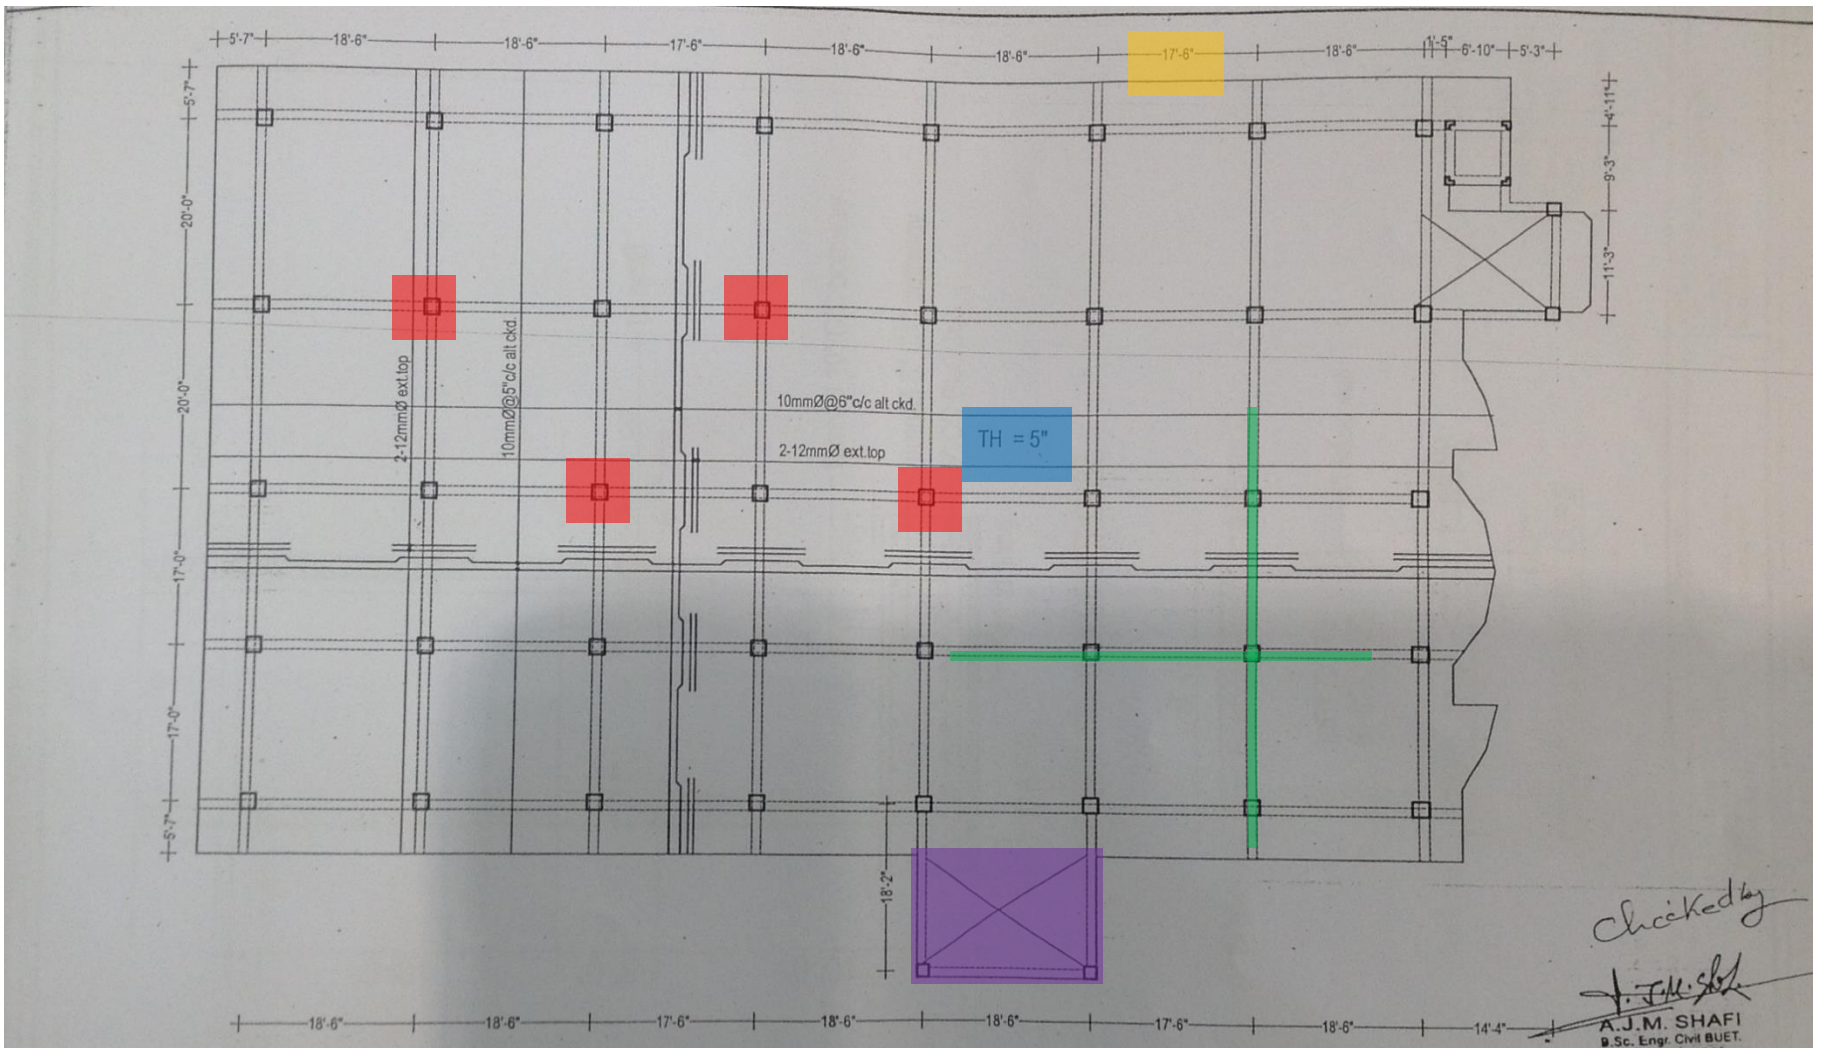
Building Engineer to review and provide clarification.

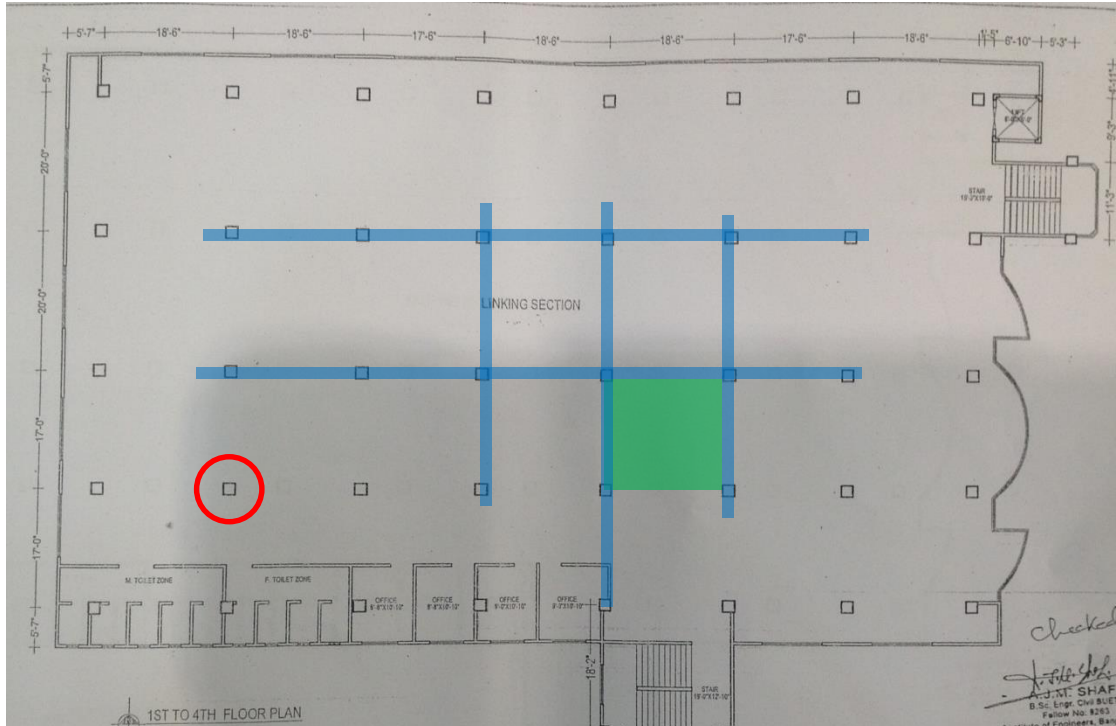
Hairline cracking was observed to the soffit of a number of beams and slabs at Ground, 2nd, 3rd, and 4th Floor levels. Building Engineer to investigate and carry out remedial works to the structure as required.

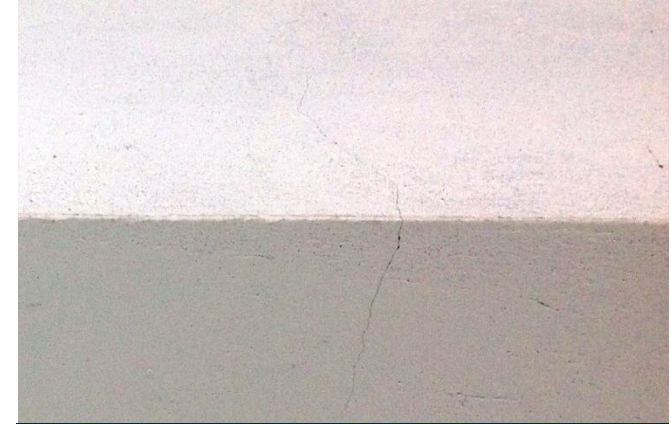
Cracking to underside of beam

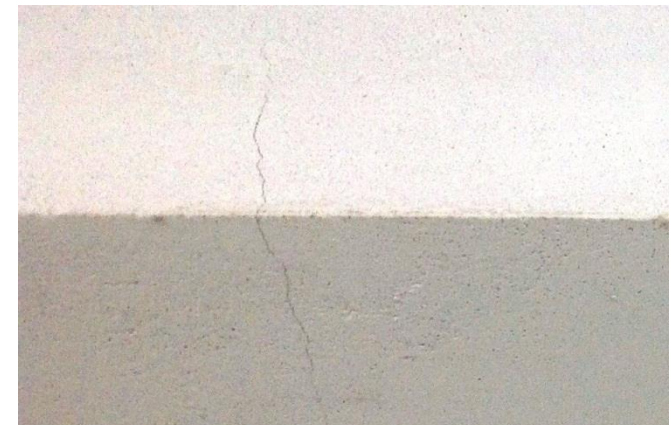
Cracking to underside of beam

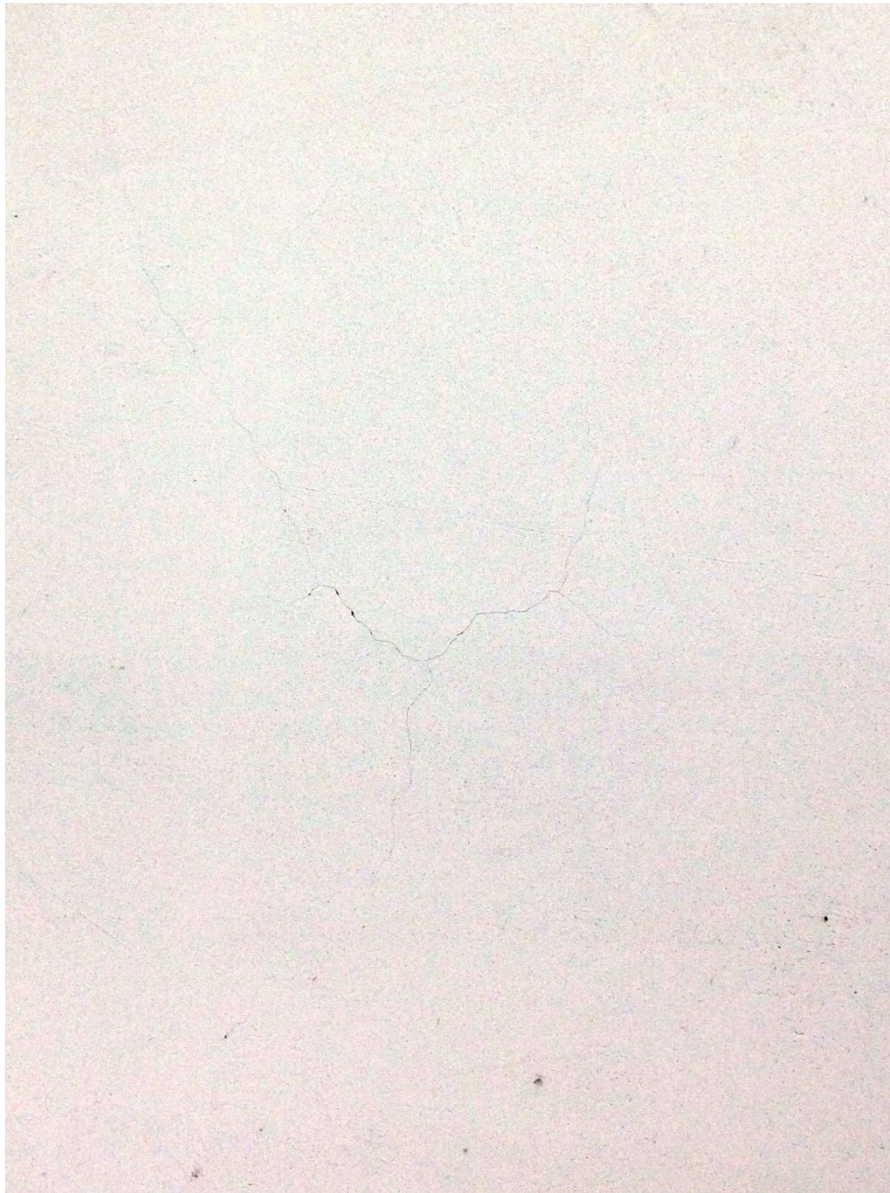
Cracking to underside of two-way spanning slab

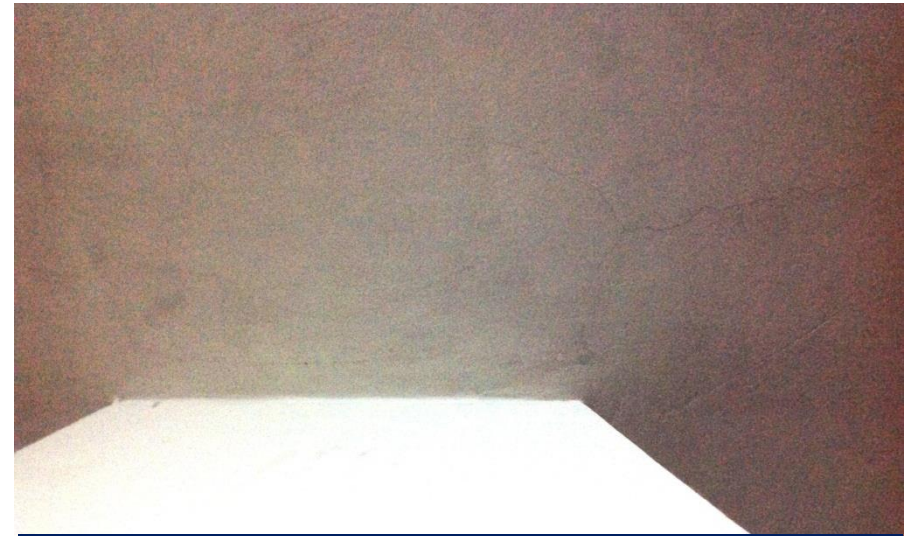
Cracking to underside of flat slab adjacent to column

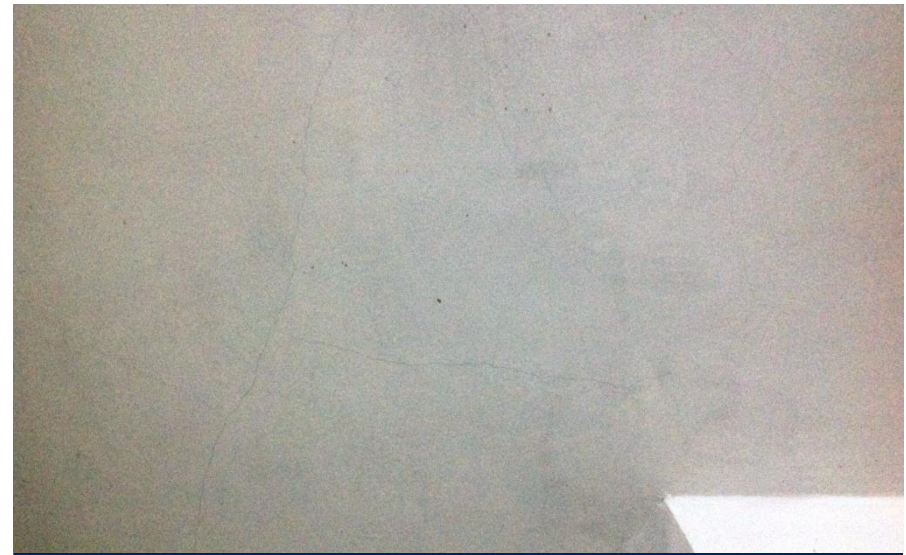
Cracking to underside of flat slab adjacent to column

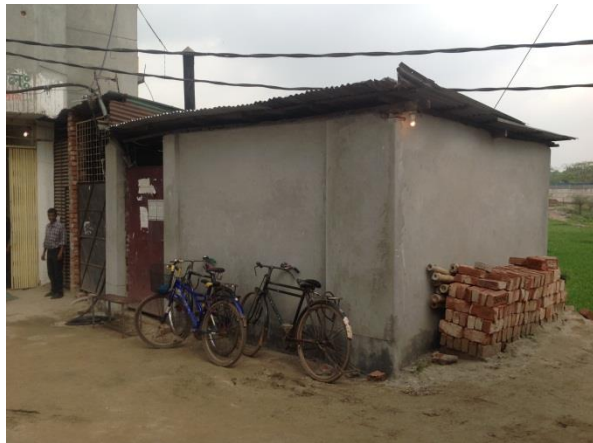
Lightweight Steel Roof to Ground Floor Generator Room

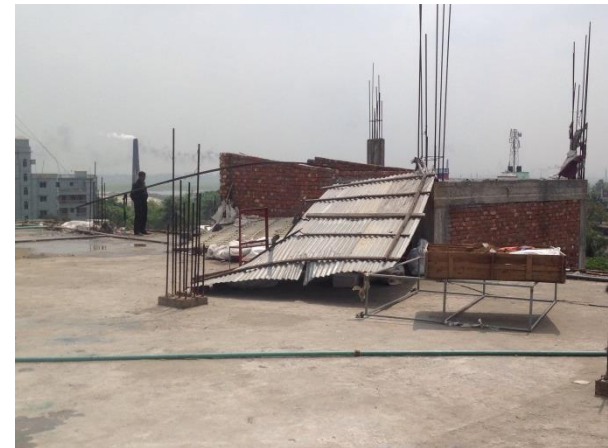
Apparently loose metal sheeting at Roof level
