# MIDLINE SWEATER LTD. FACTORY

Baro Boyka, Chandona, Gazipur Sadar, Gazipur-1702

20<sup>th</sup> February 2019

# Observation

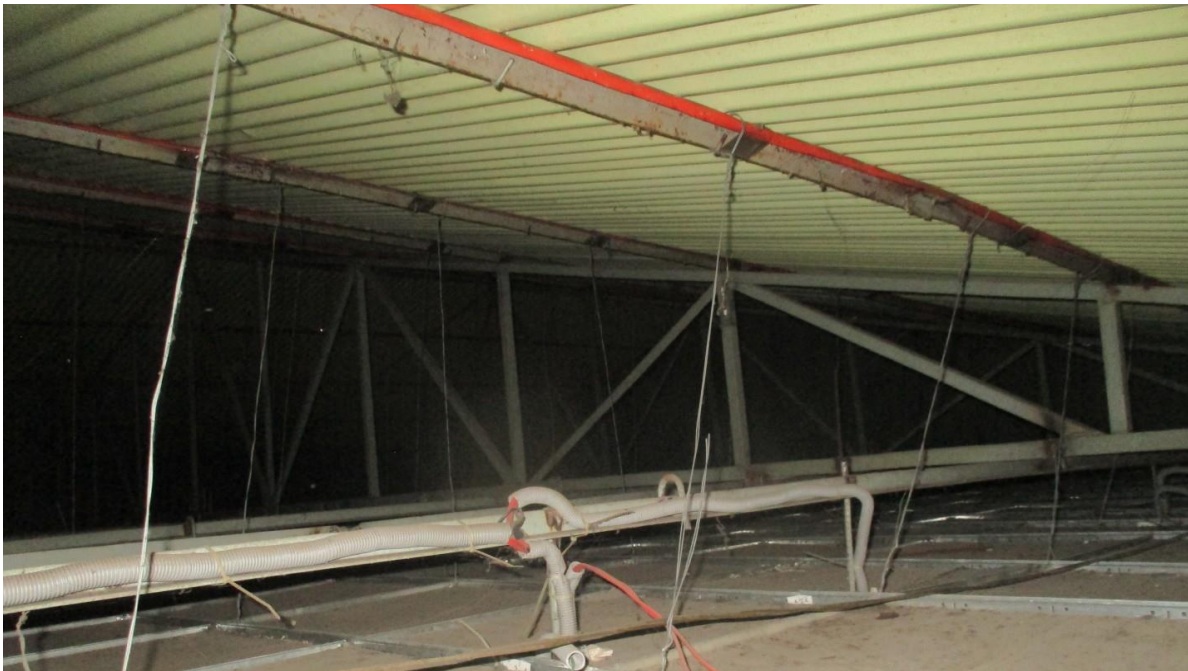
Actual Truss Section (No roof bracing)

No bracing was found at the roof level. Also poor joint connections were observed between steel truss and columns. Factory engineer is required to verify the lateral stability of the shed structure against lateral and vertical loads.

| Item No. | Observation | Recommended Action Plan | Recommended Timeline |
|---|---|---|---|
| 1 | Lateral stability to be verified. (Production shed) | Factory engineer to check the stability of lightweight steel shed against vertical and lateral loads. | 6-weeks |
| 2 | Lateral stability to be verified. (Production shed) | Carry out remedial works resulting from engineering assessment where necessary. | 6-months |

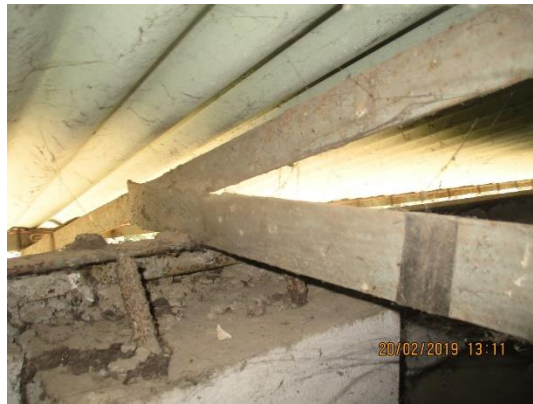
End support condition of truss

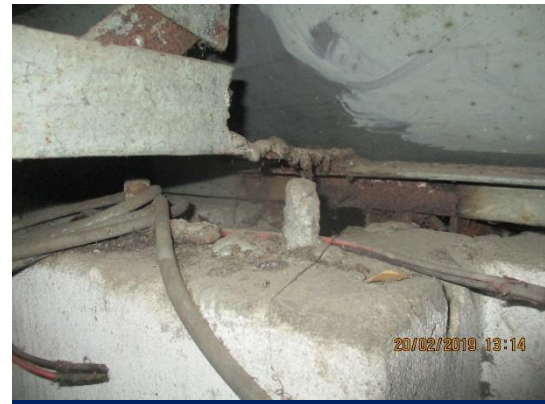
Middle support condition of truss

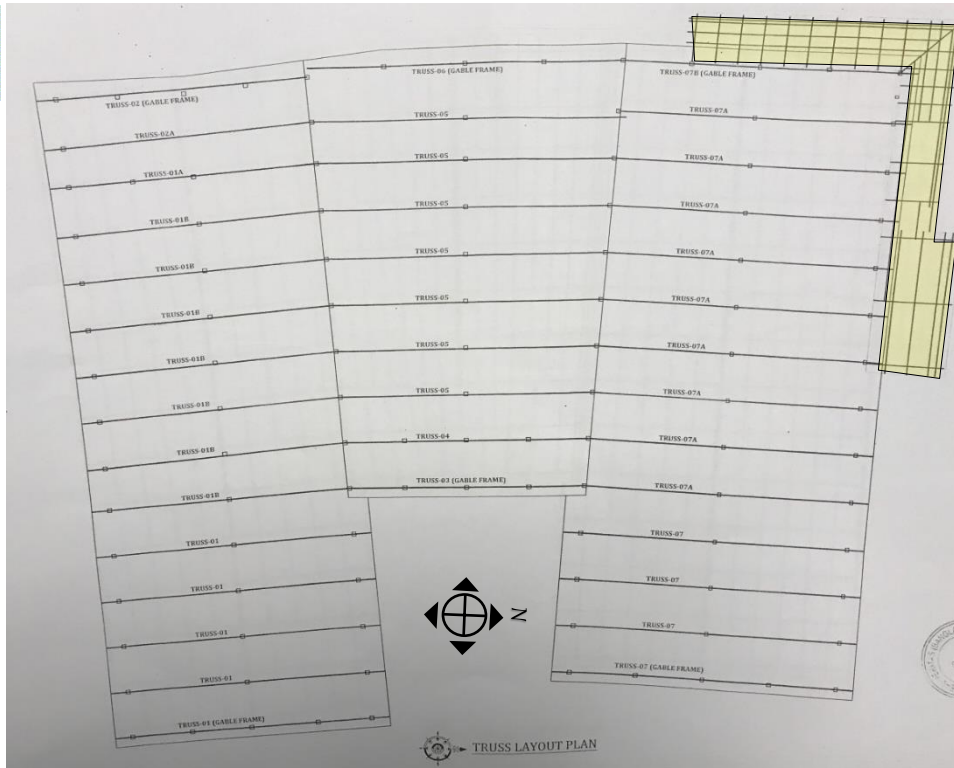
Extension part of Production shed

The support condition of the steel roof was not clear and apparently non engineered. Factory is required to replace the existing shed with an engineering shed.

| Item No. | Observation | Recommended Action Plan | Recommended Timeline |
|---|---|---|---|
| 3 | Apparently non-engineered light weight roof shed of extension part. (Production shed) | Factory is required to replace the existing shed with an engineering shed. | 6-weeks |

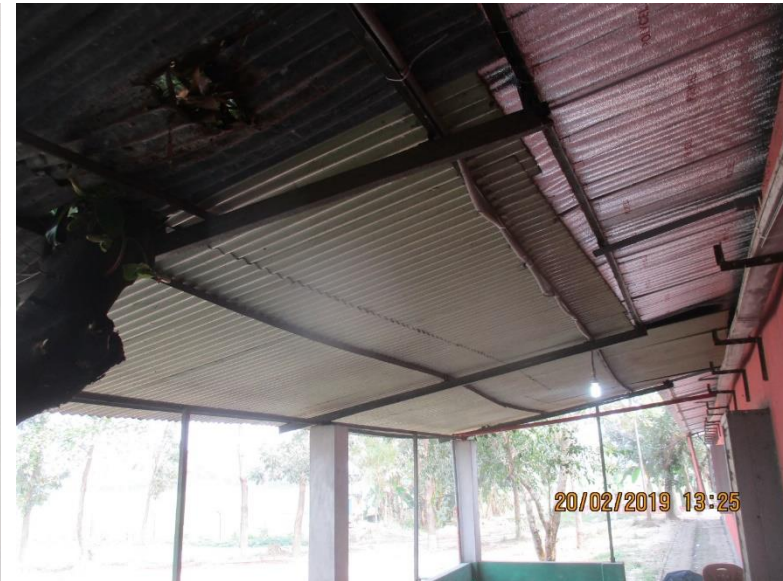
Flimsy steel roof frame

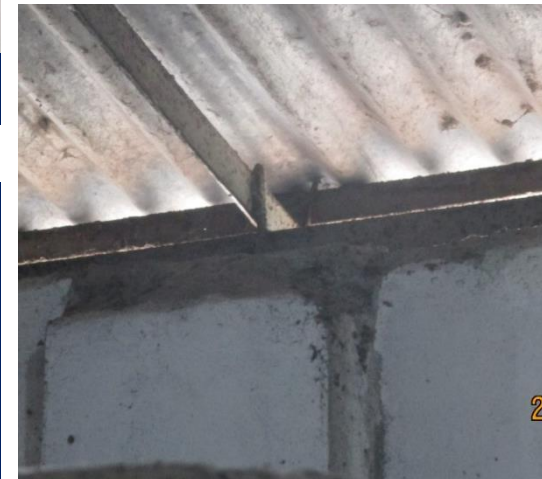
Welded connection between steel member and column's rebar

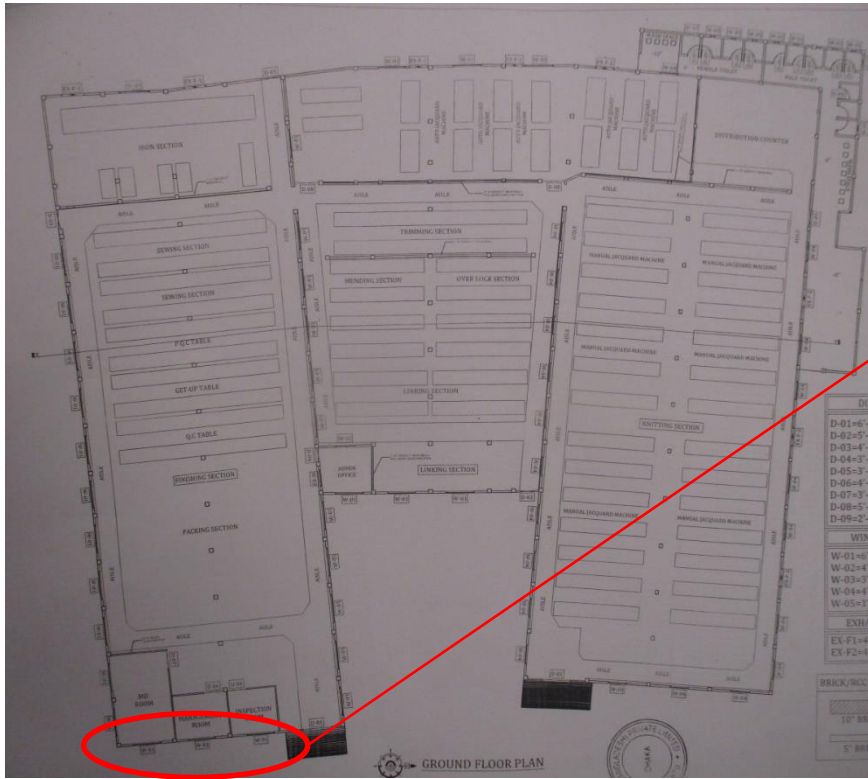
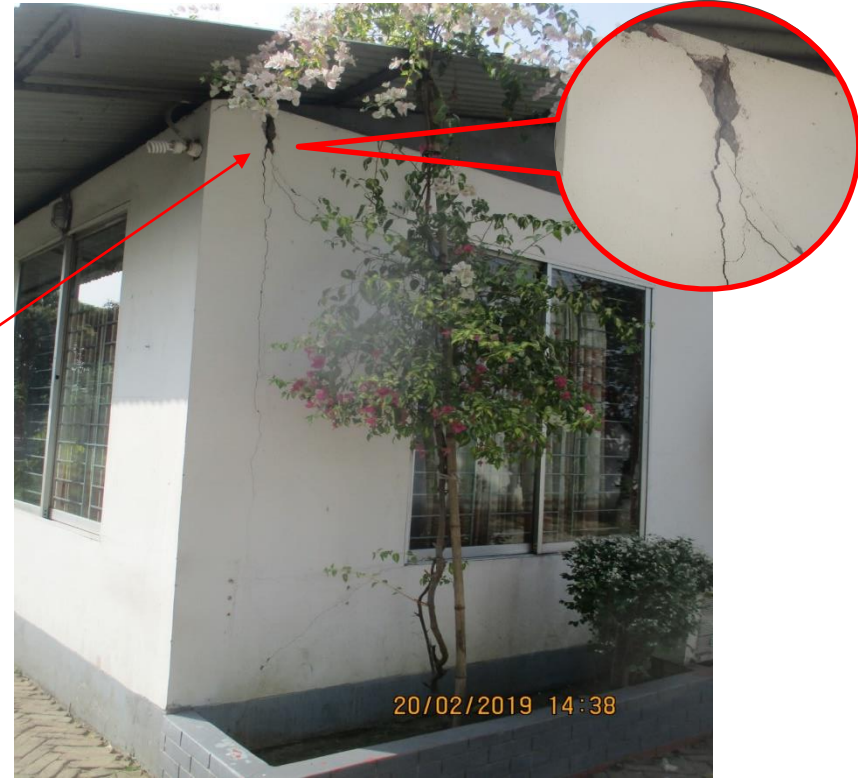
# Crack on west side peripheral masonry wall

Crack was observed in peripheral masonry wall on west side. Factory Engineer is required to identify the reasons and recommend the remedial measures.

| Item No. | Observation | Recommended Action Plan | Recommended Timeline |
|---|---|---|---|
| 4 | Crack on west side peripheral masonry wall. (Production shed) | Factory engineer is required to identify the reasons and provide the remedial measures. | 6-weeks |

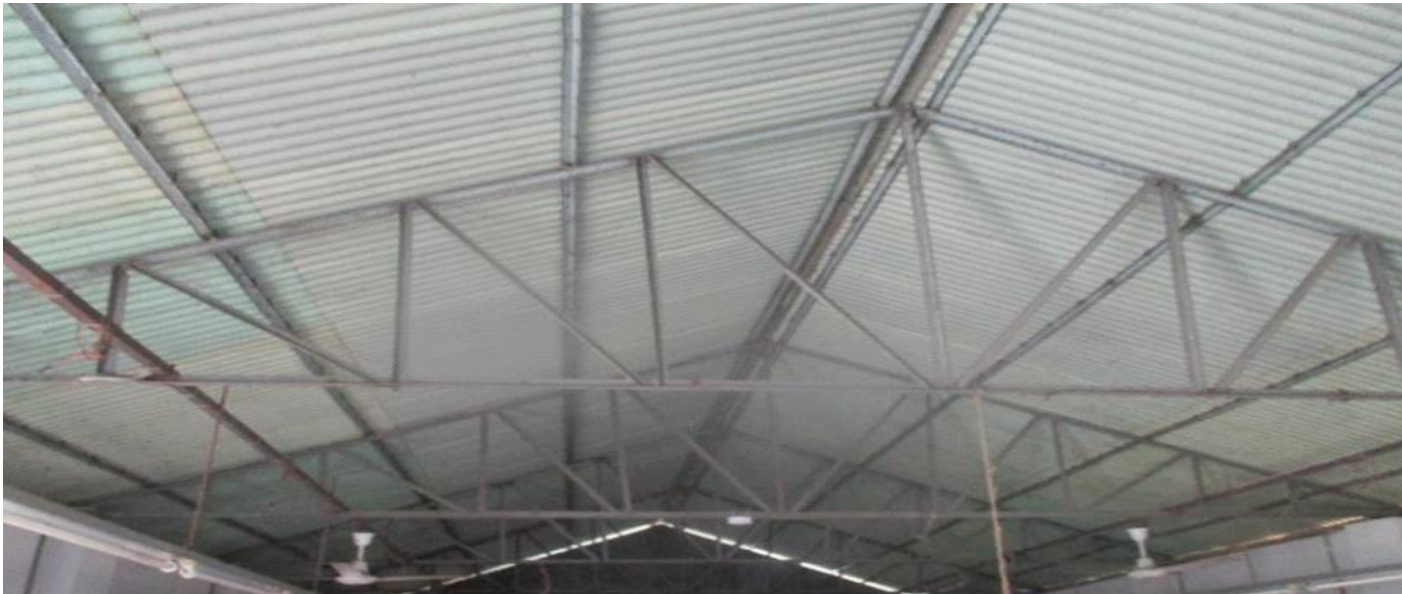
Internal truss system with no roof bracing or vertical bracing

No bracing had been installed in the winding shed. All truss-wall joints were apparently inadequate. Lateral stability of the structure was not clear. Also, no as-built drawings for this structure was available. Factory is required to produce as built drawings and analyze the lateral stability of the structure against vertical and horizontal loads.

| Item No. | Observation | Recommended Action Plan | Recommended Timeline |
|---|---|---|---|
| 5 | Lack of Lateral Stability. (Winding shed) | Factory engineer to survey the whole shed and produce as-built documentation reflecting the as constructed condition. | 6-weeks |
| 6 | Lack of Lateral Stability. (Winding shed) | Factory engineer to check the stability of lightweight steel shed against vertical and lateral loads. | 6-weeks |
| 7 | Lack of Lateral Stability. (Winding shed) | Carry out remedial works resulting from engineering assessment where necessary. | 6-months |

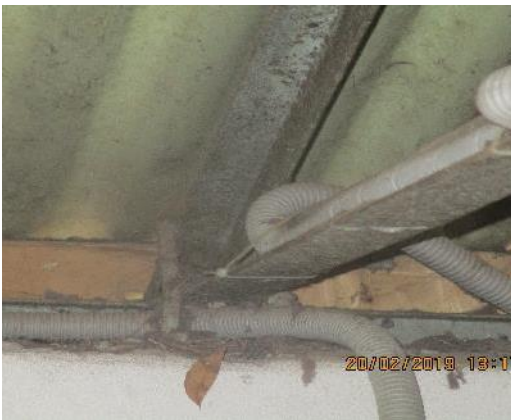
Poor welding joint at end point

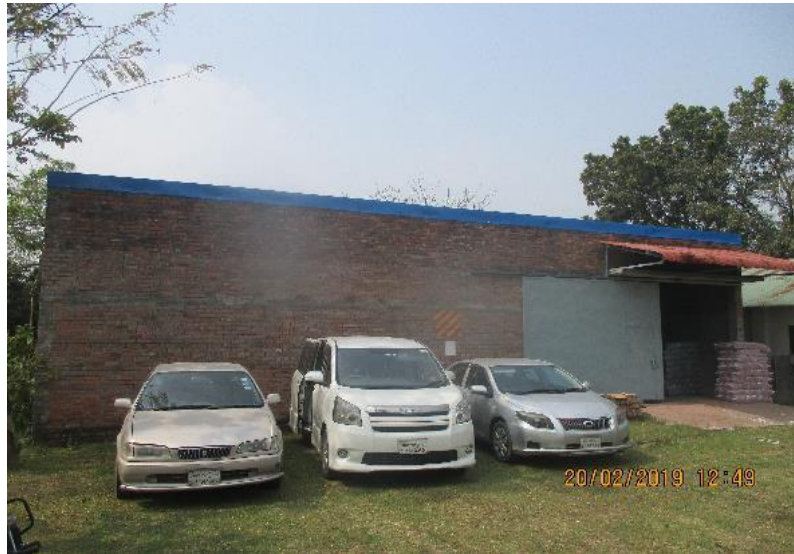
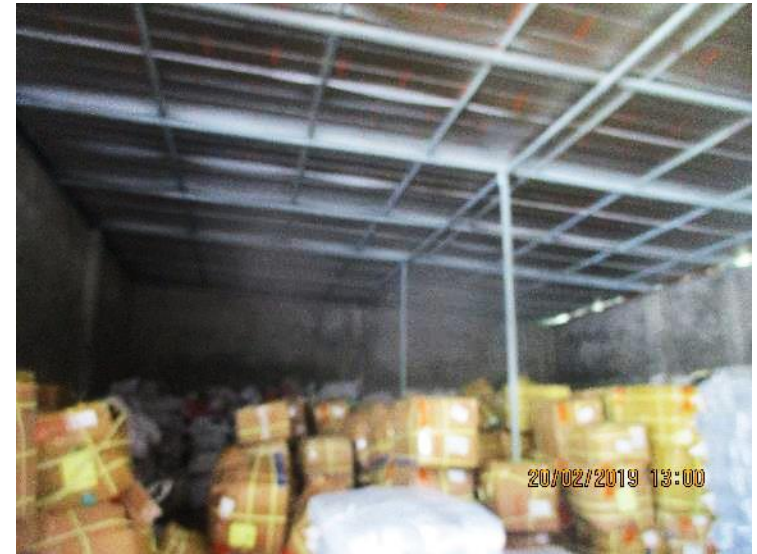
# Apparently non-engineered shed

Bonded Ware House is apparently a non engineered shed. The steel roof frame is constructed by angle sections and the wall-steel frame joints are welded. Also no as built drawings of this structure was available. Factory is required to assess the lateral stability of this structure and take necessary remedial actions as required.

| Item No. | Observation | Recommended Action Plan | Recommended Timeline |
|---|---|---|---|
| 8 | Apparently non-engineered shed. (Bonded ware house shed) | Factory engineer to survey the whole shed and produce as-built documentation reflecting the as constructed condition. | 6-weeks |
| 9 | Apparently non-engineered shed. (Bonded ware house shed) | Factory engineer to check the stability of lightweight steel shed against vertical and lateral loads. | 6-weeks |
| 10 | Apparently non-engineered shed. (Bonded ware house shed) | Carry out remedial works resulting from engineering assessment where necessary. | 6-months |

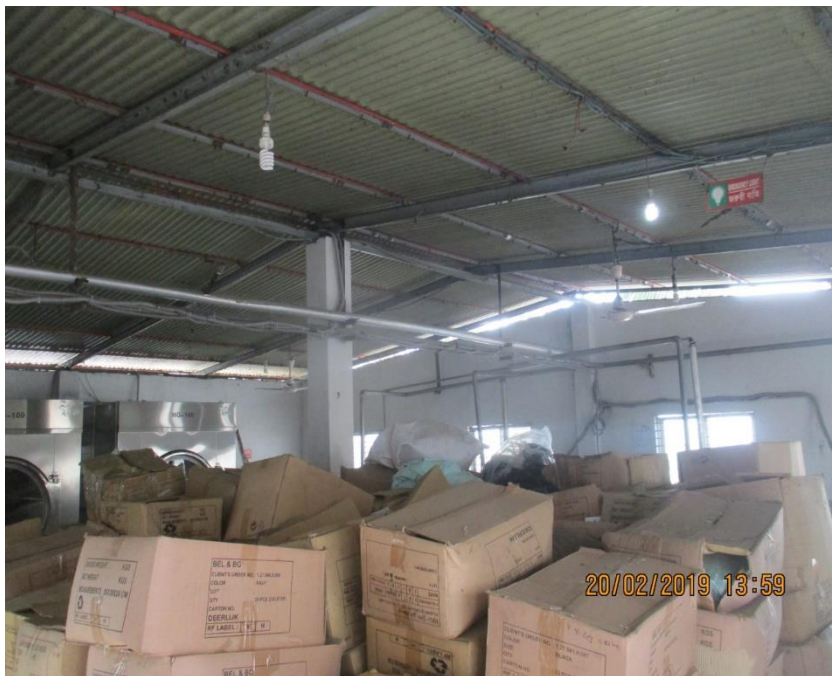
Steel roof members were supported by RC columns

The support condition of the steel roof was poorly welded with column's rebar. In addition, factory could not provide any structural document of the shed. Factory Engineer is required to produce a full set of as-built drawing reflecting actual condition and assess the lateral stability of the shed against vertical and lateral loads.

| Item No. | Observation | Recommended Action Plan | Recommended Timeline |
|---|---|---|---|
| 11 | Apparently non-engineered roof shed. (Washing shed) | Factory engineer to survey the whole shed and produce as-built documentation reflecting the as constructed condition. | 6-weeks |
| 12 | Apparently non-engineered roof shed. (Washing shed) | Factory engineer to check the stability of lightweight steel shed against vertical and lateral loads. | 6-weeks |
| 13 | Apparently non-engineered roof shed. (Washing shed) | Carry out remedial works resulting from engineering assessment where necessary. | 6-months |

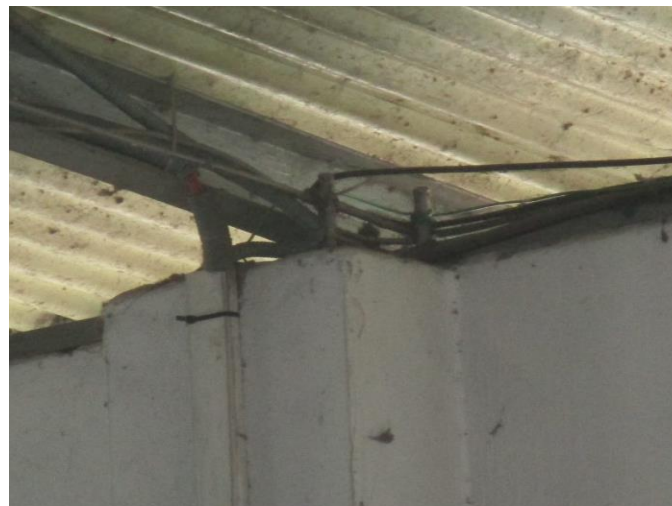
Flimsy support condition at end of steel member

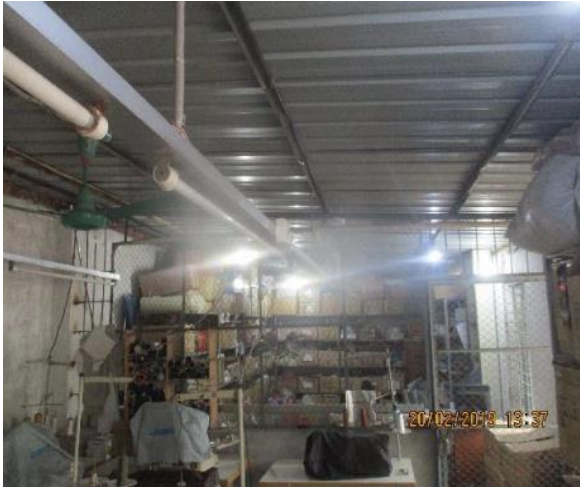
Inside Dining & Storage Shed

Dining & Storage Shed is apparently a non engineered shed. The steel roof frame is constructed by angles and the column-steel frame joints are welded. Some purlins were deflected. Also no as built drawings of this structure was available. Factory is required to assess the lateral stability of this structure and take necessary remedial actions as required.

| Item No. | Observation | Recommended Action Plan | Recommended Timeline |
|---|---|---|---|
| 14 | Apparently non-engineered shed. (Dining and storage shed) | Factory engineer to survey the whole shed and produce as-built documentation reflecting the as constructed condition. | 6-weeks |
| 15 | Apparently non-engineered shed. (Dining and storage shed) | Factory engineer to check the stability of lightweight steel shed against vertical and lateral loads. | 6-weeks |
| 16 | Apparently non-engineered shed. (Dining and storage shed) | Carry out remedial works resulting from engineering assessment where necessary. | 6-months |

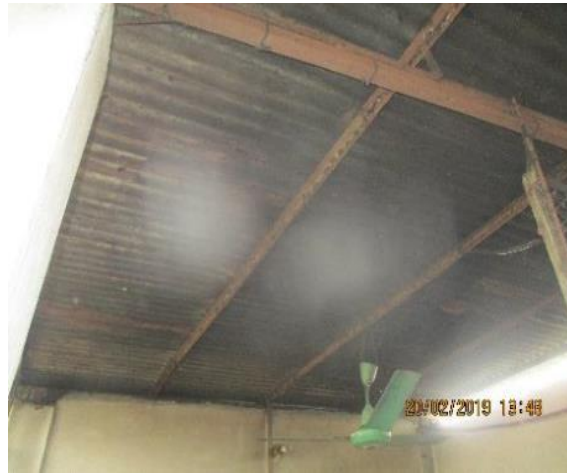
Deflected purlin

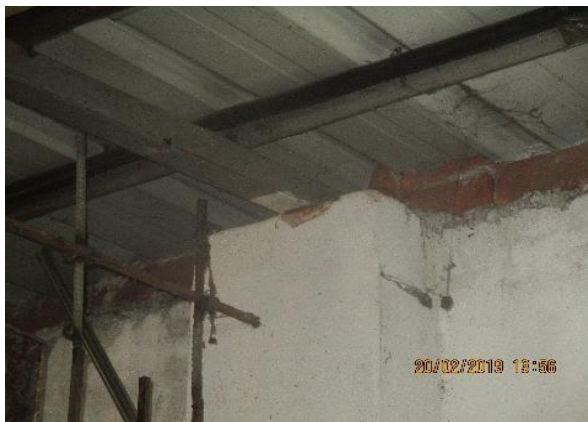
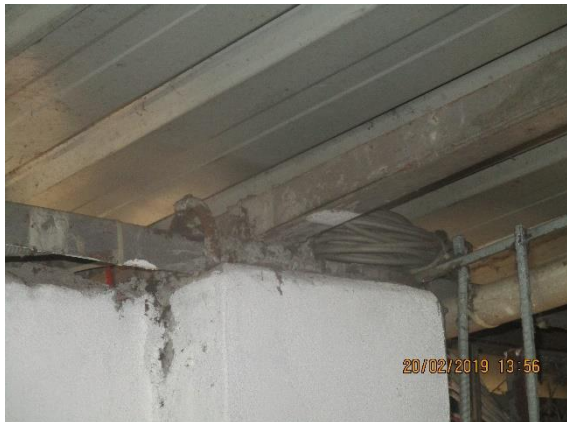
Steel frame- Wall Joints

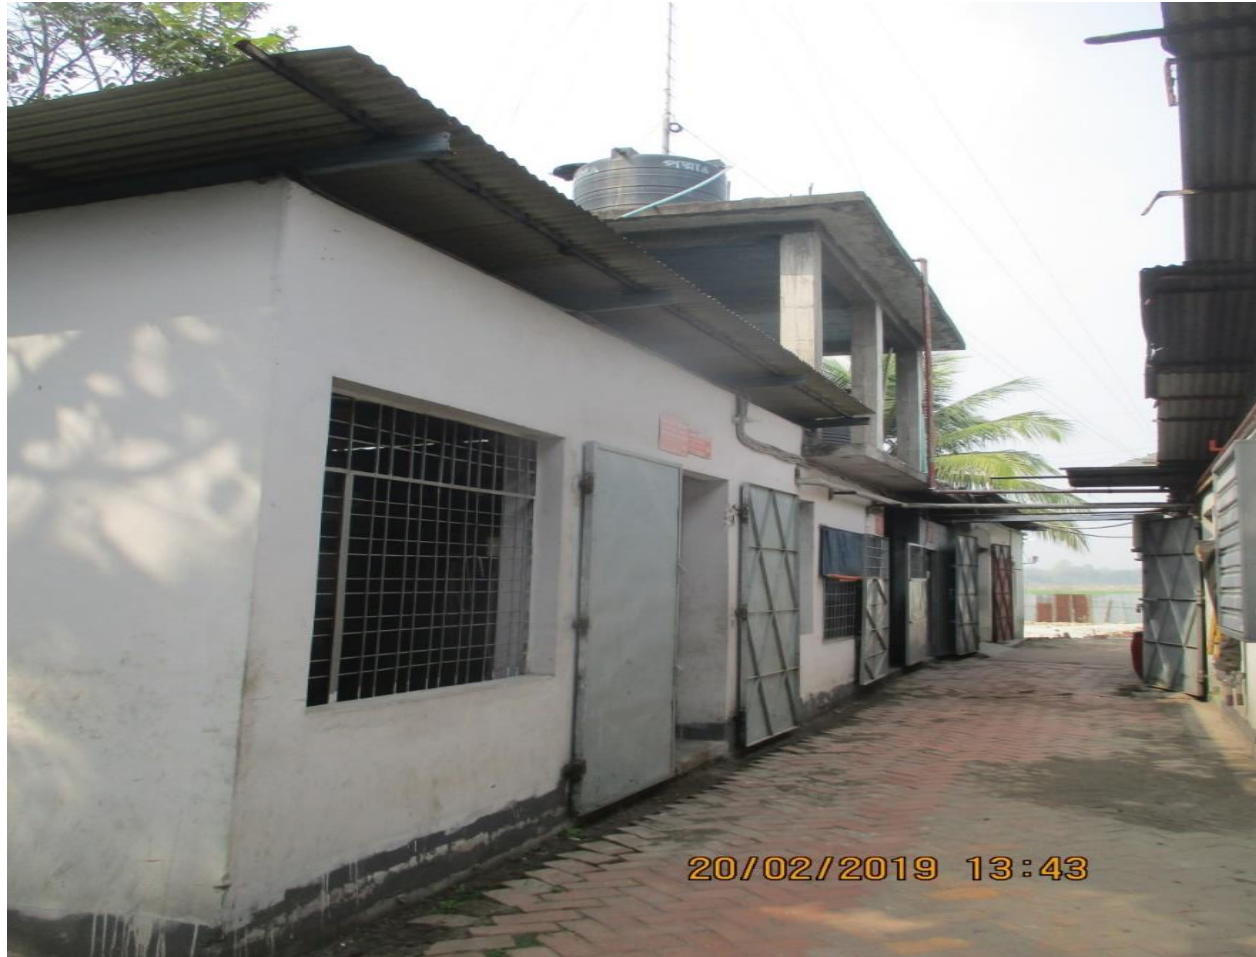
No as-built drawing was available on site for the building. Factory Engineer is required to produce a full set of as-built drawing reflecting actual condition

| Item No. | Observation | Recommended Action Plan | Recommended Timeline |
|---|---|---|---|
| 17 | Absence of as-built drawing. (Utility building) | Factory engineer to survey the whole structure and produce as-built documentation reflecting the as constructed condition. | 6-weeks |

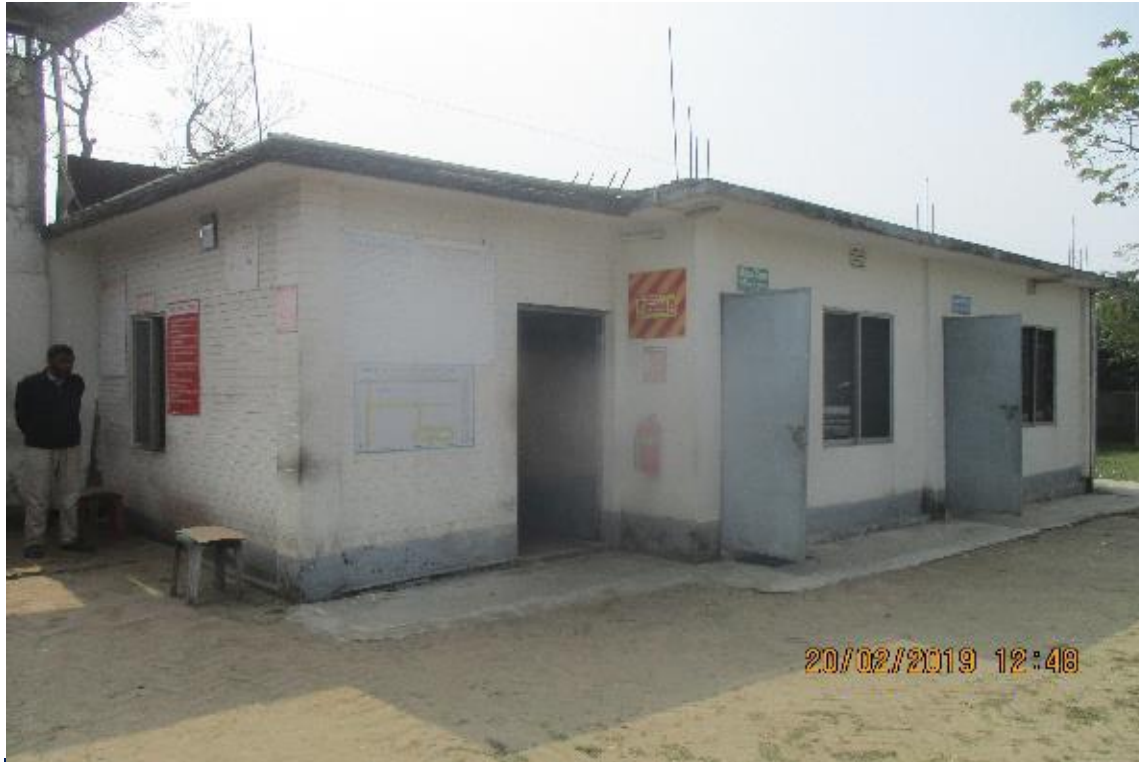
No As-Built drawings were available on site for the structure.  
Factory engineer is required to produce as-built drawings which  
reflects on-site condition.

| Item No. | Observation | Recommended Action Plan | Recommended Timeline |
|---|---|---|---|
| 18 | No drawings were available on site. (Medical and Guard room) | Factory engineer to check, collect information and produce accurate and complete as-built documentation which reflects on-site condition. | 6-weeks |
