Libas Textiles Ltd. (New building)

Nishchintapur, Mouchak, Kaliakoir, Gazipur.

10th July & 5th August 2019

Observations

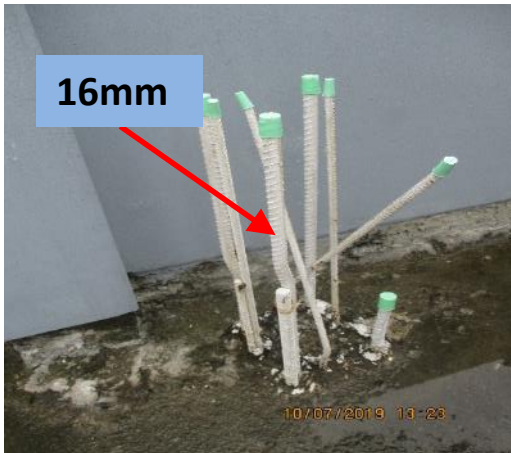
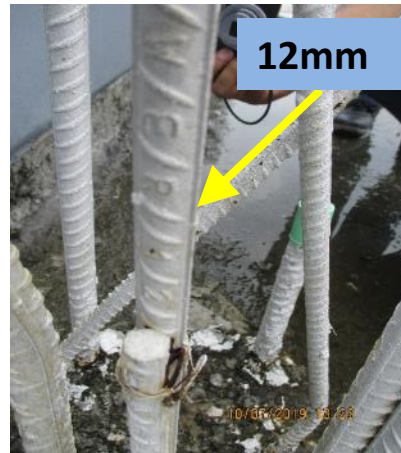
4 nos. 16 mm and 4 nos. 12 mm rebars were found on site in C-4 type column

| Item No. | Observation | Recommended Action Plan | Recommended Timeline |
|---|---|--|---|
| 1 | Discrepancies between drawings and on-site observation (Building-3) | Building Engineer to survey the whole structure and prepare accurate as-built drawings. | 6-weeks |

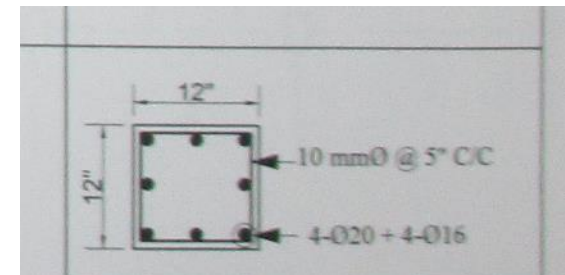
4 nos. 20mm and 4 nos. 16mm rebar were shown in column schedule for C-4 type column at roof

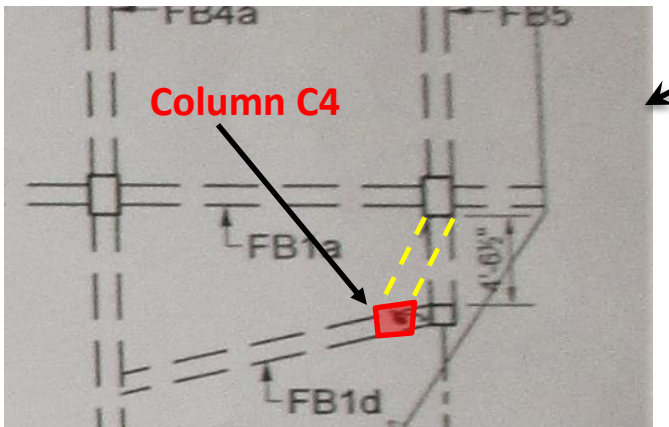
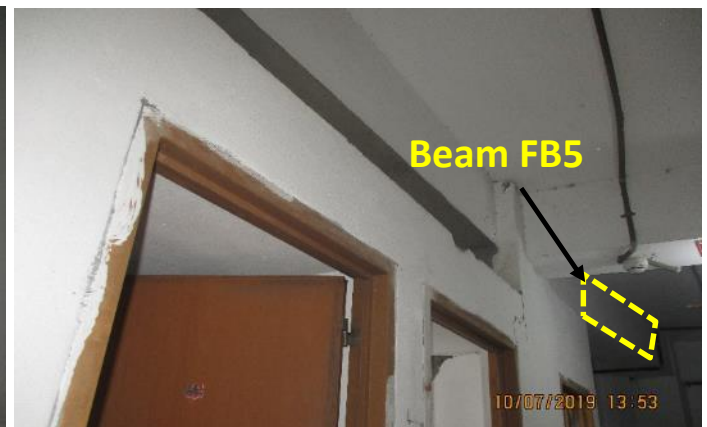
Beam FB5 was found offset towards west from grid I2'.

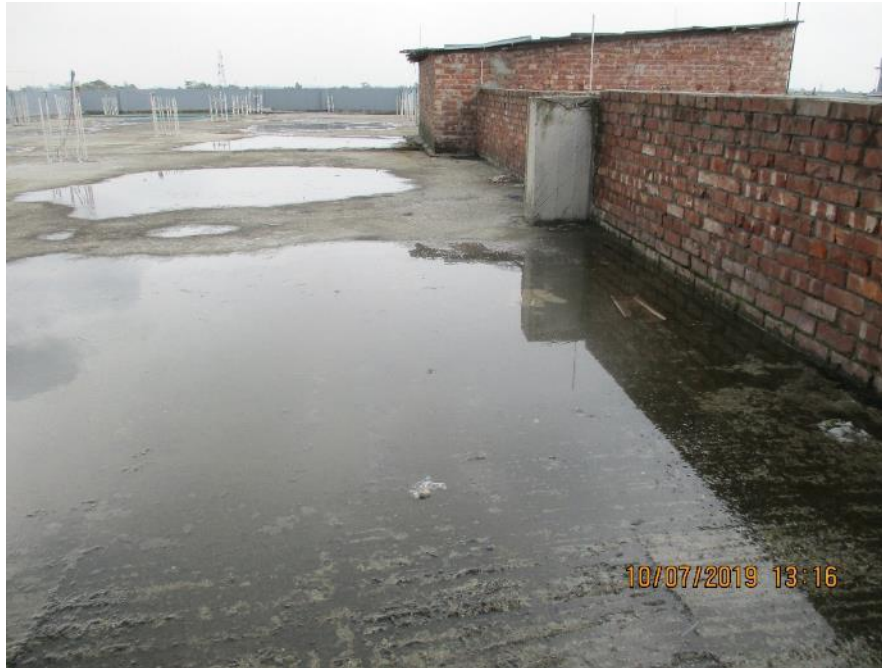
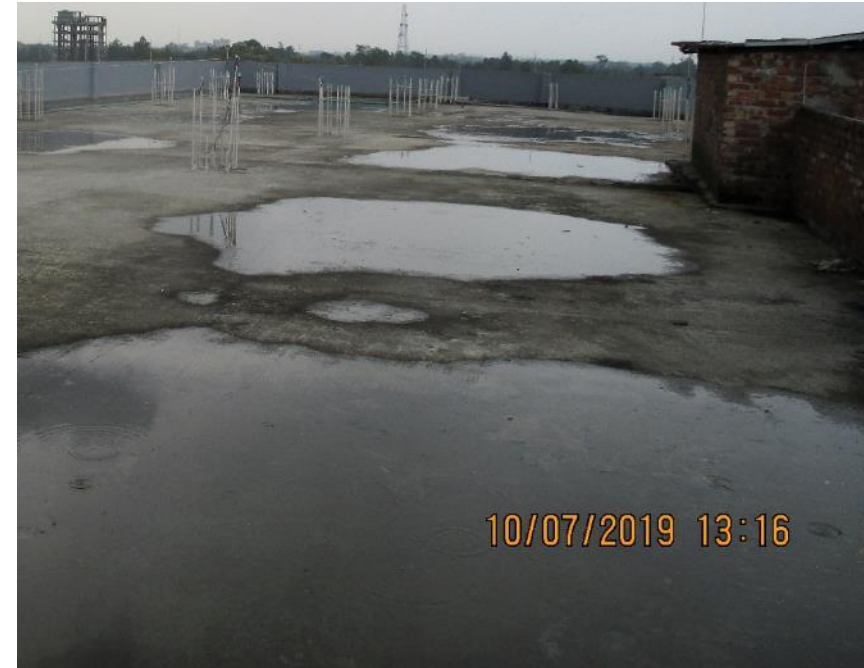
Water clogging was observed on roof top which indicates poor drainage system. Factory engineer is required to provide appropriate remediation to improve drainage system.

| Item No. | Observation | Recommended Action Plan | Recommended Timeline |
|---|---|--|---|
| 2 | Water clogging and lack of drainage system on roof (Building-3) | Drainage system on roof slab to be improved. | 6-weeks |

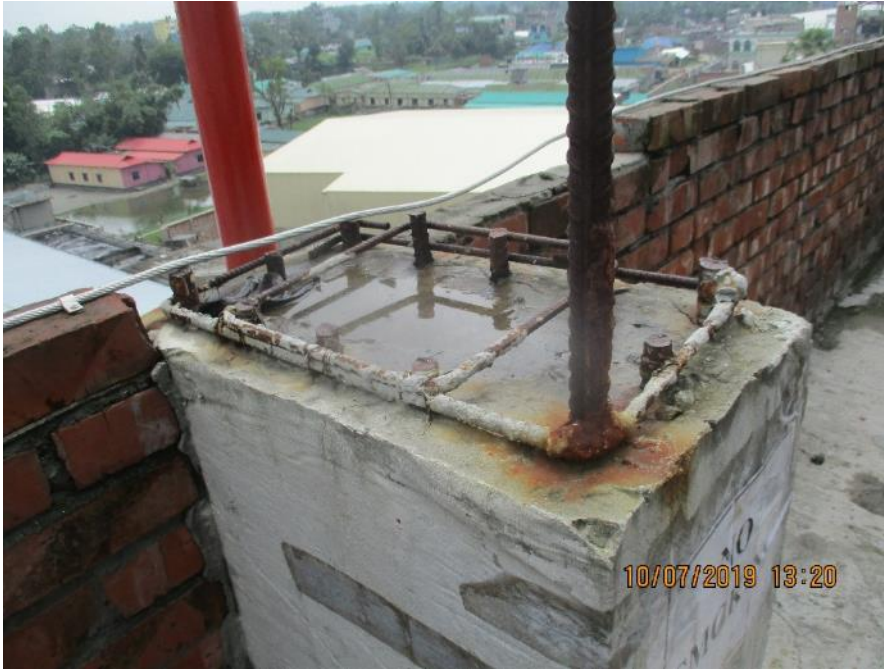
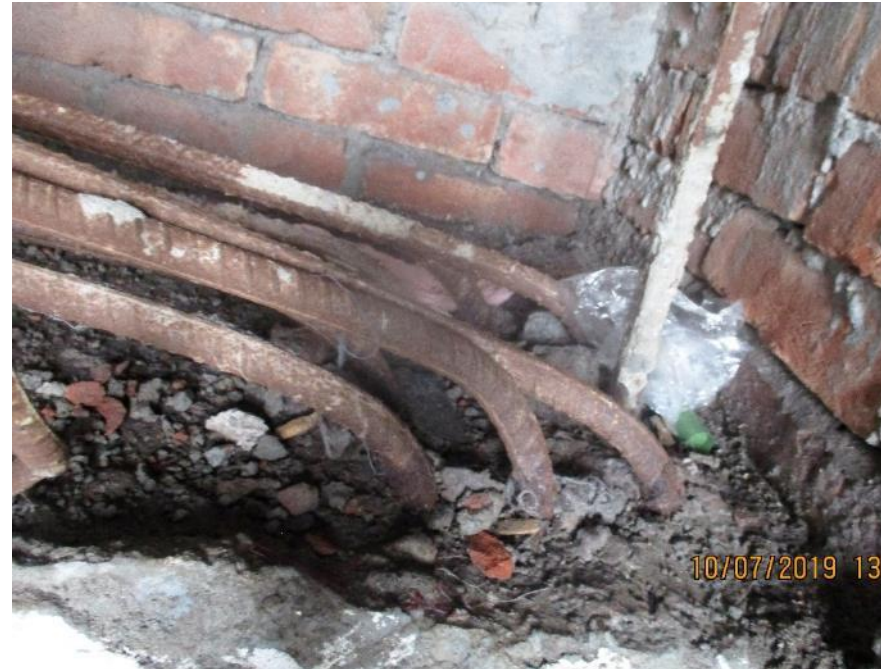
Exposed rebar on roof

Most of the exposed reinforcement on roof level were painted but some of the columns have exposed reinforcements which are susceptible to corrosion. Adequate protection from corrosion is required to be provided to all the exposed reinforcements.

| Item No. | Observation | Recommended Action Plan | Recommended Timeline |
|---|---|--|---|
| 3 | Exposed reinforcements on roof (Building-3) | Provide protection to all exposed reinforcement to prevent corrosion. | 6-weeks |

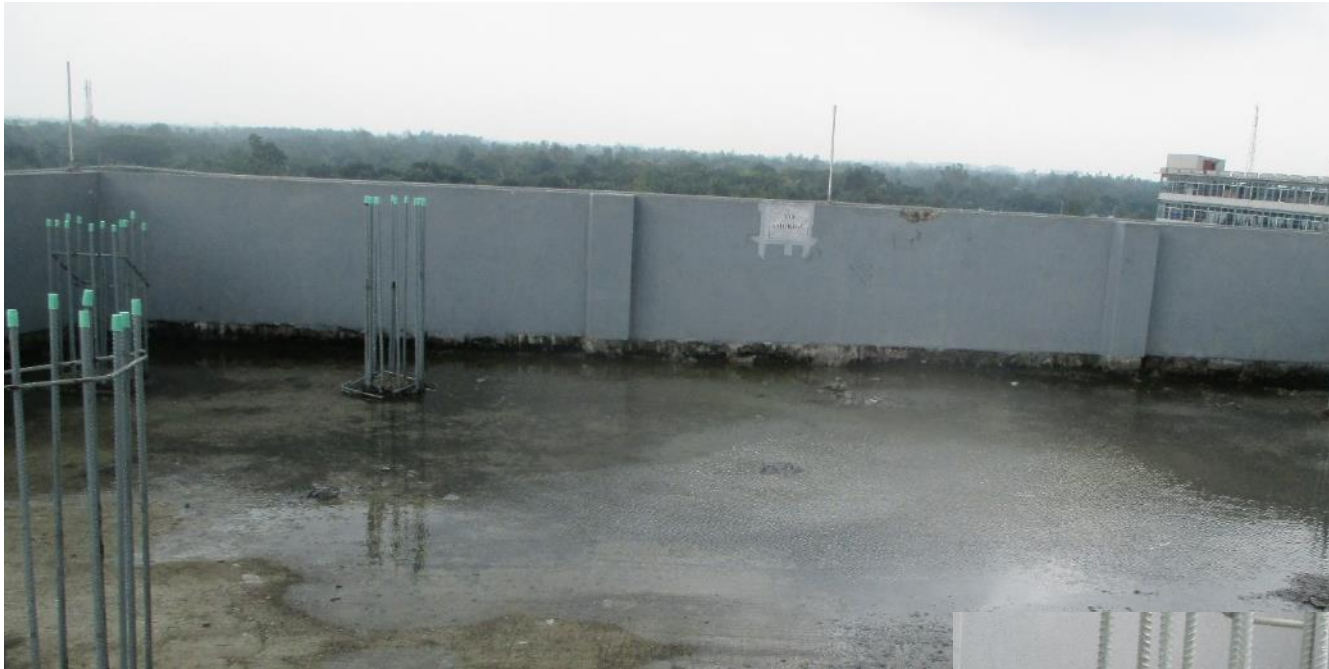
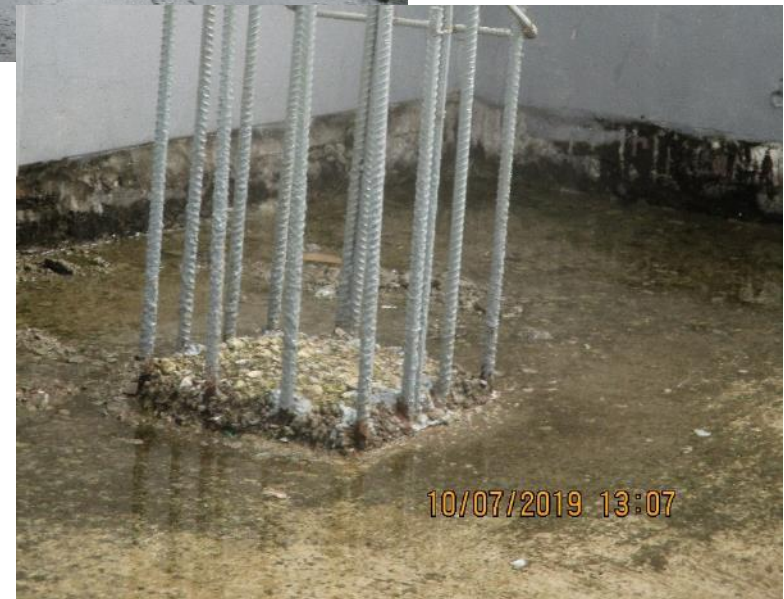
Water clogging was observed on roof top which indicates poor drainage system. Moreover, water was seeping through roof top slab. Factory engineer is required to provide water proofing material with appropriate sloping and improve drainage system.

| Item No. | Observation | Recommended Action Plan | Recommended Timeline |
|---|---|--|---|
| 4 | Water clogging and lack of drainage system on roof (Building-4) | Water proofing material is required to be provided on roof slab with appropriate sloping and drainage system to be improved. | 6-weeks |

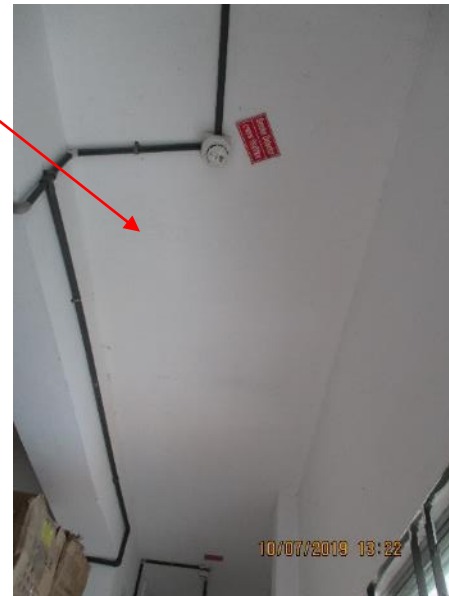
Cantilever slab with cracks

Hairline cracks were observed on slab soffit (cantilever region) and on several floor beams. Sign of water ingress through the cracks on the roof slab was observed.

| Item No. | Observation | Recommended Action Plan | Recommended Timeline |
|---|---|--|---|
| 5 | Cracks found under slab soffit & beam (Building-4) | Crack investigation report is required to be prepared stating the nature of crack and suggesting proper remedial measures. | 6-weeks |
| 6 | Cracks found under slab soffit & beam (Building-4) | Repair cracks as per recommendation of investigation report. | 6-months |

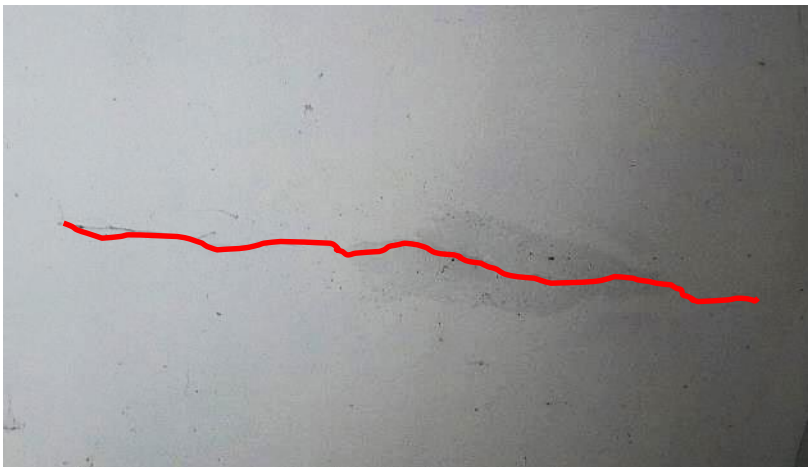
Water ingress through cracks on slab

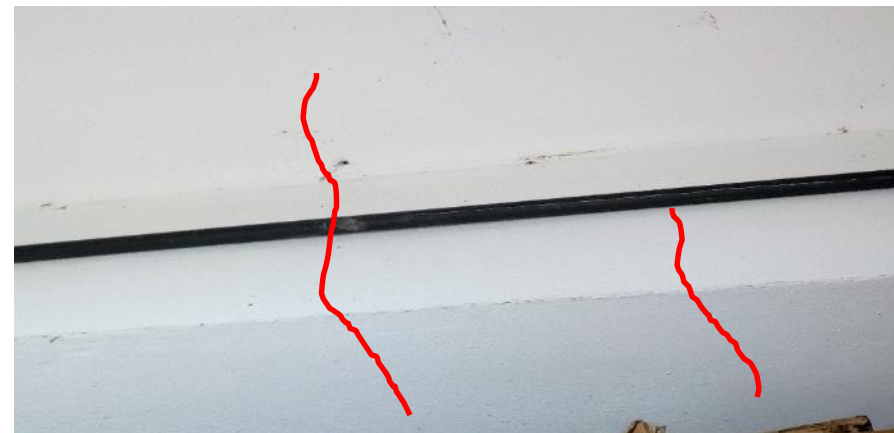
Cracks on peripheral beams

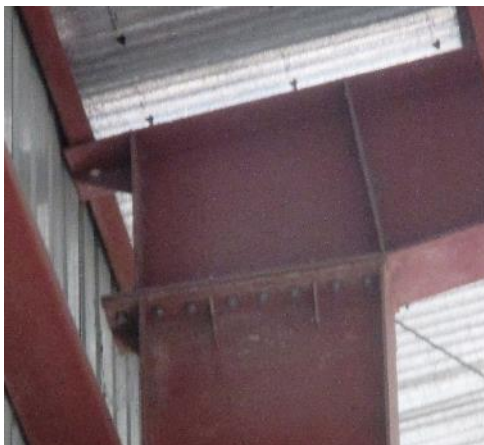
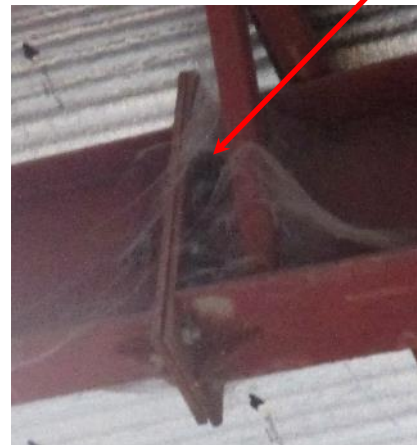
Column-rafter joint has 16-16 mm bolts and rafter-rafter joint has 12-16 mm bolts instead of 16-20 mm bolts as mentioned in as-built drawings

Connection and anchor bolt details provided in as built drawing did not match with on site condition.
Bracing layout or bracing details wasn't incorporated in the as-built drawings.

| Item No. | Observation | Recommended Action Plan | Recommended Timeline |
|---|--|--|---|
| 7 | Incomplete as-built drawings. (Dyeing Shed) | Building Engineer to survey the whole structure and prepare accurate as-built drawings representing actual on-site condition. | 6-weeks |
| 8 | Incomplete as-built drawings. (Dyeing Shed) | Building Engineer to carry out an Engineering Assessment to check connection adequacy. | 6-weeks |

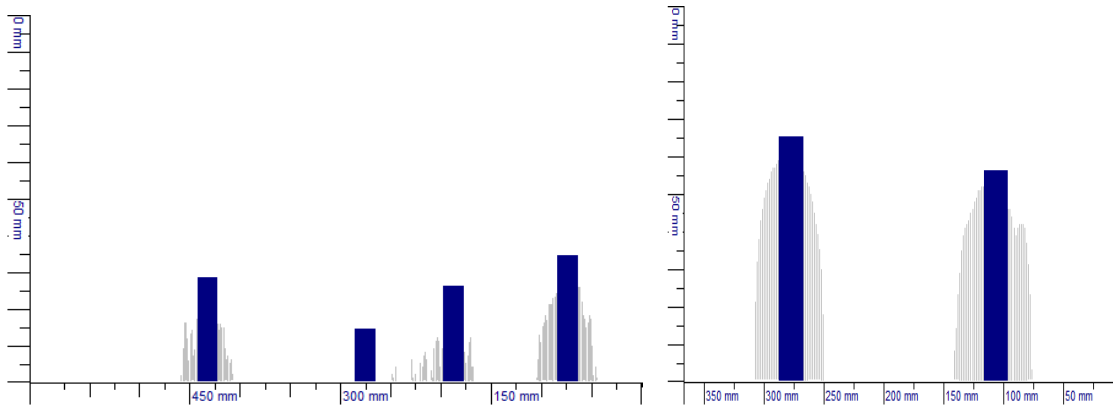
8-20 mm rebars were found in C1 type columns instead of 12-20 mm rebars.

Number of reinforcement mentioned in the as-built drawing was not representative of on site condition. Column layout also did not match with the drawing.

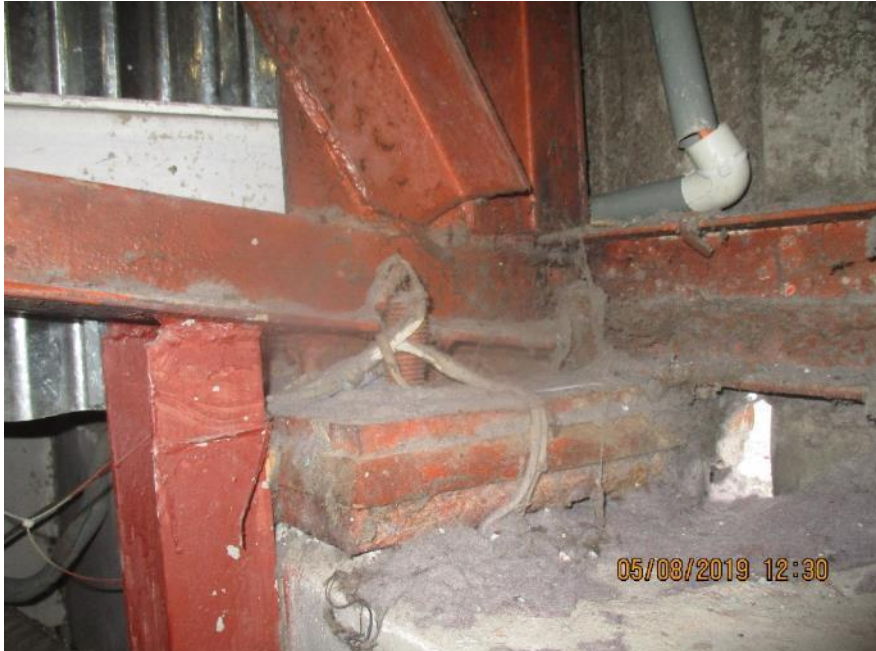
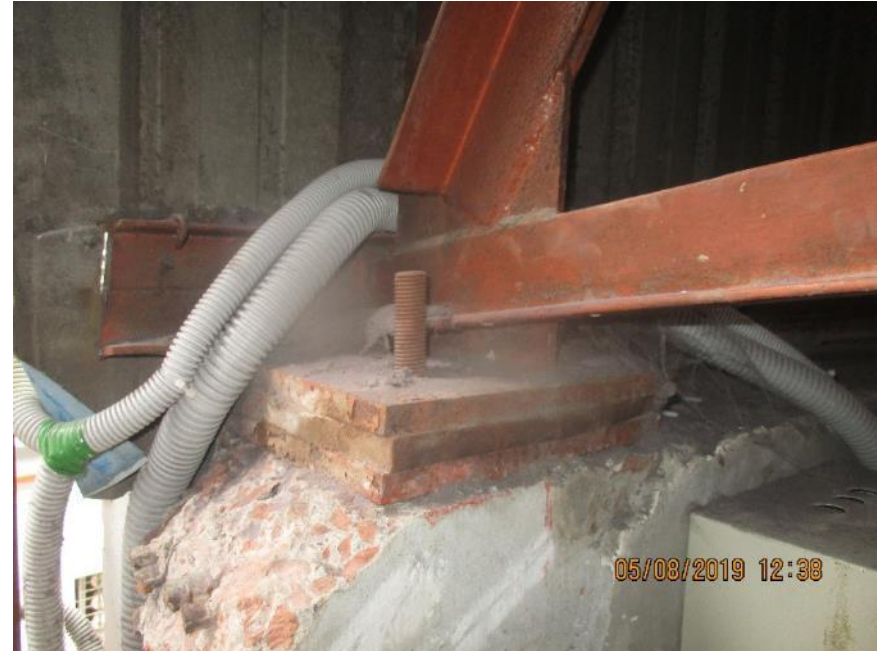
No connection detail of the RC column and steel truss was incorporated in the as-built drawing

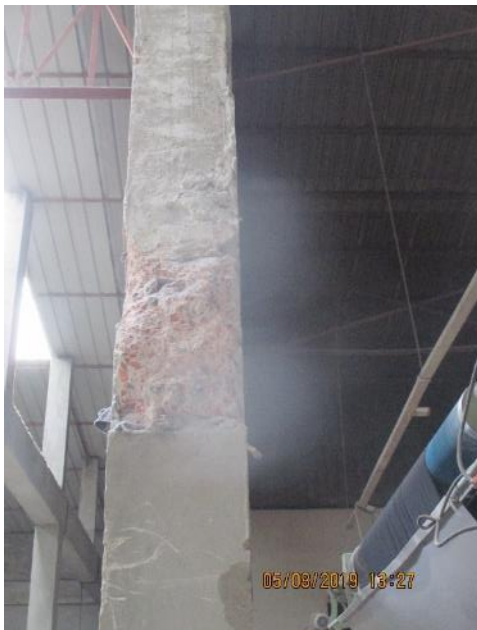
Beams were cut off at some locations.

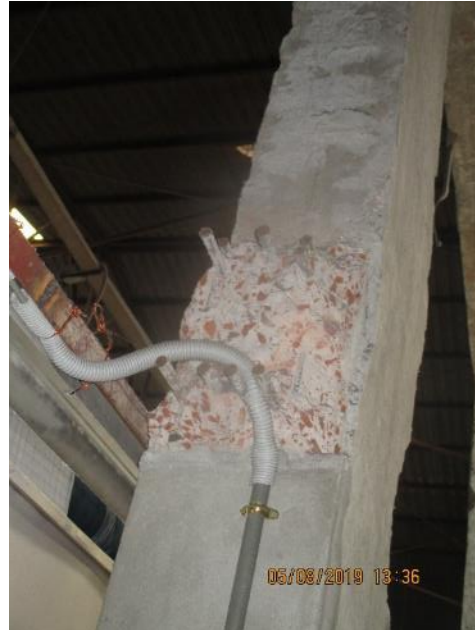
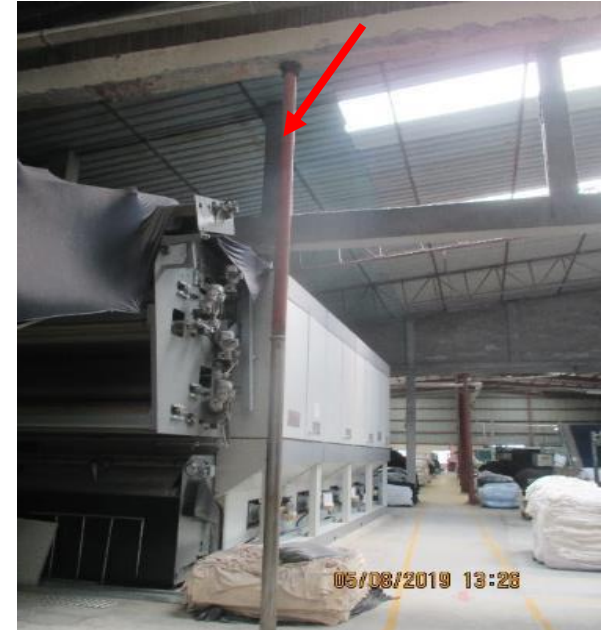
Two RC columns were replaced by a steel pipe

| Item No. | Observation | Recommended Action Plan | Recommended Timeline |
|---|--|--|---|
| 16 | Damaged Structural Member and removed beam & walls (Dyeing Shed) | Building Engineer to check structural adequacy of prop/steel pipe column support. | 6-weeks |

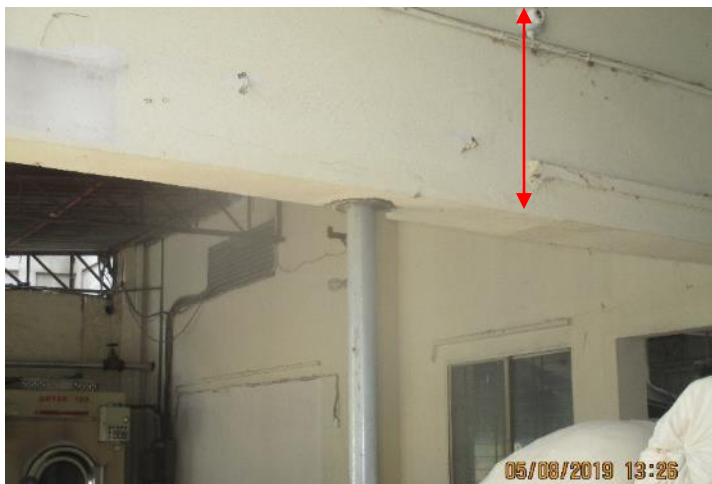
125mm thick and approximately 2m wall

Wall below lintel was removed to insert machines in the shed. And only a steel pipe was placed in the middle of the lintel to support upper wall. The total span of the wall is 5.8 m.

| Item No. | Observation | Recommended Action Plan | Recommended Timeline |
|---|--|--|---|
| 15 | Damaged Structural Member and removed beam & walls (Dyeing Shed) | Install adequate support to the overhanging wall. | Immediate - Now |

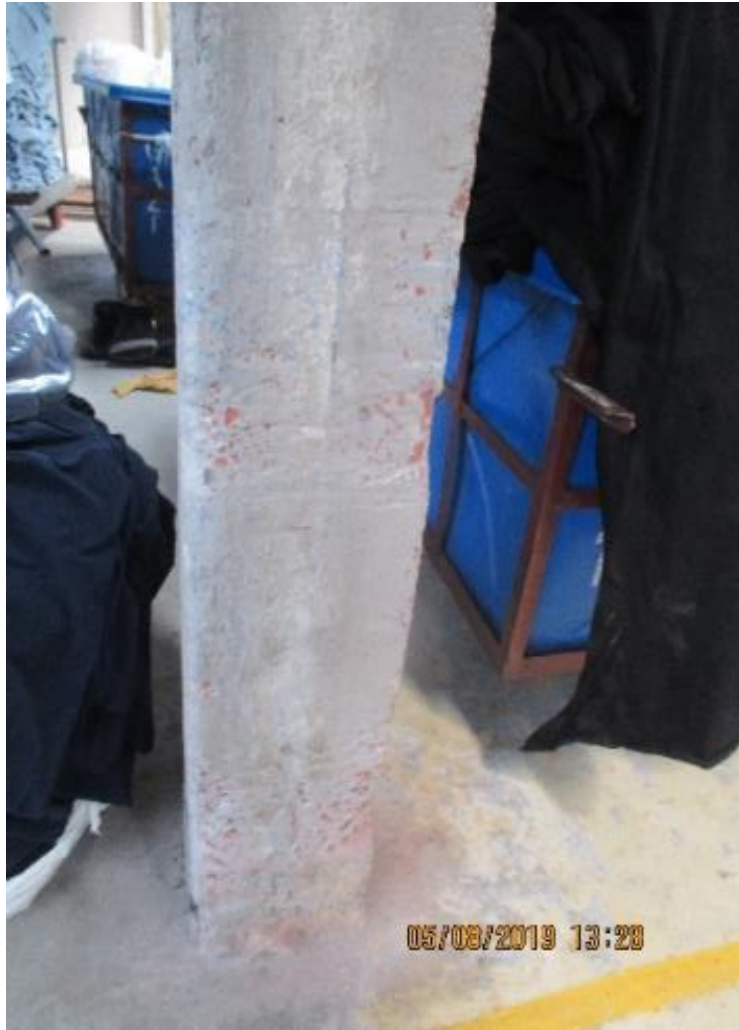
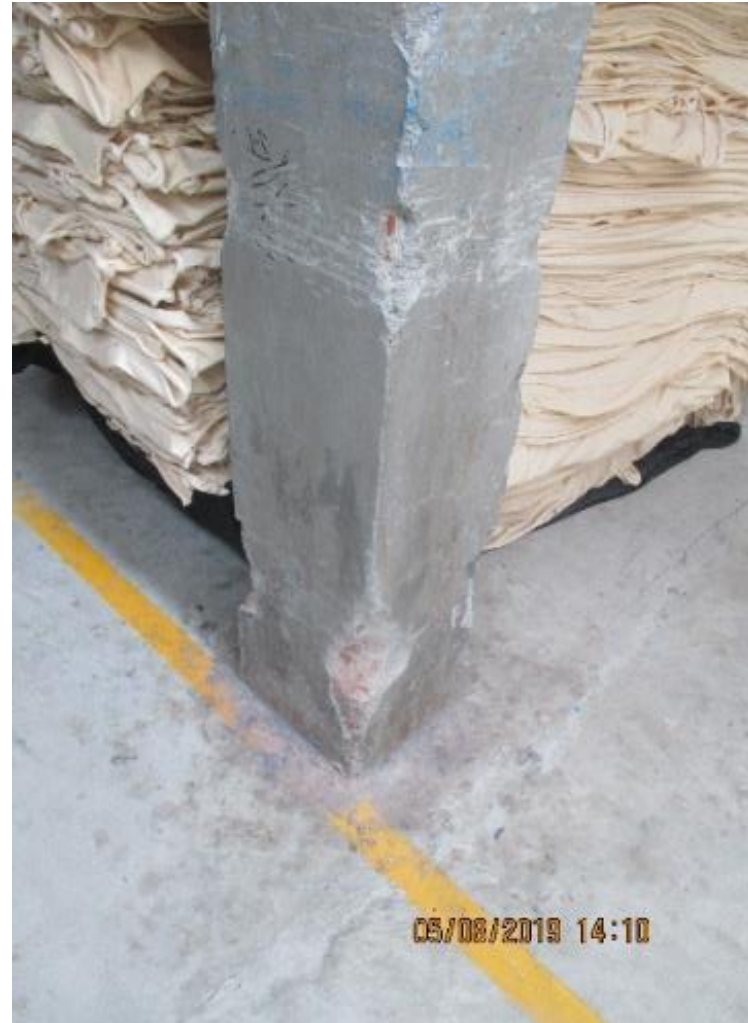
Some of the structural members were severely damaged.

| Item No. | Observation | Recommended Action Plan | Recommended Timeline |
|---|--|--|---|
| 17 | Damaged Structural Member and removed beam & walls (Dyeing Shed) | Repair the damaged columns with suitable method as suggested by building engineer. | 6-months |

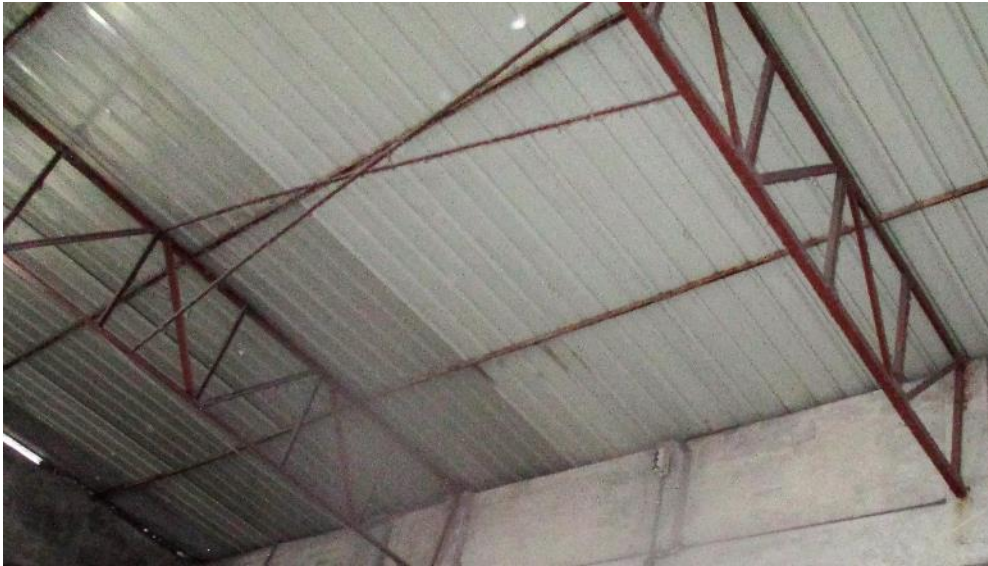
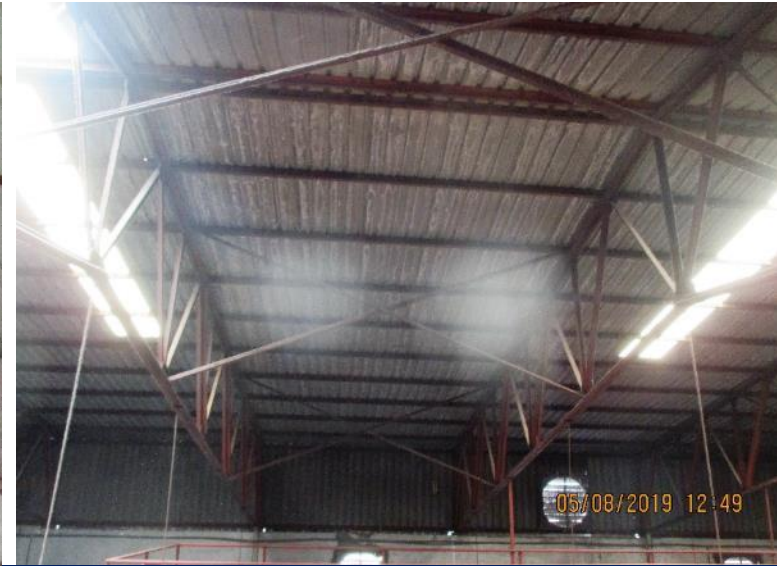
Bracings in old part of the Dyeing Shed

The ridge height is 10 m and the roof slope is quite steep. The continuous load transfer media along the long direction of roof is apparently missing. Vertical bracings between the trusses appeared to be inadequate against lateral loading. Moreover, no bracing layout or bracing details was incorporated in as-built drawings. Building engineer is required to review the design consideration and requirement of bracing system against lateral loading.

| Item No. | Observation | Recommended Action Plan | Recommended Timeline |
|---|--|--|---|
| 10 | Apparent lack of lateral stability (Dyeing Shed) | Building Engineer to check the stability of the structure against lateral loading. Also review the bracing system of existing structure. | 6-weeks |

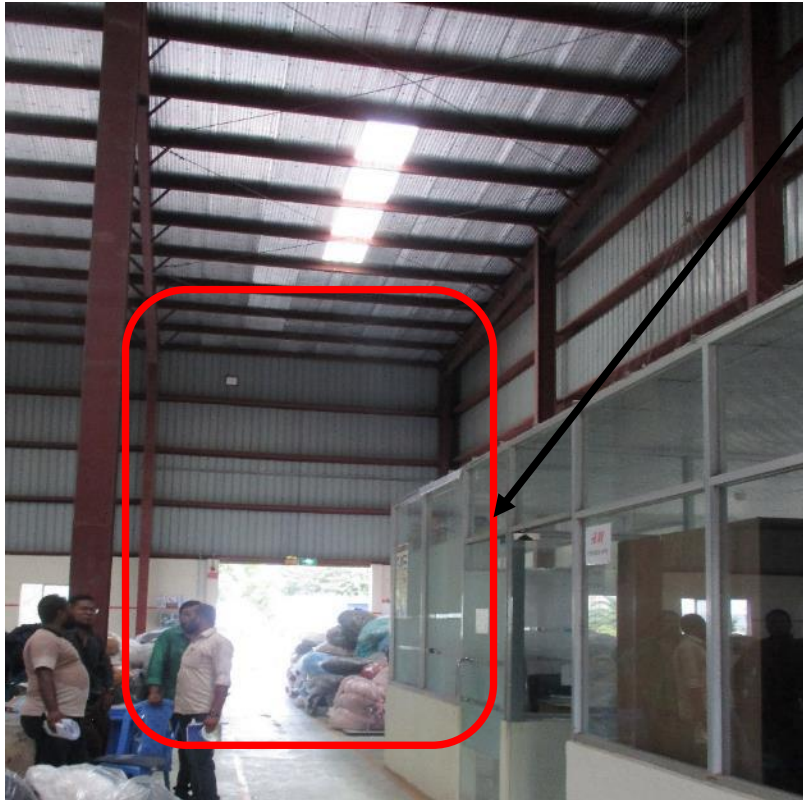
Vertical bracing was not found at grid F between 1 & 2.
Bracing layout for new part of the shed was not incorporated in the as-built drawing.

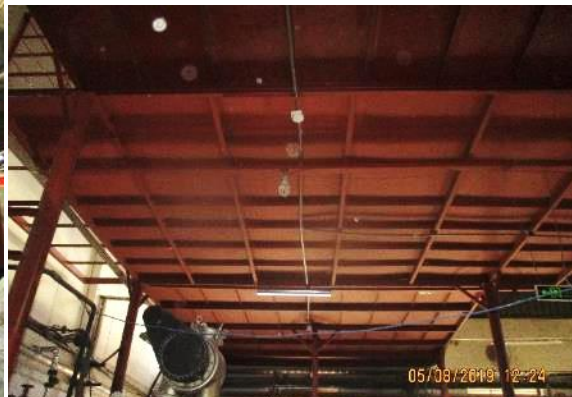
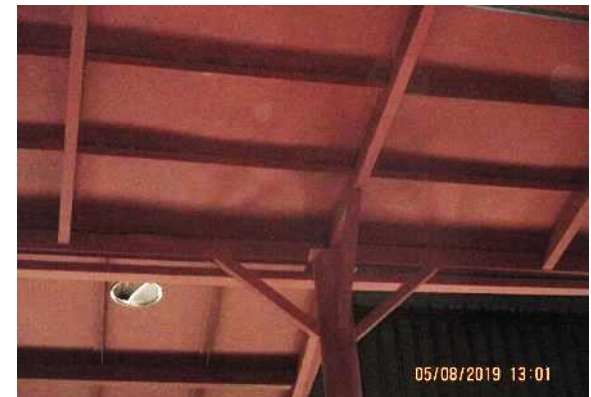
Steel Mezzanine Floor

A self supported steel mezzanine was observed in the shed for proposed store. Apparently inadequate member was observed to carry the proposed storage load. Building Engineer is required to check the adequacy of the mezzanine for vertical loading and prepare a load plan.

| Item No. | Observation | Recommended Action Plan | Recommended Timeline |
|---|--|--|---|
| 18 | Adequacy check for steel mezzanine (Dyeing Shed) | Building Engineer to check the adequacy of the steel mezzanine for vertical and lateral loading. | 6-weeks |
| 19 | Adequacy check for steel mezzanine (Dyeing Shed) | Building Engineer to prepare the allowable load plans. | 6-weeks |

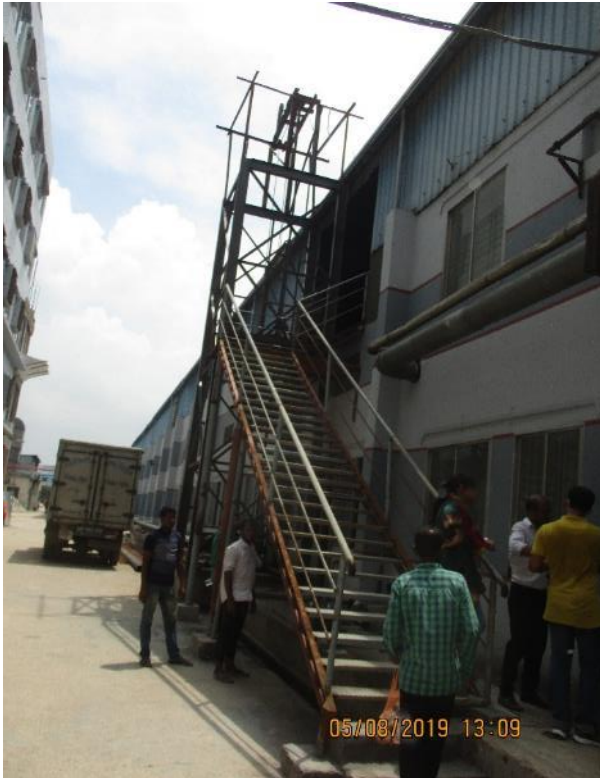
Undocumented steel stair adjacent to dyeing shed

Apparently non-engineered steel stair was observed adjacent to dyeing shed which is used for ascending on steel mezzanine. No drawings were available for those stair. Poor connection between the members was observed.

| Item No. | Observation | Recommended Action Plan | Recommended Timeline |
|---|---|---|---|
| 22 | Apparently non-engineered external steel stair (Dyeing Shed) | Building Engineer to check load bearing capacity of external escape stair and to ensure stability. | 6-weeks |

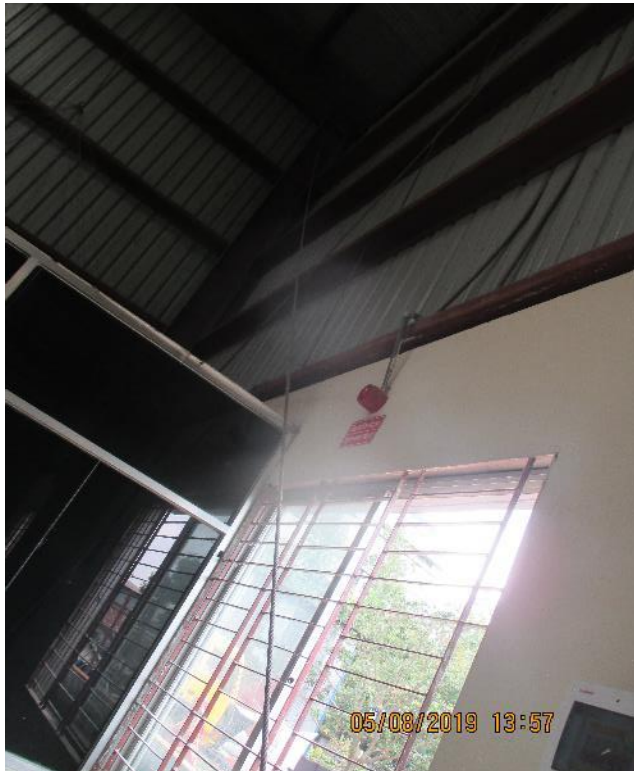
Horizontal roof bracings and vertical bracings were found loose.

Loose vertical bracing

| Item No. | Observation | Recommended Action Plan | Recommended Timeline |
|---|---|---|---|
| 24 | Loose cable bracings (Dyeing Shed) | Building Engineer to survey the whole structure and tighten loose bracings where necessary. | 6-weeks |

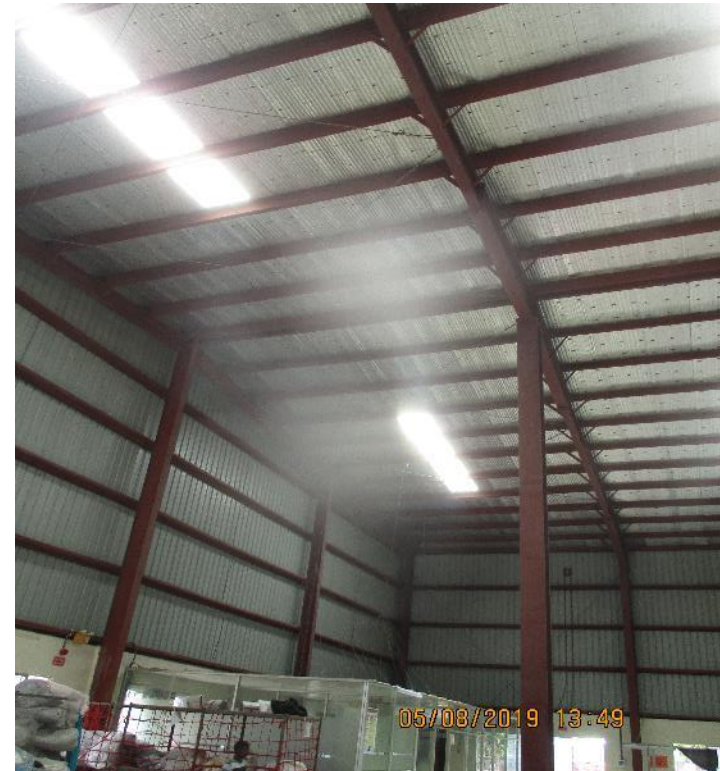
Loose roof bracing

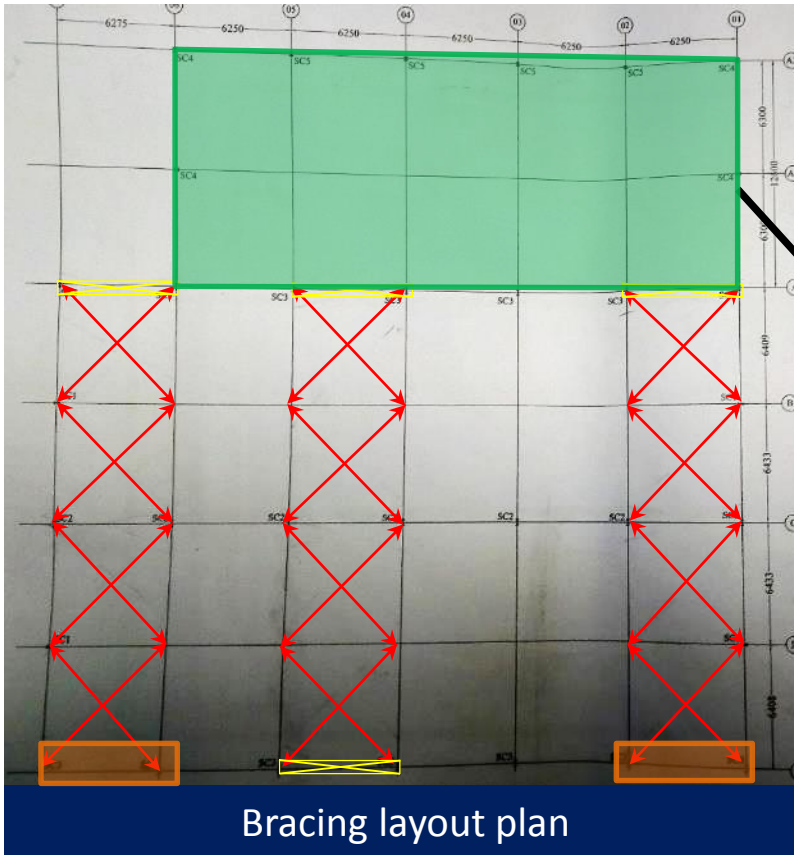
Bracing layout plan

No vertical bracing was found at Grid E between 1 & 2 and 6 & 7. Bracing from this location was removed due to exit placement. Moreover, there were no bracing in the marked region of the shed.

| Item No. | Observation | Recommended Action Plan | Recommended Timeline |
|---|---|---|---|
| 25 | Wall bracing missing in long direction (Finished Goods Store) | Building engineer is required to check the existing bracing system of the structure and requirement of bracing for stability. | 6-weeks |

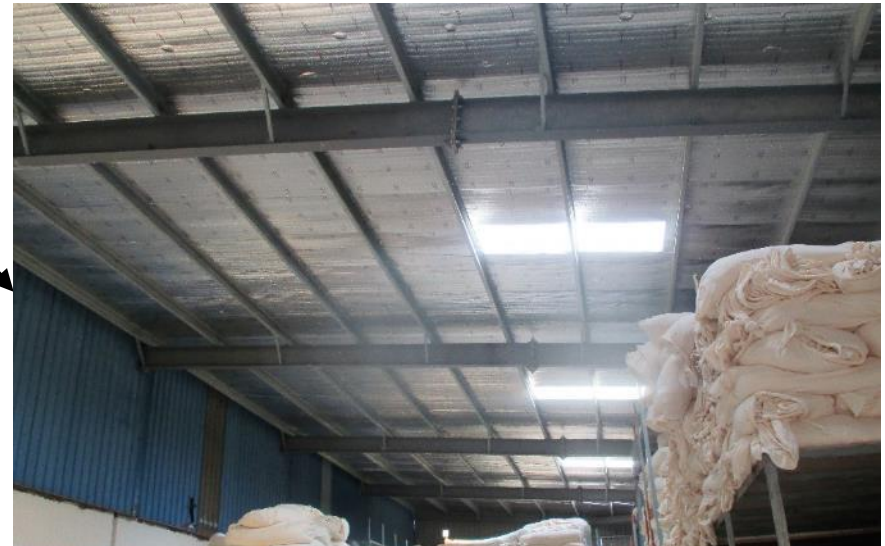
No roof bracing was observed in this part

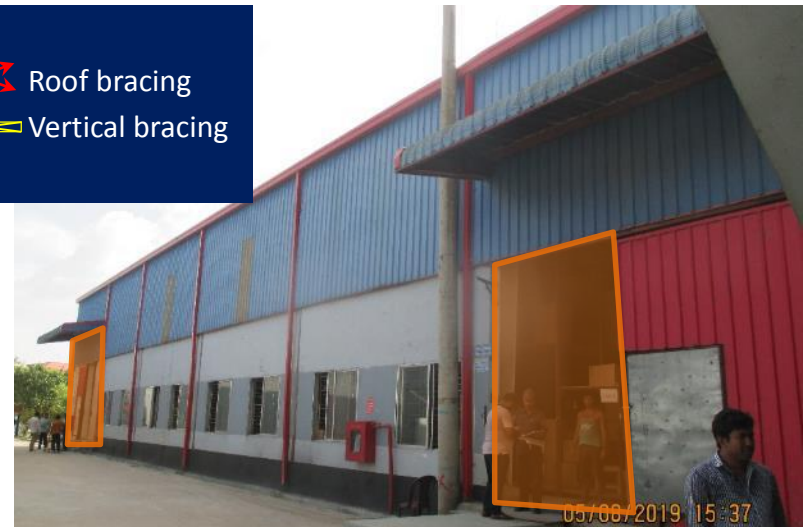
Position of two exits at Grid E

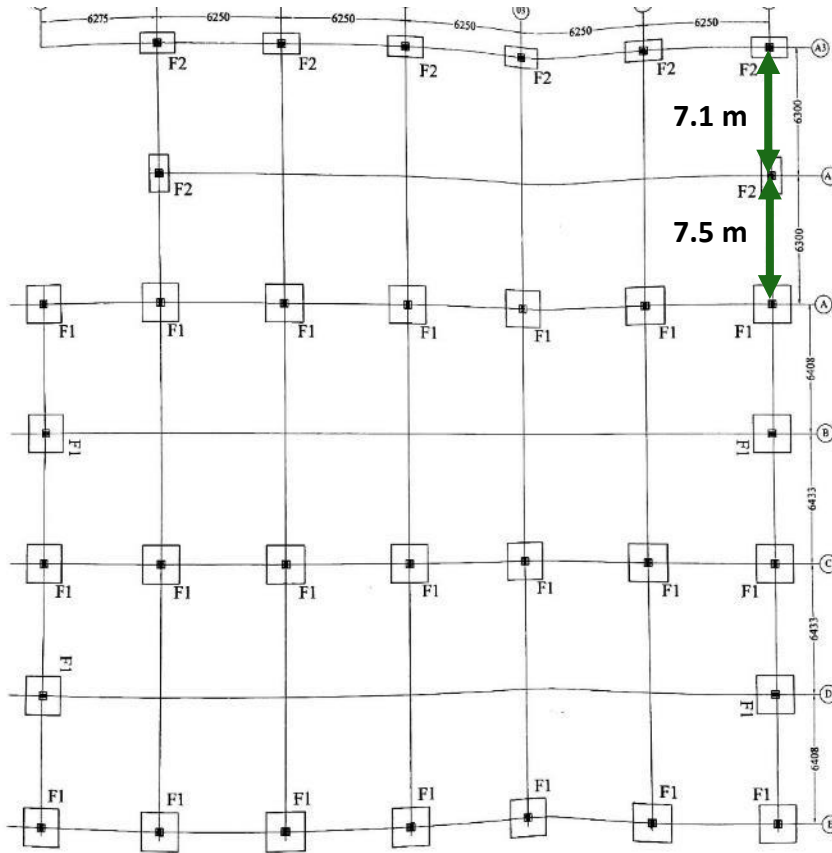
Grid dimension mentioned in the provided as built drawing (Shown on the layout) does not match the on site condition.

Building Engineer is required to survey the whole structure to prepare accurate as-built drawings with actual dimension.

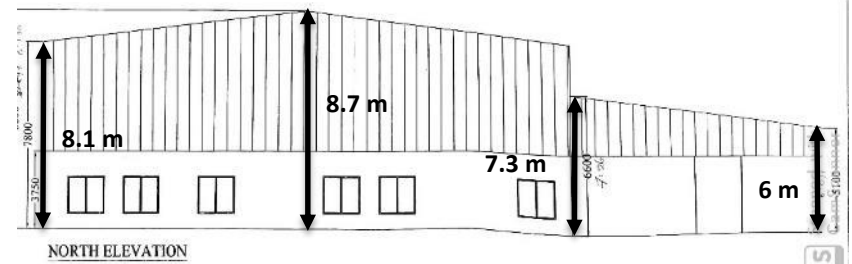
Section height mentioned in the provided as built drawing (Shown on the layout) does not match the on site condition.

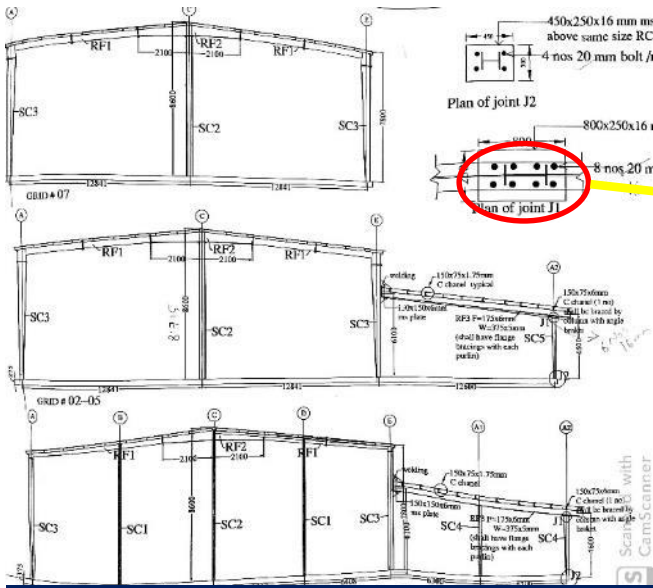
Section drawing

Joint J1 has 8-16 mm bolts instead of 8-20 mm bolts as mentioned in as-built drawings

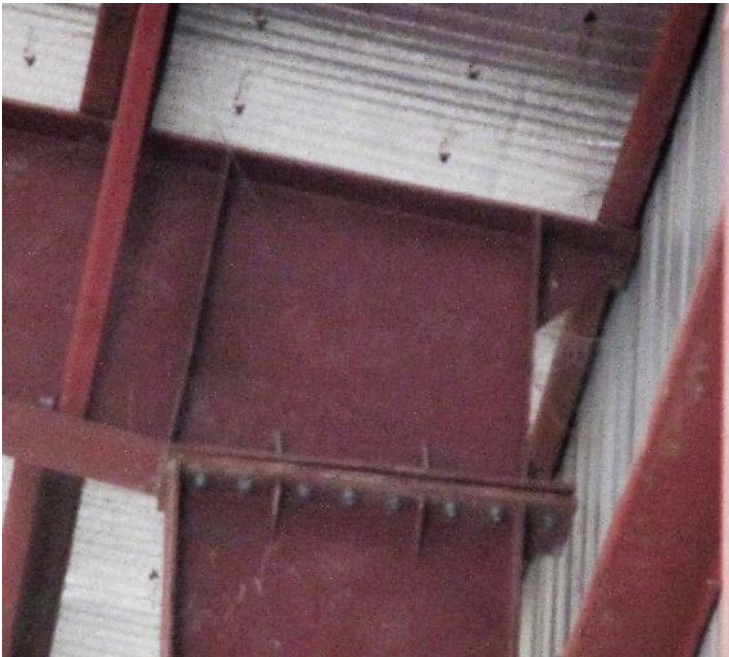
Gap between column-rafter connection

Existence of significant gap was observed between column-rafter and rafter-rafter connections at several locations. Building engineer is required to take required remediation to diminish the gaps between the connections.

| Item No. | Observation | Recommended Action Plan | Recommended Timeline |
|---|---|---|---|
| 33 | Existence of significant gap between connections. (Yarn Store) | Building engineer to survey the whole structure to locate the gap in joints and take suitable measures. | 6-weeks |

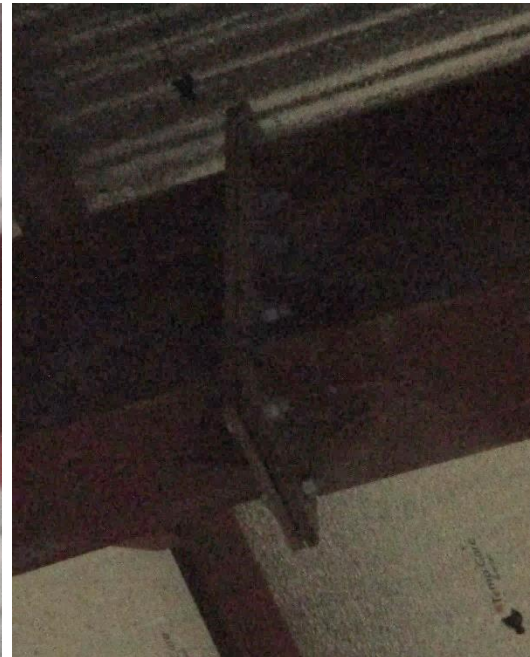
Gap between rafter-rafter connections

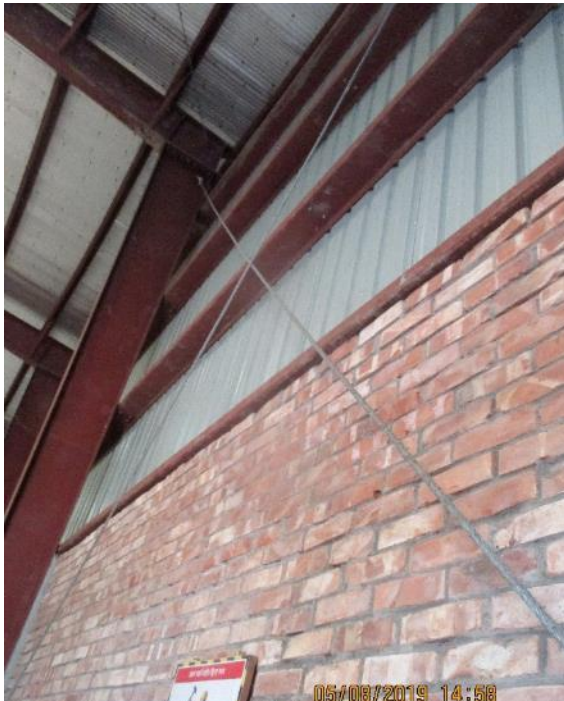
Roof and vertical cable bracings were found loose.

Loose vertical bracing

| Item No. | Observation | Recommended Action Plan | Recommended Timeline |
|---|---|---|---|
| 34 | Loose cable bracings (Yarn Store) | Building Engineer to survey the whole structure and tighten loose bracings where necessary. | 6-weeks |

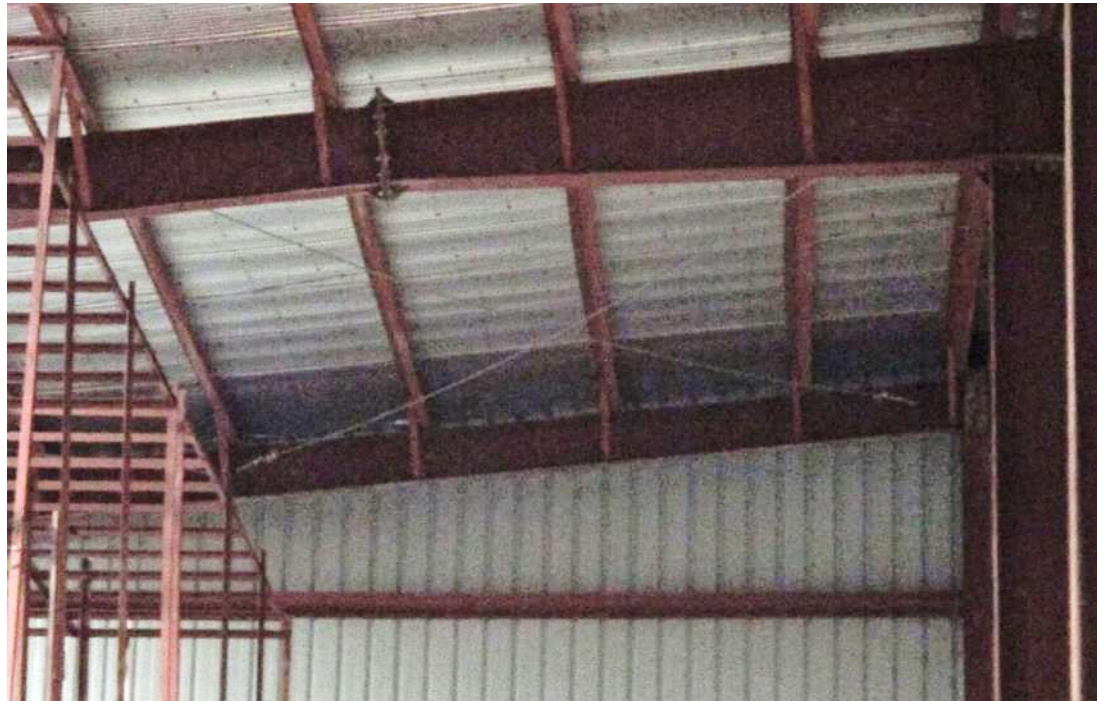
Loose roof bracing

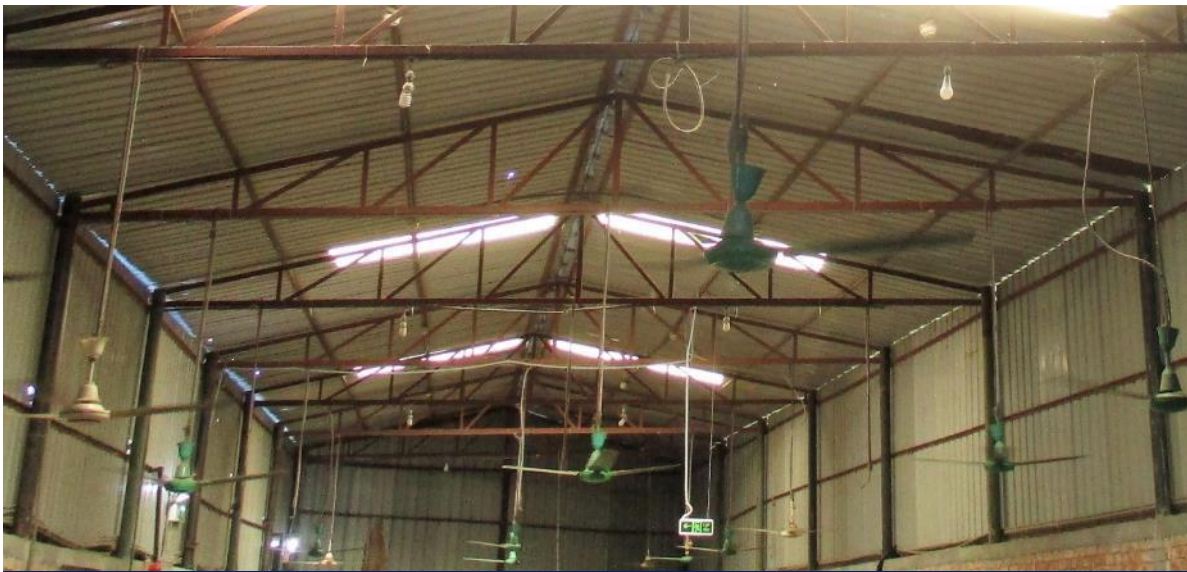
No apparent lateral stability system was observed in Worker Dining, Left-Over Store and Finishing Accessories. The connections between truss and pipe columns appeared to be inadequate in all those sheds.

| Item No. | Observation | Recommended Action Plan | Recommended Timeline |
|---|--|--|---|
| 36 | Apparent lack of lateral stability and inadequate connections (Worker Dining, Left-Over Store and Finishing Accessories) | Building Engineer to check the lateral stability and connection adequacy of the structure. | 6-weeks |
