Libas Textiles Ltd. (New building)

Nishchintapur, Mouchak, Kaliakoir, Gazipur.

10th July & 5th August 2019

Observations

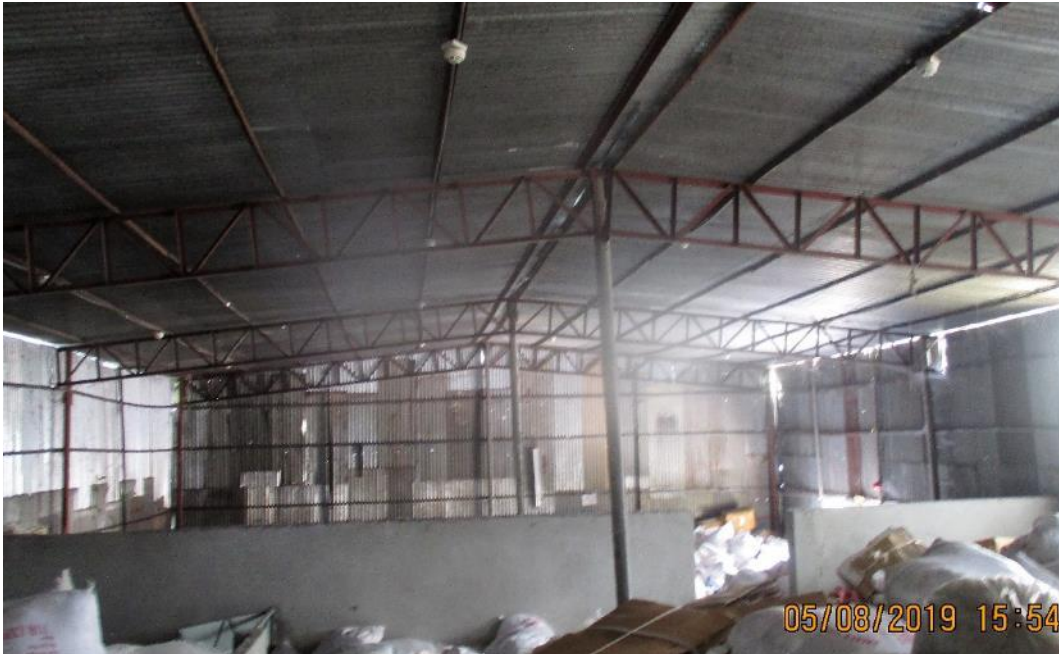
Missing load transfer in long direction

No apparent lateral stability system was observed in the shed. Also, the connections between truss and pipe columns appeared to be inadequate.

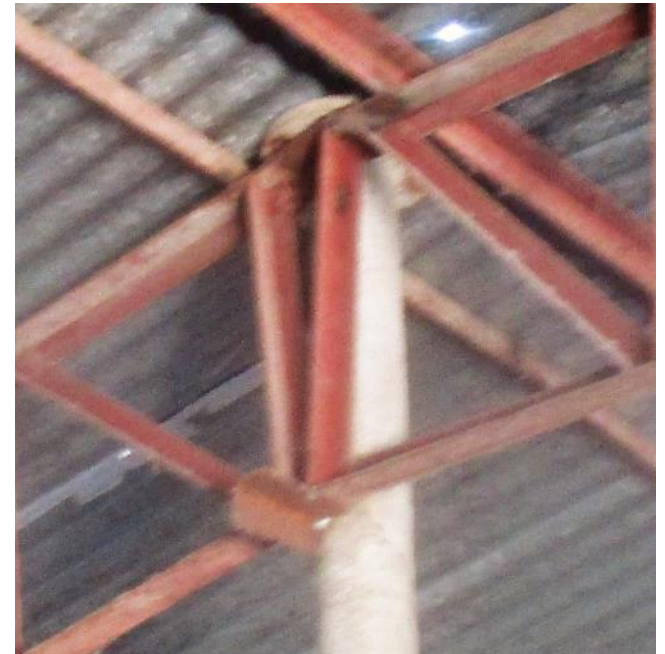
Truss-column connection

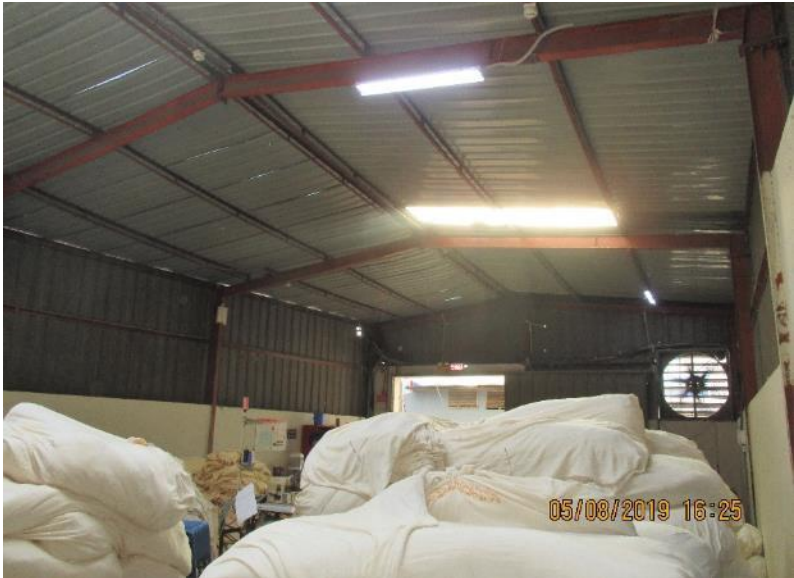
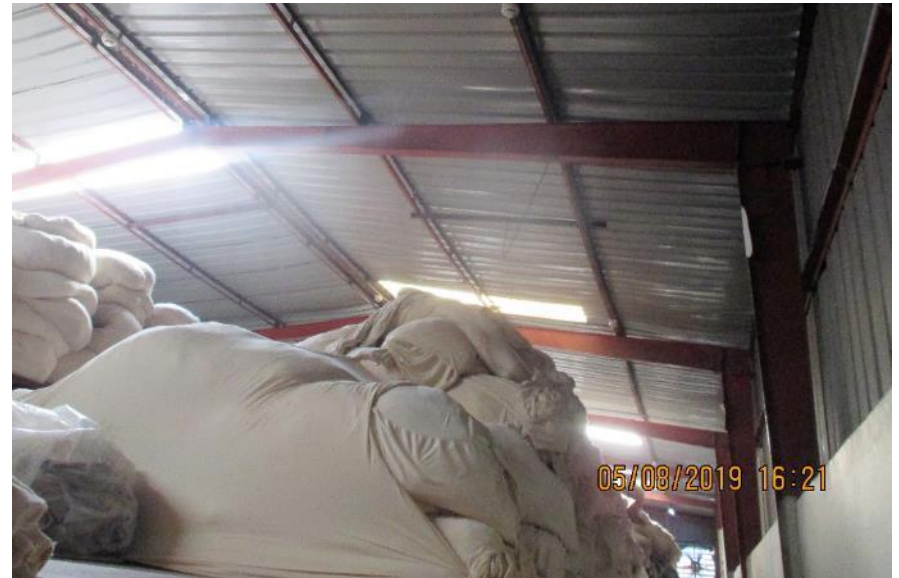
No apparent stability system (bracing, strut) was observed against lateral loading

| Item No. | Observation | Recommended Action Plan | Recommended Timeline |
|---|---|--|---|
| 41 | Apparent lack of lateral Stability (Batch Store) | Building Engineer to check the stability of the structure against lateral loading. | 6-weeks |

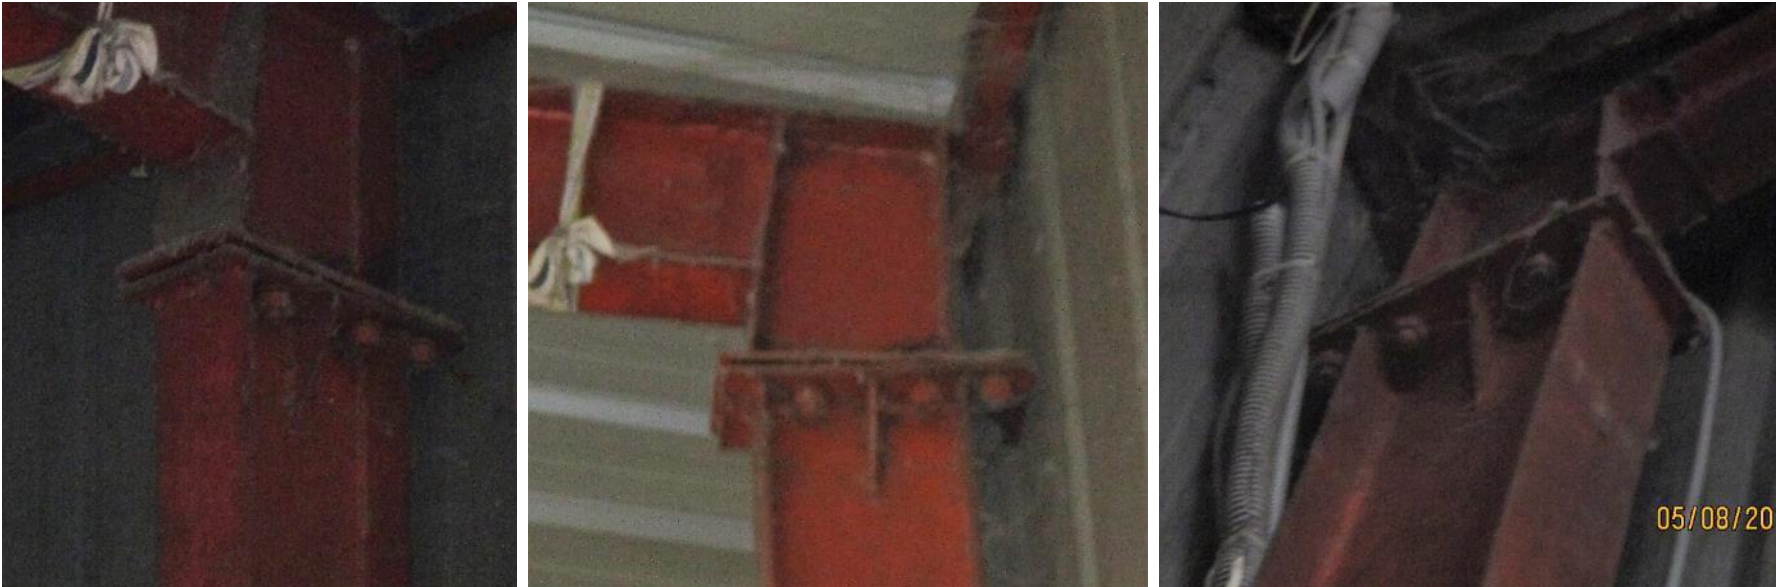
Existence of significant gap was observed between column-rafter and rafter-rafter connections at several locations.

| Item No. | Observation | Recommended Action Plan | Recommended Timeline |
|---|--|---|---|
| 46 | Existence of significant gap between connections. (Batch Store) | Building engineer to survey the whole structure to locate the gap in joints and take suitable measures. | 6-weeks |

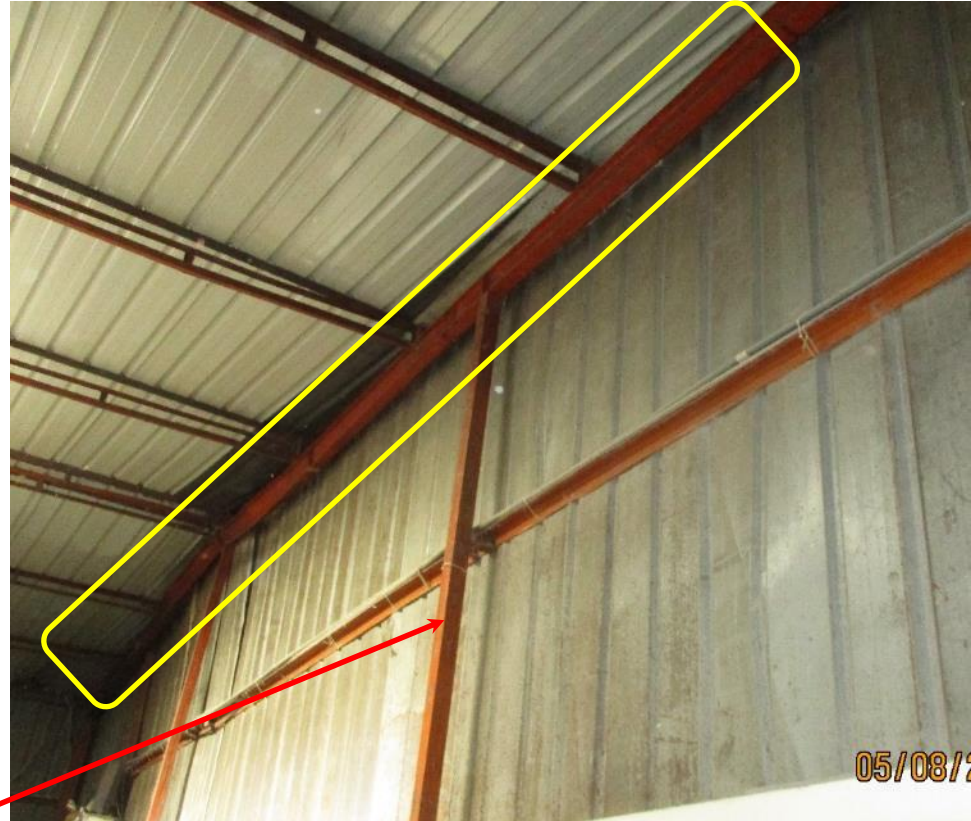
Rafter at Grid-1 was found twisted. Some box section was placed on the peripheral wall at Grid-1 to support the rafter.

| Item No. | Observation | Recommended Action Plan | Recommended Timeline |
|---|--|---|---|
| 47 | Damaged rafter at end bay (Batch Store) | Building engineer to check the extent of damage to the rafter and suggest proper remedial measures. | 6-weeks |

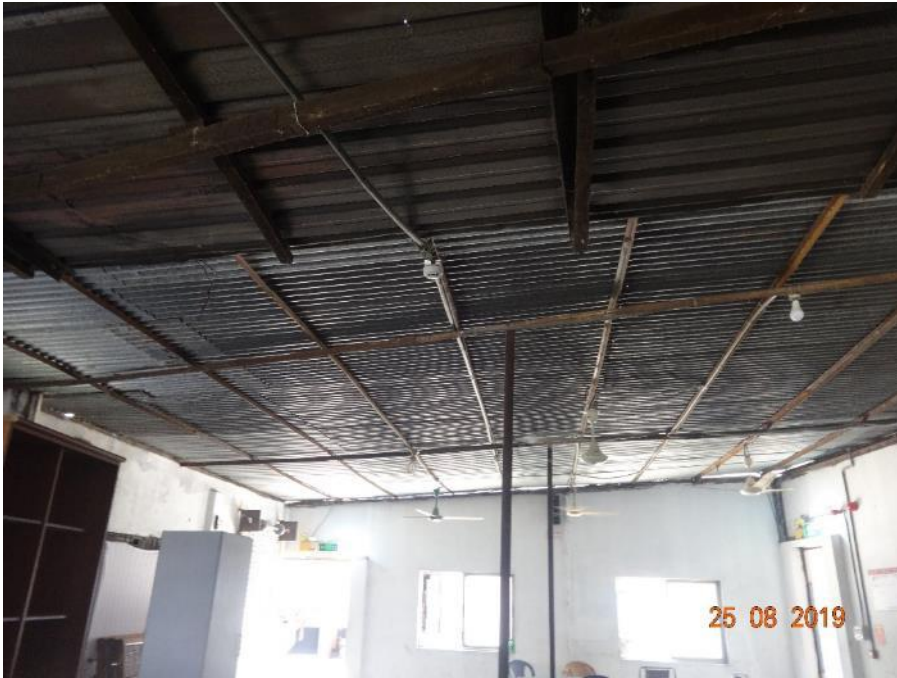
Light weight roof supported on peripheral wall

Staff Dining is apparently non-engineered shed. Angle rafter is embedded in peripheral brick wall. Building engineer to check the stability of the lightweight roof structure against lateral loading and if inadequate then replace the structure with an engineered one.

| Item No. | Observation | Recommended Action Plan | Recommended Timeline |
|---|--|---|---|
| 49 | Apparently non-engineered shed (Staff Dining) | Building engineer to check the stability of the lightweight roof structure against lateral loading and if inadequate then replace the structure with an engineered one. | 6-weeks |

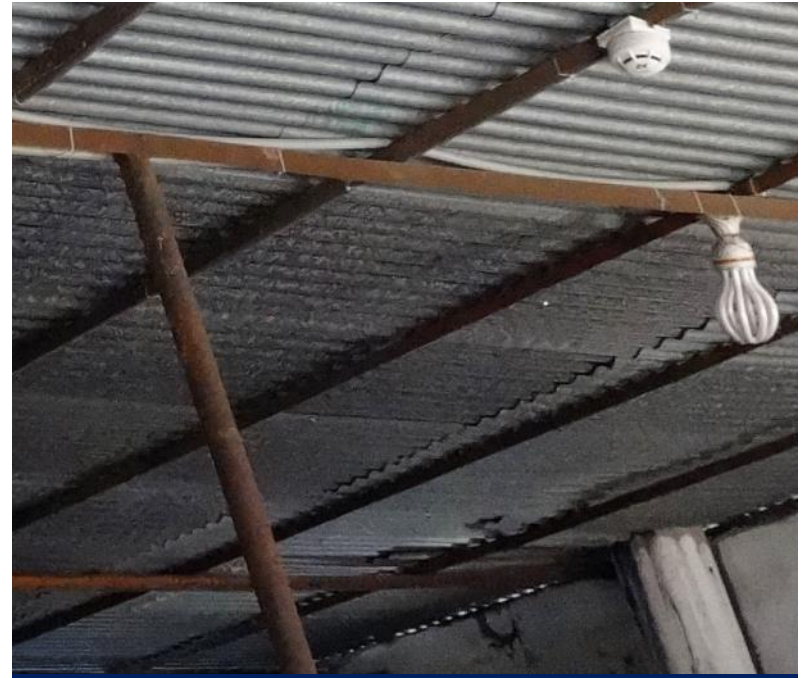
Non-engineered connection

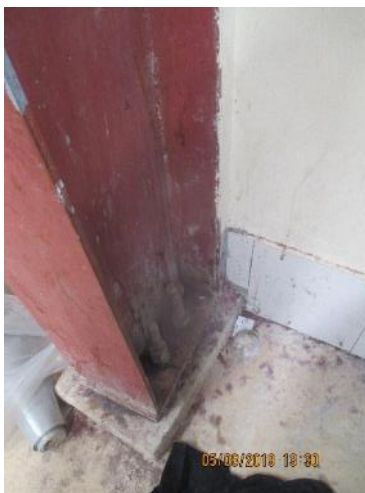
Dyeing shed

Corrosion was found on columns and rafters of all steel structures.

| Item No. | Observation | Recommended Action Plan | Recommended Timeline |
|---|--|---|---|
| 51 | Corrosion in steel members (All sheds) | Building engineer to survey all the steel structures to identify the locations of corrosions and take necessary measures to remove corrosion. | 6-weeks |
