# Unity Fabric Industries Ltd (Unit-2)

BAHADURPUR, BHAWAL MIRZAPUR, GAZIPUR 1703, BANGLADESH

15<sup>th</sup> & 22<sup>nd</sup> July 2019

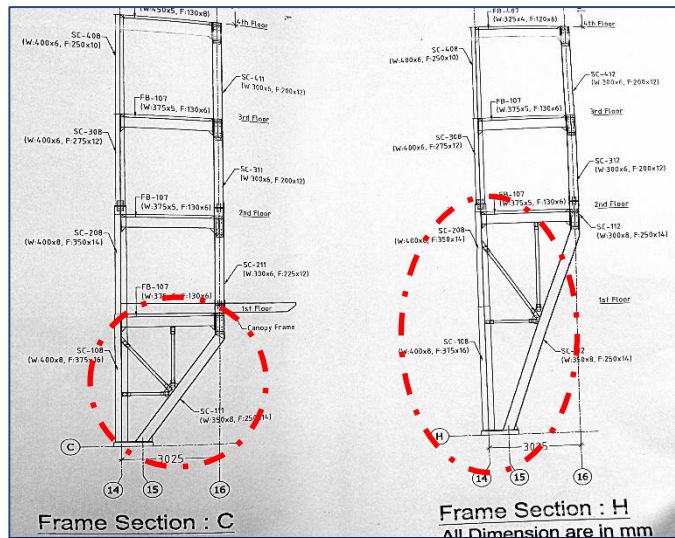
Bracing layout

**Bracing has not been installed**

In the structural drawing, bracing was suggested but not installed on site. The factory engineer is required to check the bracing requirement of the structure and install the necessary bracings accordingly.

| Item No. | Observation | Recommended Action Plan | Recommended Timeline |
|---|---|---|---|
| 1 | Bracing has not been installed. (Production Building) | The factory engineer is required to check the bracing requirement of the structure as part of engineering assessment. | 6-weeks |
| 2 | Bracing has not been installed. (Production Building) | Carry out any remedial measures recommended in the engineering assessment report. | 6-months |

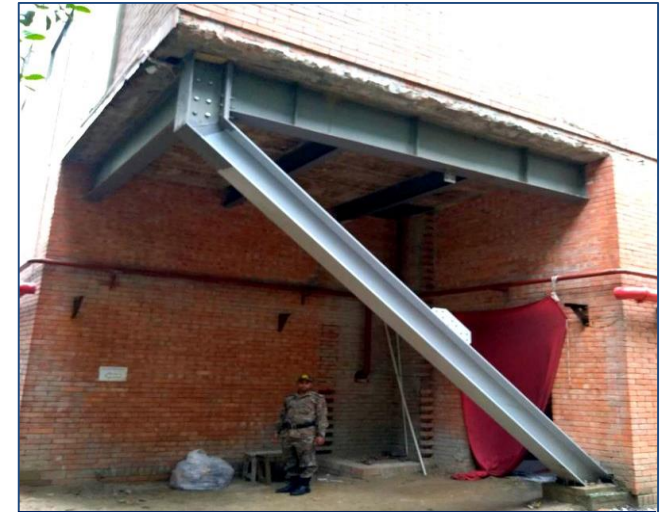
Bracing not installed on site

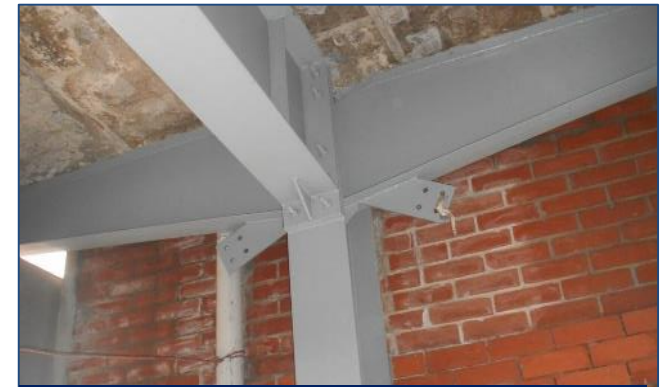
Bracing not installed on site

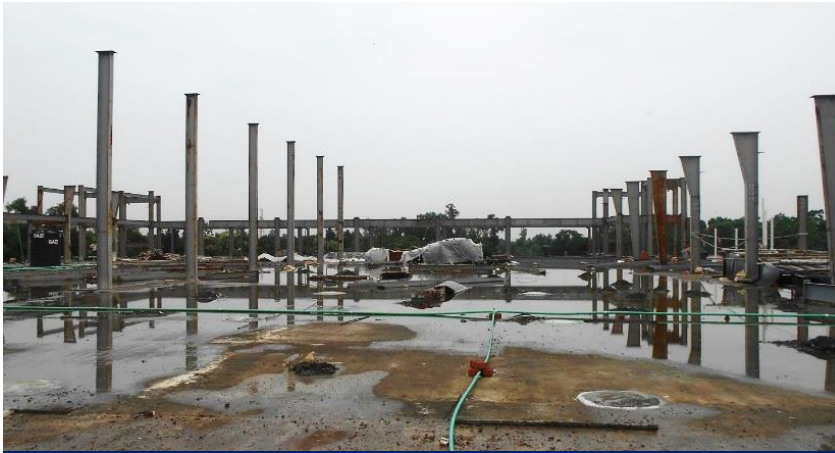
Under construction frame on 3<sup>rd</sup> floor

Flange thickness of steel beam on grid-02 was found 12 mm instead of 14mm. On the other hand, 3<sup>rd</sup> floor roof was under construction so that the rafter size of the roof could not be verified.

| Item No. | Observation | Recommended Action Plan | Recommended Timeline |
|---|---|---|---|
| 3 | Inconsistency between as-built drawing and as-built condition. (Production Building) | Factory Engineer is required to survey the structures and prepare a full set of architectural and structural drawings. | 6-weeks |

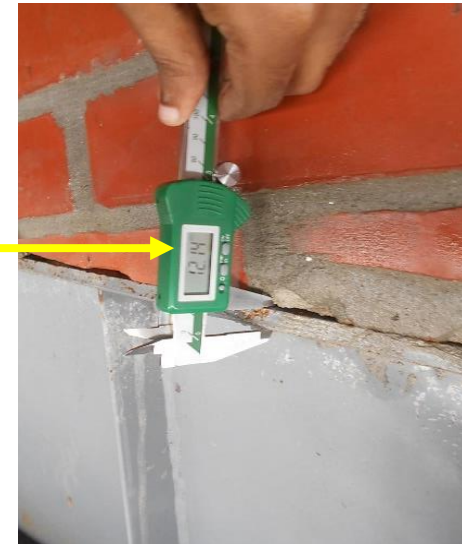
12 mm thick flange instead of 14 mm

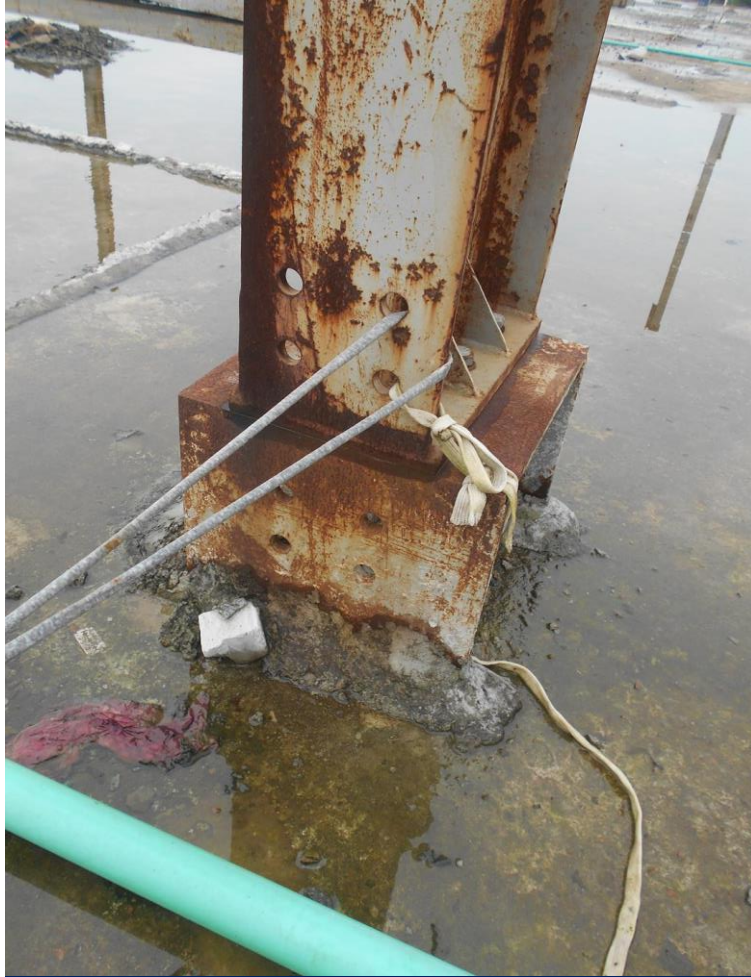
Corrosion in steel column

Corrosion found in column at 3<sup>rd</sup> floor (currently roof). Corrosion also found in column joint at 2<sup>nd</sup> floor.

| Item No. | Observation | Recommended Action Plan | Recommended Timeline |
|---|---|---|---|
| 4 | Corrosion in steel member. (Production Building) | The building engineer to investigate the reason & extent of corrosion and suggest proper remedial measure accordingly. | 6-weeks |
| 5 | Corrosion in steel member. (Production Building) | Take necessary measures to prevent further corrosion and repair the corroded steel members as per engineer's suggestion. | 6-months |

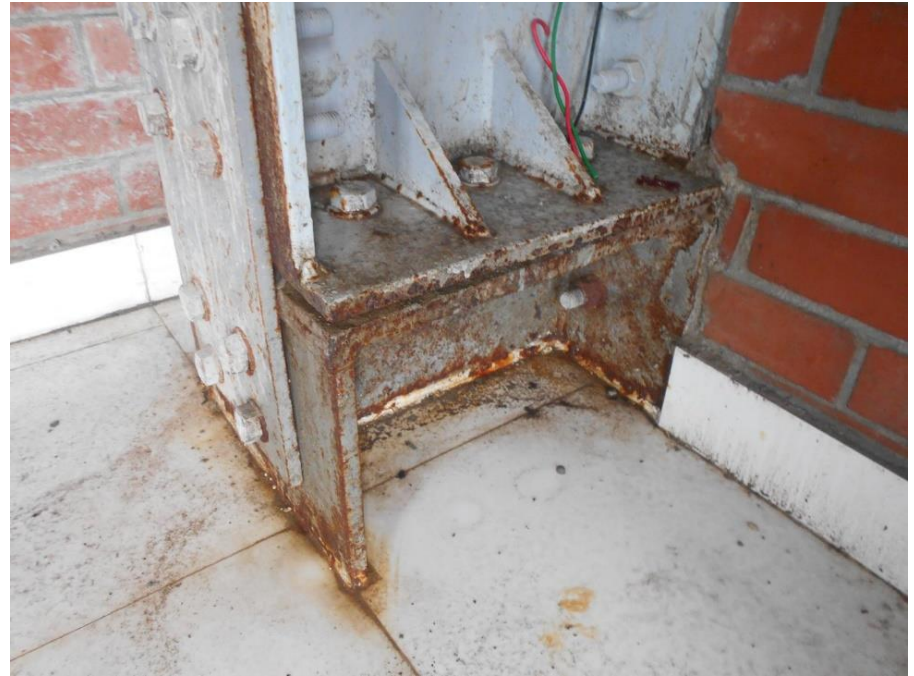
Corrosion at column joint

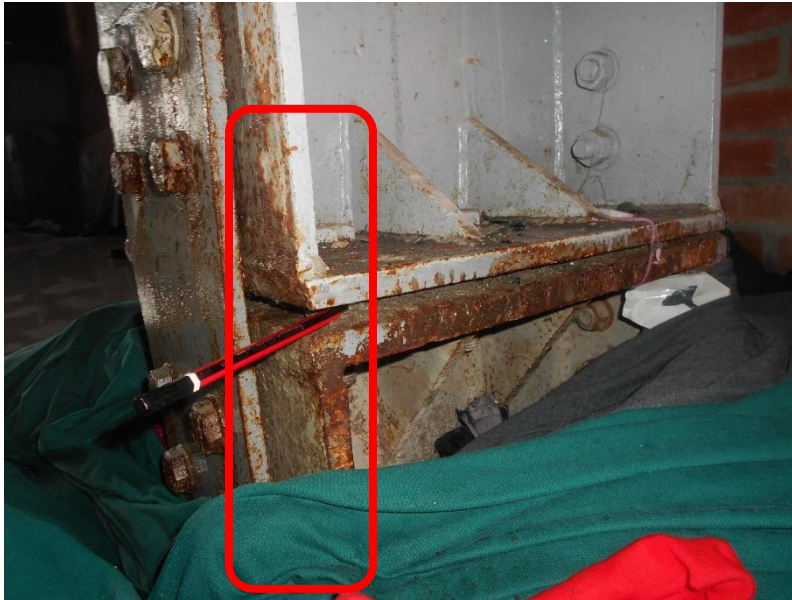
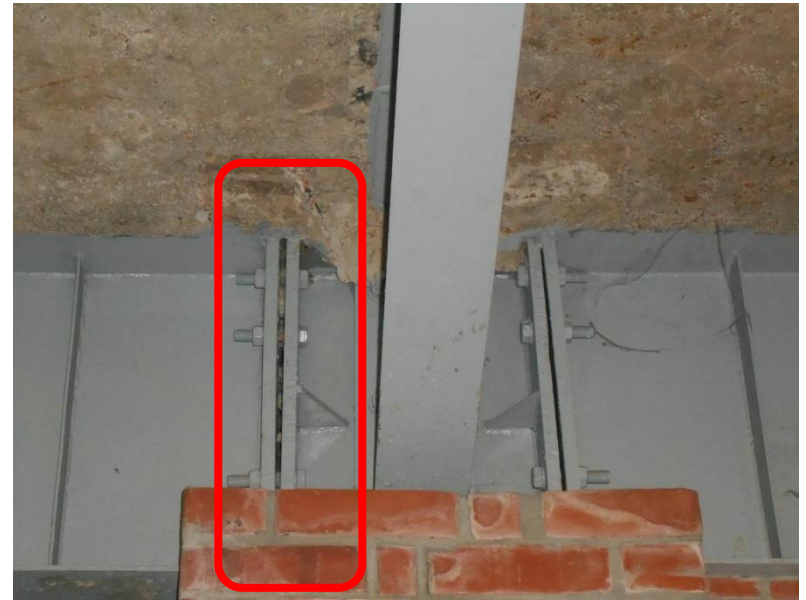
Significant gap found in the beam-column joint. The factory Engineer is required to investigate the connections and take remedial proper actions where required.

Gap in between beam-column joint

| Item No. | Observation | Recommended Action Plan | Recommended Timeline |
|---|---|---|---|
| 6 | Significant gap in the beam-column joint | Building Engineer to investigate the connection of steel joint and suggest necessary remediation. | 6-weeks |

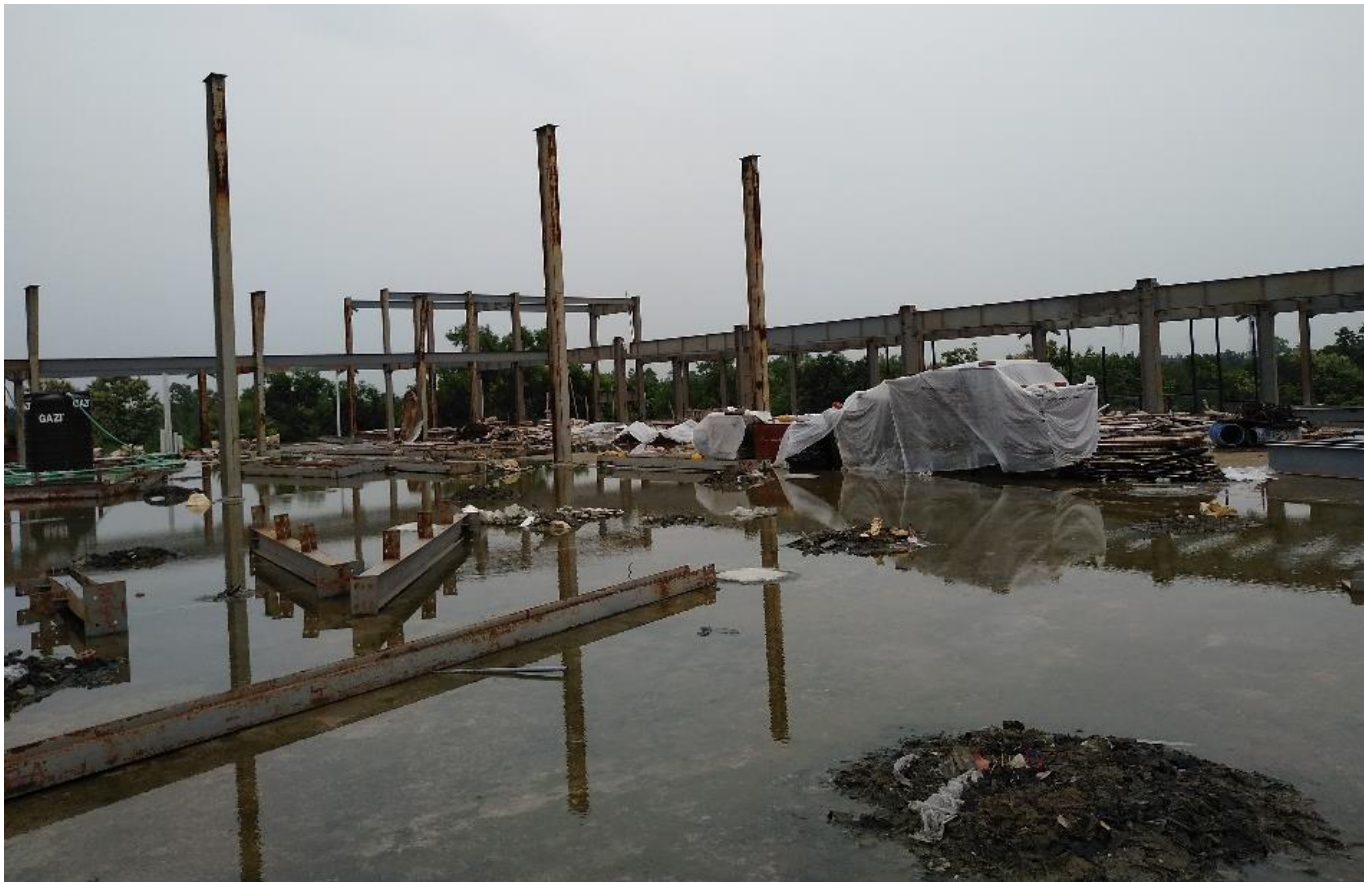
There is no parapet on 3rd floor which may cause falling hazard. Also, construction debris found all over the roof. All hazards need to be removed from roof and develop proper drainage system on roof (currently 3<sup>rd</sup> floor).

Construction debris on the 2<sup>nd</sup> floor roof.

| Item No. | Observation | Recommended Action Plan | Recommended Timeline |
|---|---|---|---|
| 7 | Stacking of construction debris on the roof. (Production Building) | Stacked materials need to be removed. | 6-weeks |
| 8 | Stacking of construction debris on the roof. (Production Building) | Drainage system to be developed on roof. | 6-months |

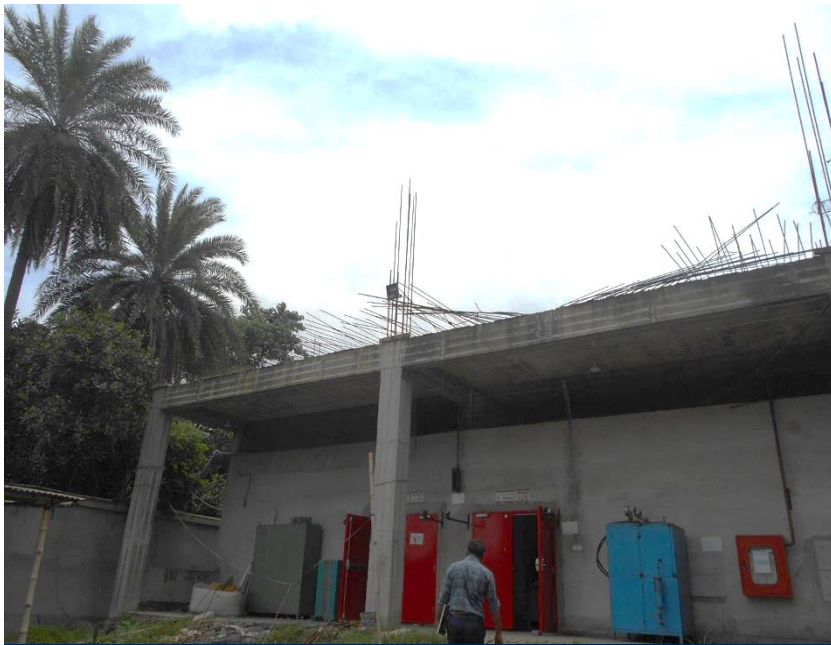
Column reinforcements are exposed on roof and slab reinforcements are exposed at South side. Factory has a future plan to extend the building both vertically and horizontally up-to 2<sup>nd</sup> floor. Factory engineer is required to carry out a Detail Engineering Assessment considering BNBC provision prior to any further extension work.

Exposed Rebar at south

| Item No. | Observation | Recommended Action Plan | Recommended Timeline |
|---|---|---|---|
| 9 | Possible vertical & horizontal extension. (Utility Building) | Prior any extension work, Detail Engineering Assessment required to be carried out following BNBC requirement. | 6-weeks |
| 10 | Possible vertical & horizontal extension. (Utility Building) | Remedial works required to be carried out where necessary. | 6-months |

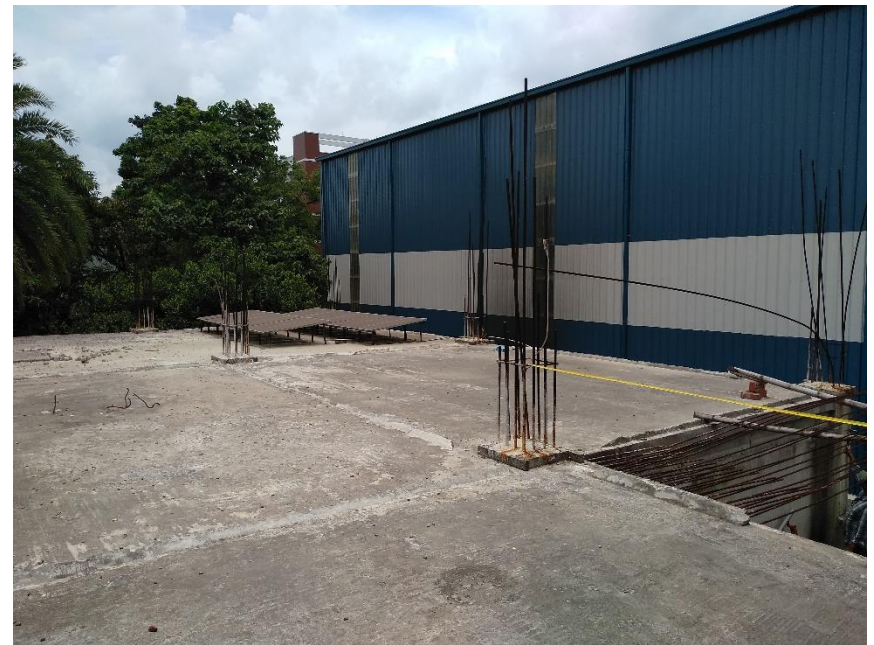
Exposed Rebar on roof

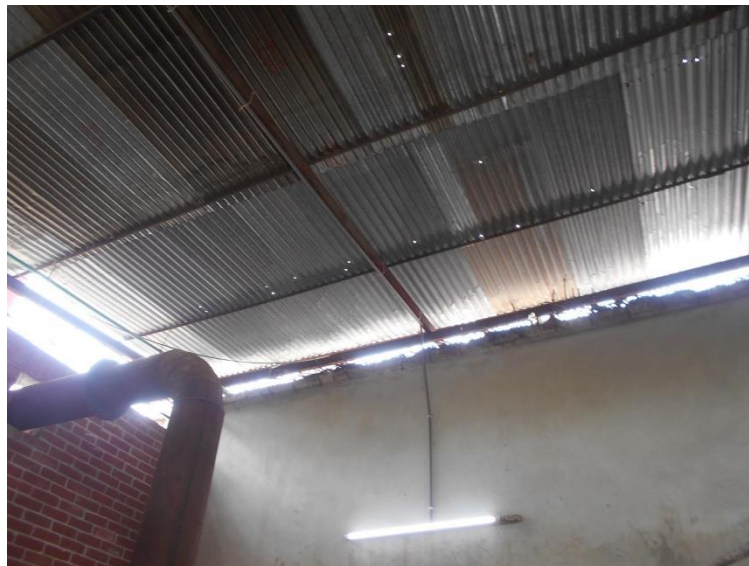
West part of roof slab has not been constructed. Factory has made a temporary lightweight tin roof which connection appeared to be inadequate. Factory is required to complete the roof slab by RC casting as per drawings.

lightweight roof connection with brick wall appeared to be non-engineered

| Item No. | Observation | Recommended Action Plan | Recommended Timeline |
|---|---|---|---|
| 11 | Incomplete roof slab. (Boiler and Biogas Building) | Complete the RC slab construction by replacing the existing lightweight tin roof. | 6-weeks |

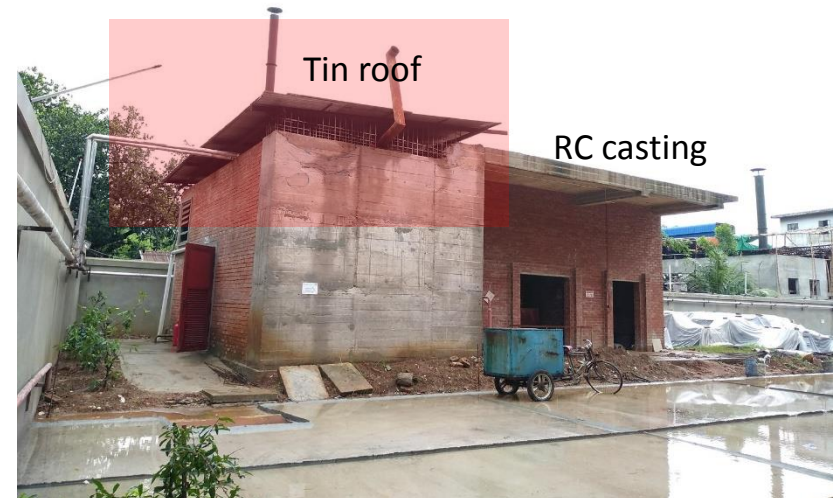
Incomplete Roof Slab at West

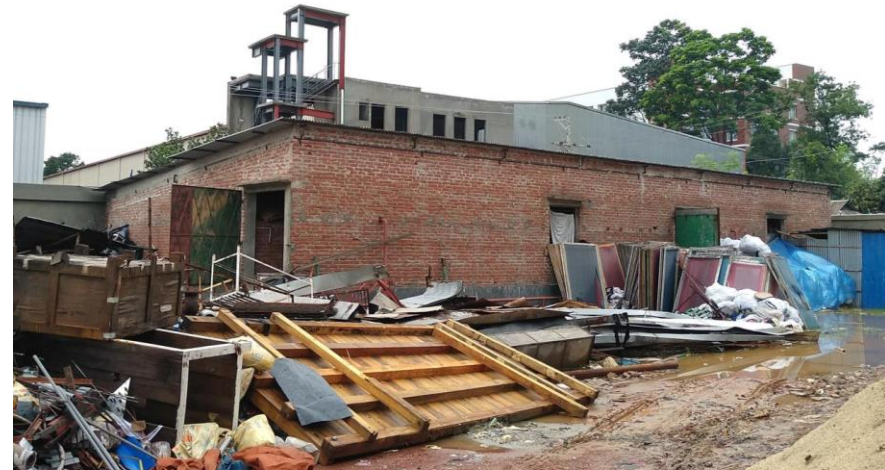
Garbage Shed

No documents were available for Garbage Shed. Building engineer is required to prepare “as constructed” drawings with complete structural information.

| Item No. | Observation | Recommended Action Plan | Recommended Timeline |
|---|---|---|---|
| 12 | Lack of as-built documents. (Garbage shed) | Factory Engineer is required to survey the structures and prepare a full set of as-built documents. | 6-weeks |

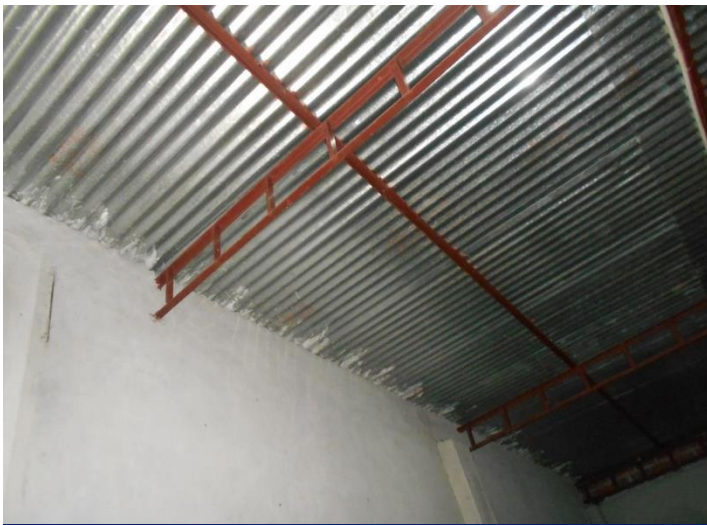
Truss-Brick wall connection

There is no roof bracing and definite system to transfer the lateral loading through roof. Also, the connections between truss & brick columns are appeared to be inadequate. Factory engineer is required to assess the adequacy of the connections and propose proper suggestions.

| Item No. | Observation | Recommended Action Plan | Recommended Timeline |
|---|---|---|---|
| 13 | Lack of lateral stability and apparently non-engineered anchorage against uplift forces. (Garbage shed) | The factory engineer to investigate the anchorage system and check its capacity for the possible uplift forces as part of engineering assessment. | 6-weeks |
| 14 | Lack of lateral stability and apparently non-engineered anchorage against uplift forces. (Garbage shed) | Carry out remedial works where necessary. | 6-months |

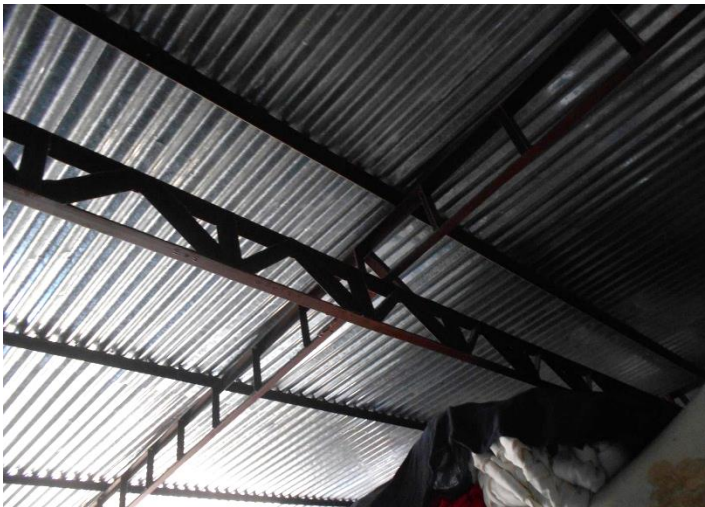
Truss to truss connection

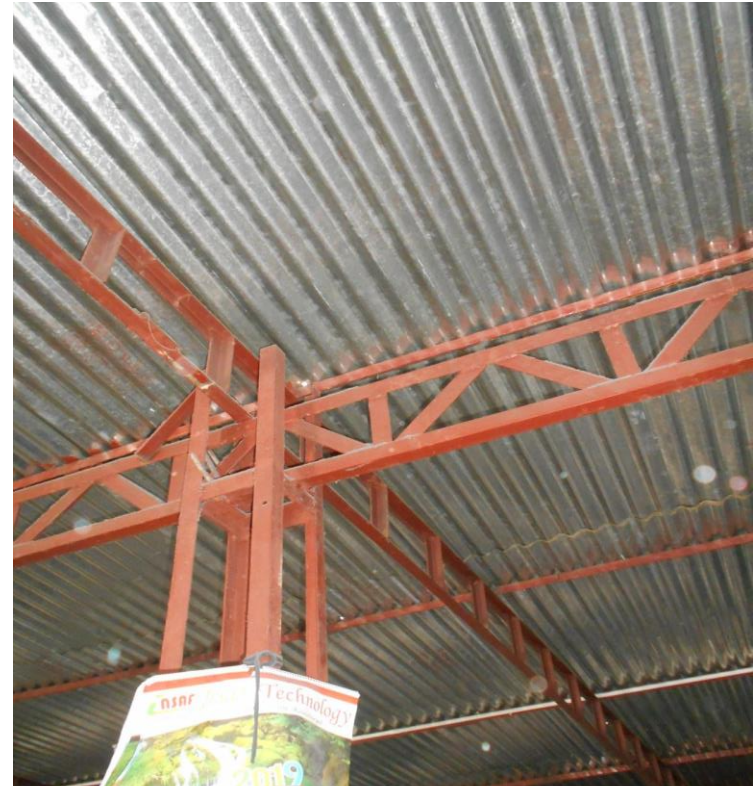
Roof without bracing
