Sams Attire Ltd. (Extension)

Bhuiyan Tower, Plot #10, Jamgora, Ashulia Road, Saver, Dhaka, Bangladesh

20th August 2019

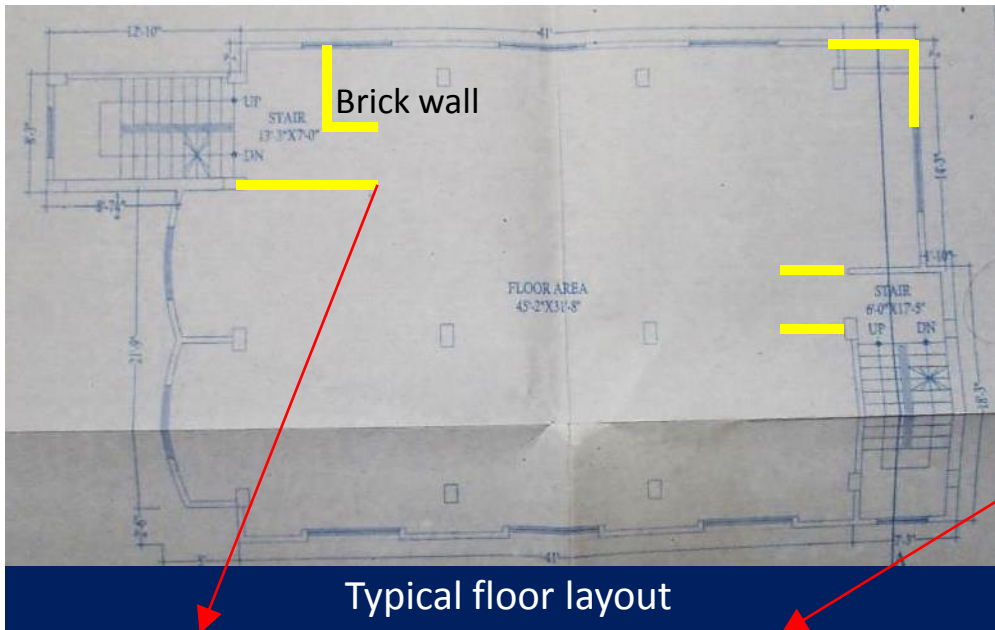
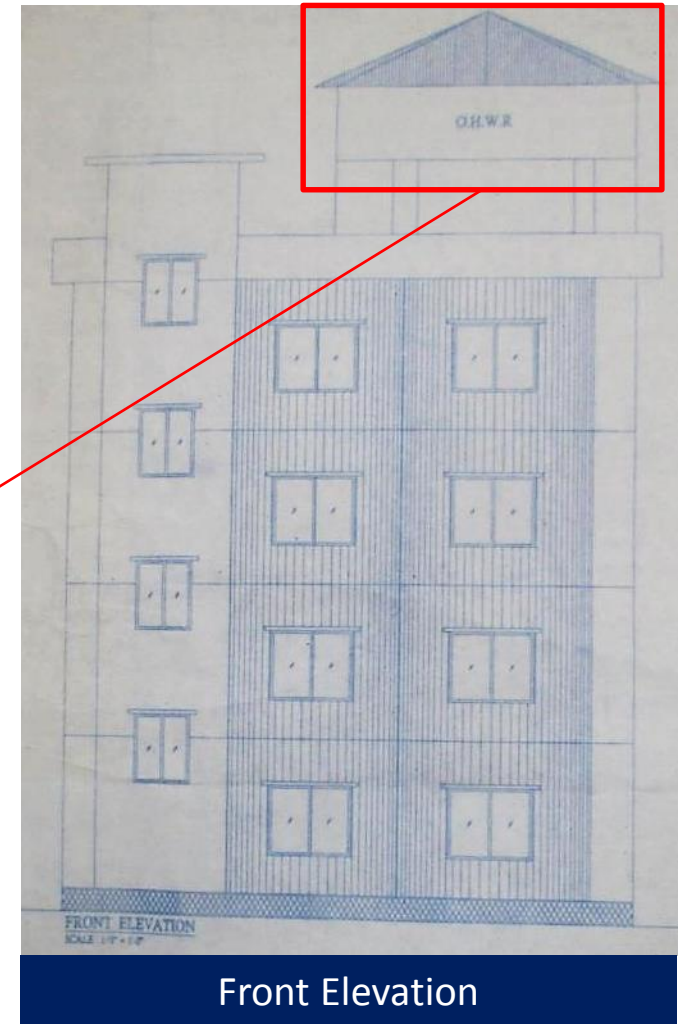
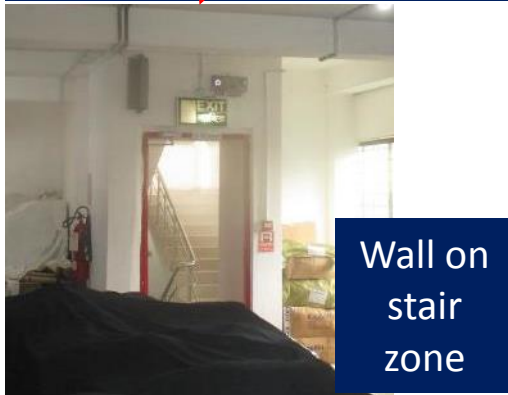
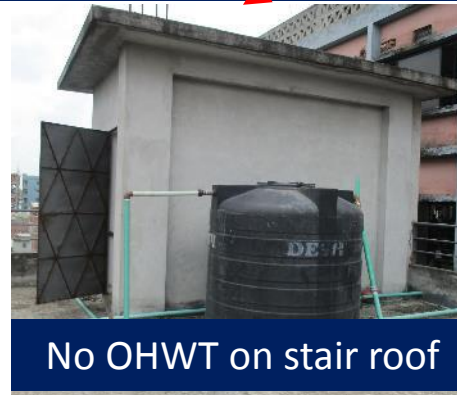
Lack of as-built documents

- Permit drawings not indicative to the site condition.
- Structural drawings not available.
- The factory engineer is required to survey the structure and prepare a full set of as-built drawing.

| Item No. | Observation | Recommended Action Plan | Recommended Timeline |
|---|---|---|---|
| 1 | Lack of as-built documents (Building-2) | The factory engineer is required to survey the structure, collect information and produce as-built architectural and structural documentations. | 6-weeks |

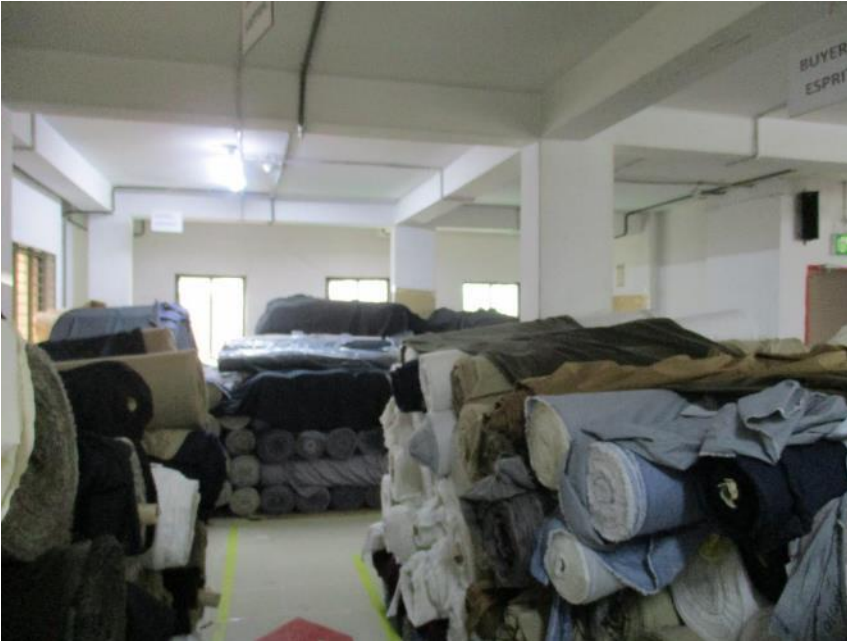
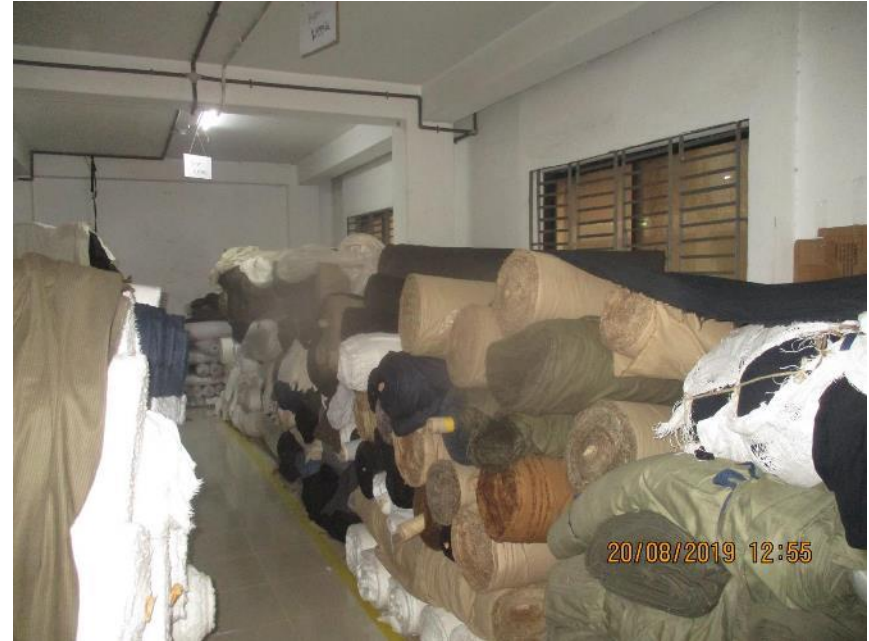
Heavy loading observed on 1st floor

During inspection floor loading observed above 4 kPa was on 1st floor. No load plan available during inspection. The factory engineer is required to produce a loading plan as per floor load capacity.

| Item No. | Observation | Recommended Action Plan | Recommended Timeline |
|---|---|---|---|
| 2 | Heavy loading on 1st floor (Building-2) | Reduce loading to 3 kPa. | Immediate - Now |
| 3 | Heavy loading on 1st floor (Building-2) | Produce and actively manage a loading plan for all floor plates consideration to slab, beam, column and foundation capacity. | 6-weeks |
| 4 | Heavy loading on 1st floor (Building-2) | Continue to implement floor load plan. | 6-months |

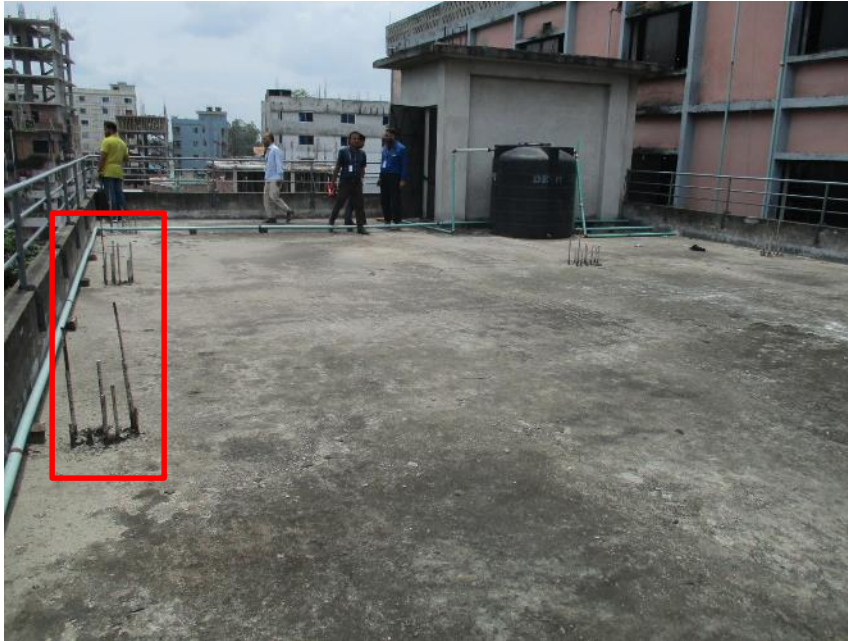
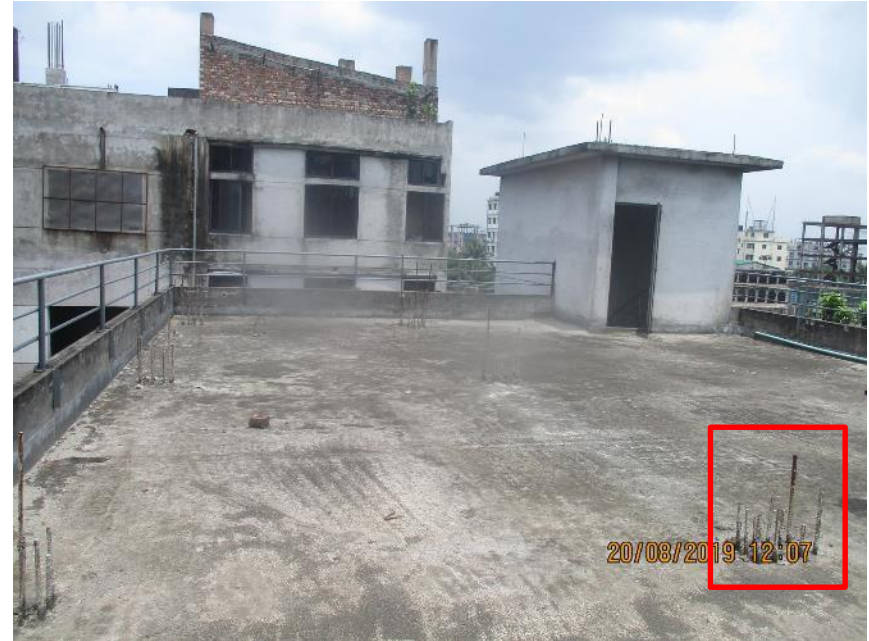
Exposed rebars on roof slab.

Exposed rebar was found on roof. Factory engineer is required to take necessary steps to protect the rebars from corrosion.

| Item No. | Observation | Recommended Action Plan | Recommended Timeline |
|---|---|---|---|
| 5 | Exposed rebar on roof (Building-2) | Apply corrosion resistance paint to the exposed rebars. | 6-weeks |

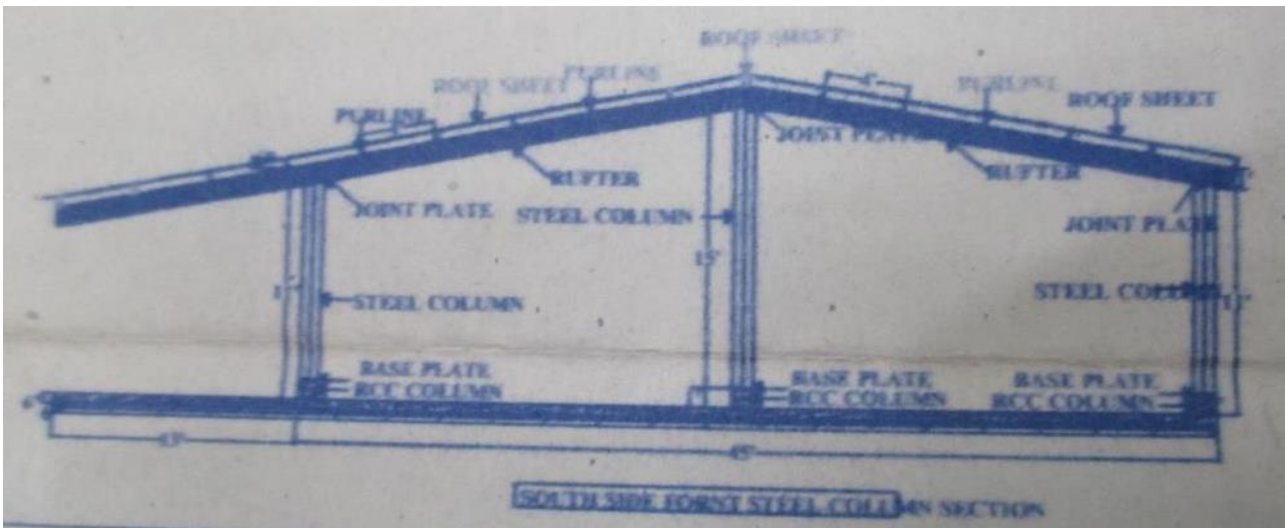
Column and rafter sizes and details not shown in structural drawing.

A set of permit layout drawings was provided where detail drawings not available. Also, the reinforced concrete column size and rebar detail does not match with on site. The factory engineer is required to survey the structure and prepare a full set of as-built drawings.

| Item No. | Observation | Recommended Action Plan | Recommended Timeline |
|---|---|---|---|
| 6 | Insufficient as-built drawing (Shed-5) | The factory engineer is required to survey the structure, collect information and produce as-built architectural and structural documentations. | 6-weeks |

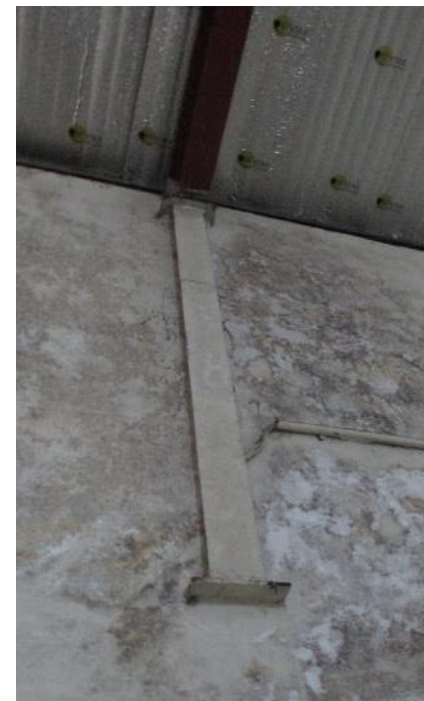
Steel post from wall not shown in drawing

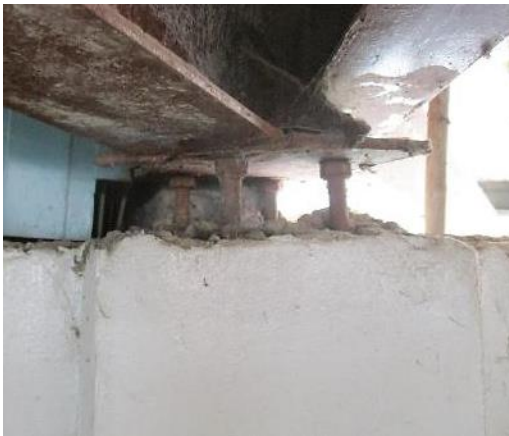
8 rebar was shown in RC column where 4 rebar was found by ferro scanning. Also, column size was found 250 mm instead 300 mm.

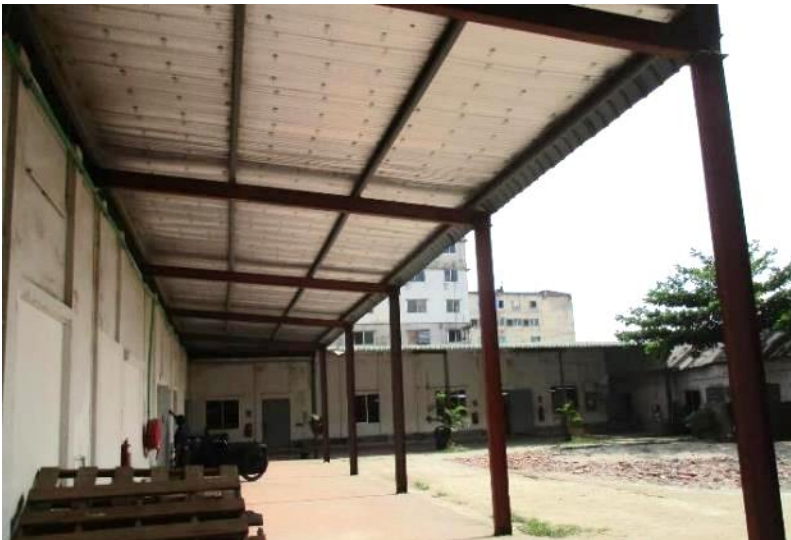
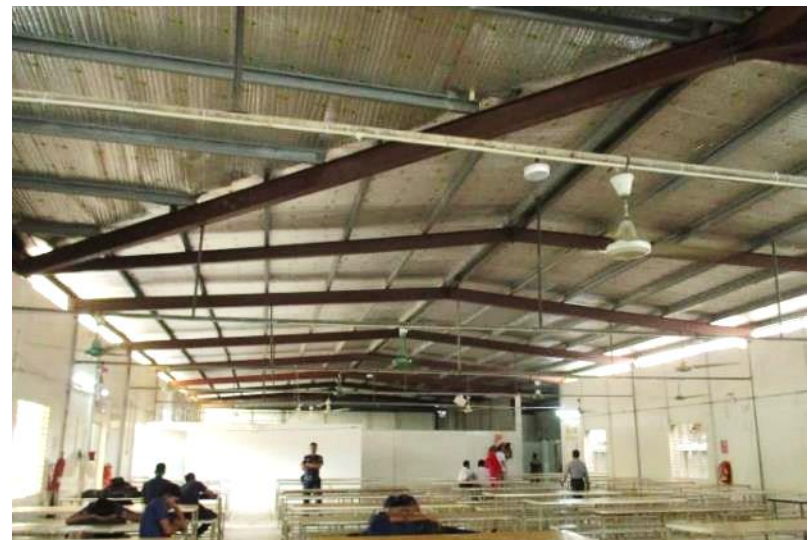
No compression strut and bracing at roof

No compression strut and bracing was observed at roof level. Also, connection gap between joint plates of column and rafter was observed in several locations. The factory engineer is required to verify the lateral stability system of the shed.

| Item No. | Observation | Recommended Action Plan | Recommended Timeline |
|---|---|---|---|
| 7 | Lateral stability system (Shed-5) | Carry out an engineering assessment to verify the lateral stability of the structure. | 6-weeks |
| 9 | Lateral stability system (Shed-5) | Carry out remedial works as outcome of engineering assessment report. | 6-months |

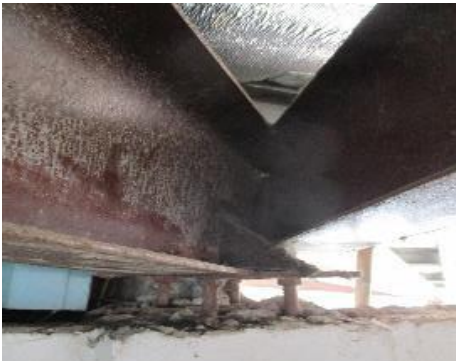
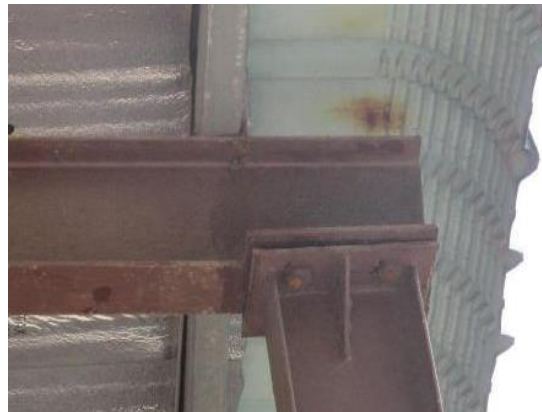
Gap in RC column-steel rafter connection

| Item No. | Observation | Recommended Action Plan | Recommended Timeline |
|---|---|---|---|
| 8 | Lateral stability system (Shed-5) | Building engineering is required to carry out repair works on the significant gaps. | 6-weeks |

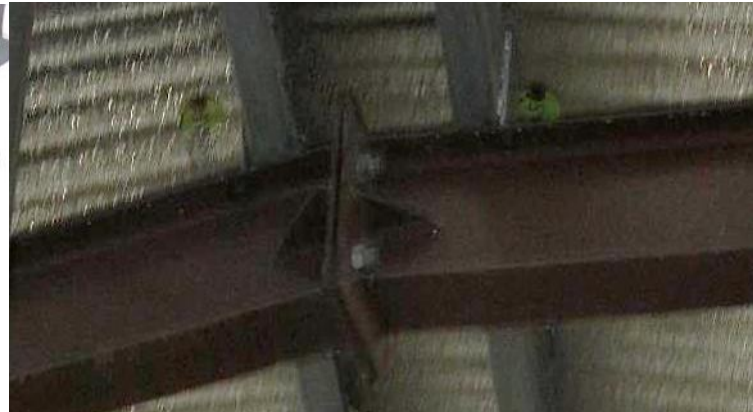
Significant gap between joint plates and support

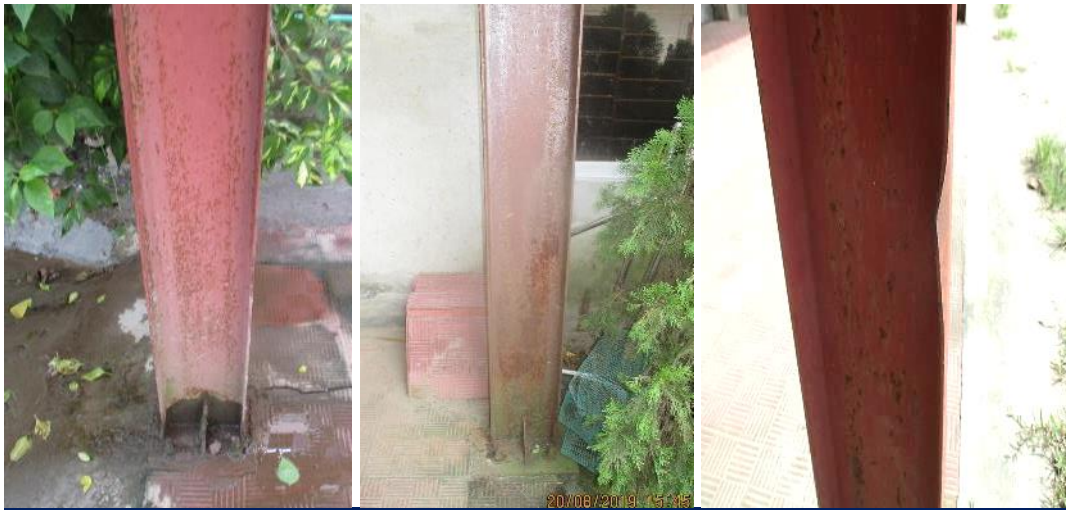
Corrosion in steel column

Corrosion in steel member was observed in several locations. Also, dampness in the peripheral wall was observed in the north-east corner. The factory engineer is required engineer to investigate the reason & extent of corrosion/dampness and suggest proper remedial measure accordingly.

| Item No. | Observation | Recommended Action Plan | Recommended Timeline |
|---|--|--|---|
| 10 | Corrosion and dampness (Shed-5) | The factory engineer to investigate the reason & extent of corrosion and suggest proper remedial measure accordingly. | 6-weeks |
| 12 | Corrosion and dampness (Shed-5) | Carry out remedial works where necessary. | 6-months |

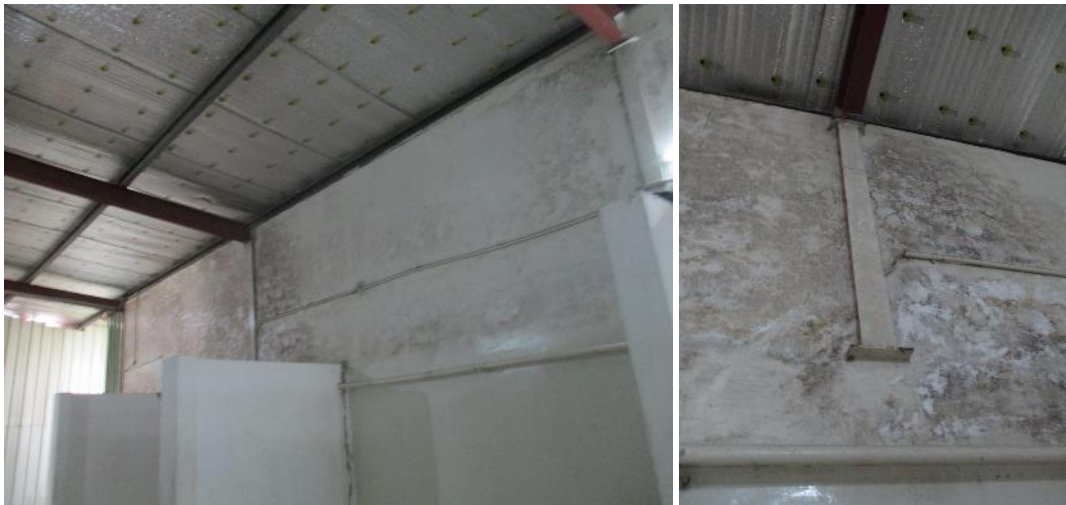
Dampness on peripheral wall

| Item No. | Observation | Recommended Action Plan | Recommended Timeline |
|---|--|--|---|
| 11 | Corrosion and dampness (Shed-5) | The factory Engineer to investigate the cause of dampness at periphery wall and suggest appropriate remedial measures. | 6-weeks |

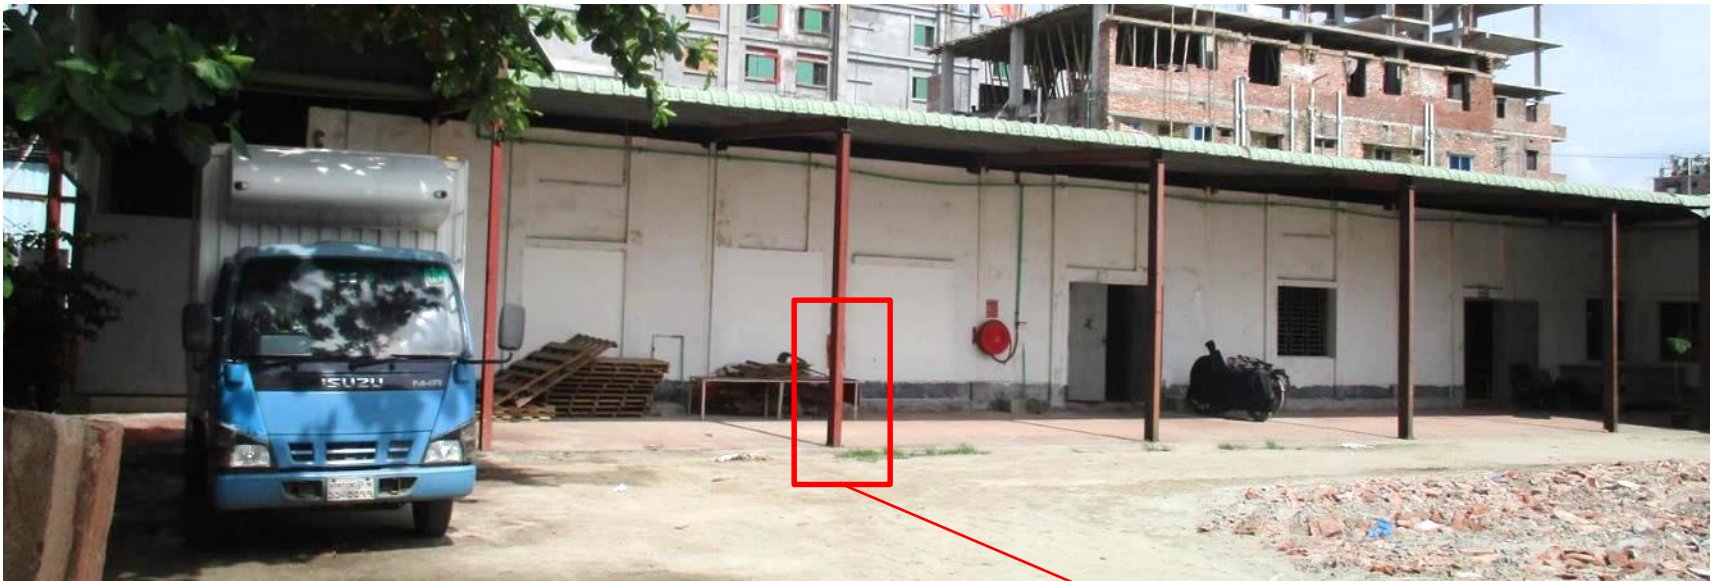
Column is susceptible to vehicle impact

Impact protection barriers are not provided to columns which are susceptible to impact loading from vehicles.

| Item No. | Observation | Recommended Action Plan | Recommended Timeline |
|---|--|--|---|
| 13 | Column susceptible to vehicle impact (Shed-5) | Factory is required to provide barrier and proper signage for the columns susceptible to vehicle impact. | 6-weeks |

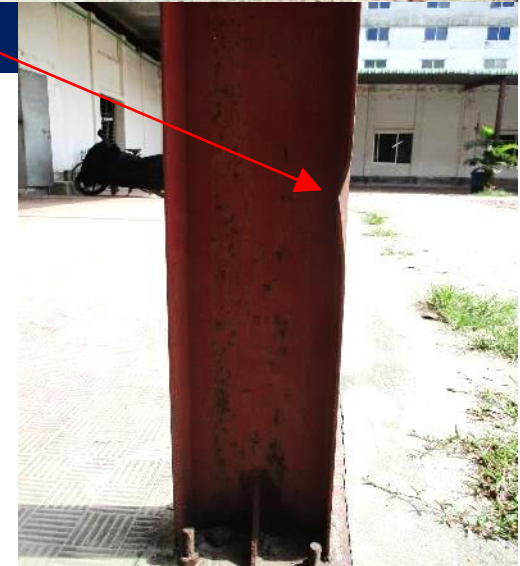
Damage column

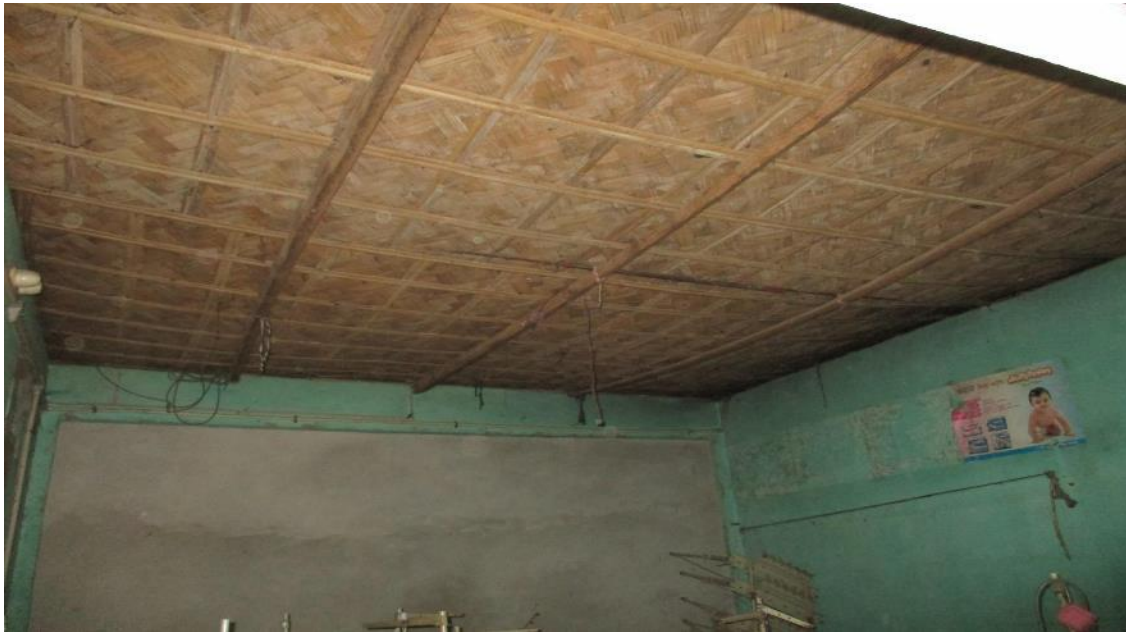
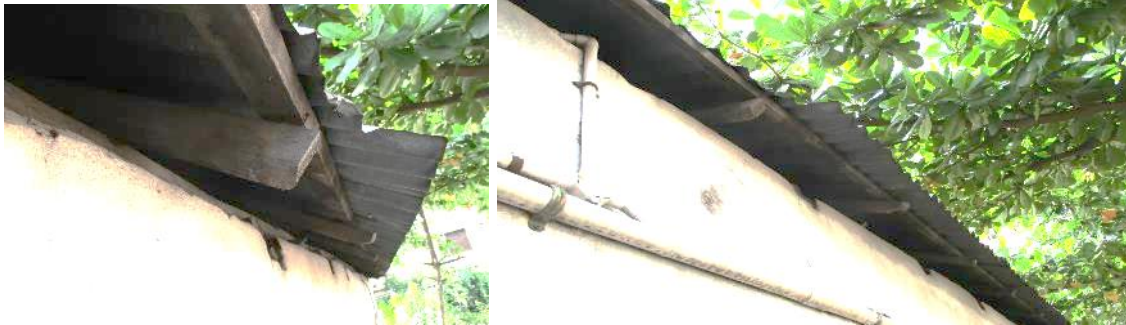
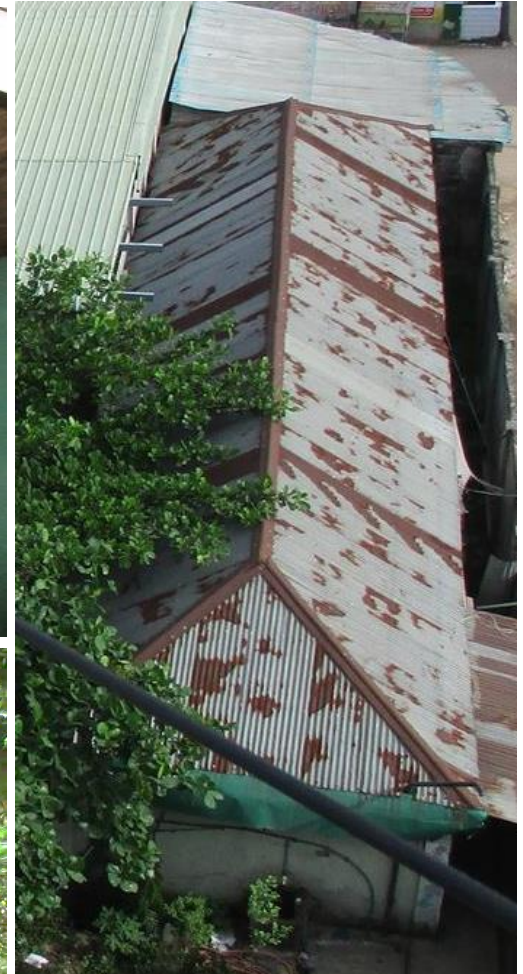
The shed is made by wooden frame with tin sheet and seems to be non-engineered.

| Item No. | Observation | Recommended Action Plan | Recommended Timeline |
|---|--|--|---|
| 14 | Non-engineered shed (Shed-6) | Replace the non-engineered shed by an engineered structure. Otherwise, carry out engineering assessment for the shed. | 6-weeks |
| 15 | Non-engineered shed (Shed-6) | Carry out remedial works suggested by the factory engineers. | 6-months |

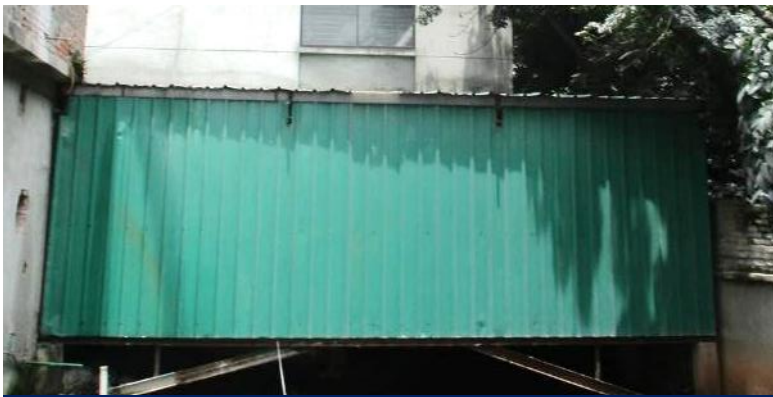
The bottom support system of steel deck

The connection and member size of roof truss and steel deck floor seems to inadequate. The factory engineer is required to check the stability of the shed for lateral and gravity loads.

| Item No. | Observation | Recommended Action Plan | Recommended Timeline |
|---|--|--|---|
| 16 | Stability of steel mezzanine and roof truss (Shed-7) | As part of engineering assessment, the factory engineer is required to review design, loads and stresses of the beam & column. | 6-weeks |
| 17 | Stability of steel mezzanine and roof truss (Shed-7) | Produce and actively manage a loading plan for the decking floor considering the beam, column capacity. | 6-weeks |
| 18 | Stability of steel mezzanine and roof truss (Shed-7) | Carry out remedial works suggested by the factory engineers. | 6-months |

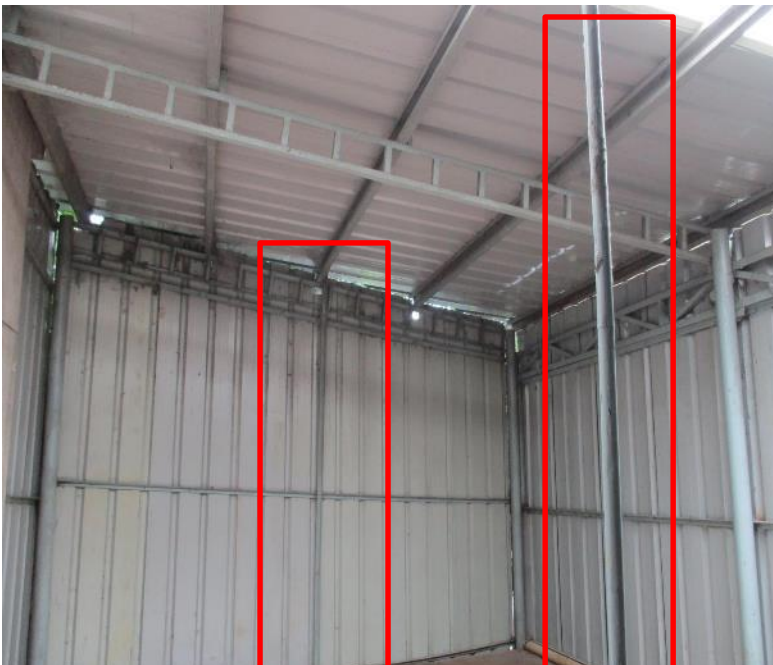
Single angle provide as column

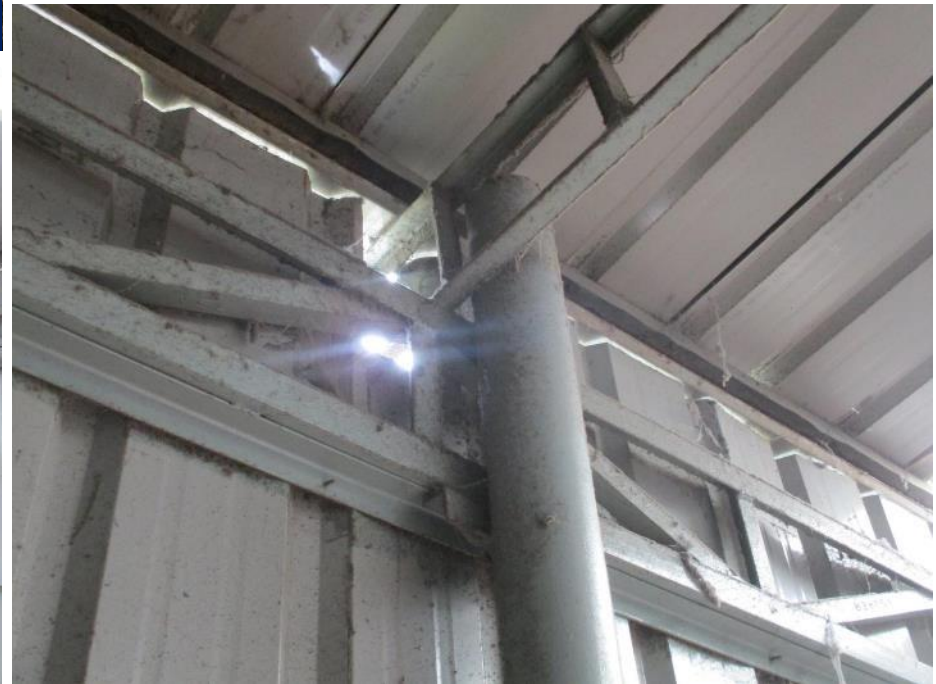
Connection between vertical member and roof truss
