# Kaniz Fashions Ltd

Plot no. A80 (part), A81 & A82, BSCIC Industrial Area,  
Konabari, Gazipur- 1700, Bangladesh.

26<sup>th</sup> August 2019

# Observations

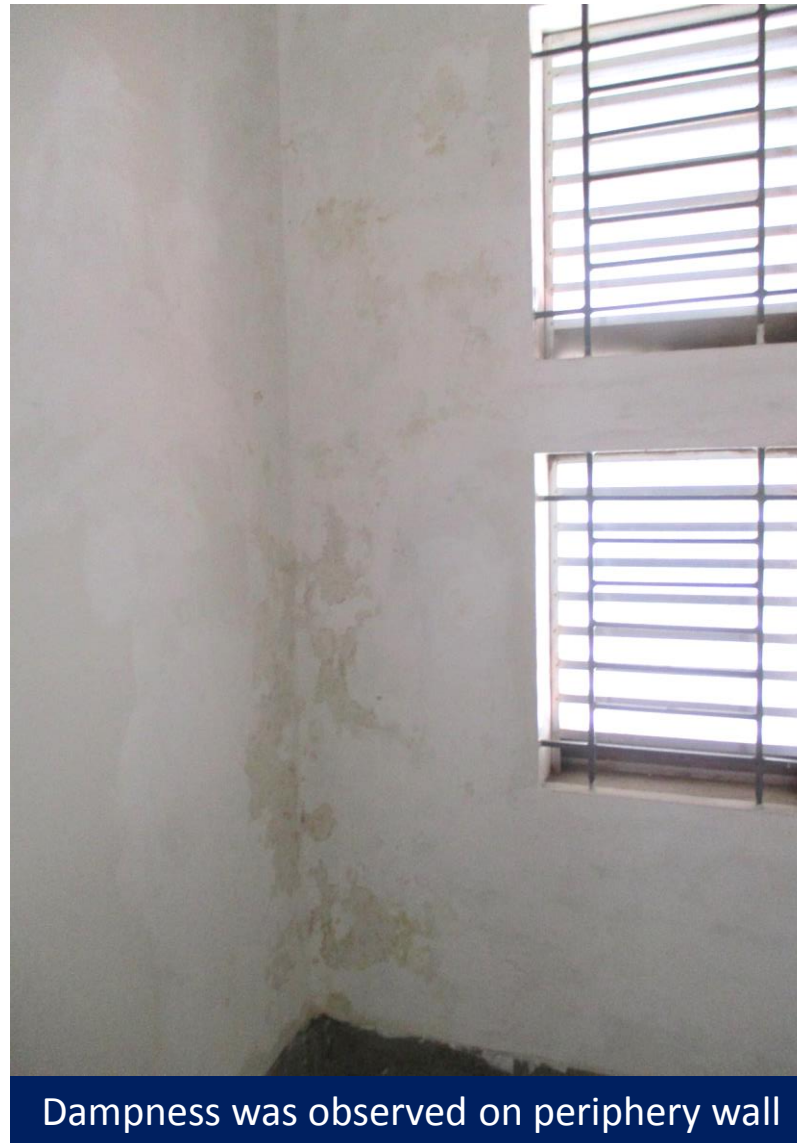
## Water damage at peripheral wall

Dampness was observed on periphery wall

| Item No. | Observation | Recommended Action Plan | Recommended Timeline |
|---|---|---|---|
| 1 | Water damage at peripheral wall | Investigate the cause of dampness on the wall. | 6-weeks |
| 2 | Water damage at peripheral wall | Carry out required measures to remove dampness on walls as per recommendation of factory engineer. | 6-months |

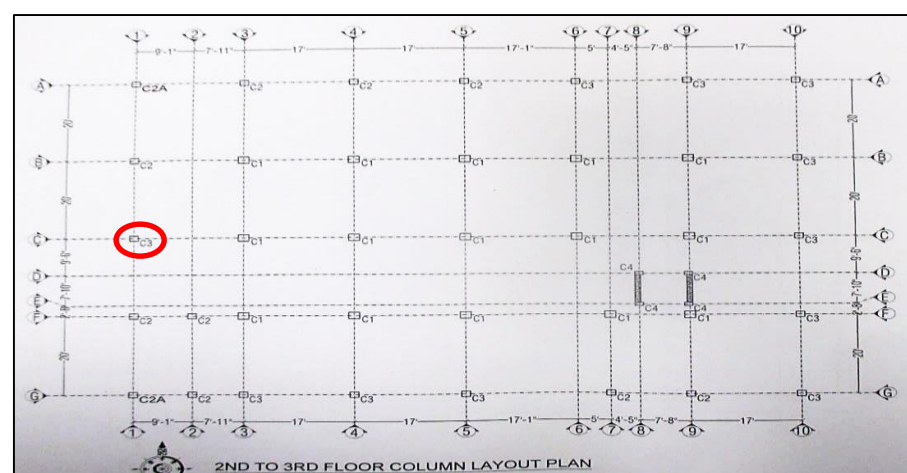
2<sup>nd</sup> for 6<sup>th</sup> floor column Layout

At grid 1-C, C2 column has been assigned at 2<sup>nd</sup> & 3<sup>rd</sup> Floor and C3A column has been assigned at 4<sup>th</sup> to 6<sup>th</sup> floor in FEA model. But in as-built drawing only C3 column has been shown from 2<sup>nd</sup> to 6<sup>th</sup> floor at that mentioned grid. Also there is no column as C3A in column schedule.

| Item No. | Observation | Recommended Action Plan | Recommended Timeline |
|---|---|---|---|
| 3 | Mismatch found between as built drawing & FEA model | Factory engineer is required to survey the structure and update the as-built drawing and revise the DEA report accordingly. | 6-weeks |

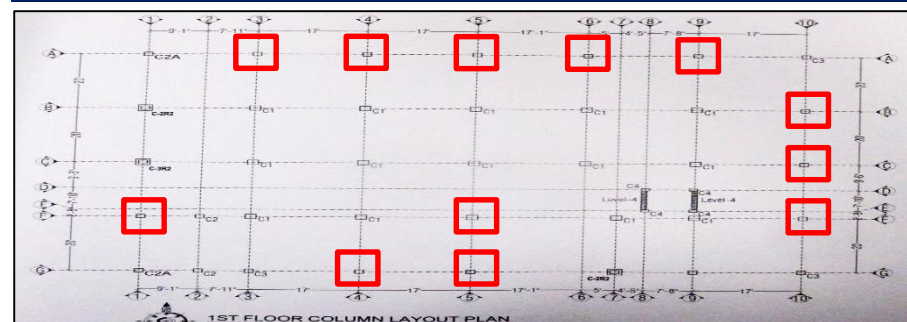
1<sup>st</sup> floor column Layout; Column ID missing

In column layout plan, column ID is missing in several location of different floors.

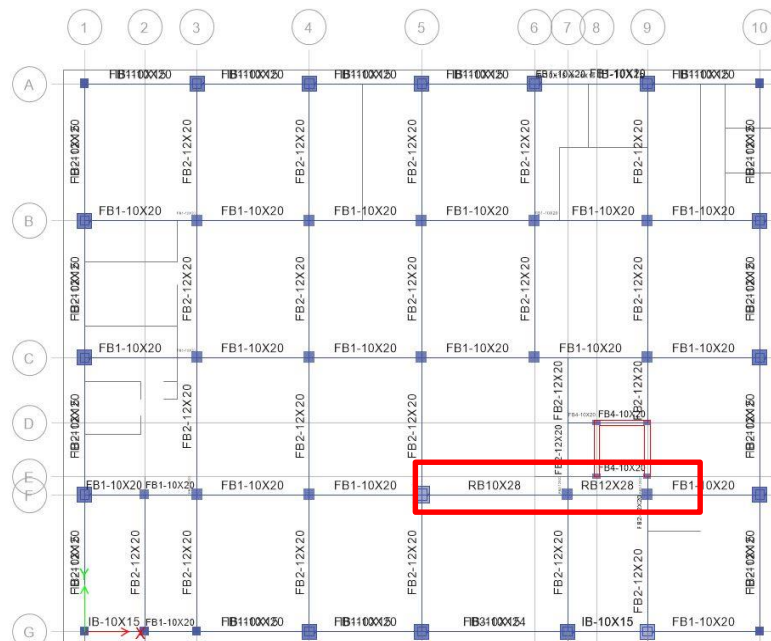
Beam Layout plan from ETABS.

At grid (7-9/F) from 1<sup>st</sup> floor to stair RB-12X28 has been assigned in FEA model. But in as built drawing FB3- 10X24 beam has been shown. Similarly RB10X28 beam has been assigned in FEA model at grid (5-7/F) instead of FB4 10X20

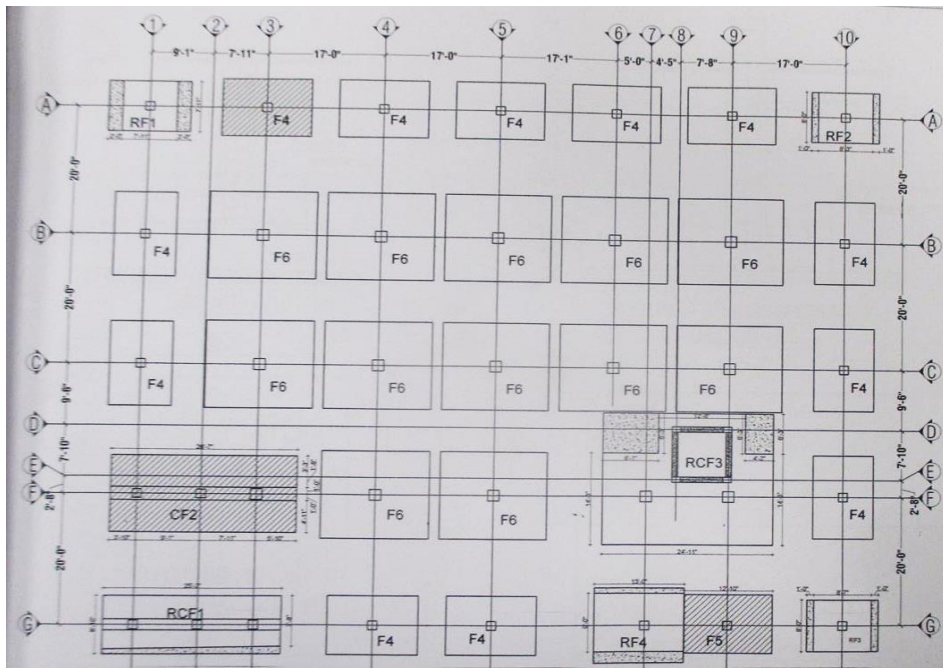
## Foundation Layout plan

In foundation layout plan for the interior foundations denoted as F6, no sectional details have been provided.
