# EMS Apparels Ltd

Barenda, Kashimpur, Gazipur  
(23.976675, 90.310703)  
24<sup>th</sup> July & 28<sup>th</sup> August 2019

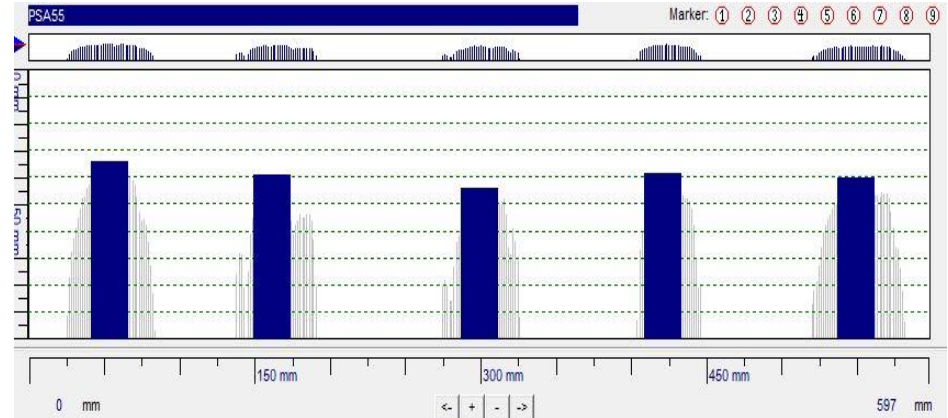
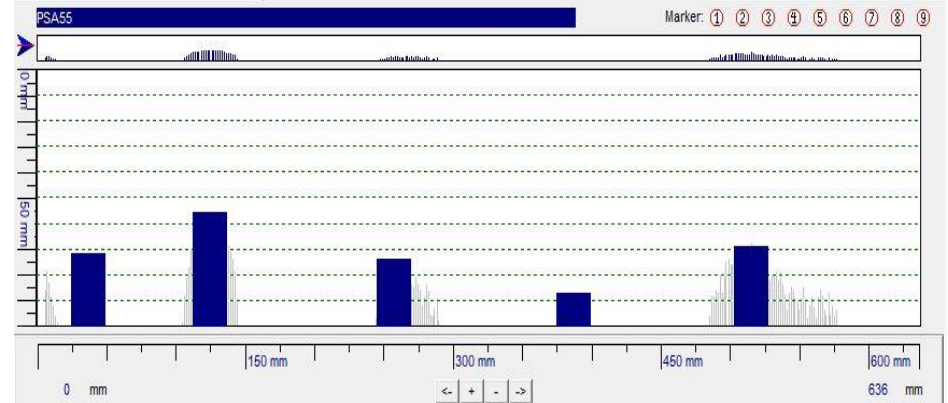
Scan result

Number of rebar of C8 type column does not match with column schedule. 18 nos of rebar were shown in column schedule whereas 16 nos of rebar are found by ferro scanning.

| Item No. | Observation | Recommended Action Plan | Recommended Timeline |
|---|---|---|---|
| 1 | Discrepancies between provided drawings/load plan and on-site condition | Building Engineer to survey the structure and prepare accurate as-built drawings. | 6-weeks |

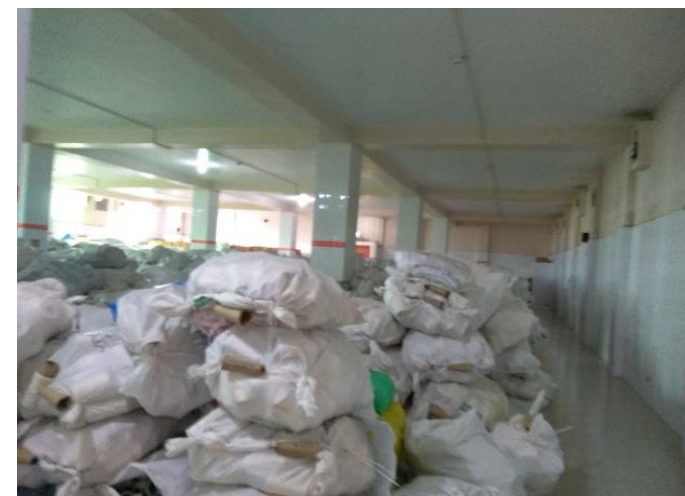
Observed floor loading

The provided load plans are not matched with posted load plan. Also the prepared load plan not comply with BNBC. Factory is required to revise the design report including load plan that comply the BNBC.

During inspection over loading wasn't found. Factor of Safety calculation for internal & external columns were found satisfactory considering 3kPa allowable floor live loading for the building.

| Item No. | Observation | Recommended Action Plan | Recommended Timeline |
|---|---|---|---|
| 2 | Discrepancies between provided drawings/load plan and on-site condition | Factory is required to revise the design report including load plan that comply the BNBC. | 6-weeks |
| 3 | Discrepancies between provided drawings/load plan and on-site condition | Produce and actively manage a loading plan for all floor plates within the factory, considering floor, column and foundation capacity as per BNBC provision. | 6-weeks |

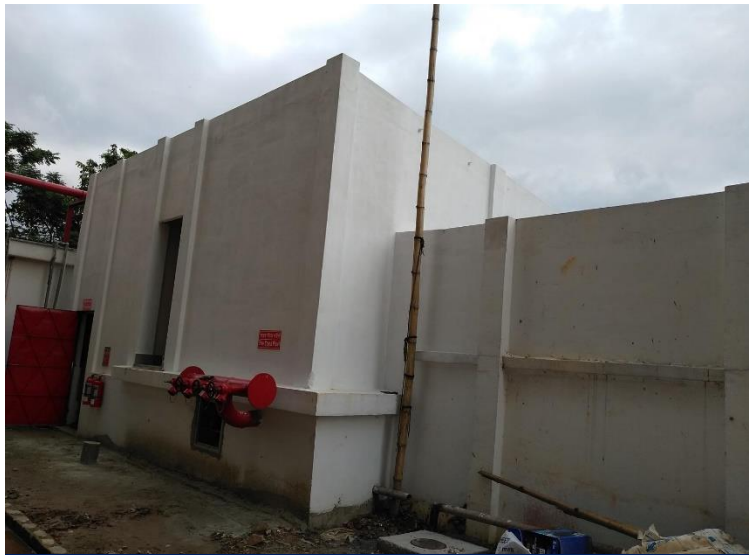
Fire pump room

As-built documents weren't available for Fire pump room, Bonded warehouse, Wastage Shed. Building engineer is required to prepare "as constructed" drawings with complete structural information.

| Item No. | Observation | Recommended Action Plan | Recommended Timeline |
|---|---|---|---|
| 4 | As-built documents for Fire pump room, Bonded warehouse, Wastage Shed not available | Prepare “as constructed” drawings which reflect the actual site dimensions with complete structural information. | 6-weeks |

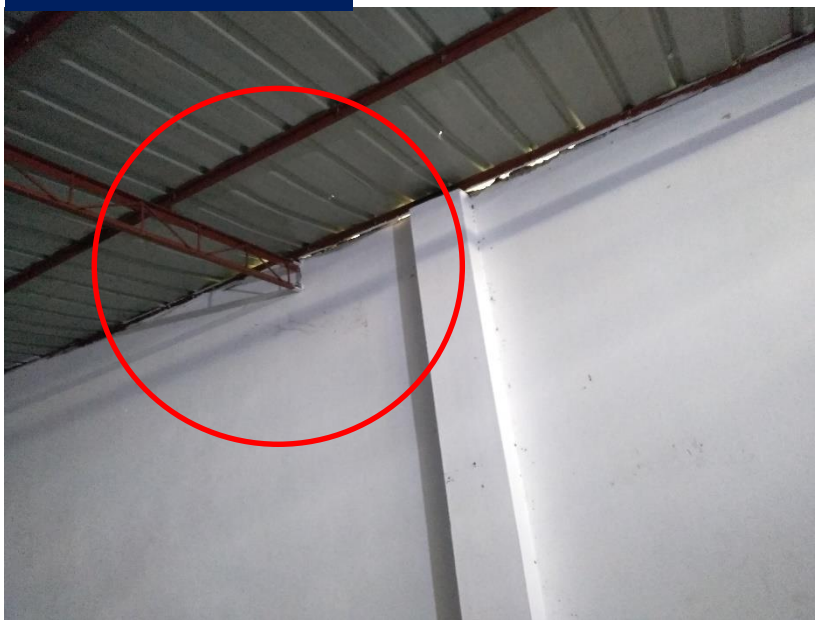
Bonded warehouse

Apparently non-engineered shed. Light weight roof truss structure supported on 125 mm brick wall. The connections appeared to be non-engineered.

Poor connection

| Item No. | Observation | Recommended Action Plan | Recommended Timeline |
|---|---|---|---|
| 5 | Apparently non-engineered Shed | Building engineer to check the adequacy of the lightweight roof structure against lateral loading. | 6-weeks |
| 6 | Apparently non-engineered Shed | Carry out remedial works resulting from engineering assessment if necessary. | 6-months |

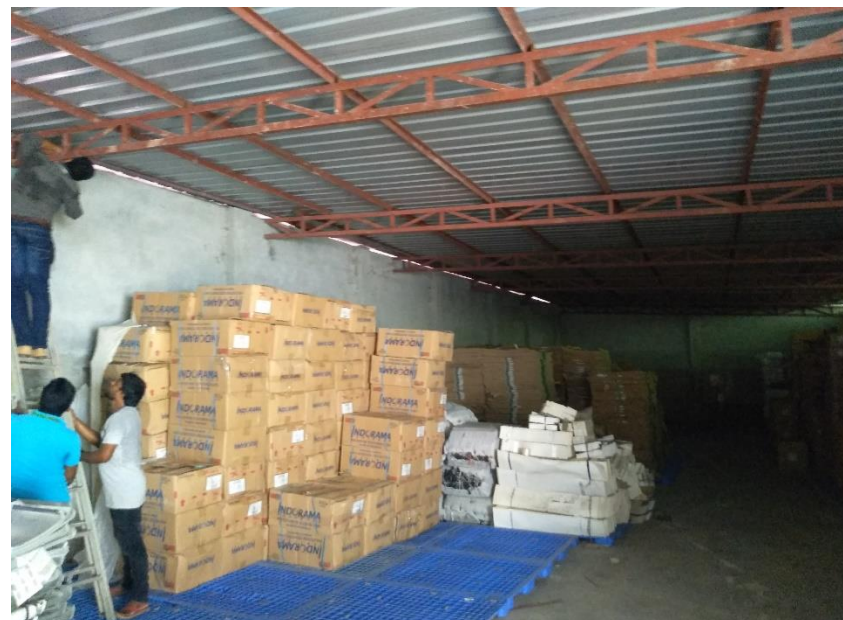
Non-engineered connection
