# Aptech Caswier Ltd

Aptech Industrial Park Holding 30, Sarabo Kashimpur, Gazipur.

30<sup>th</sup> September and 13<sup>th</sup> October 2019

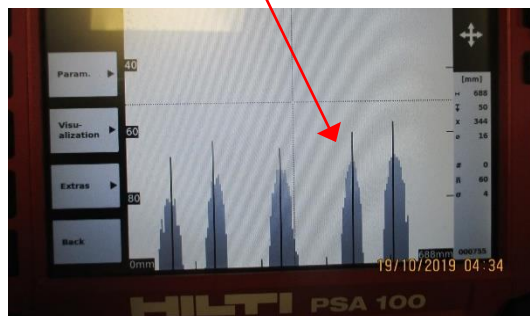
5 rebar were found in long face of C14 column where 6 rebar shows in the column schedule. (14 rebar found instead of 16)

The factory engineer to survey the structure and update the as-built drawings accordingly.

| Item No. | Observation | Recommended Action Plan | Recommended Timeline |
|---|---|---|---|
| 1 | Discrepancies between drawings and on-site observation. (Suit Building) | The factory engineer is required to survey the structures and update the as-built drawings. | 6-weeks |

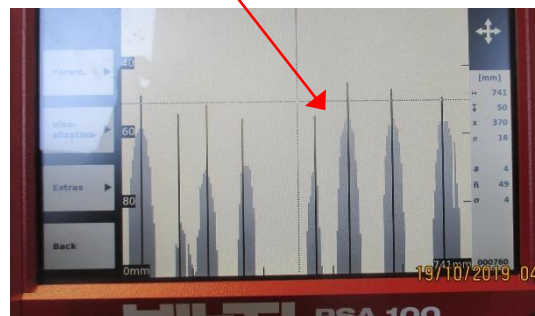
8 rebar were found in long face of C16 column where 10 rebar shows in the column schedule. (18 rebar found instead of 22)

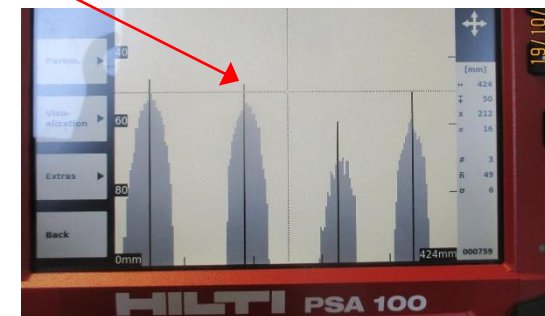
4 rebar were found in both face of C13 column where 5 rebar shows in the column schedule. (12 rebar found instead of 16)

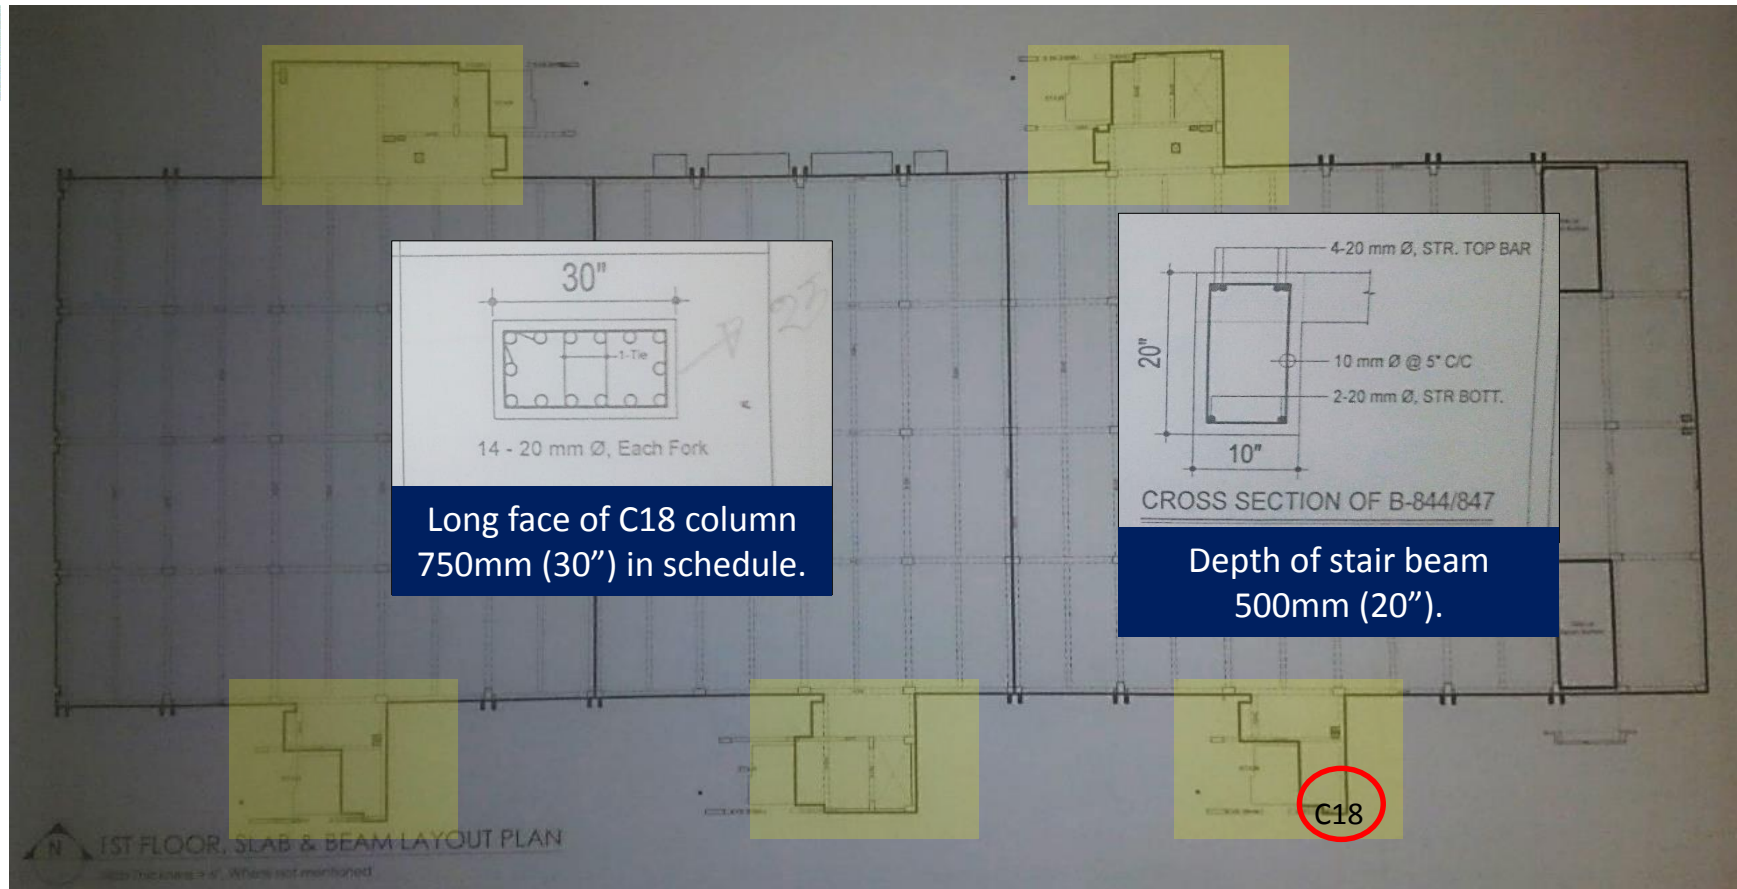
Long face of C18 column  
750mm (30") in schedule.

Depth of stair beam  
500mm (20").

long face of C18 column was measured 625mm on site where drawings shows 750mm (30"). Also, down stand of the beams in the stair zone was measured 450mm where provided drawings shows 500mm (20") as total depth.

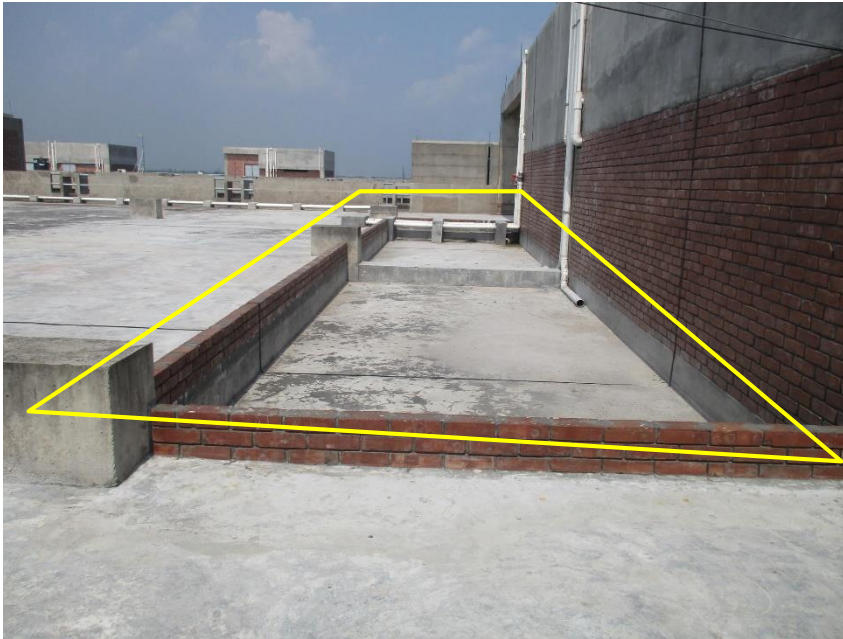
Down area on the roof.

Water damage was observed underside of the roof slab. The factory engineer to develop drainage system otherwise apply proper water proofing layer on the top of roof slab to resist water seepage.

| Item No. | Observation | Recommended Action Plan | Recommended Timeline |
|---|---|---|---|
| 2 | Water damaged underside of the roof slab. (Suit Building) | Develop the drainage system otherwise provide proper water proofing layer on the roof to prevent water seepage. | 6-months |

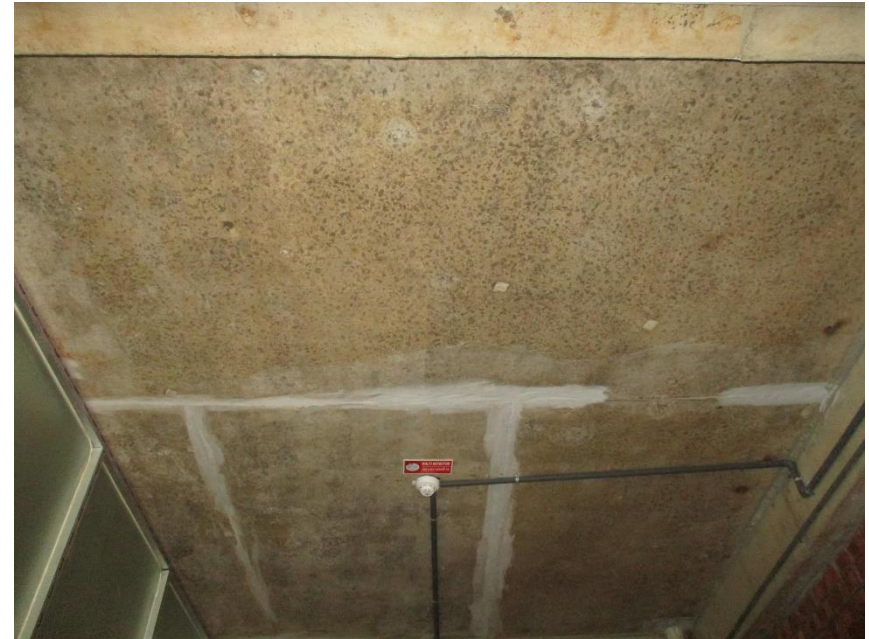
Sign of dampness underside the down slab.

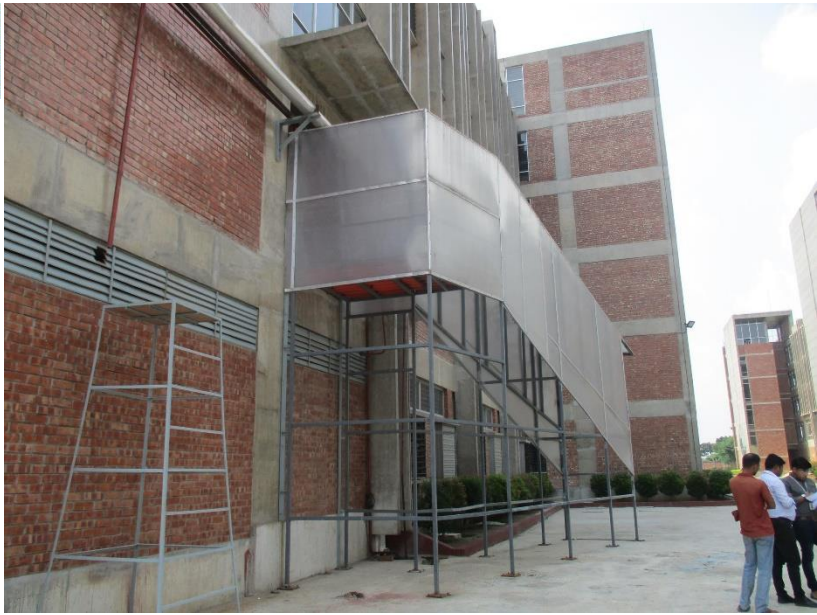
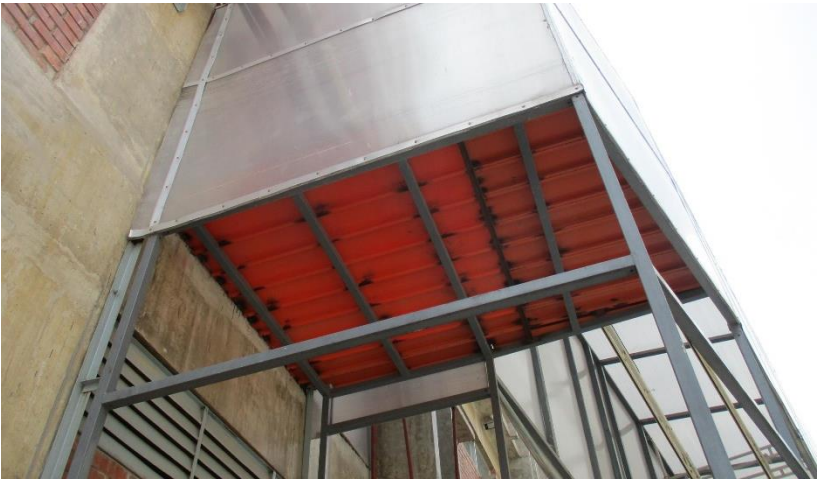
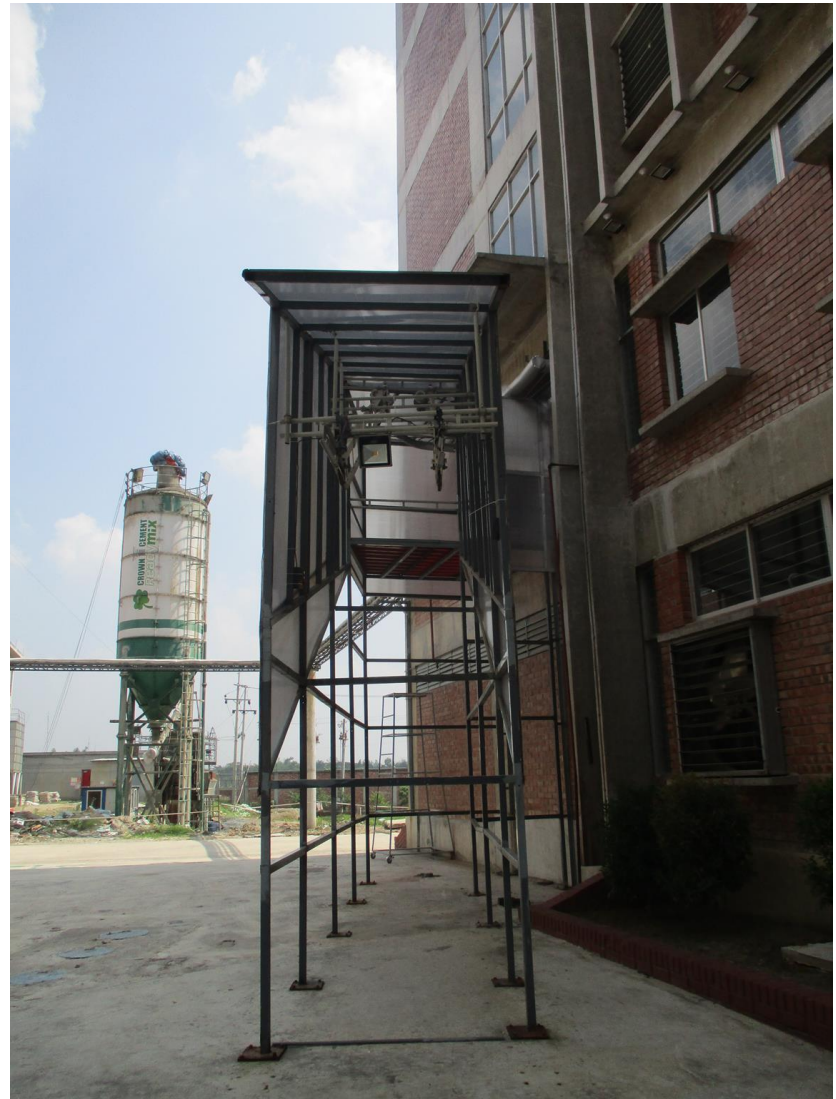
Undocumented lightweight steel conveyer shed was made adjacent to Suit Building. The factory engineer to survey the structure, connections and produce necessary drawings.

| Item No. | Observation | Recommended Action Plan | Recommended Timeline |
|---|---|---|---|
| 3 | Undocumented conveyer shed. (Suit Building) | The factory engineer is required to survey the structures and produce as-built drawings for the structure. | 6-weeks |

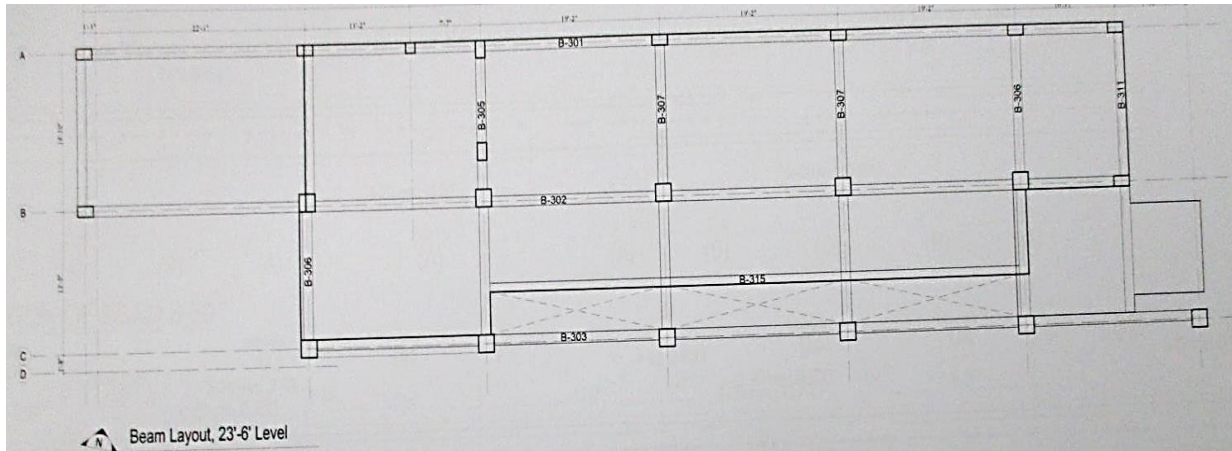
Beam layout shown up to 23'-6" (7.16m) level only

The architectural, structural and floor load plan drawings for the roof level was not available in the provided documents. Beam layout for the roof level was not available in the provided drawings.

| Item No. | Observation | Recommended Action Plan | Recommended Timeline |
|---|---|---|---|
| 4 | Mismatch in as-built drawings. (Ancillary Building) | The factory engineer is required to survey the structures and update the as-built drawings. | 6-weeks |

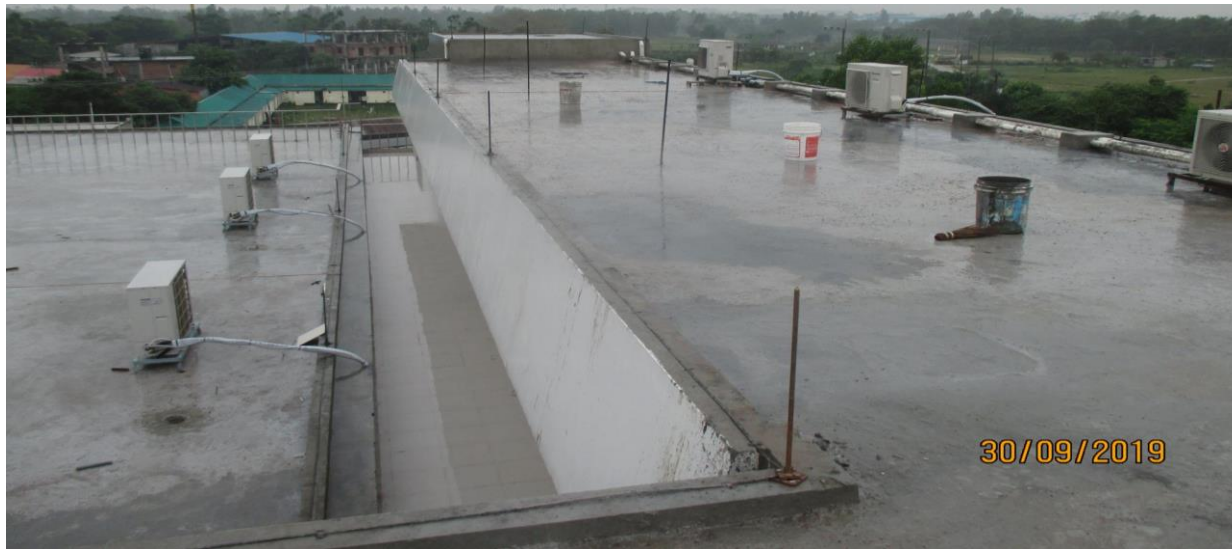
Level difference of roof: 3 storey and 4 storey

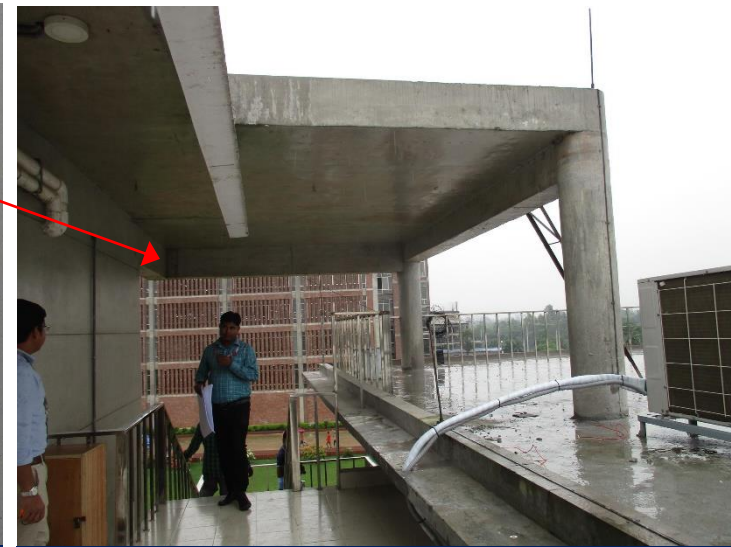
Beam at roof level not match with dwg.

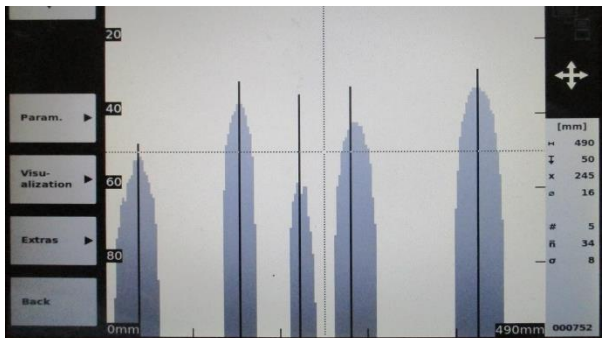
Rebar of C6 column in the schedule

For the C6 column at grid 3-A, Ferro-scanning image shows 5 rebar in long face of where drawing shows 8.

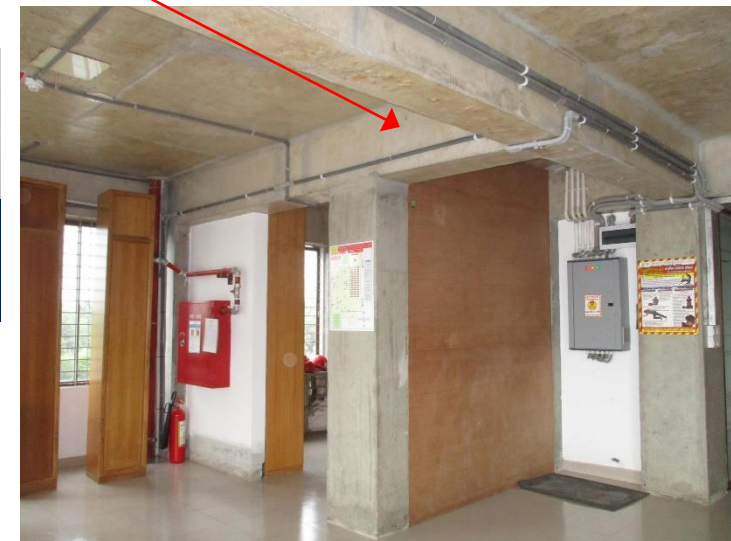
Beam at 2<sup>nd</sup> floor not match with dwg.
