# Loopdot Fashion Limited

Basil, Hazir Bazar, Bhaluka, Mymensingh, Bangladesh.

11<sup>th</sup> September 2019

# Observations

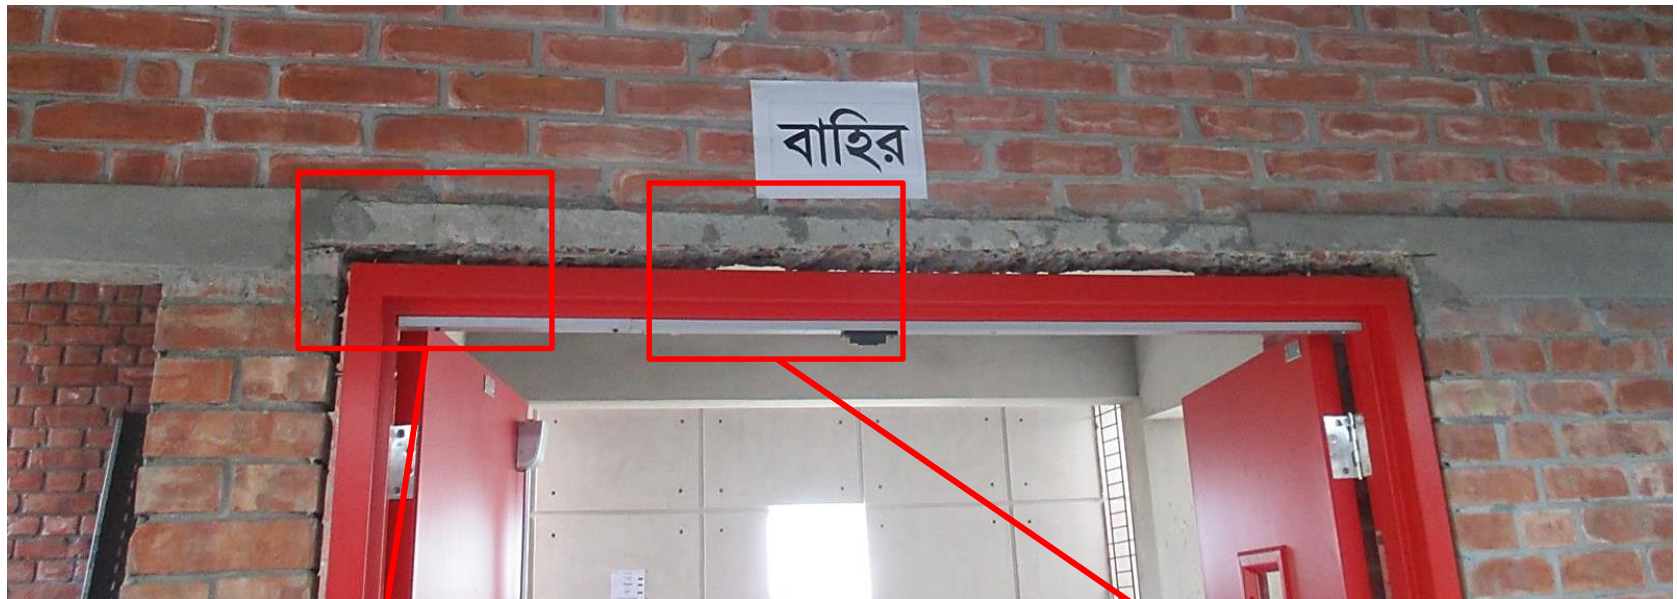
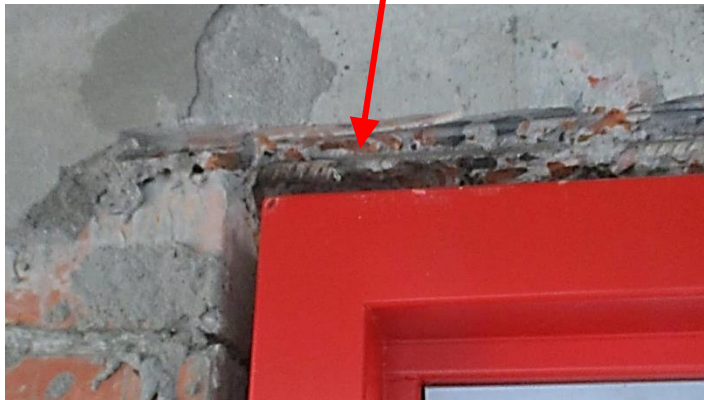
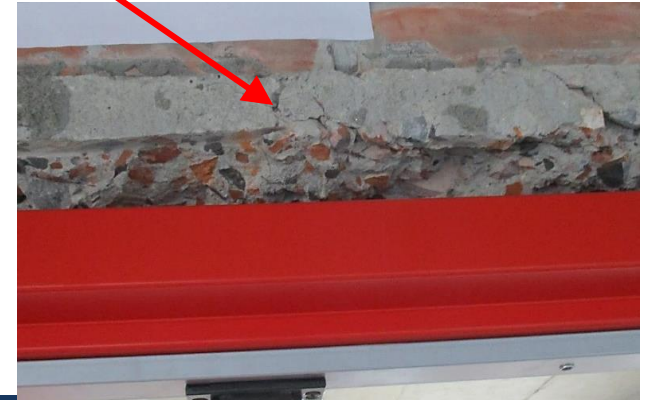
The bottom rebar of 2<sup>nd</sup> floor exit lintel also removed. There are 1.2m high brick wall supported on the lintel beam. Some cracks have been developed on the middle of lintel. The factory engineer to investigate the damage lintel and suggest proper remedial measure.

| Item No. | Observation | Recommended Action Plan | Recommended Timeline |
|---|---|---|---|
| 1 | Damaged Lintel (Production Building) | The factory engineer is required to investigate the damaged area and suggest proper remedial actions. | 6-weeks |
| 2 | Damaged Lintel (Production Building) | Implement remedial actions suggested by the factory engineer. | 6-months |

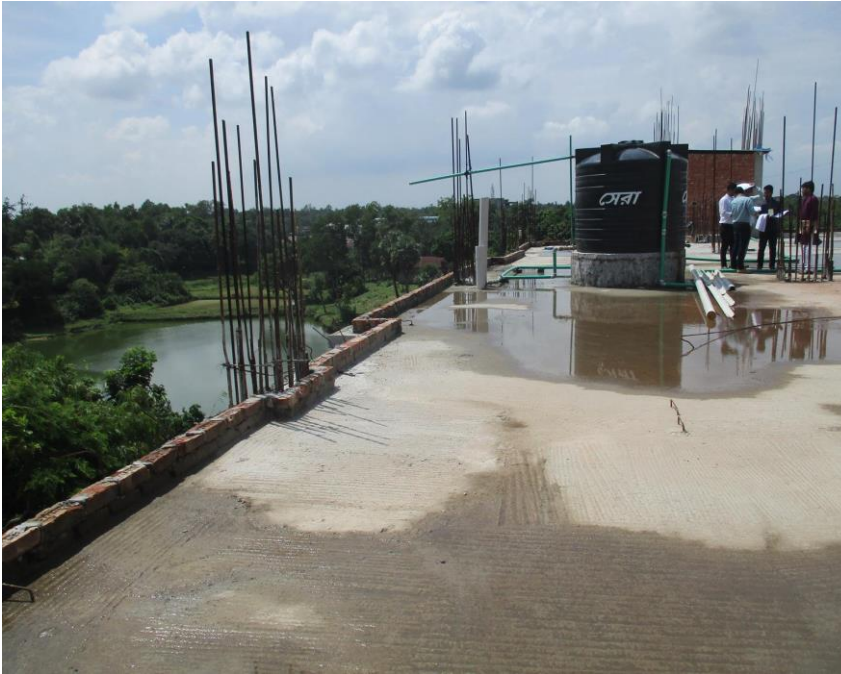
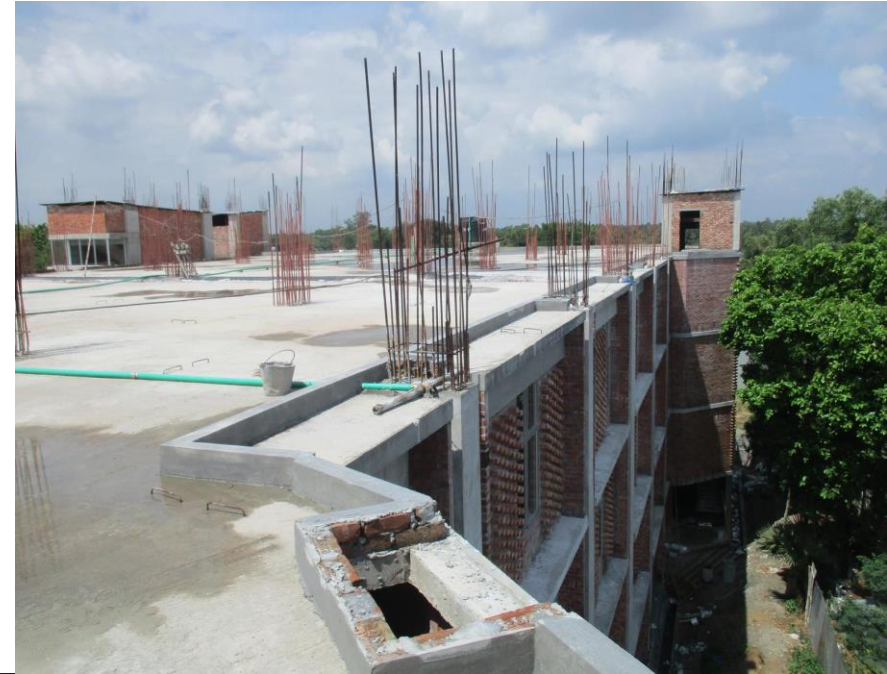
No safety guard or parapet was observed at roof. This area is prone to falling hazard.

| Item No. | Observation | Recommended Action Plan | Recommended Timeline |
|---|---|---|---|
| 3 | Falling hazard. (Production Building) | The factory is required to install railing or parapet wall on the roof to resist falling hazard. | 6-weeks |

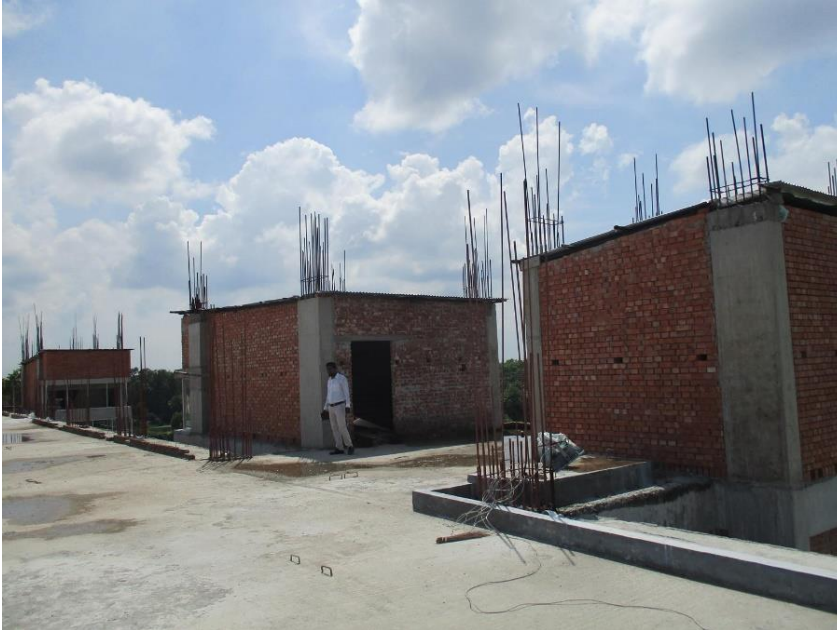
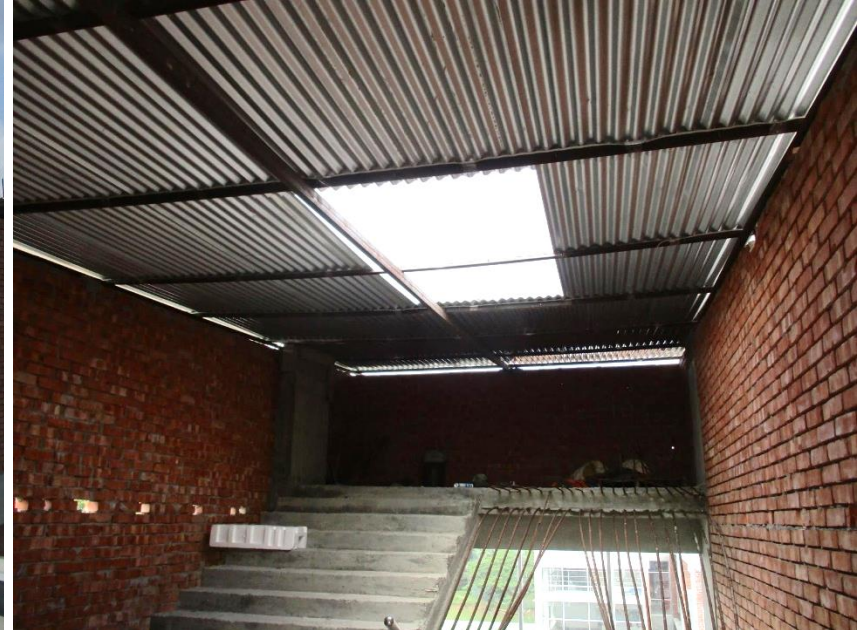
There are four number of stair roof in the building. The connections of lightweight roof are non engineered. The factory engineer to check and upgrade the connections properly.

| Item No. | Observation | Recommended Action Plan | Recommended Timeline |
|---|---|---|---|
| 4 | Non-engineered stair roof. (Production Building) | The factory engineer is required to check the connections and suggest the proper remedial actions. | 6-weeks |
| 5 | Non-engineered stair roof. (Production Building) | Implement remedial actions suggested by the factory engineer. | 6-months |

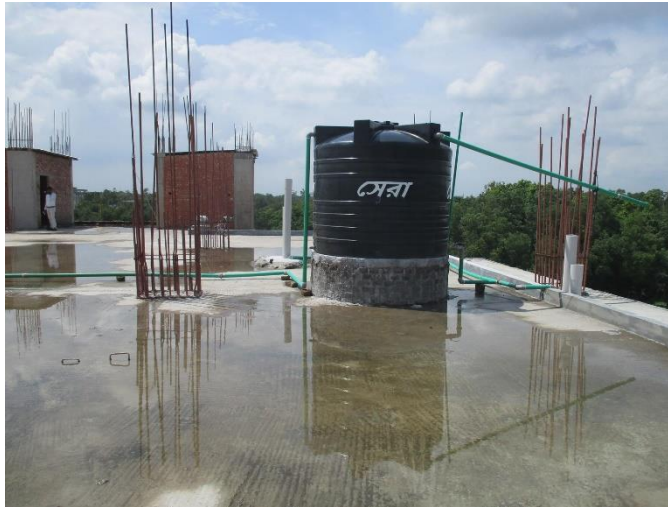
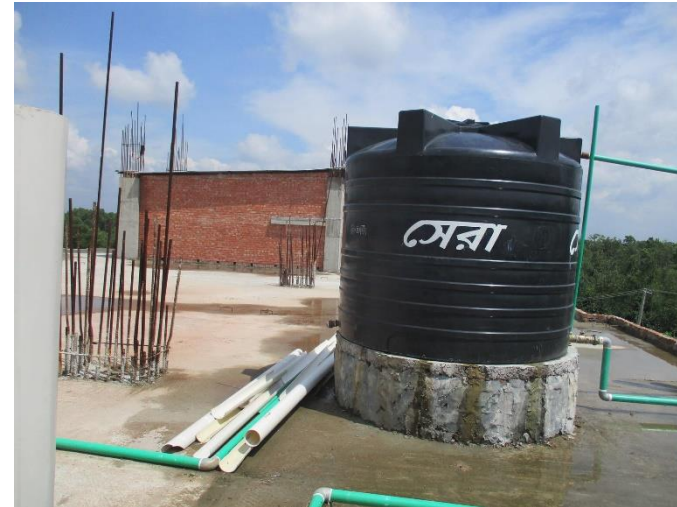
2 x 5,000-liter plastic water tanks were observed on roof which are not mentioned in the as-built drawing as well as floor loading plan.

| Item No. | Observation | Recommended Action Plan | Recommended Timeline |
|---|---|---|---|
| 6 | Incomplete as-built documents. (Production Building) | The factory engineer is required to update the as-built drawing and floor loading plan for the roof floor. | 6-weeks |

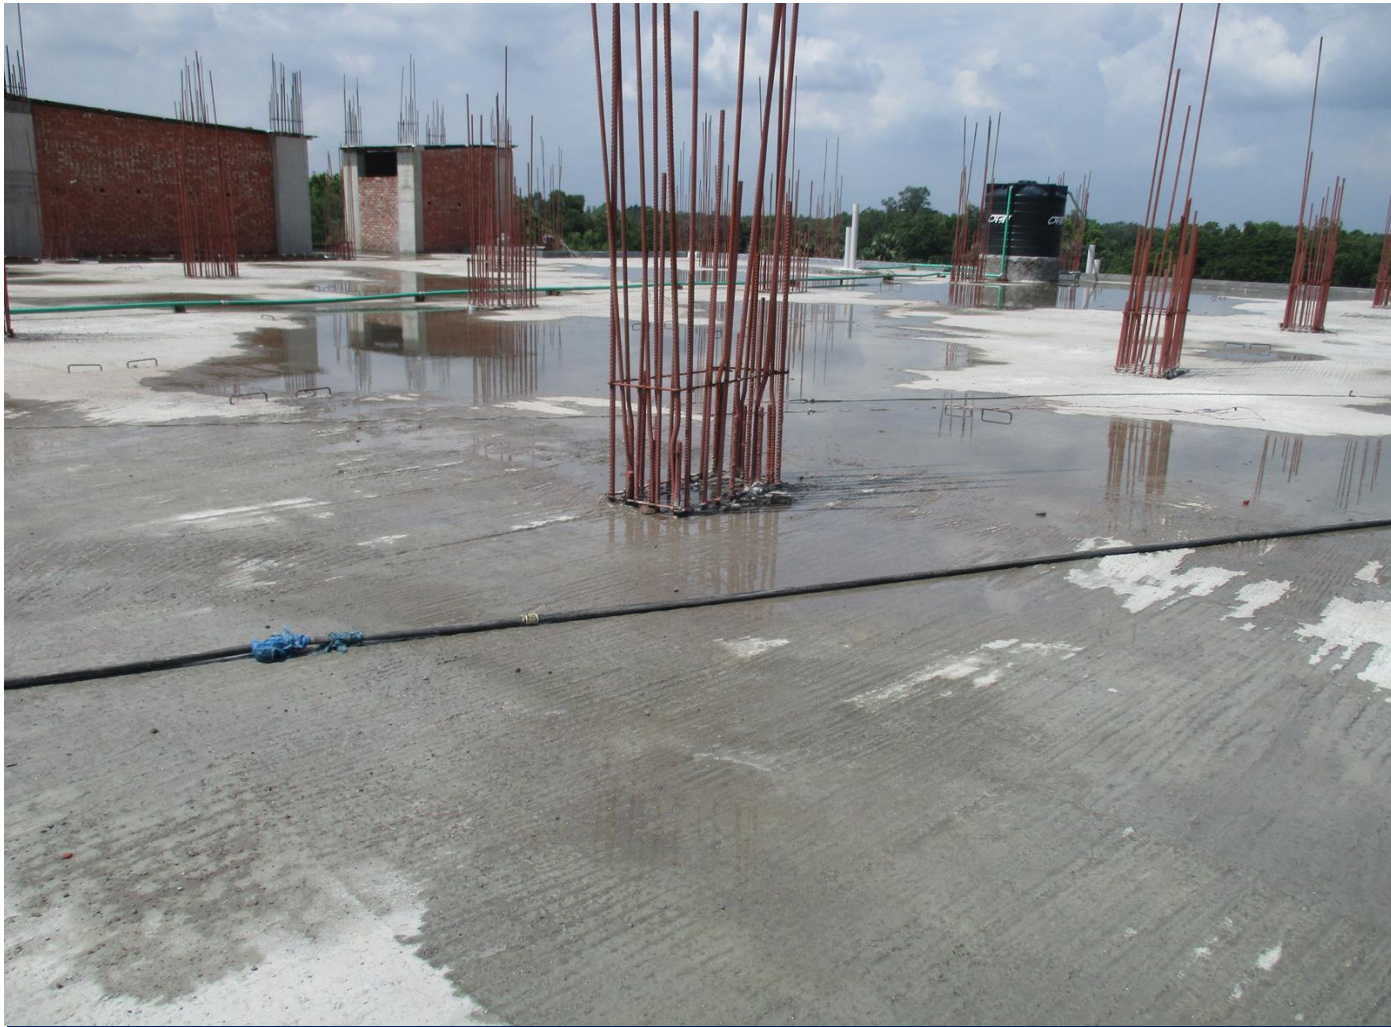
Water ponding was observed on the roof. Building engineer to develop proper drainage system with adequate slope on roof.

| Item No. | Observation | Recommended Action Plan | Recommended Timeline |
|---|---|---|---|
| 7 | Water ponding on roof.<br>(Production Building) | Develop drainage system on roof with proper slope. | 6-months |

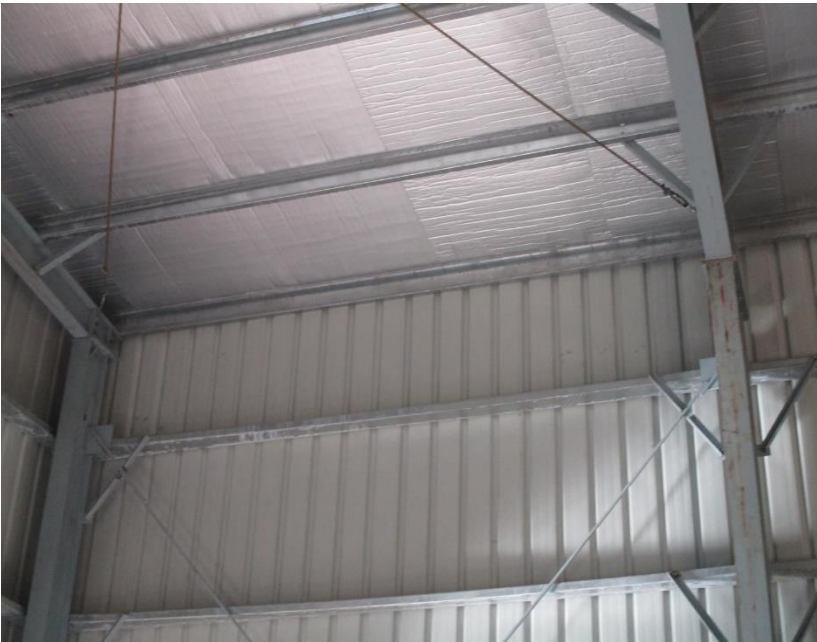
No compression strut at cable bracing system.

The shed is single bay structure along short direction. There is no lateral load transfer media along long direction at the eave level. In addition, 1.2m wide canopy added with portal frame. Factory engineer to check the stability of the shed against lateral forces following BNBC provisions.

| Item No. | Observation | Recommended Action Plan | Recommended Timeline |
|---|---|---|---|
| 8 | Lateral Stability System.<br>(Utility Shed) | The factory engineer is required to carry out Engineering Assessment (EA) to check the stability of the structure against lateral forces following BNBC. | 6-weeks |
| 9 | Lateral Stability System.<br>(Utility Shed) | Implement the recommendations of engineering assessment report. | 6-months |

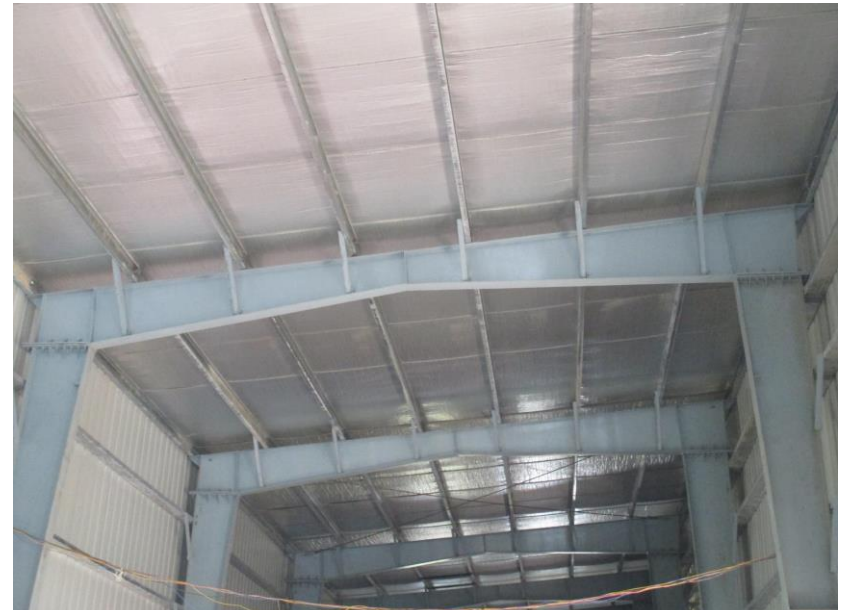
At eave level lateral load transfer media along long direction of the shed was not provided

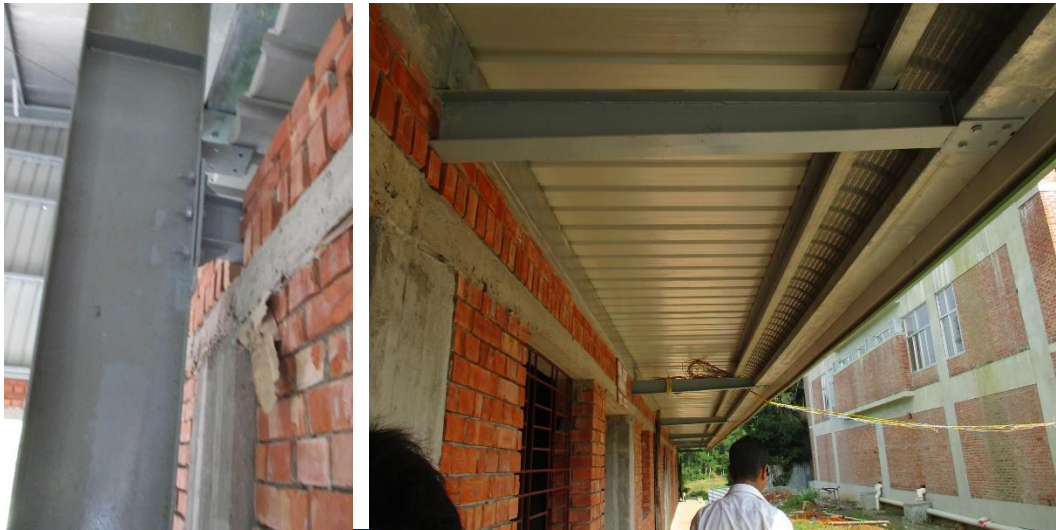
Canopy observed at south

Undocumented canopy at south was observed on site but not shown in provided as-built drawings. Also, structural details of canopy was not available on drawings.

| Item No. | Observation | Recommended Action Plan | Recommended Timeline |
|---|---|---|---|
| 10 | Undocumented canopy at south. (Utility Shed) | Building engineer is required to survey the structure and update the as-built drawings as required. | 6-weeks |
