BANDO DESIGN LTD. [NEW BUILDING]

PURBA NARSINGHAPUR, EARPUR UNION PARISHAD ROAD, ASHULIA, SAVAR, DHAKA-1349
(23.560502N, 90.181293E)

20th November 2017

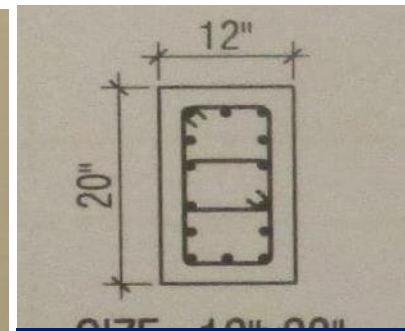
C-2 column size shown 300mm x 500mm in provided drawing

Item No.	Observation	Recommended Action Plan	Recommended Timeline
1	(New building) Discrepancies between provided drawing and on site condition	Building Engineer required to prepare As –Built drawings reflecting the actual condition.	6-weeks
2	(New building) Prepared load plan required to be verified	Maintain 3 Kpa load on all floors.	6-weeks
3	(New building) Prepared load plan required to be verified	Produce and actively manage a loading plan for all floor plates within the factory giving consideration to floor capacity and column capacity if loading above 3kpa is considered.	6-weeks
4	(Bonded warehouse building) Discrepancies between provided drawing and on site condition	Building Engineer required to prepare As –Built drawings reflecting the actual condition.	6-weeks
5	(Bonded warehouse building) Prepared load plan required to be verified	Maintain 3 Kpa load on all floors.	6-weeks
6	(Bonded warehouse building) Prepared load plan required to be verified	Produce and actively manage a loading plan for all floor plates within the factory giving consideration to floor capacity and column capacity if loading above 3kpa is considered.	6-weeks

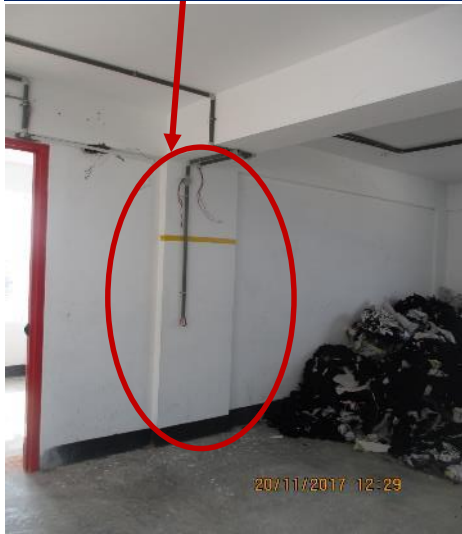
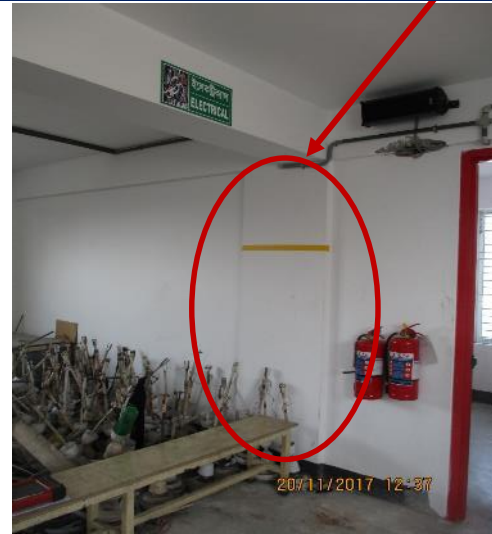
Marked Columns size found 300mm x 680mm which are denoted as C2 (300mm x 500mm) type column in column layout

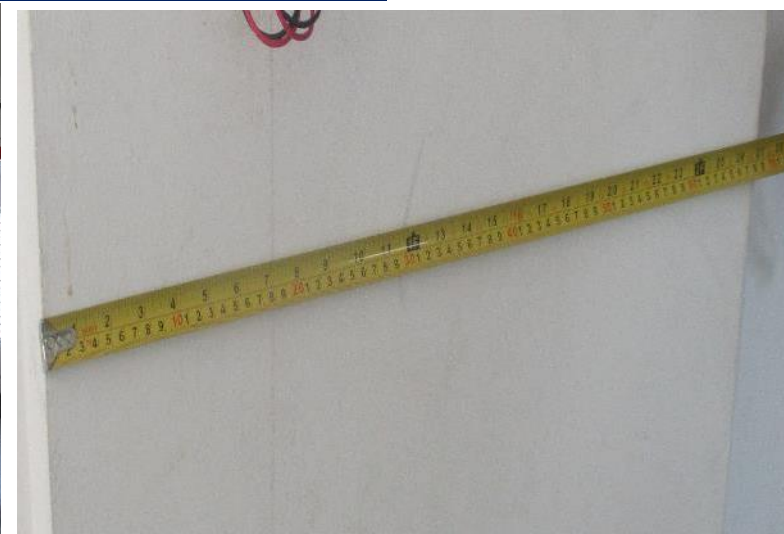
Marked column size in long direction was measured 680mm

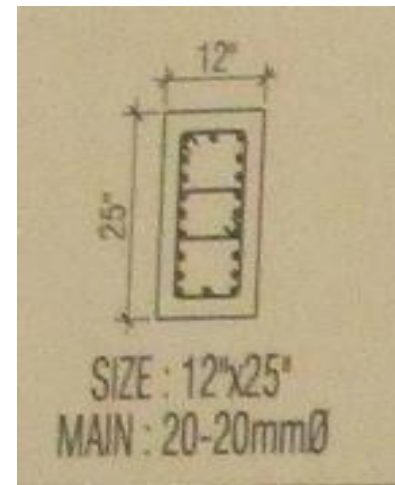
9 nos. rebar were shown on long direction of C3 column in ground floor

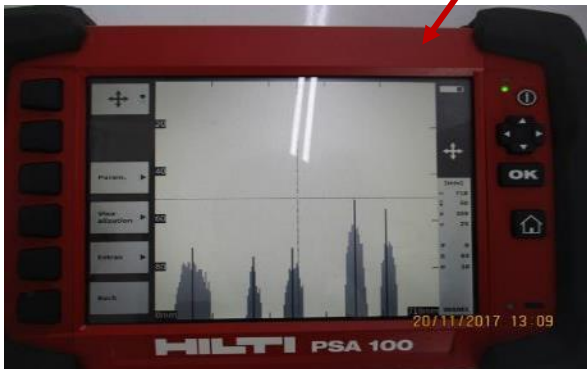
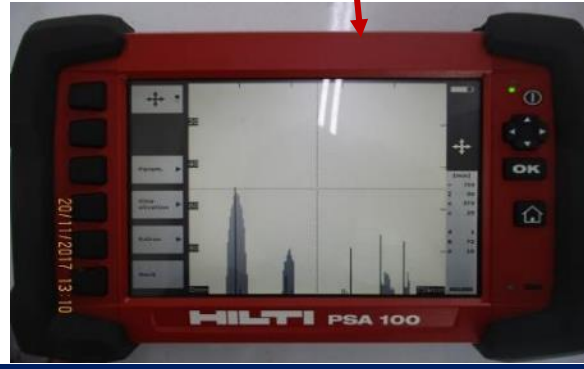
Ferro Scanning Image of marked column

5 Nos of reinforcement found in long direction of C3 type columns at ground floor and 1st floor. But in column schedule, 9 nos of rebar shown for same direction of C3 type column.

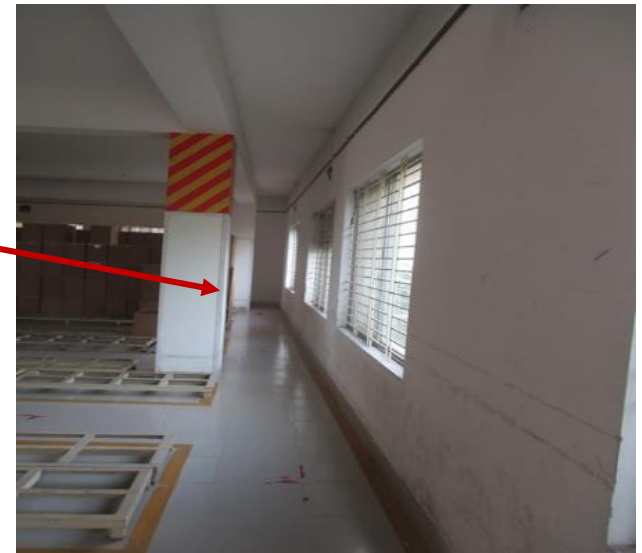
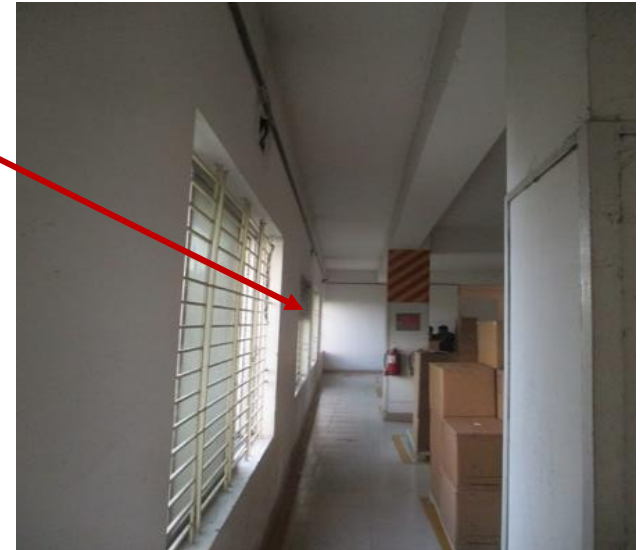
2.1m wide cantilever on East side which was not shown in drawing

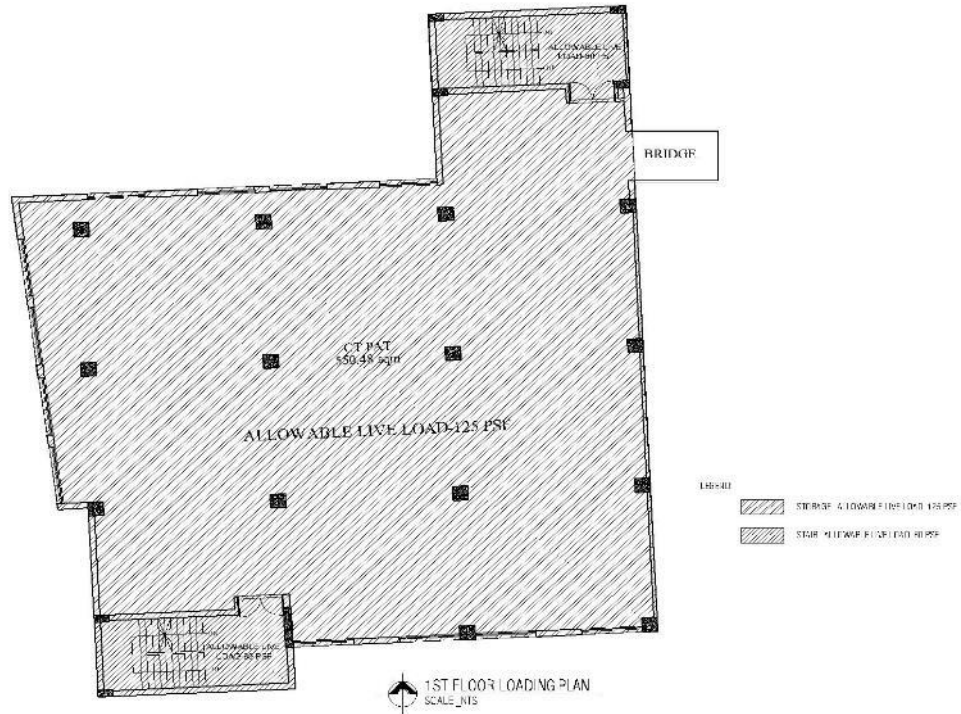
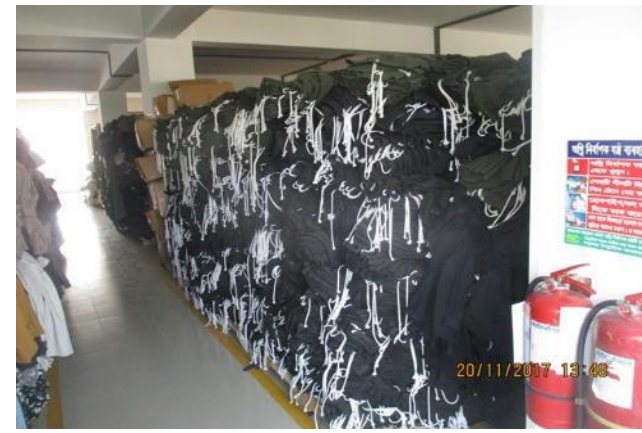
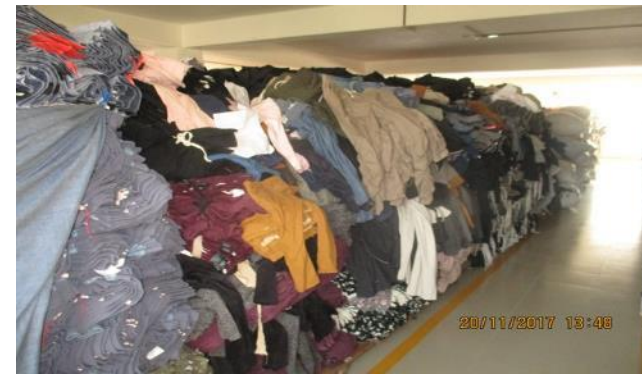
Factory engineer prepared a load plan considering 6 kPa allowable floor loading. Design review required if the factory management wants to implement the load plan.

During inspection overloading was observed above 5 kPa and FOS calculation for internal column was found satisfactory considering 3kPa allowable floor live loading.

Factory is required to maintain the floor live load 3 kPa until further verification by design engineer.

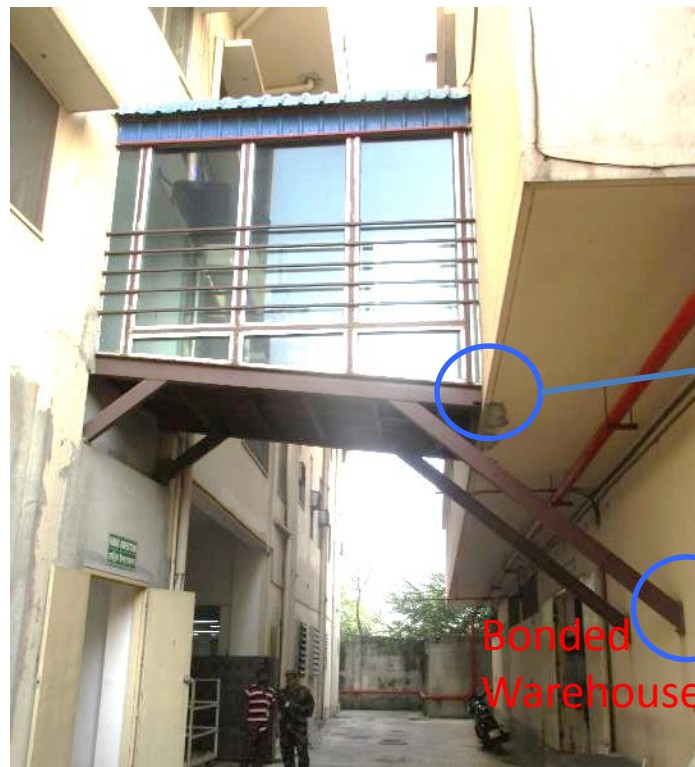
Connecting bridge was found on the north side of the building

Factory is required to engage a qualified engineer for verify the capacity of the peripheral brick wall of the Bonded Warehouse for the imposed loading of the bridge

Item No.	Observation	Recommended Action Plan	Recommended Timeline
8	(Bonded warehouse building) Presence of bridge between the Bonded warehouse building and Building-2	The factory engineer is to verify the capacity of beams and peripheral wall.	6-weeks
9	(Bonded warehouse building) Presence of bridge between the Bonded warehouse building and Building-2	Carry out remedial works resulting from engineering assessment if necessary.	6-months
10	(Childcare building and Boiler & Pumphouse building) Lack of as-built documentations	Factory engineer is required to survey and produce accurate as-built drawing as per actual condition.	6-weeks

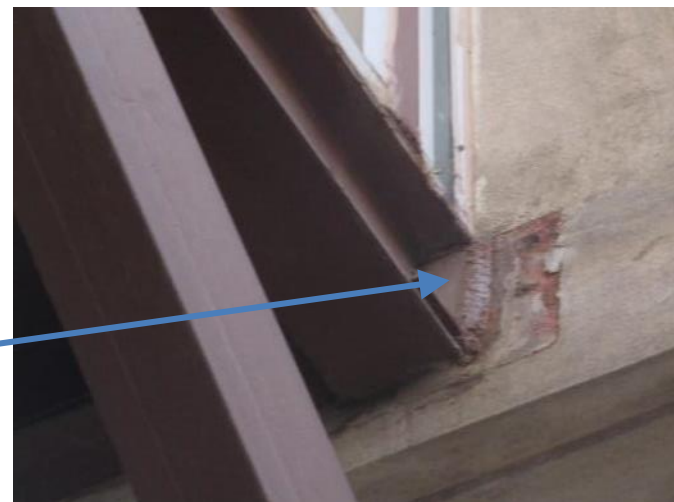
Steel beam was welded with RC beam of the building

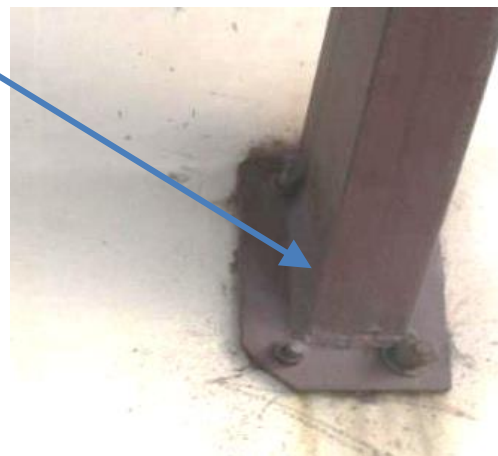
Steel member were supported by brick wall with bolt and steel plate

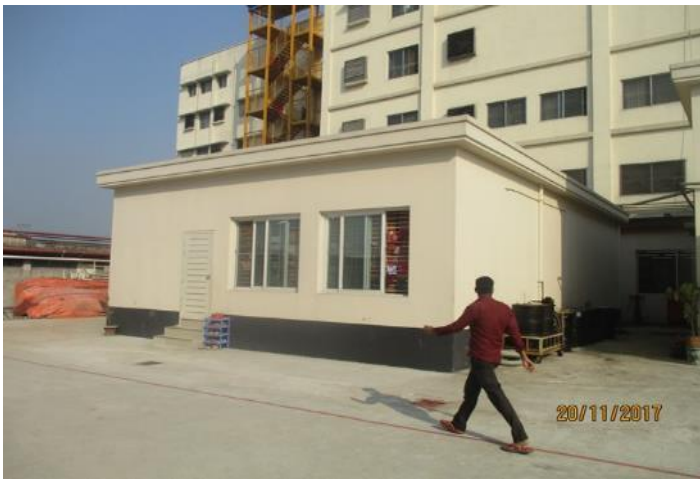
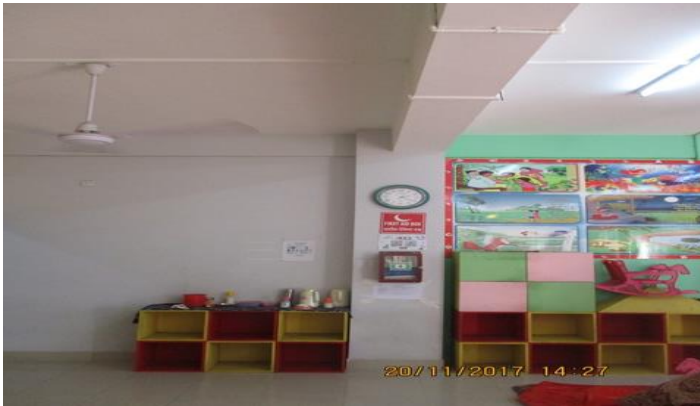
Childcare Building

No drawing was found during inspection regarding this two structures.
