# Torque Fashions Limited sheds 7, 9 & 13

Paragram, Ashulia, Ashulia Bazar, Dhaka, Bangladesh  
(23.877551, 90.332523)

1<sup>st</sup> & 17<sup>th</sup> September 2019

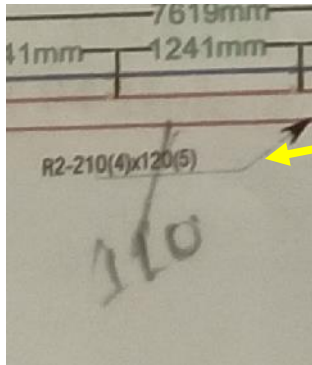
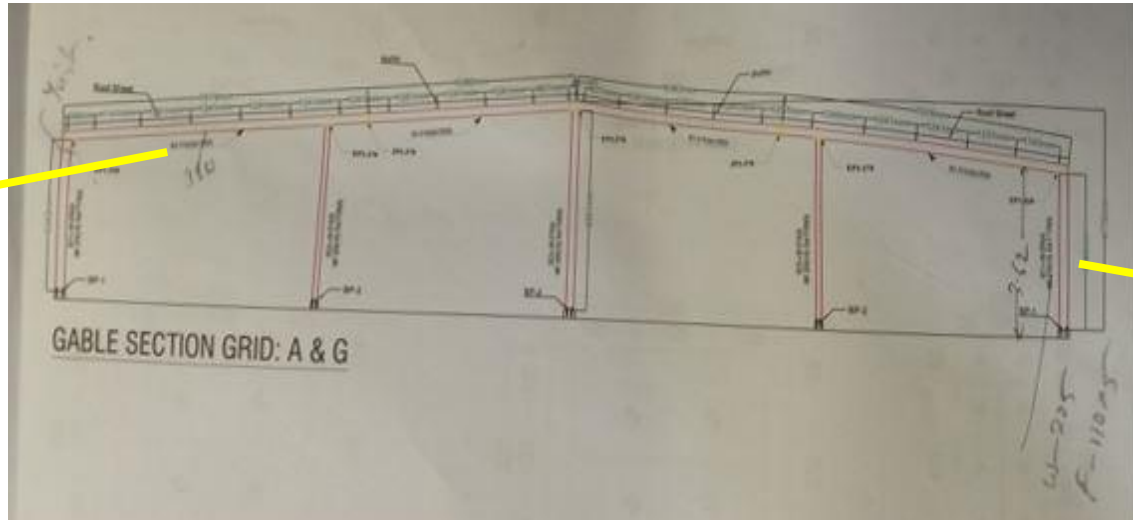
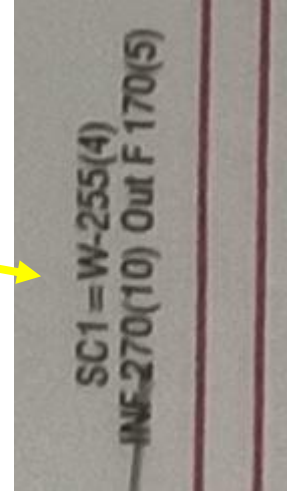
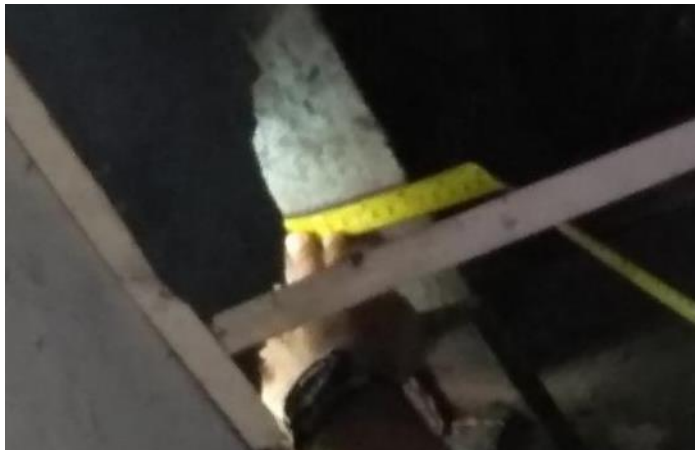
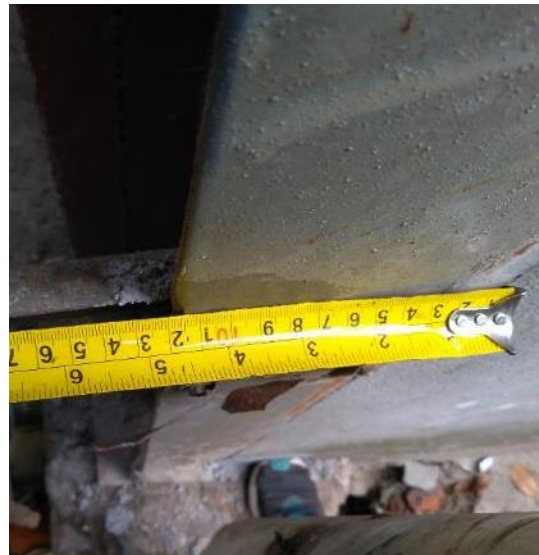
Column (SC-1) and rafter (R1) size of grid A & G were found different from provided drawing.  
Also, connection details were not provided in structural drawing

Web length of SC-1 column was measured 225 mm instead of 255mm and length of flange was measured 110 instead of 170 mm.

| Item No. | Observation | Recommended Action Plan | Recommended Timeline |
|---|---|---|---|
| 1 | Mismatch in as-built drawing (Shed-7, 10, 11, 12) | The building engineer to check the structure, collect information and produce accurate and complete as-built architectural and structural documentations. | 6-weeks |

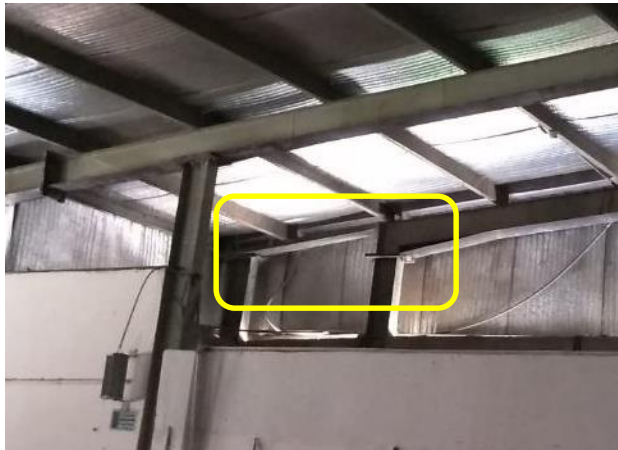
Size of column base plate and section of grid-1 didn't match with as-built drawings. Also connection details are not shown in provided drawings.

No rafter in marked location

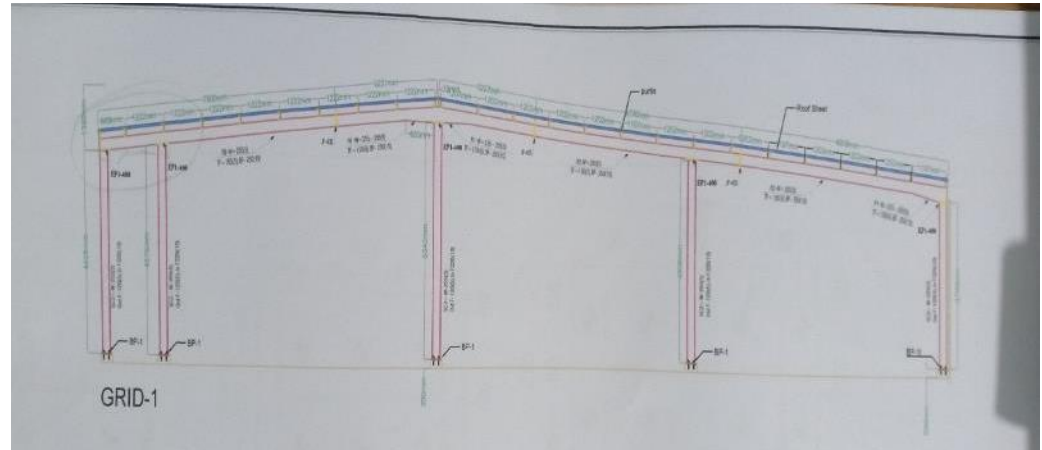
Sectional details of grid-1

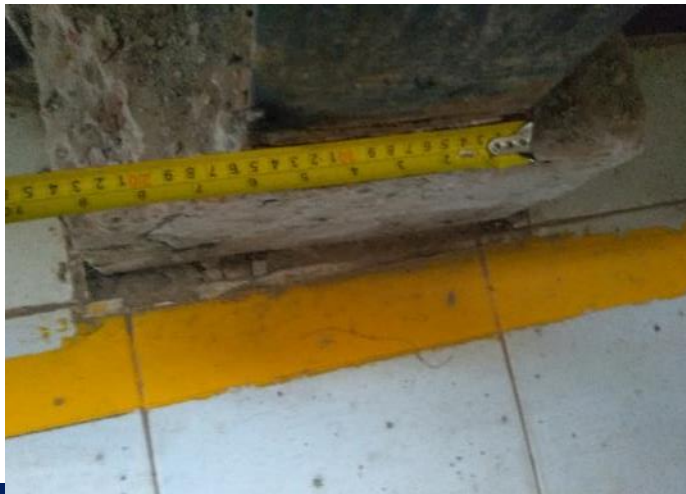
Width of base was measured 150mm instead of 200 mm

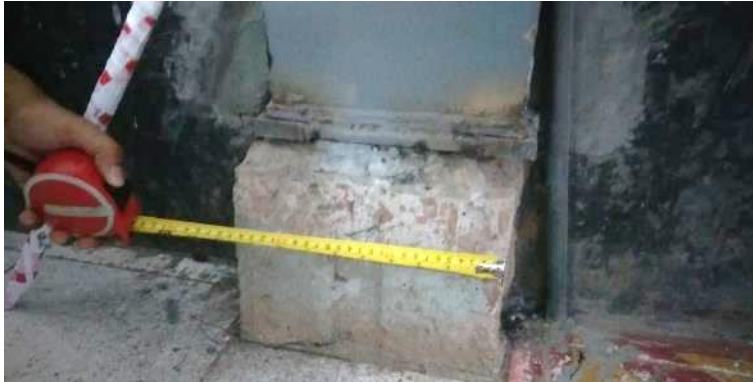
Factory has carried out a Detailed Engineering Assessment for Shed-7,10, 11 & 12. As per recommendation of the DEA, retrofitting is required for those sheds. During inspection, retrofitting work was found ongoing in all sheds. Factory is required to revise the DEA as per revised as-built drawings and submit to ACCORD for further review. Factory is required to carry out the remedial works as per accepted DEA.

Incomplete retrofitting of short column & base pale, Shed-7

| Item No. | Observation | Recommended Action Plan | Recommended Timeline |
|---|---|---|---|
| 2 | Incomplete retrofitting works | Revise the DEA report and complete the review with ACCORD. | 6-weeks |
| 3 | Incomplete retrofitting works | Complete remedial works arising from DEA report after being reviewed by ACCORD. | 6-months |

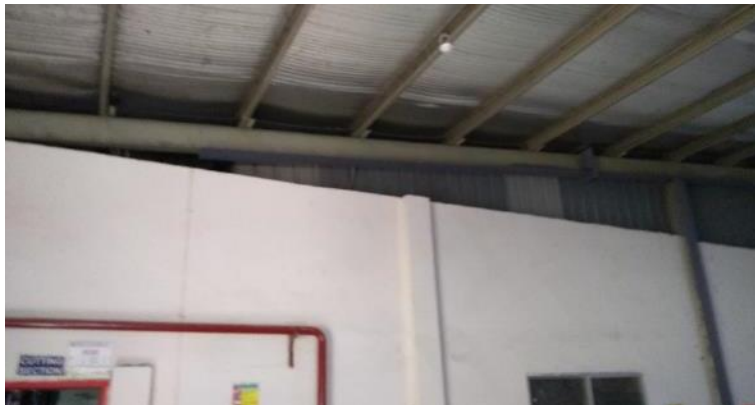
Incomplete retrofitting of short column, base pale, column & rafter, Shed-10

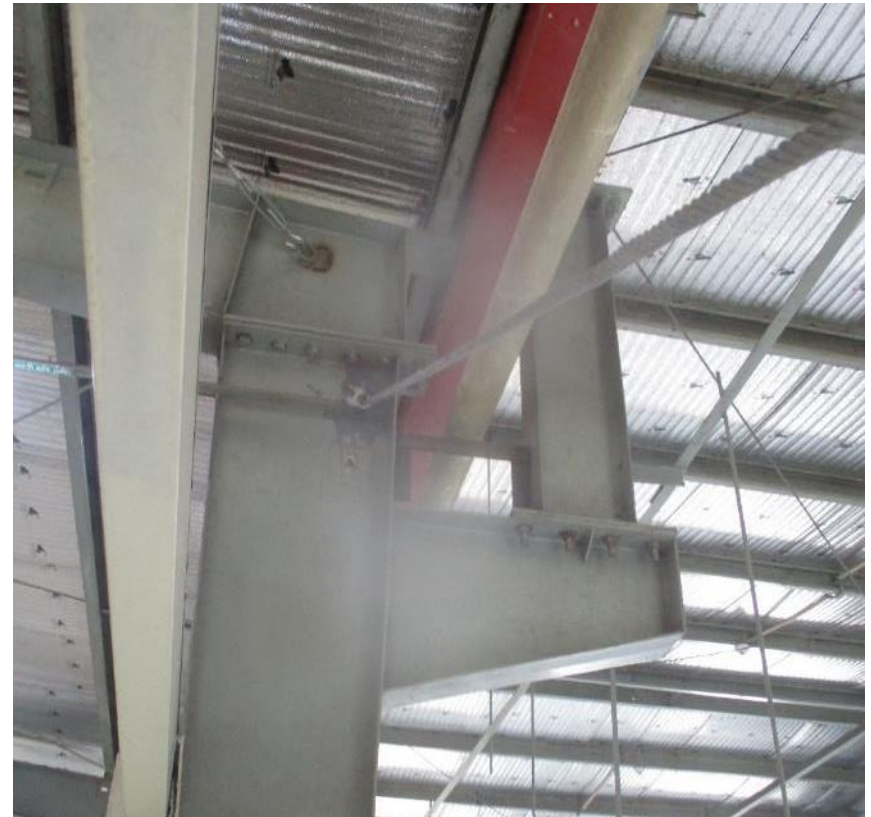
Incomplete separation work of part A & B, Shed-12

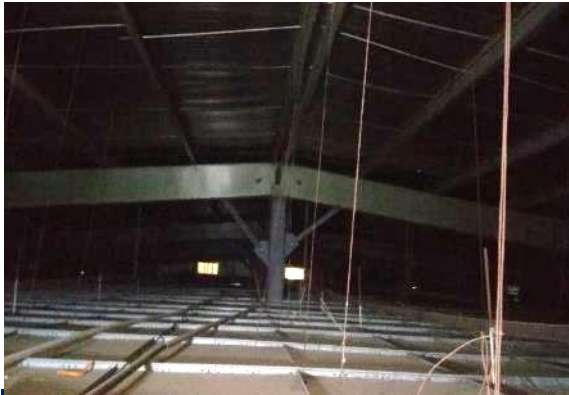
Shed-7

Vertical bracings were designed as stability system against lateral loading. But no compression strut member was observed in long direction. Also, vertical bracings were found missing and existing bracings were loose at several locations. The building engineer is required to check the lateral stability system of the structure against the lateral loads.

| Item No. | Observation | Recommended Action Plan | Recommended Timeline |
|---|---|---|---|
| 4 | Lack of lateral Stability. (Shed-7, 9, 10, 11, 12 & 13) | Factory engineer is required to check stability system against lateral loading. | 6-weeks |
| 5 | Lack of lateral Stability. (Shed-7, 9, 10, 11, 12 & 13) | Carry out remedial works as per recommendation of engineering assessment report. | 6-months |

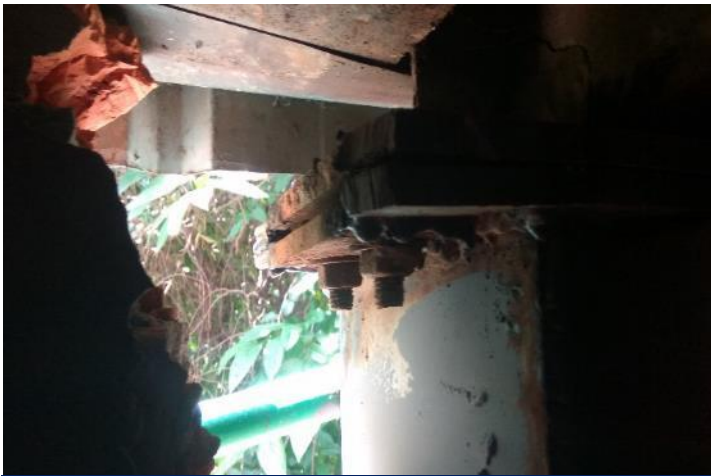
Shed-7

Corrosion found in column base plate & column-rafter joint in almost all sheds of the factory. The factory engineer is required to investigate the reason and extent of corrosion and take proper remedial actions after.

| Item No. | Observation | Recommended Action Plan | Recommended Timeline |
|---|---|---|---|
| 6 | Corrosion in steel member. (Shed-7, 9, 10, 11, 12 & 13) | The building engineer to investigate the reason & extent of corrosion and suggest proper remedial measure accordingly. | 6-weeks |
| 7 | Corrosion in steel member. (Shed-7, 9, 10, 11, 12 & 13) | Take necessary measures to prevent further corrosion and repair the corroded steel members as per engineer's suggestion. | 6-months |

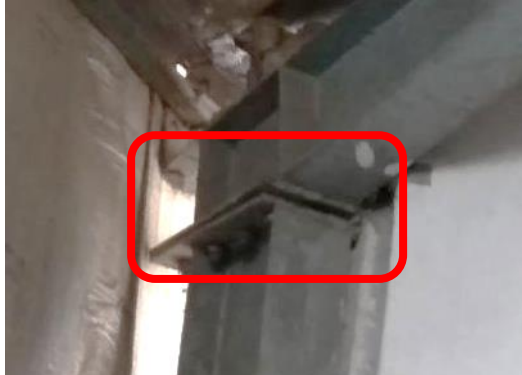
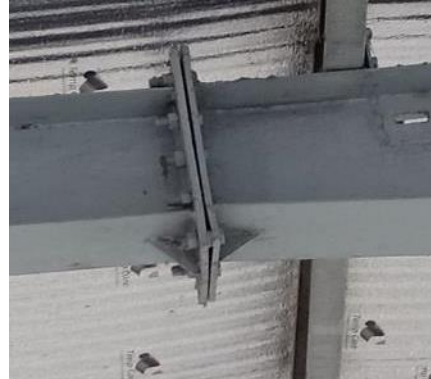
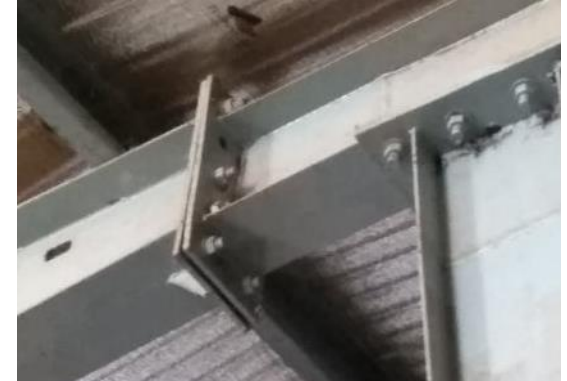
Bolt missing and significant gap found in the beam-column joint in almost all sheds of the factory. The factory Engineer is required to investigate the connections and take necessary remedial measures where required.

Gap in between beam-column joint

| Item No. | Observation | Recommended Action Plan | Recommended Timeline |
|---|---|---|---|
| 8 | Significant gap in the beam-column joint. (Shed-7, 9, 10, 11, 12 & 13) | Factory Engineer is required to investigate the connections and take necessary remedial measures where required | 6-weeks |

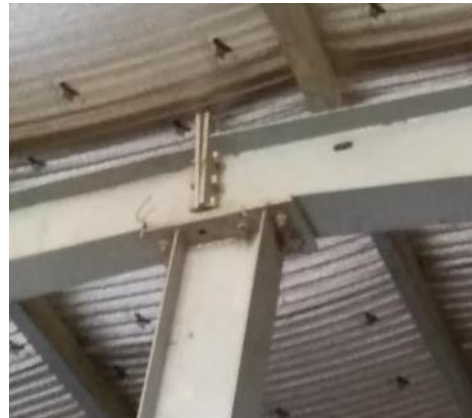
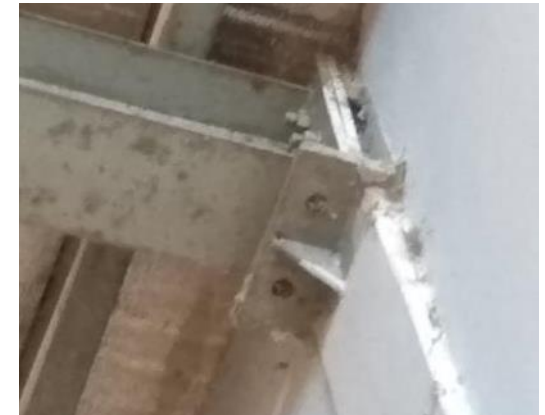
Bolt missing in connection
