# Chorka Textile Ltd (Extension -2)

Kazirchor, Danga, Palash, Narshingdi

15<sup>th</sup> October 2019

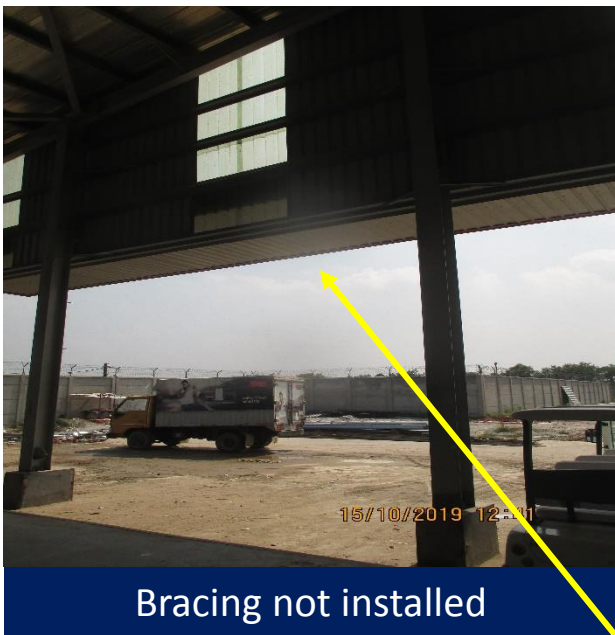
Bracing not installed

Vertical bracings are not installed as per drawings on grid 1-2 and H-I. Factory engineer is required to install missing bracings otherwise provide alternative load transferring media from design review.

| Item No. | Observation | Recommended Action Plan | Recommended Timeline |
|---|---|---|---|
| 1 | Bracing missing at Southeast Corner | Factory engineer is required to install the missing bracings otherwise provide alternative load transferring media from design review. | 6-weeks |

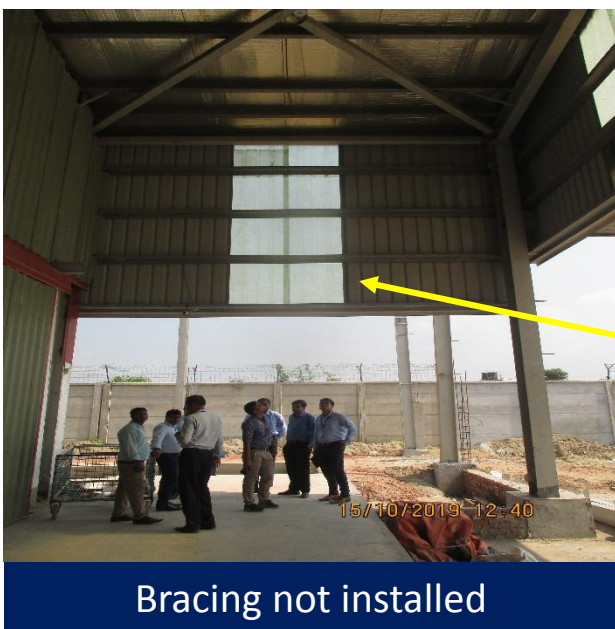
Bracing not installed

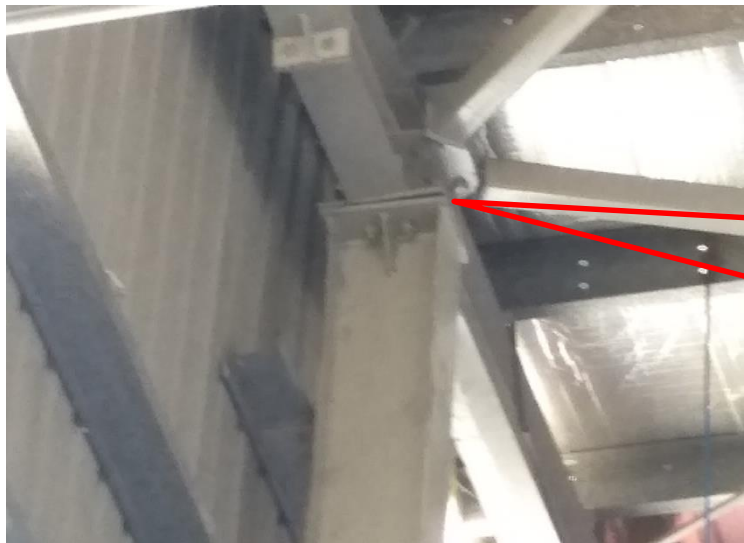
Gap in column-rafter joint

Significant gaps were found in column-rafter-rafter joint. Factory engineer is required to carry out suitable remedial works.

| Item No. | Observation | Recommended Action Plan | Recommended Timeline |
|---|---|---|---|
| 3 | Significant gaps in connection | Factory engineer is required to carryout suitable repair works. | 6-weeks |

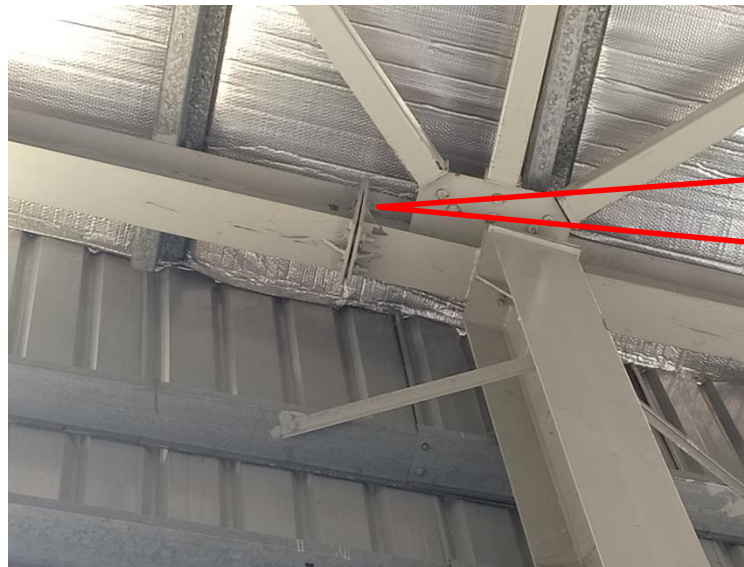
Gap in rafter-rafter joint

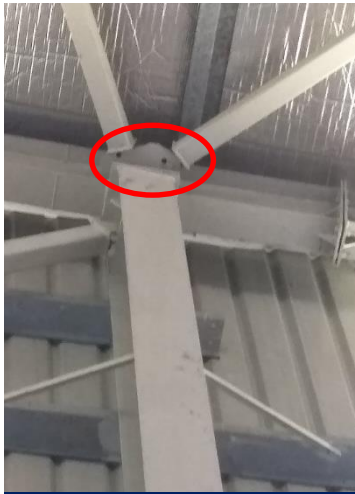
Bolt missing at bracing connection

Bolts were found missing in several connections. Factory Engineer is required to identify the locations of missing bolts and install bolts as per specifications.

| Item No. | Observation | Recommended Action Plan | Recommended Timeline |
|---|---|---|---|
| 4 | Bolt missing and light connection | Factory Engineer is required to identify the locations of missing bolts and install bolts as per specifications. | 6-weeks |

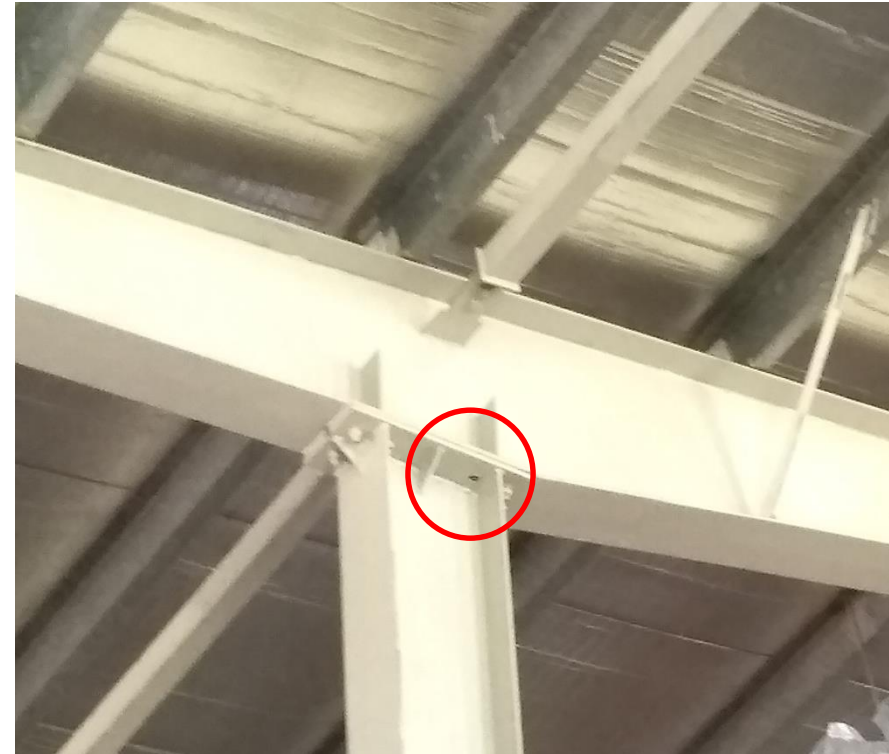
Bolt missing at column-rafter joint

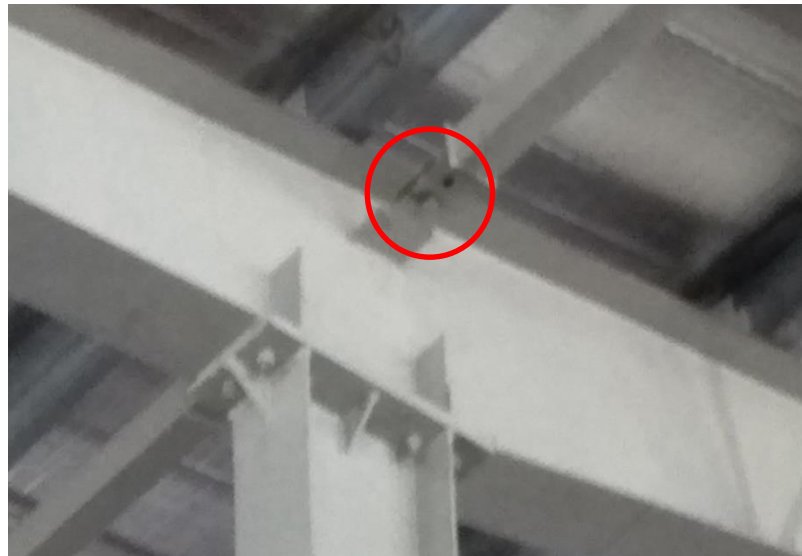
Bolt missing at strut connection

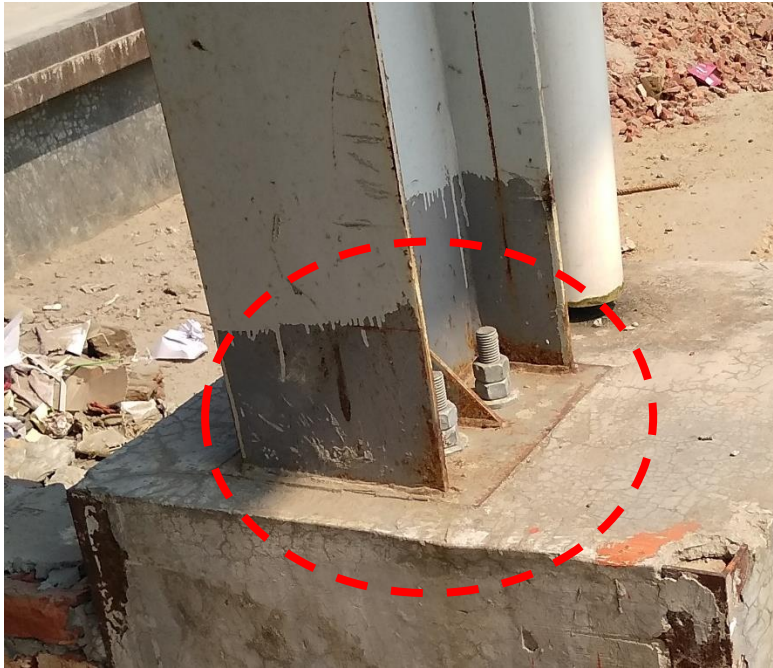
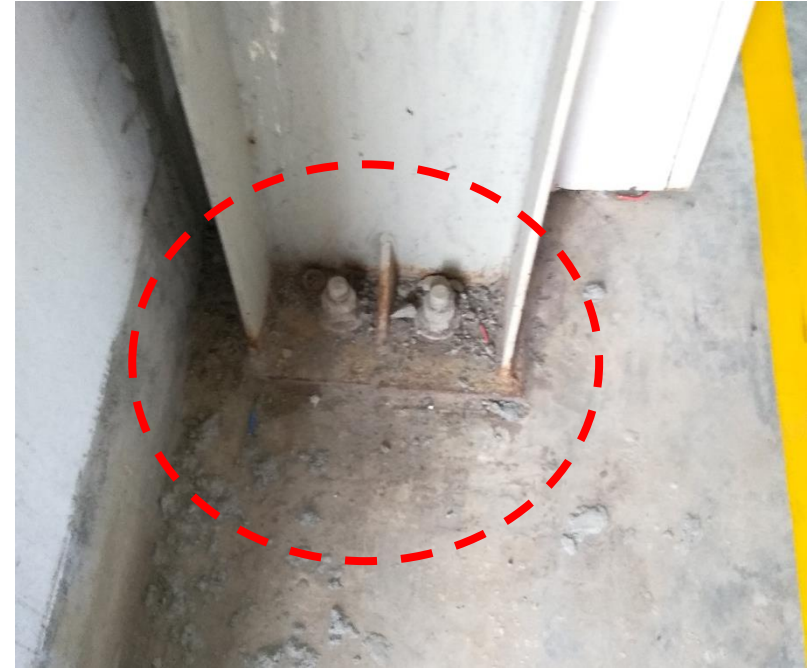
Corrosion was observed at joint of pedestal column and steel column.

Corrosion was observed on steel columns on different locations of ground floor areas. Factory is required to identify the corroded locations and take proper remedial measures.

| Item No. | Observation | Recommended Action Plan | Recommended Timeline |
|---|---|---|---|
| 5 | Corrosion observed at steel sections | Factory Engineer to suggest and implement proper remedial measures to protect steel sections from corrosion. | 6-weeks |

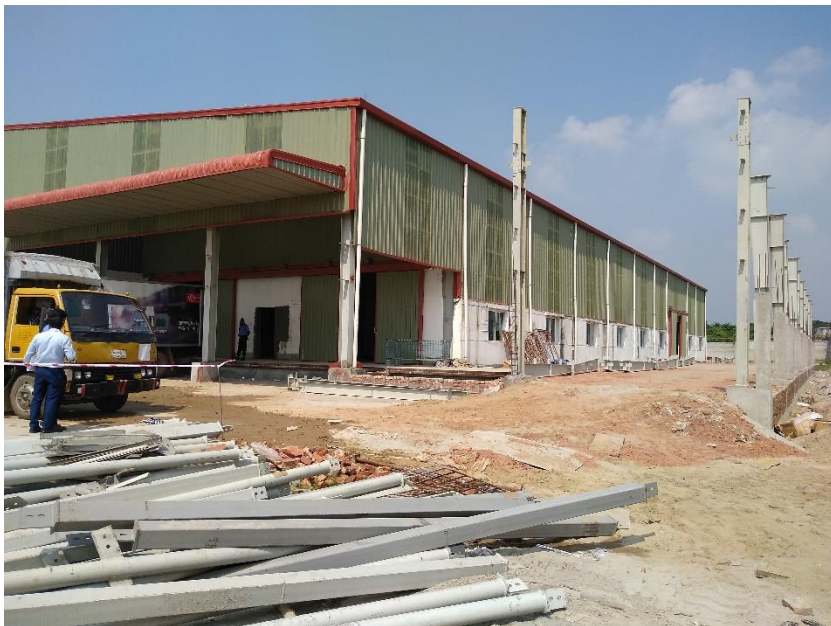
Some additional steel columns were found at east side of the structure. Factory management has a future plan to extend the shed horizontally. Factory engineer is required to carry out a Detail Engineering Assessment considering BNBC provision prior to any further extension work on existing structure.

Possible horizontal extension

| Item No. | Observation | Recommended Action Plan | Recommended Timeline |
|---|---|---|---|
| 6 | Possible Horizontal Extension | In case of extension, Detail Engineering Assessment required to be carried out following BNBC requirement. | 6-weeks |

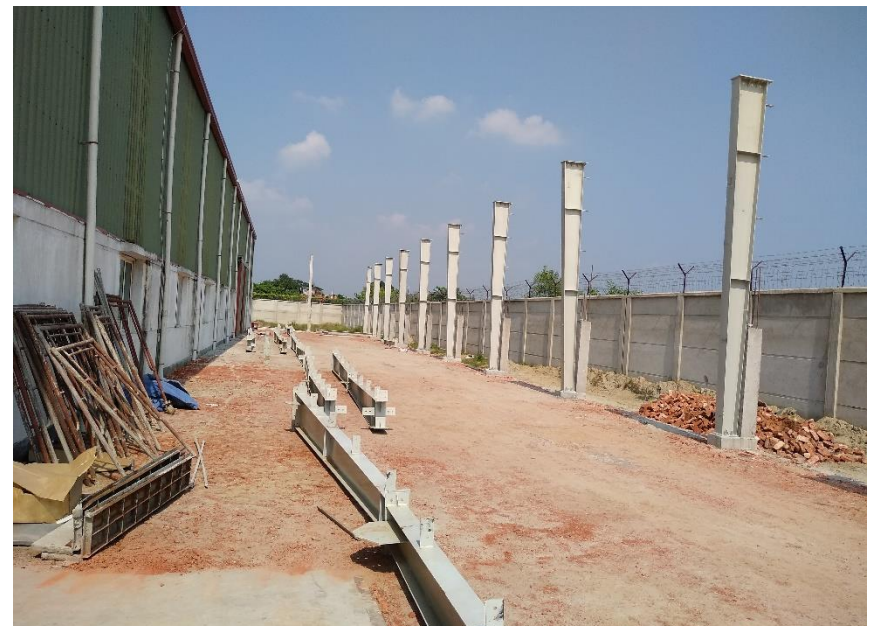
Additional Steel column
