Southern Garments Ltd (New Building)

Zirabo, Ashulia, Savar, Dhaka
(23.911717, 90.314552)
07th July 2019

Observations

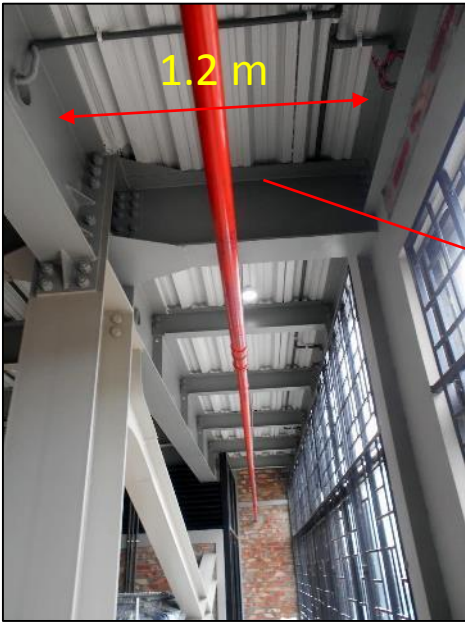
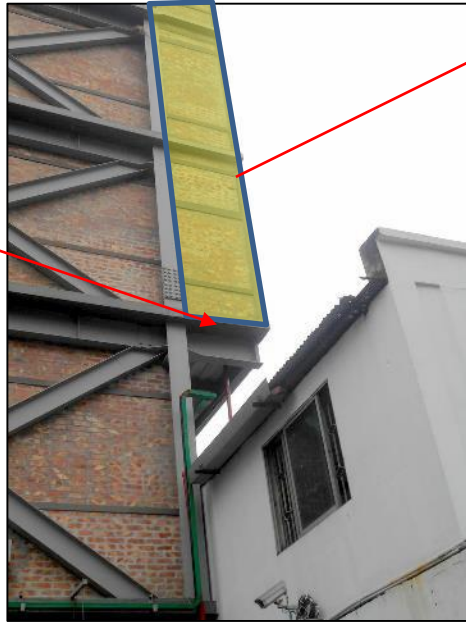
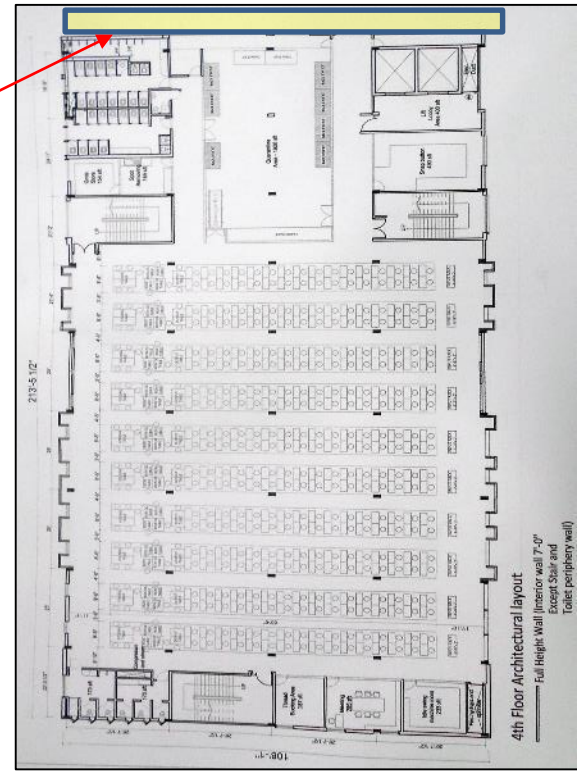
Cantilever portion was observed in the north side from 2nd floor to 4th floor

Cantilever slab on north side and stair landing details is not shown the drawing. As-built drawing is required to be updated.

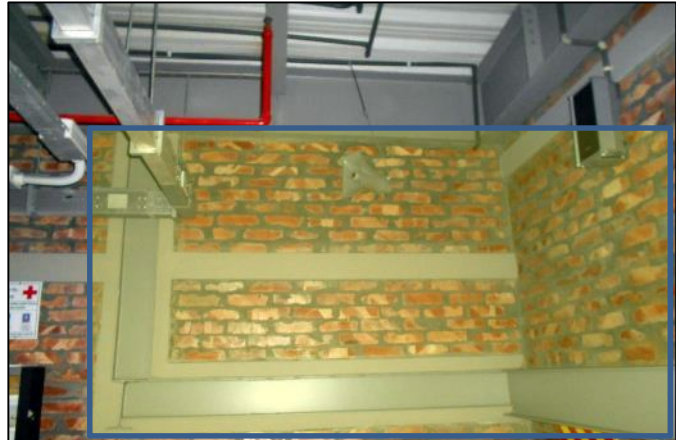
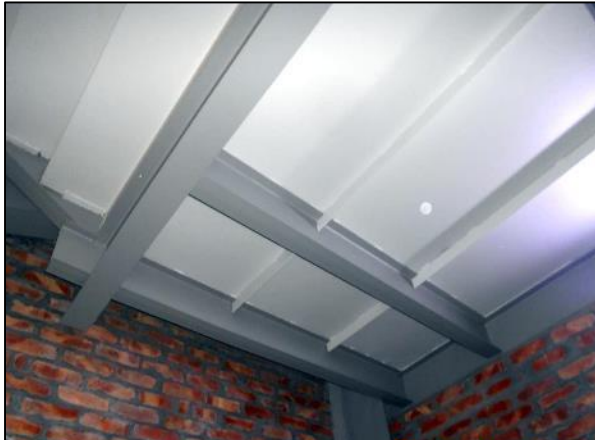
Stair landing supporting system from main beam

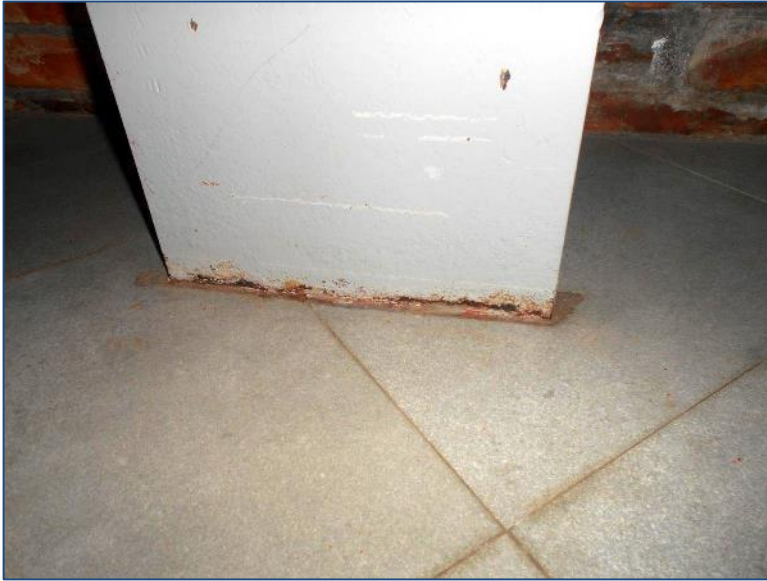
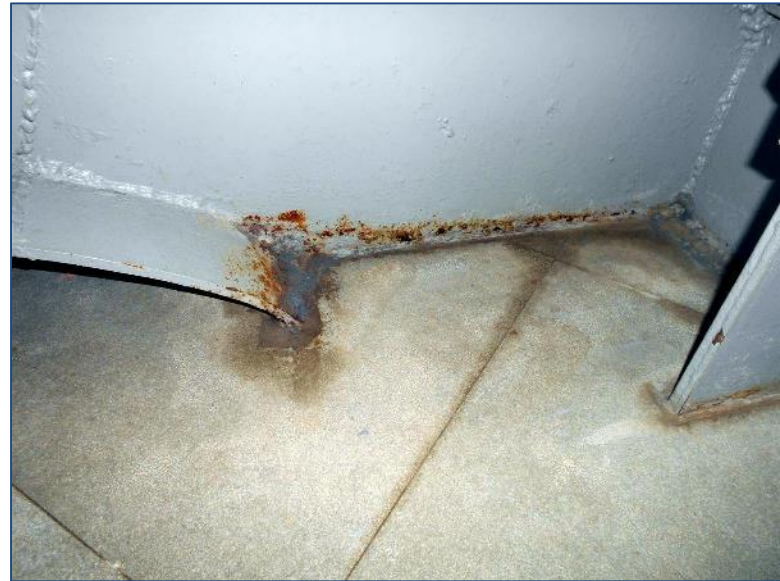
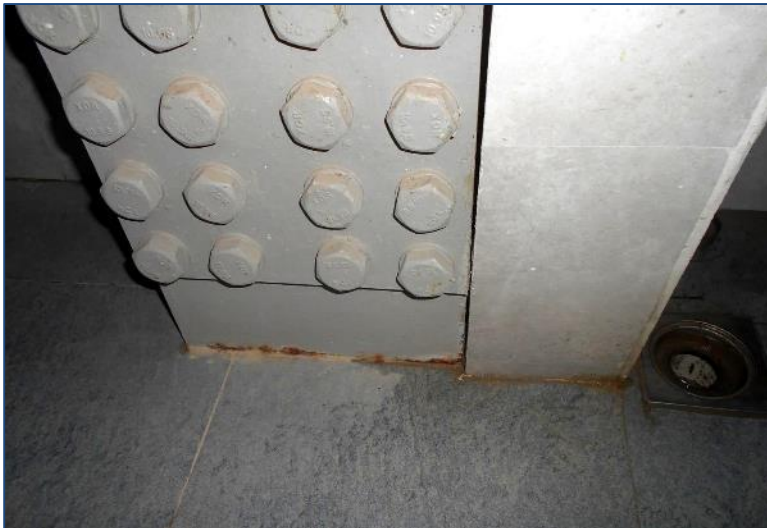
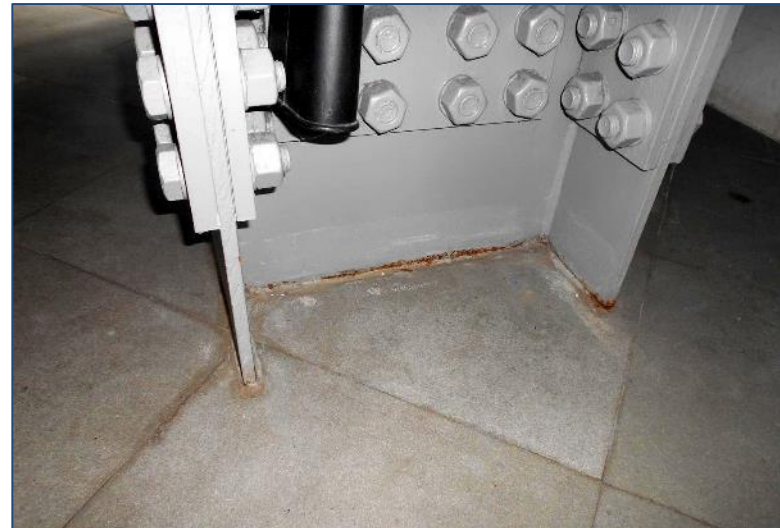
Corrosion on steel column

Corrosion found in column and bracing joint connection.

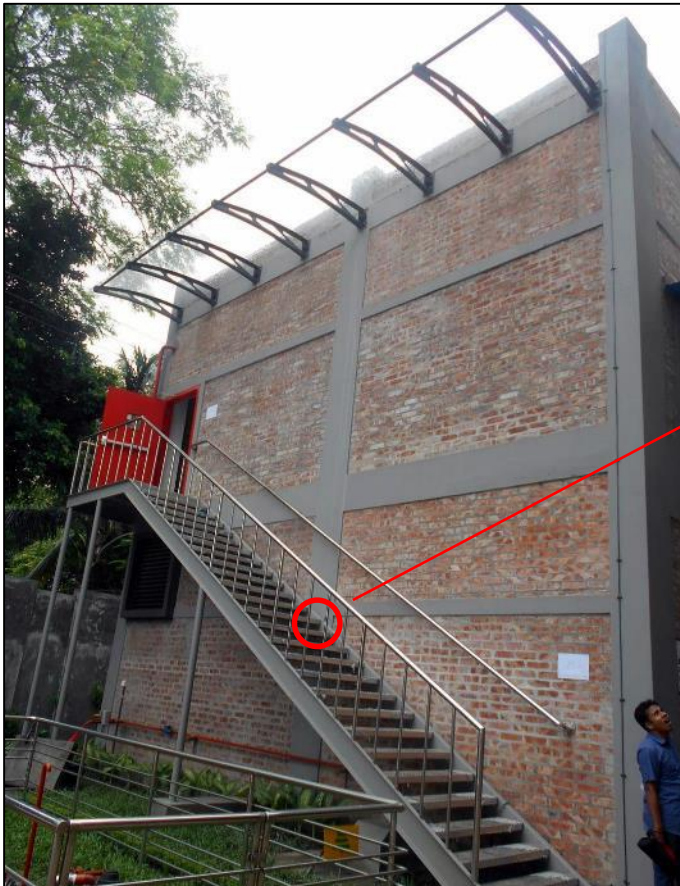
Steel stair on the north side

No drawing was available for the stair. The stairs do not have adequate bracing and the connection with the building appears to be poor. Building Engineer to carry out a design check of the steel stair with emphasis on bracing and connections, and to carry out the necessary remedial works if required.

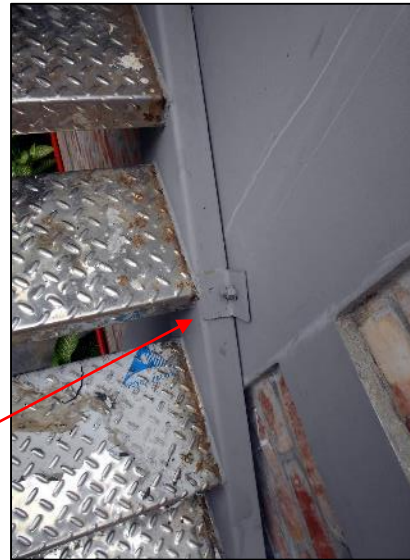
Connection with building wall

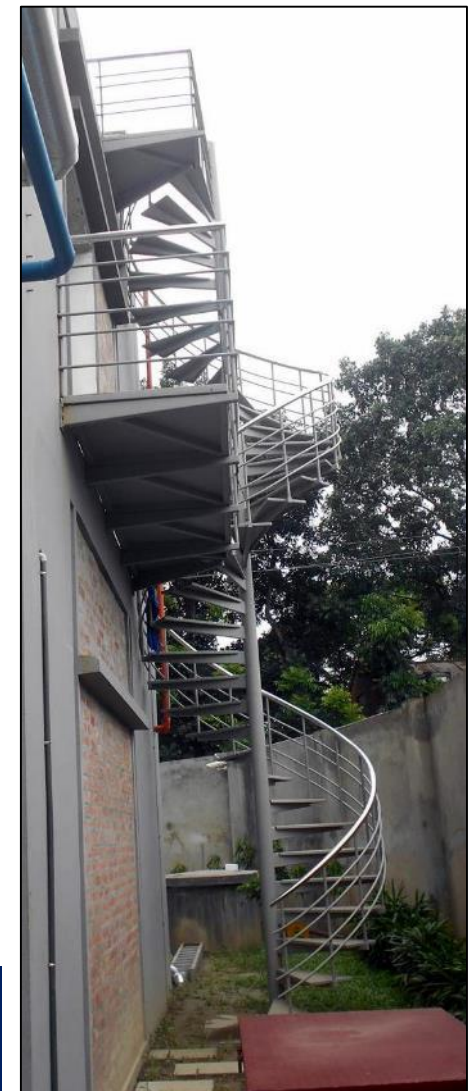
Spiral Steel stair on the south side
