P.M. Knittex (Pvt.) Ltd. -New Building -3

Plot No.- Chowdhuri bari, Godhnail, Narayangonj.

05th November 2019

Discrepancies between as-built drawings and on-site condition

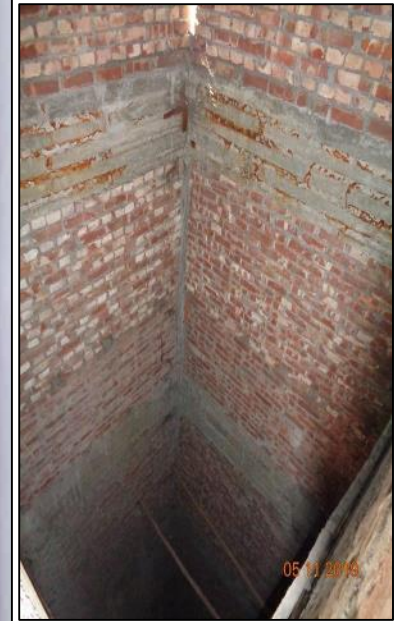
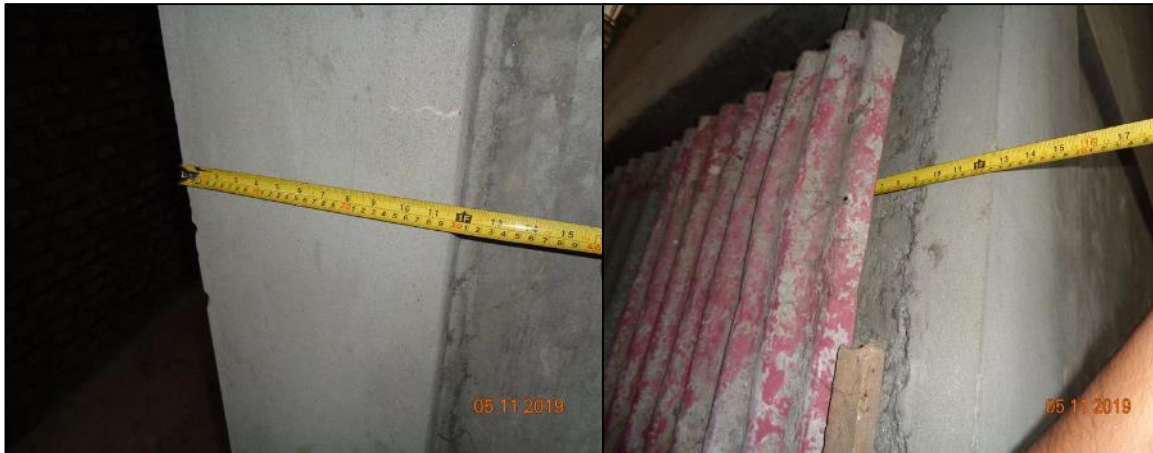
Lift Core

Column size was found 300mmX250mm

Column was found at marked location for lift core. Column size was found 300mmX250mm. But in as-built drawing, no columns has been shown. Grid dimensions was found missing in the column Layout plan.

Item No.	Observation	Recommended Action Plan	Recommended Timeline
1	Discrepancies between as-built drawings and on-site condition	The factory engineer is required to survey the structure and produce as-built drawings with complete structural information.	6-weeks
2	Uncontrolled loading at 1st Floor	Factory is required to prepare the floor loading plan and maintain accordingly.	6-weeks
3	Uncontrolled loading at 1st Floor	Continue to implement load plan.	6-months
4	Column to be stressed above normal design limit for possible vertical extension	The factory engineer is required to carry out a Detail Engineering Assessment considering BNBC provision prior to any extension work.	6-weeks
5	Column to be stressed above normal design limit for possible vertical extension	Carryout remedial works if required.	6-months
6	Corrosion in Exposed Re-bar at roof	All exposed reinforcement to be protected from corrosion.	6-weeks

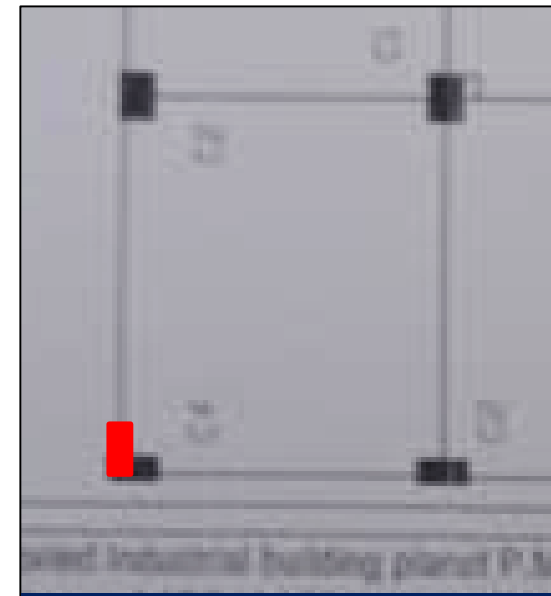
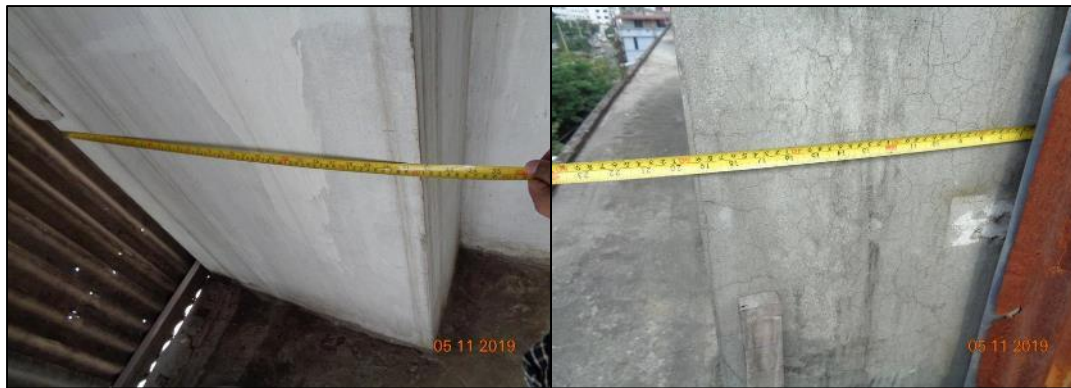
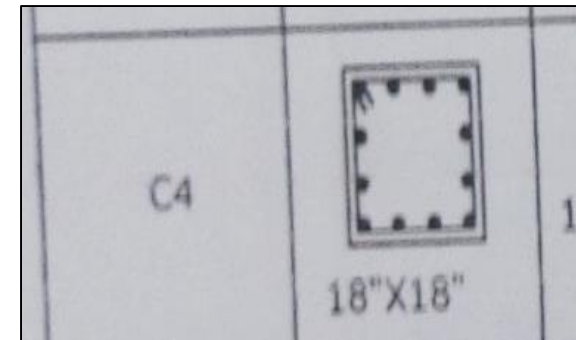
Column Orientation Mismatch

Actual Size of column was found 750mmX450mm

Size of column shown
450mmX450mm

Column orientation was found mismatch with site condition (as shown in drawing). Long face of column was found along north direction. Size of column was found 750mmX450mm instead of 450mmX450mm.

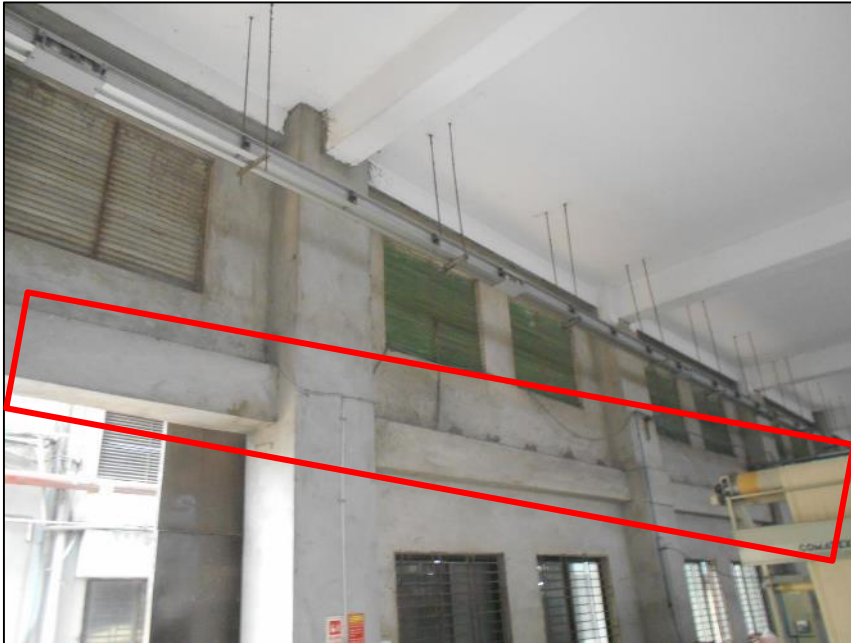
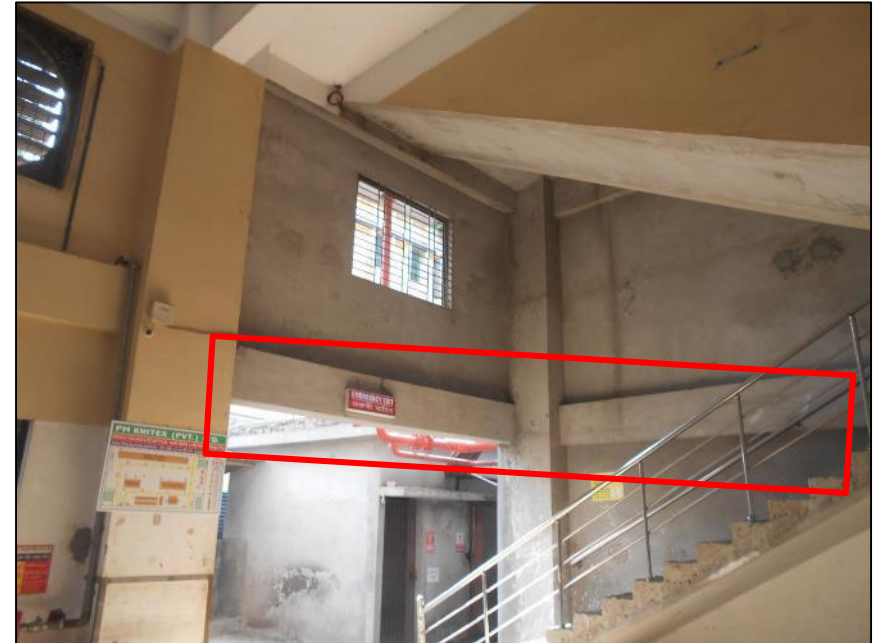
Tie beam was found in Ground Floor along periphery. But in as built drawing, layout and sectional details of the tie beam was not found.

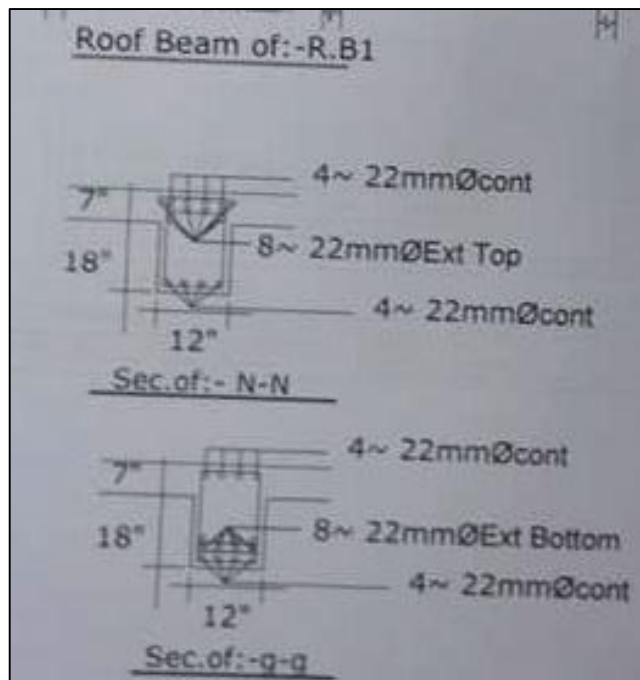
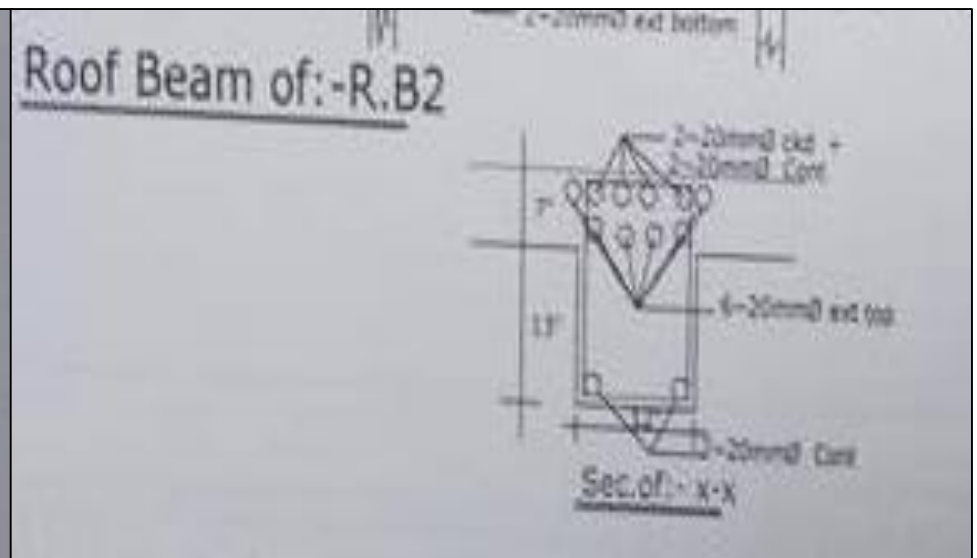
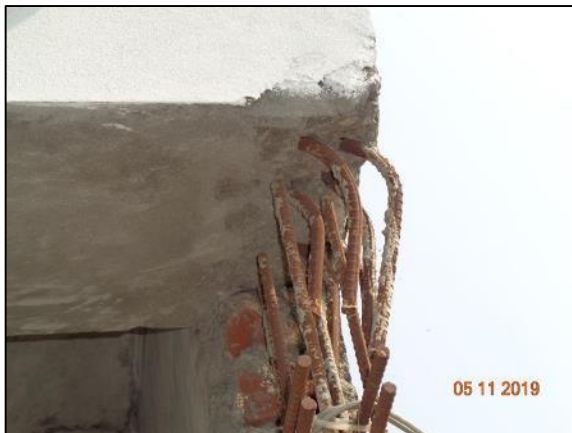
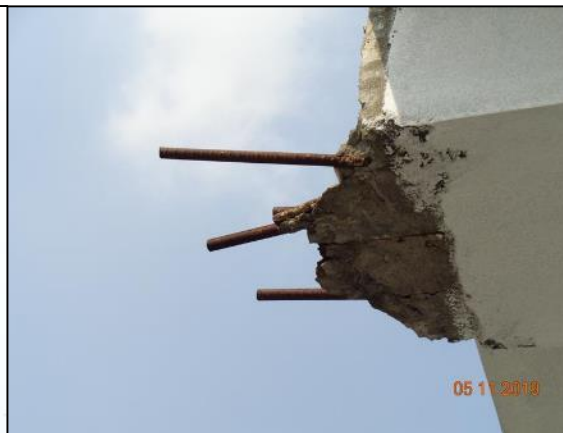
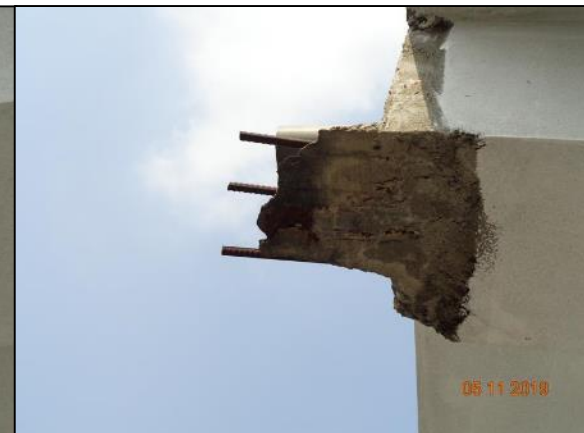
In As-built drawing, size of re-bar for beam has been used for 20mm & 22mm dia re-bar.

Re-bar of the beam was found 10mm diameter at site condition. Also the actual number of the re-bar in beam was found less than the as-built drawing.

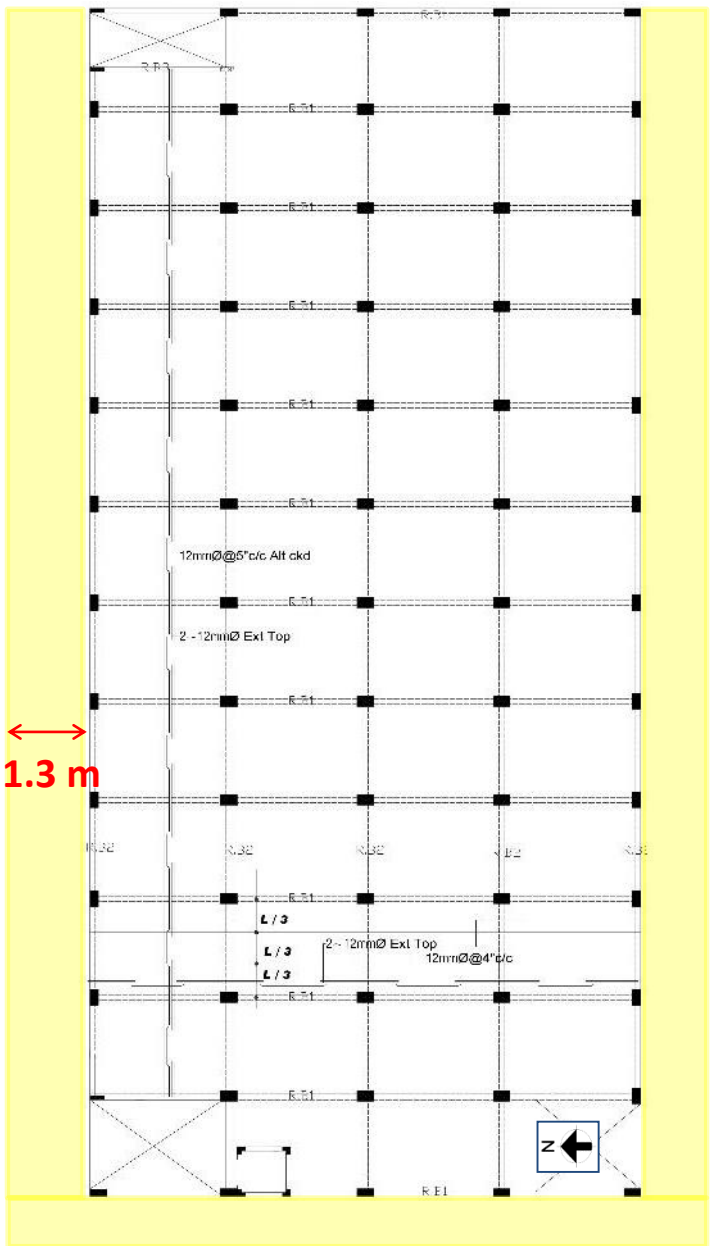
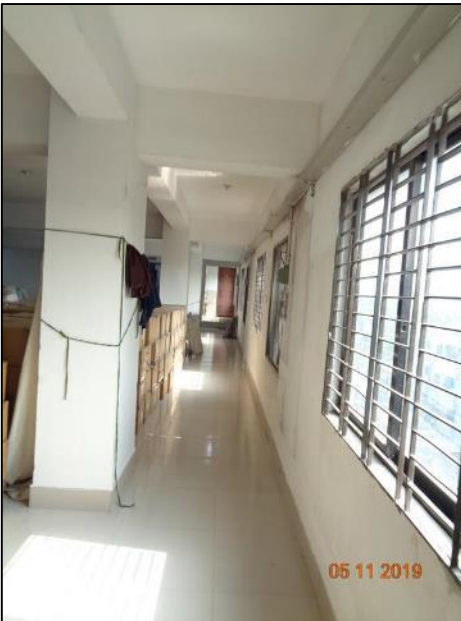
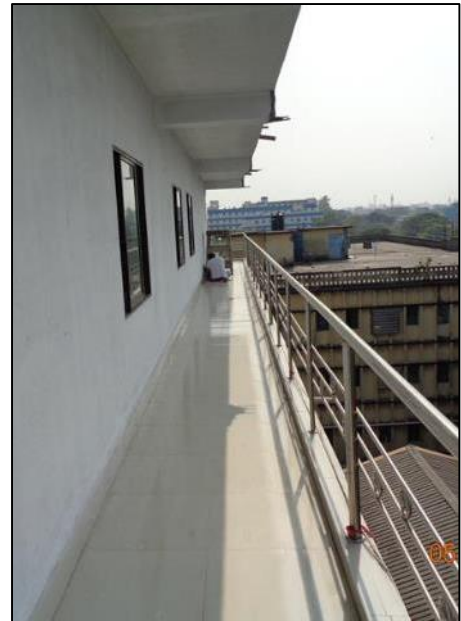
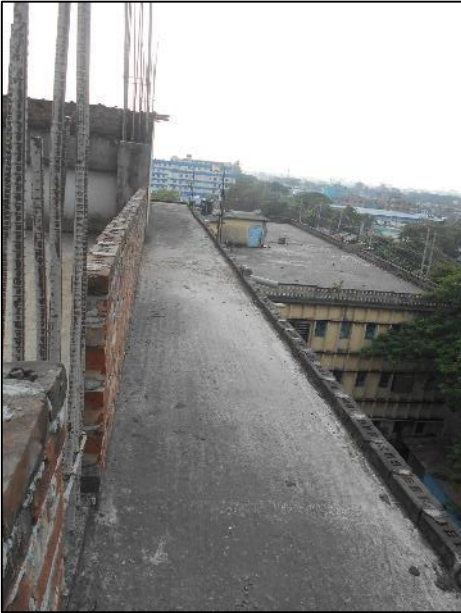
Beam-Slab Layout

1.3 m Cantilever slab was found in three sides of the structure. No information was provided in the structural drawing.

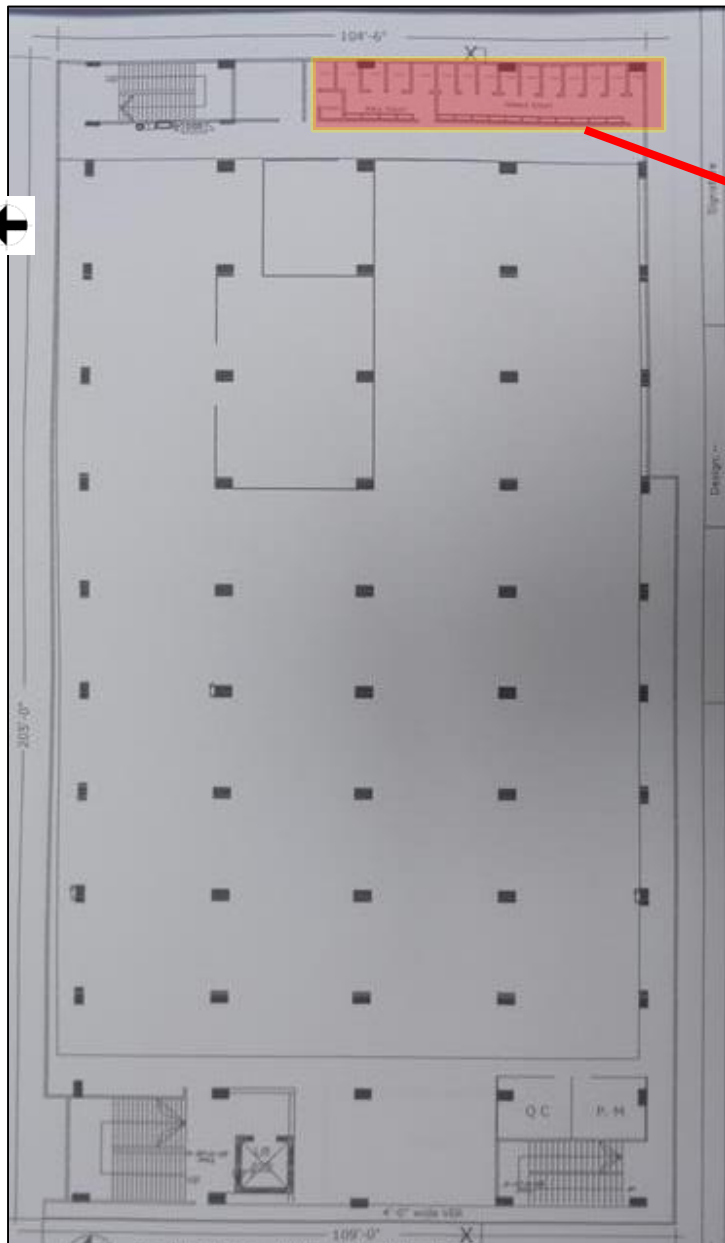
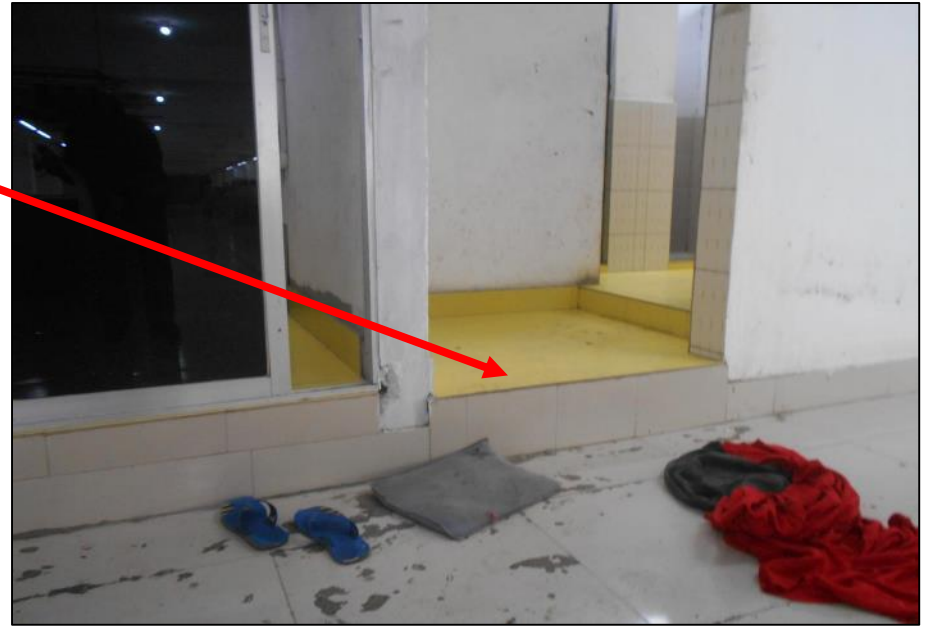
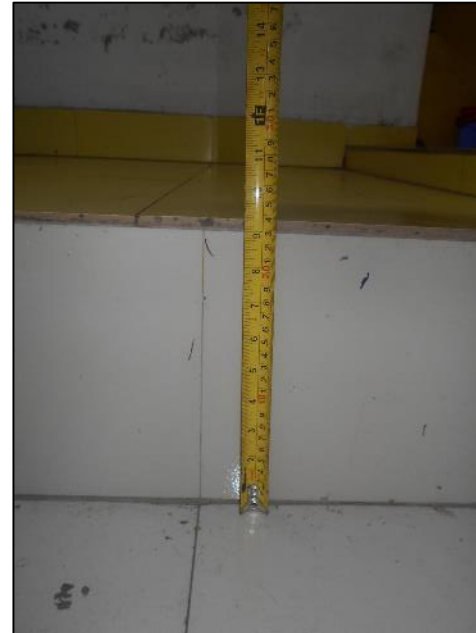
Floor plan

225mm build up was found in toilet zone. No information was provided in the drawings.

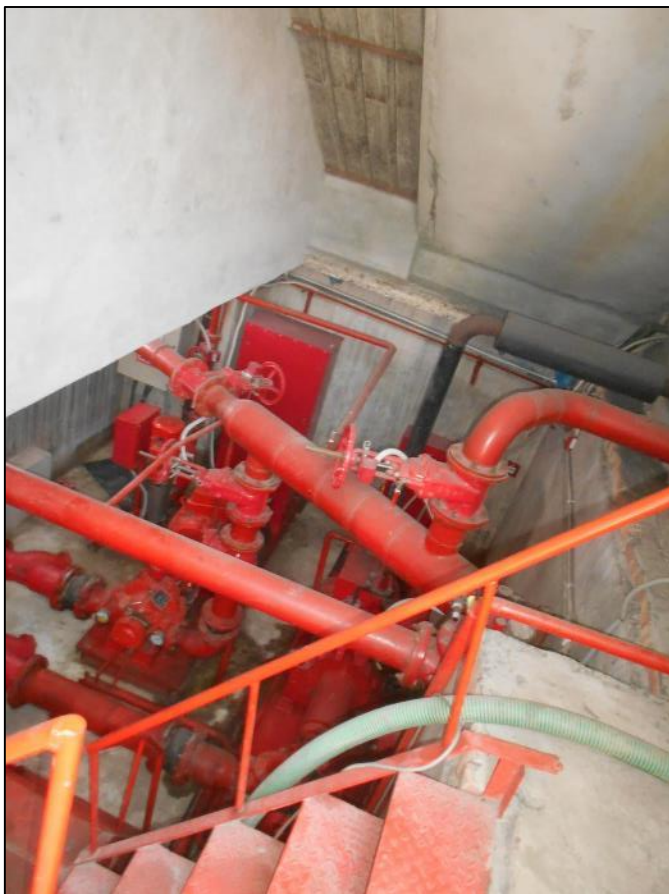
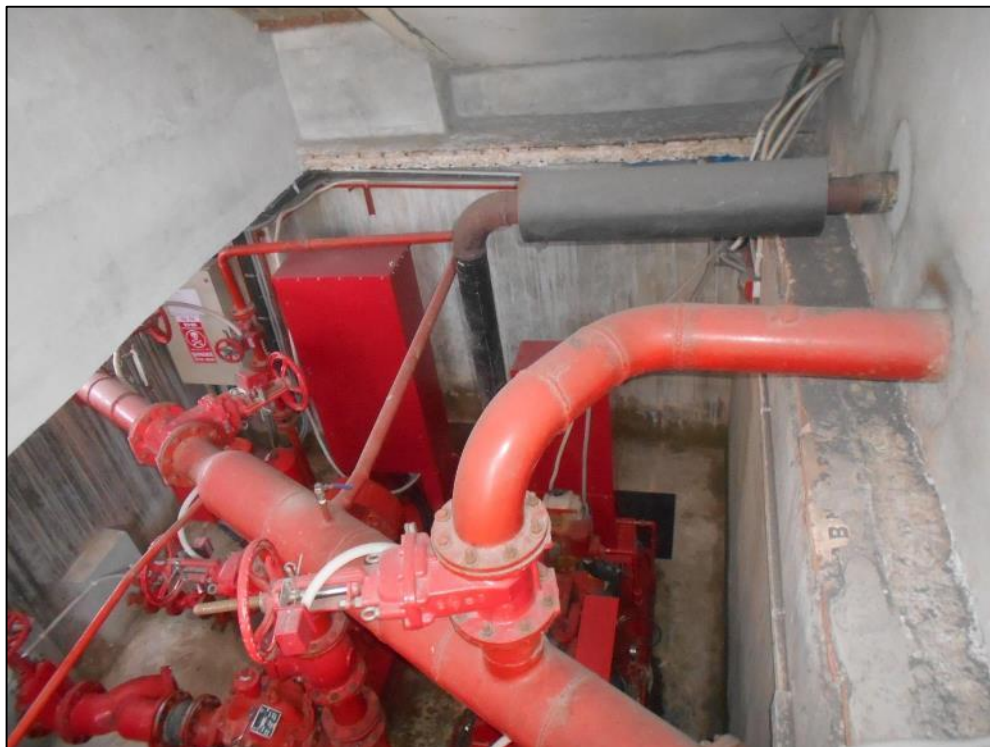
Fire pump room was found at ground floor (- 2.7 m from PL). But in drawing, details of the fire pump room has not been included.

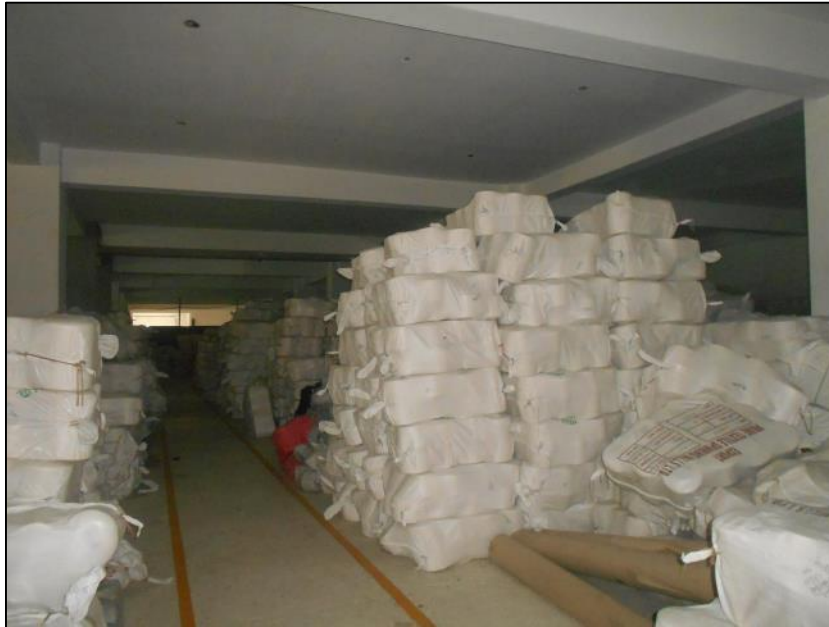
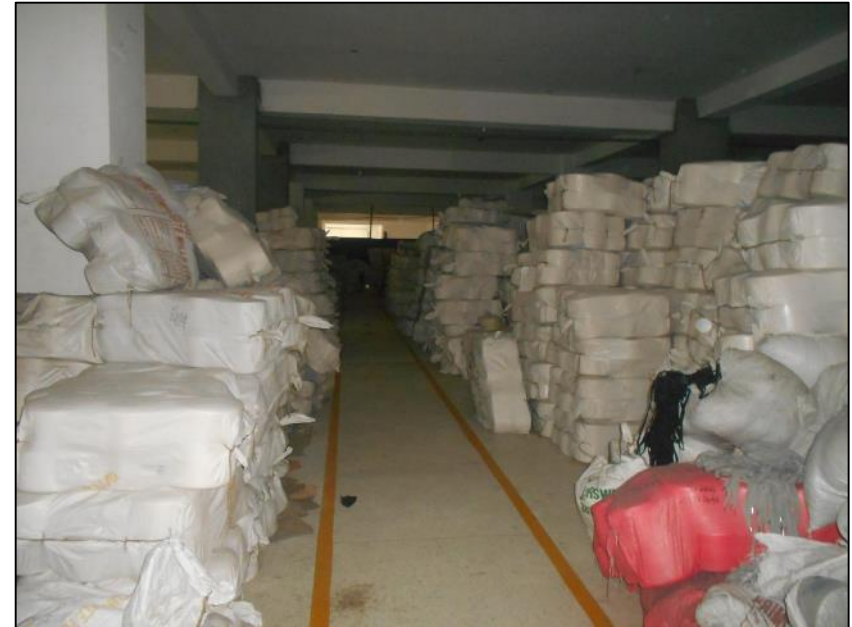
Uncontrolled loading at 1st Floor

Uncontrolled loading was found at 1st floor of the building. Loading was found more than 3 kPa. Factory is required to reduce the loading to 3 kPa. Factory is required to prepare the floor loading plan and maintain accordingly.

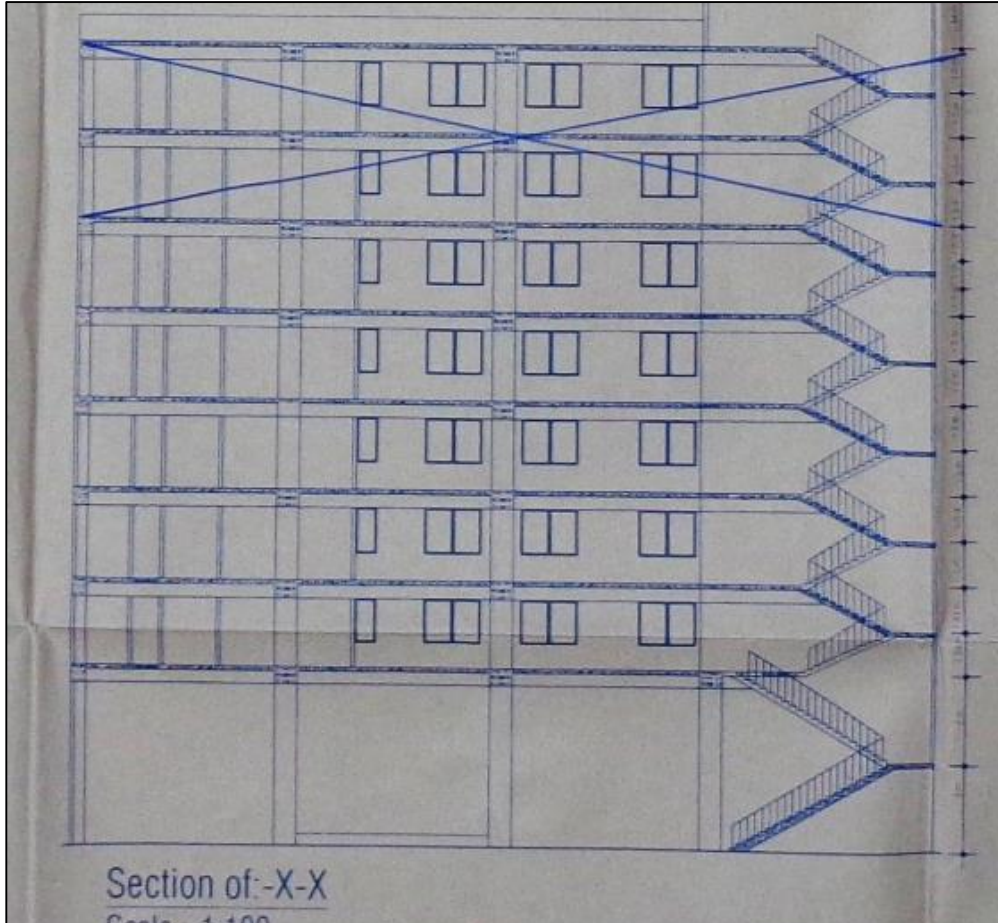
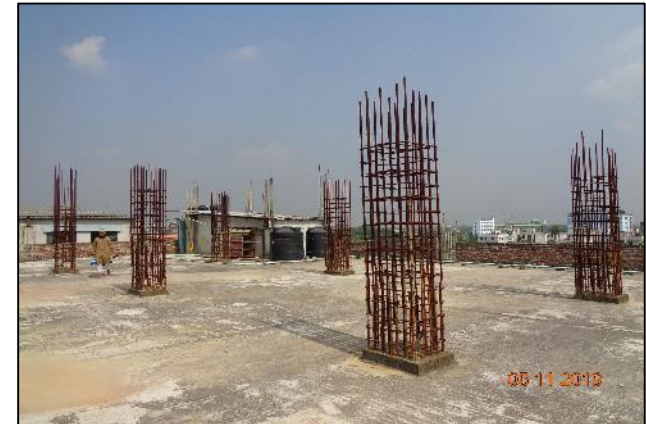
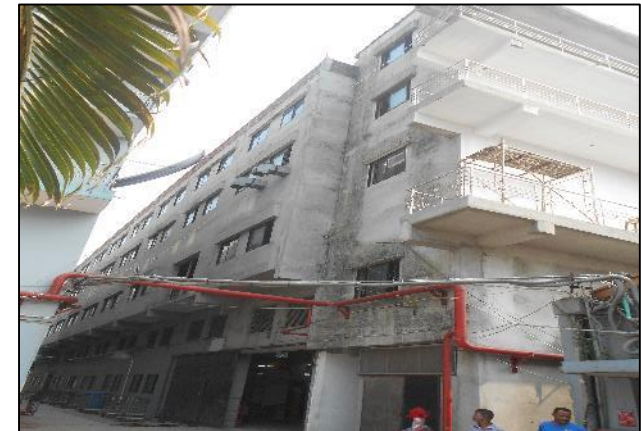
Column to be stressed above normal design limit for possible vertical extension

This building is permitted for Six (G+5) storied from local authority. Currently, the building is four storied (G+3). Extended portion of column rebar was found at roof level which indicates the possibility of vertical extension. The factory engineer is required to carry out a Detail Engineering Assessment considering BNBC provision prior to any extension work.

Permitted drawing of Six storied building from local authority

Rebar extension at roof level

Existing four Storied Building

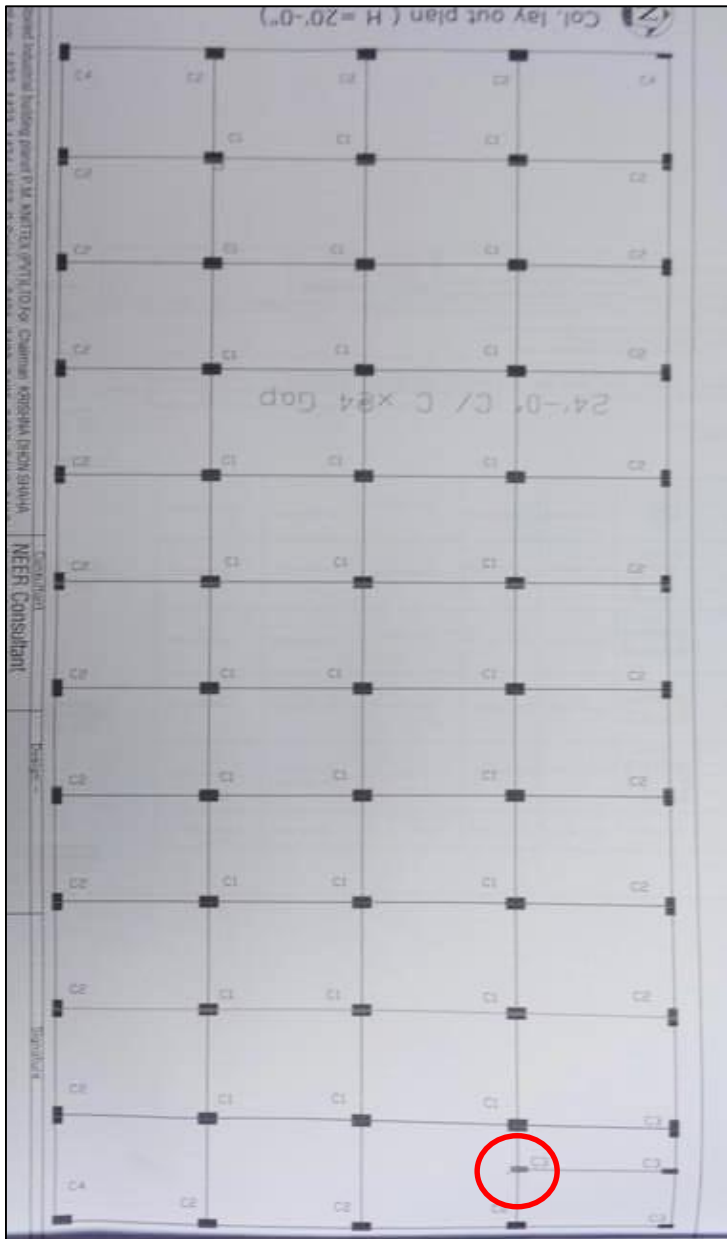
Typical Column layout

Cursory calculation indicates that the working stress of one ground floor column (marked in layout) exceed the normal design limit considering six storied (G+5) building and 3kPa floor loading with minimum concrete strength. The Building engineer is required to review the design, loads and columns stress as per BNBC for possible vertical extension. For the existing four storied (G+3), the working stress of the ground floor column is within normal design limit.

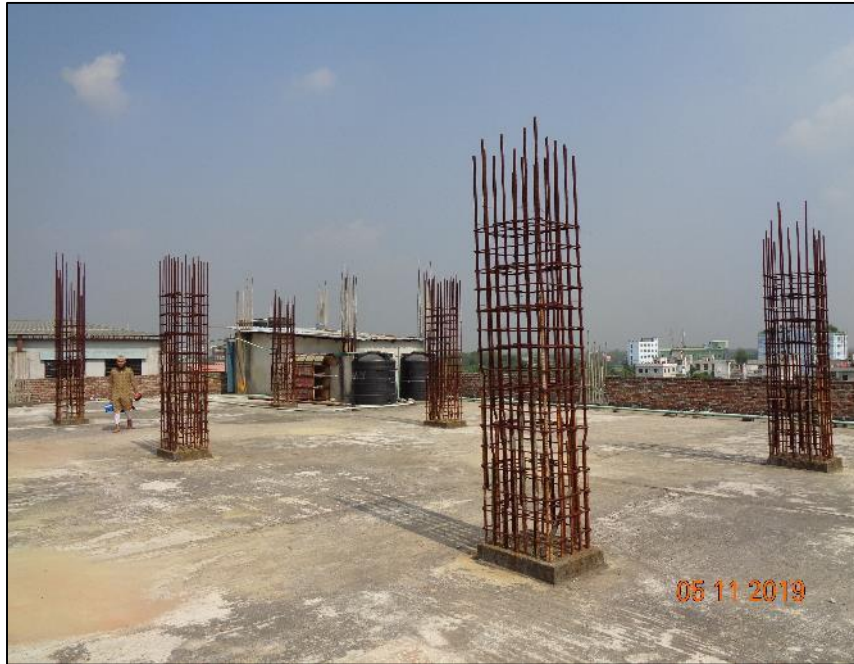
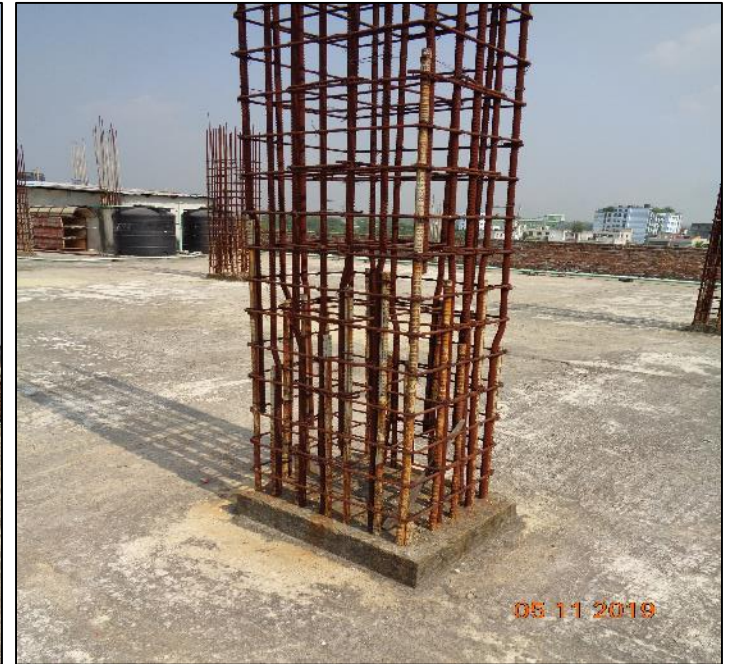
Corrosion in Exposed Re-bar at roof

Corrosion was found in exposed re-bar roof level. Factory is required to take necessary action to prevent corrosion in exposed re-bar due to weathering effect.

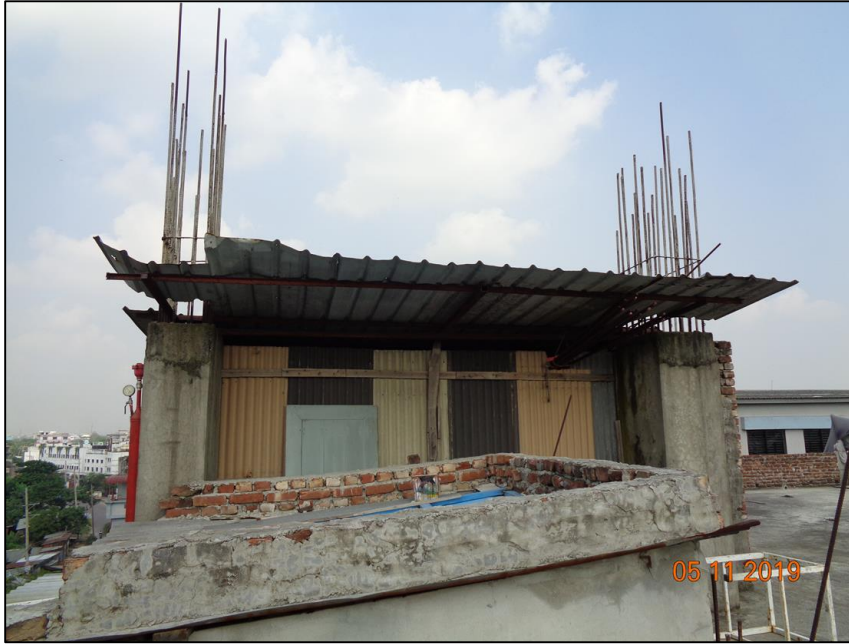
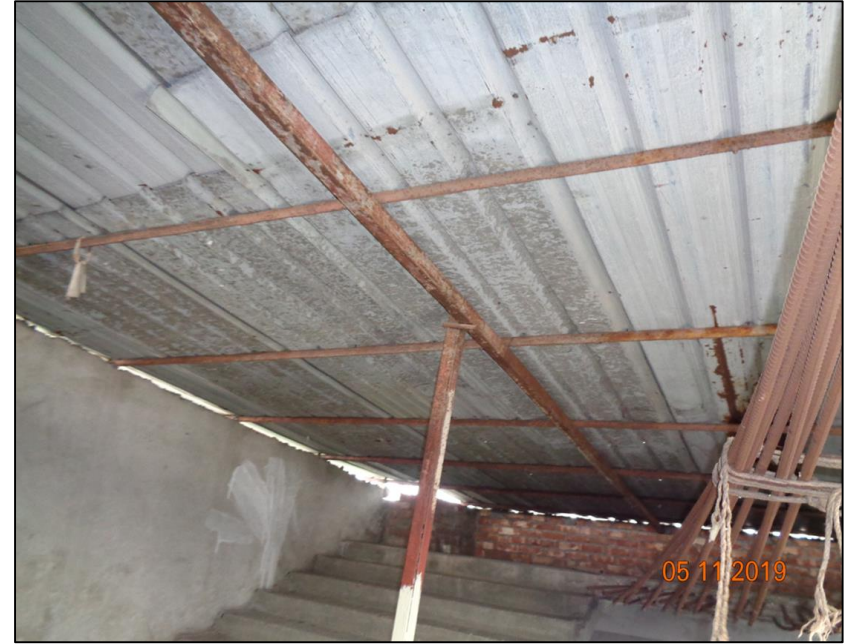
Poor support system of Stair Roof.

Non-engineered stair roof shed was found. Poor connection was found in roof shed & supporting wall. Factory engineer is required to check the capacity of the connection and suggest to develop the connections.

7	Poor support system of Stair Roof	Factory engineer is required to check the capacity of the connection and suggest to develop the connections.	6-weeks
8	Poor support system of Stair Roof	Implement the action suggested by factory engineer.	6-months
9	Lack of as-built drawing	Prepare “as constructed” drawings with complete structural information.	6-weeks

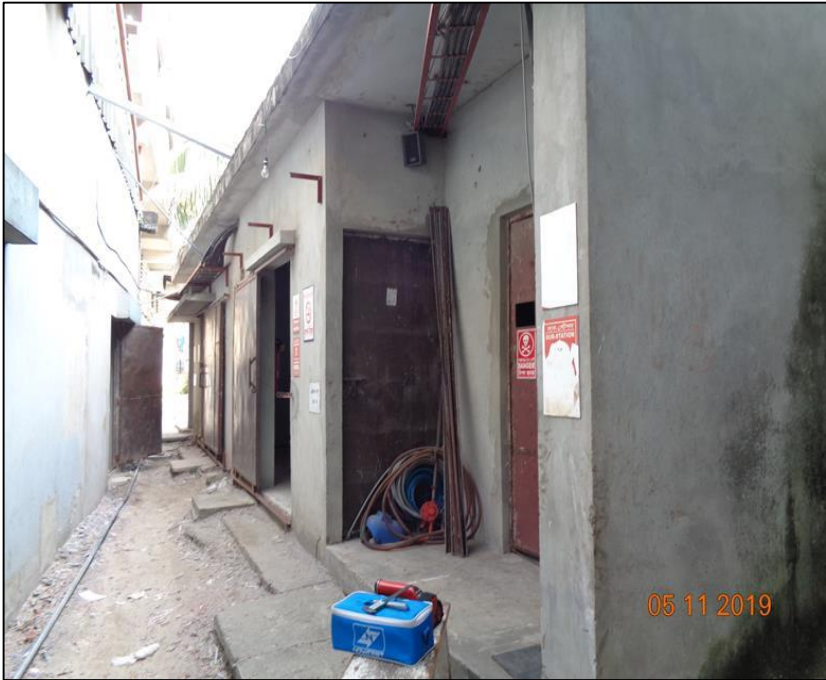
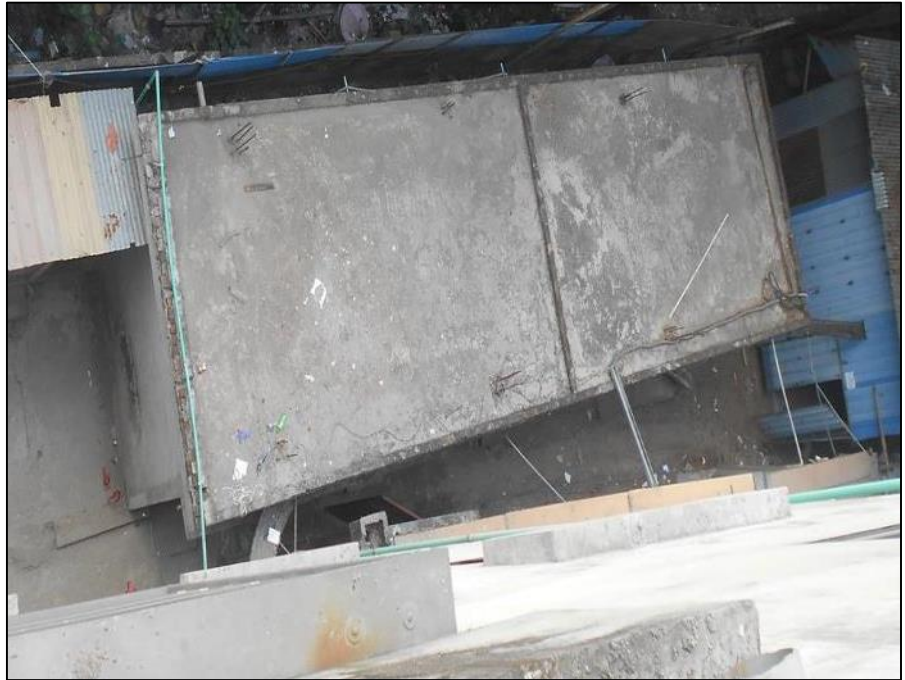
Lack of as-built drawing

No documentation was available onsite for the Utility Building
