# Pakiza Knit Composite Ltd. (New Building)

A-1/5, Mojidpur (Boro-bolimeher), Savar, Dhaka 1340  
(23.842333, 90.259173)

5<sup>th</sup> January 2020 & 19<sup>th</sup> January 2020

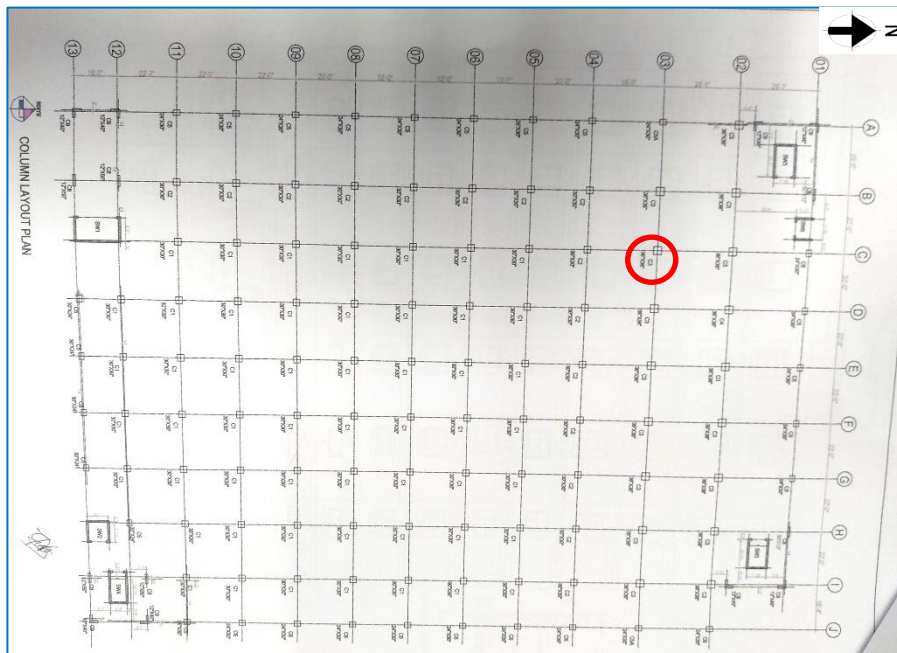
Column Layout

Number of rebar in C-3 type column didn't match with column schedule. In C-3 column 7 rebars were counted by ferro scanning in one direction instead of 9 rebars.

| Item No. | Observation | Recommended Action Plan | Recommended Timeline |
|---|---|---|---|
| 1 | Discrepancy in as-built drawing | Building Engineer to confirm the number of rebar in all column and prepare accurate as-built structural drawing. | 6-weeks |

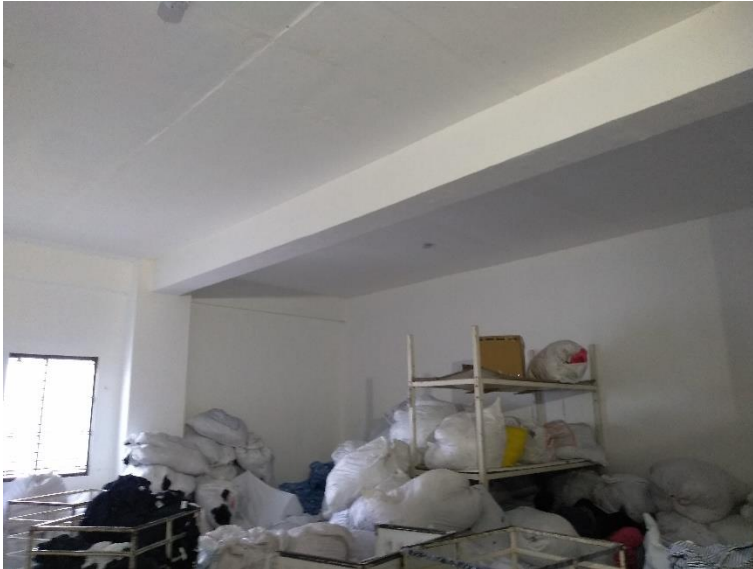
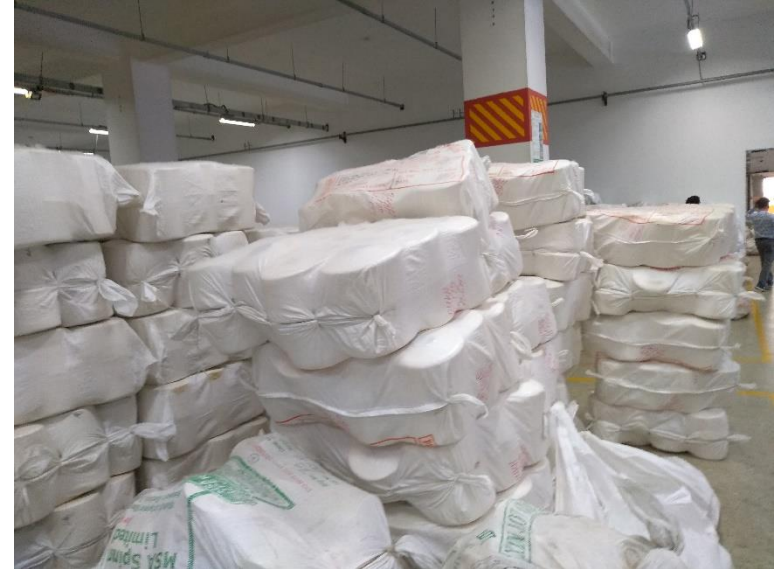
Current floor loading

No load management program was visible on-site. We have checked the column capacity considering 3 kPa floor live load and minimum concrete strength. The column stresses was found within normal design limit. Follow 3 kPa floor live load on typical floors of the building and make sure that the workers understand the loading requirements.

| Item No. | Observation | Recommended Action Plan | Recommended Timeline |
|---|---|---|---|
| 2 | Implement floor load management program | Produce and actively manage a loading plan of 3 KPa for typical floor plates. Engineering assessment is required if floor loading is being considered more than 3 KPa. | 6-weeks |
| 3 | Implement floor load management program | Continue to implement loading plan. | 6-months |

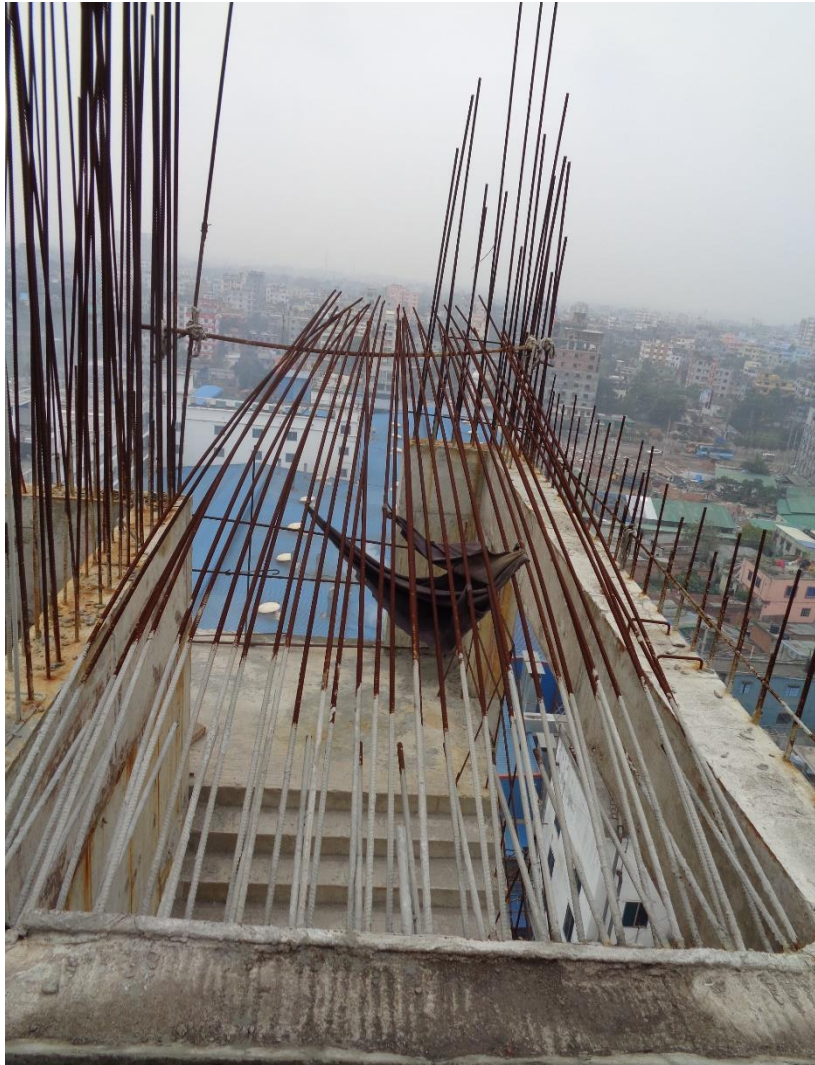
Exposed rebar at Stair

Corrosion was observed on some exposed reinforcement on roof. Factory must provide adequate protection to the structural elements from corrosion.

| Item No. | Observation | Recommended Action Plan | Recommended Timeline |
|---|---|---|---|
| 4 | Exposed rebar at roof | All exposed reinforcement is to be protected from corrosion. | 6-weeks |

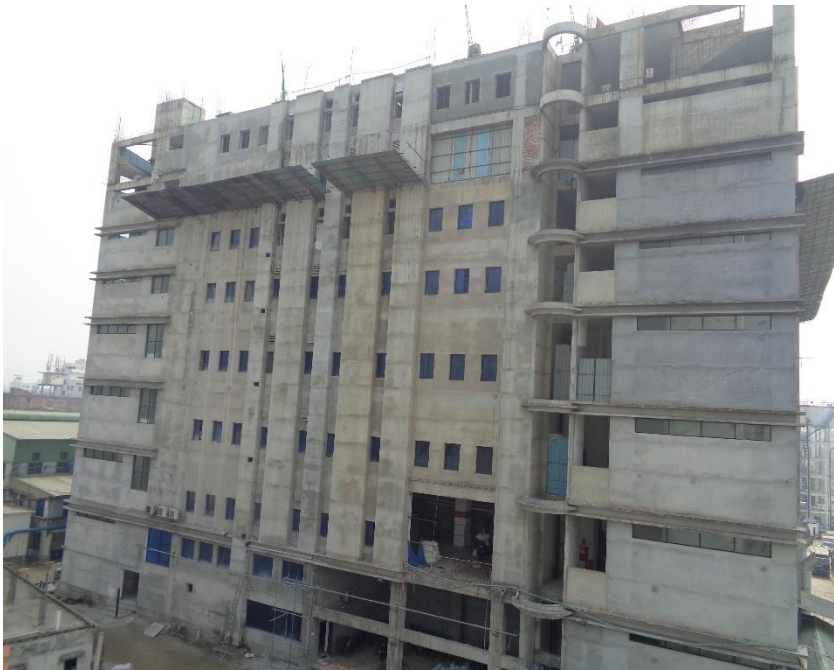
Existing Building

This building is permitted for 10 (G+9) storied from local authority. Currently the building is partially 8 storied. Factory owner has a future plan to extend the building. Factory engineer is required to carry out a Detail Engineering Assessment considering BNBC provision prior to any extension work.

| Item No. | Observation | Recommended Action Plan | Recommended Timeline |
|---|---|---|---|
| 5 | Possible vertical extension (Main Building) | Factory engineer is required to carry out a Detail Engineering Assessment considering BNBC provision prior to any extension work. | 6-months |
| 6 | Possible vertical extension (Main Building) | Remedial works required to be carried out where necessary. | 6-months |

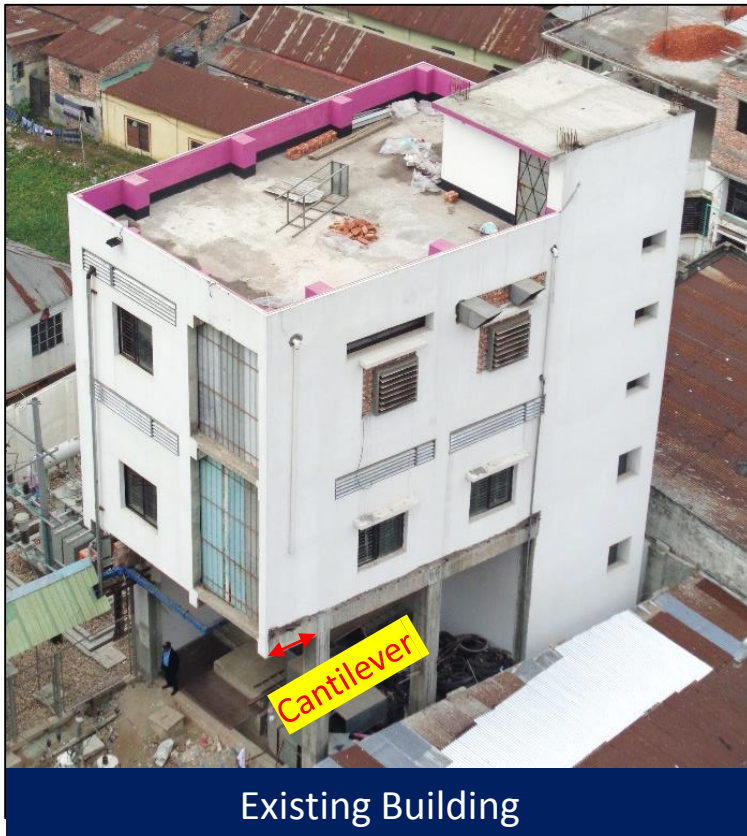
Existing Building

The building columns arranged irregularly. The ground floor height is long and the bays are large having infill walls. Also, a portion of the building has not been constructed yet. The factory engineer to review the design of the existing building for lateral forces.

Please undertake a specific check on the moment resisting frames to ensure that they can resist the applied lateral load with sufficient FoS.

| Item No. | Observation | Recommended Action Plan | Recommended Timeline |
|---|---|---|---|
| 7 | Lateral stability. (Sub-station Building) | Factory engineer requires to check the building frame system against lateral forces. | 6-weeks |
| 8 | Lateral stability. (Sub-station Building) | Carry out remedial works as per recommendation of engineering assessment report. | 6-months |

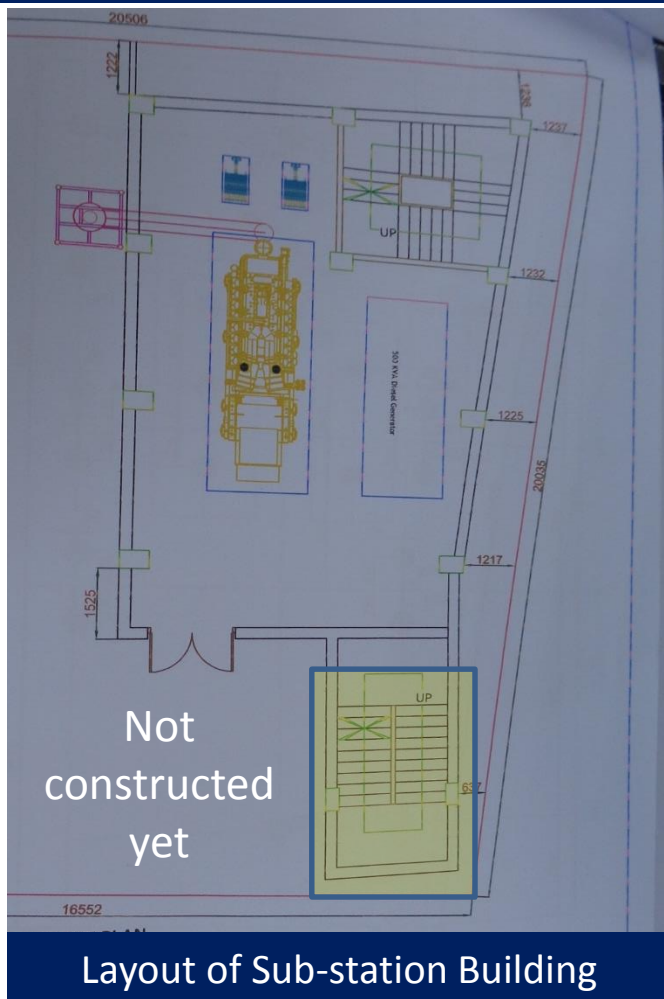
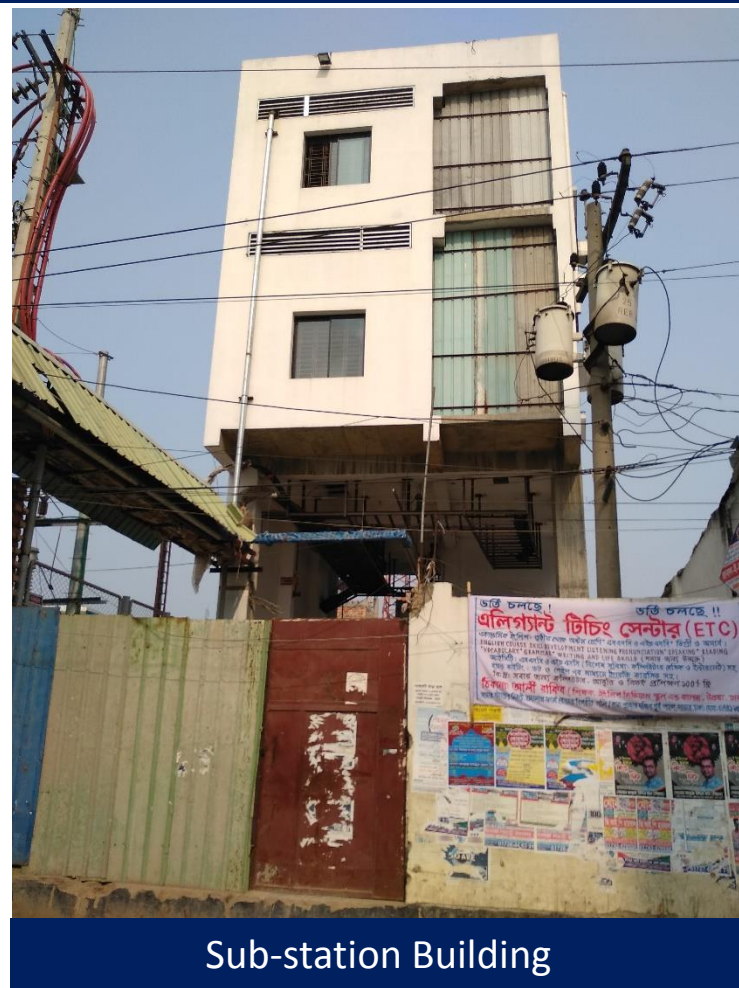
A set of proposed drawings has been provided for Sub-station building. Also, Grade beam reinforcements are found exposed at South side of the structures. Factory owner has a future plan to extend the building horizontally. Factory engineer is required to carry out a Detail Engineering Assessment considering BNBC provision prior to any further extension work.

| Item No. | Observation | Recommended Action Plan | Recommended Timeline |
|---|---|---|---|
| 9 | Possible horizontal extension. (Sub-station Building) | Factory engineer is required to carry out a Detail Engineering Assessment considering BNBC provision prior to any extension work. | 6-months |
| 10 | Possible horizontal extension. (Sub-station Building) | Carry out remedial works from outcome of Detail Engineering Assessment where necessary before further construction. | 6-months |
