Emon Fashion Ltd. (New Unit)

42, Mariyali, Joydebpur, Gazipur.

16th July 2019

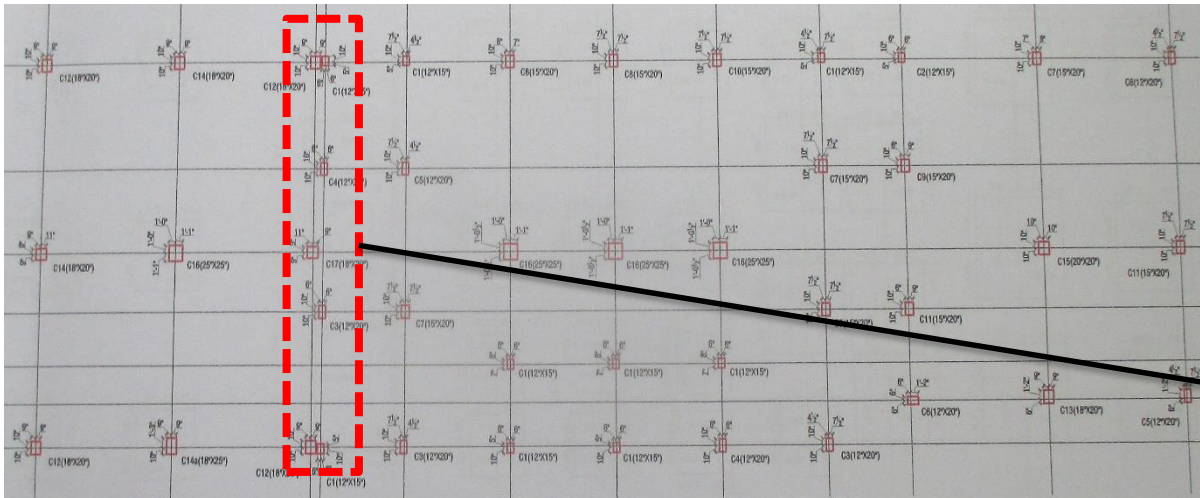
Location of separation in column layout drawing

Outline between the building does not have adequate clearance

The building is analyzed in two parts, but on-site clear gap was not observed. Building Engineer is required to ensure whether the structures are separated or structurally connected. If separated, then adequate gap is required to be provided for movement and seismic provision. If the structures are connected, then factory is required to carryout analysis of the building considering a single structure.

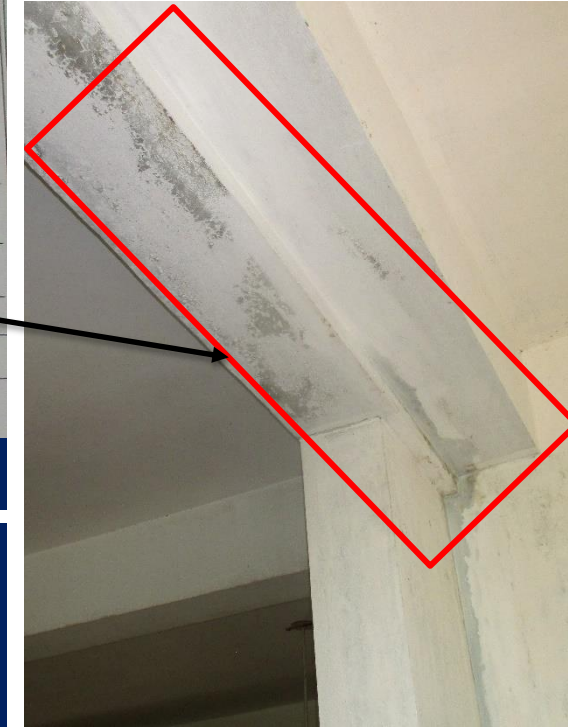
Outline between two parts

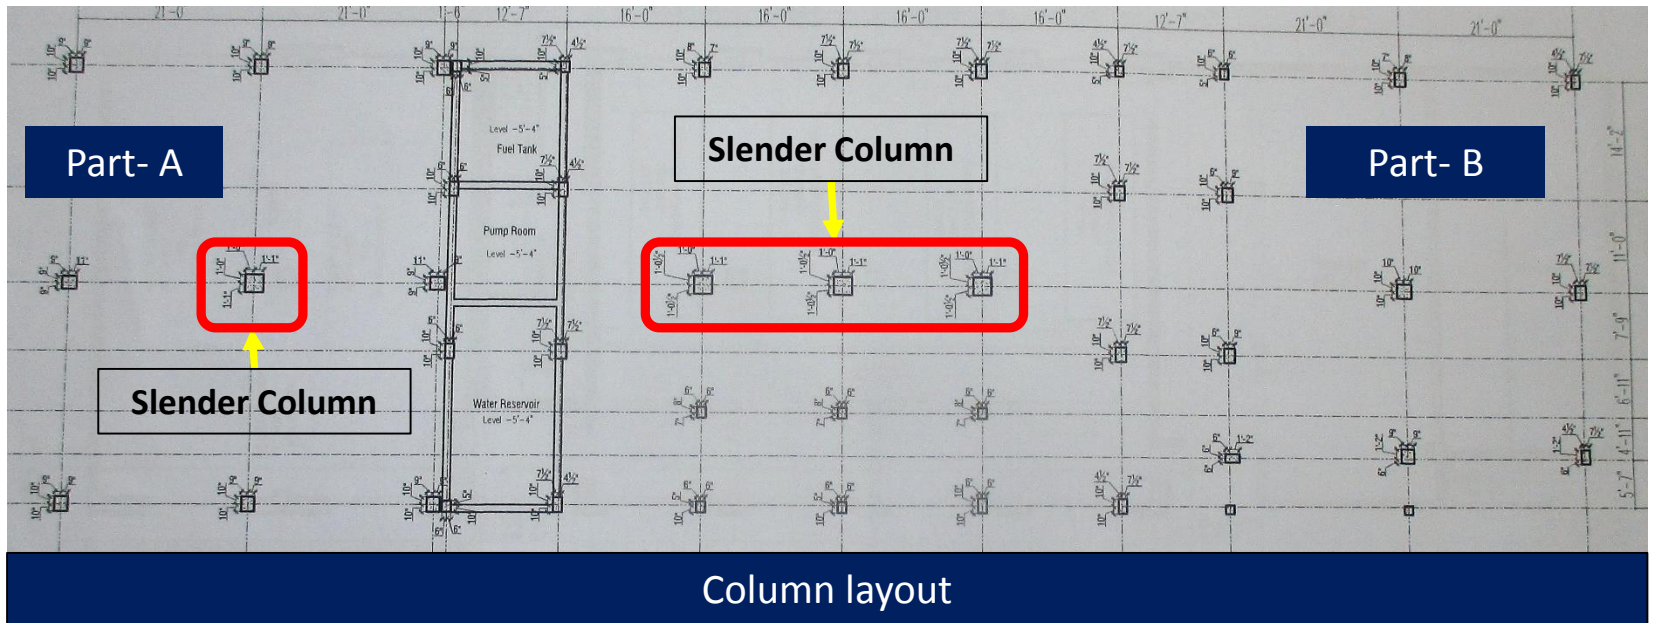
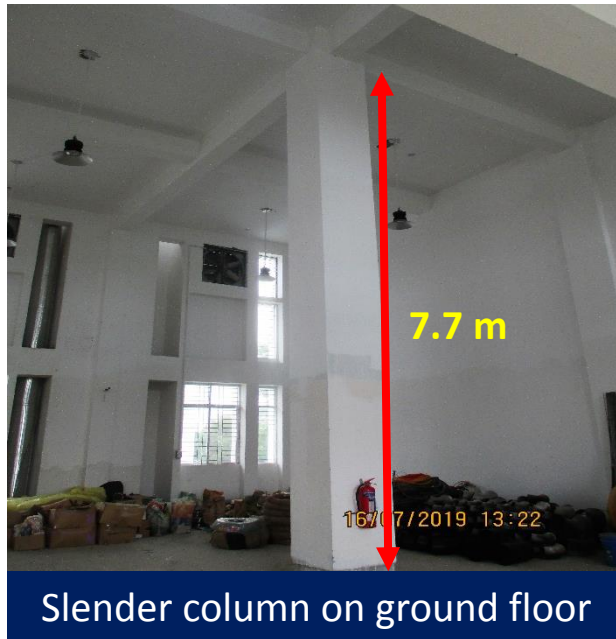
Slenderness effect of internal columns not addressed in design report

There is no tie beam for internal grids. Tie beams exist only in peripheral grids. Slenderness effect may act on the internal columns. Also, in design report slenderness effect of columns was not addressed. Factory engineer is required to check the slenderness effect of those columns.

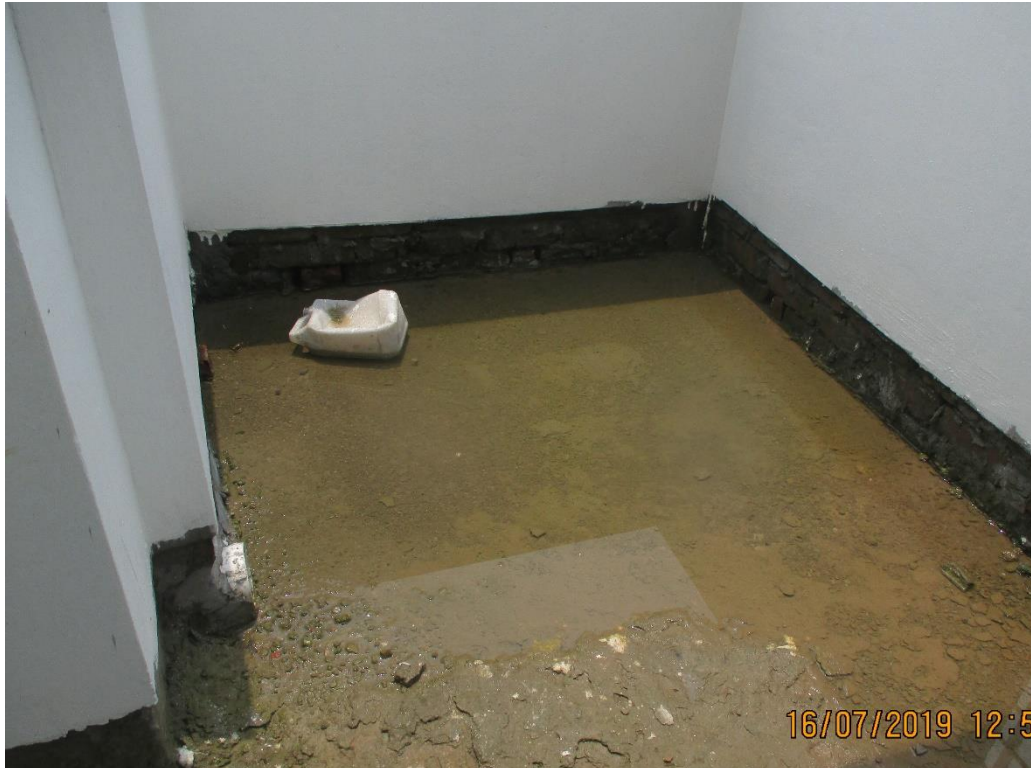
Water ponding observed on 3rd floor

Factory is required to install the proper drainage system on floor slabs susceptible to water ponding.

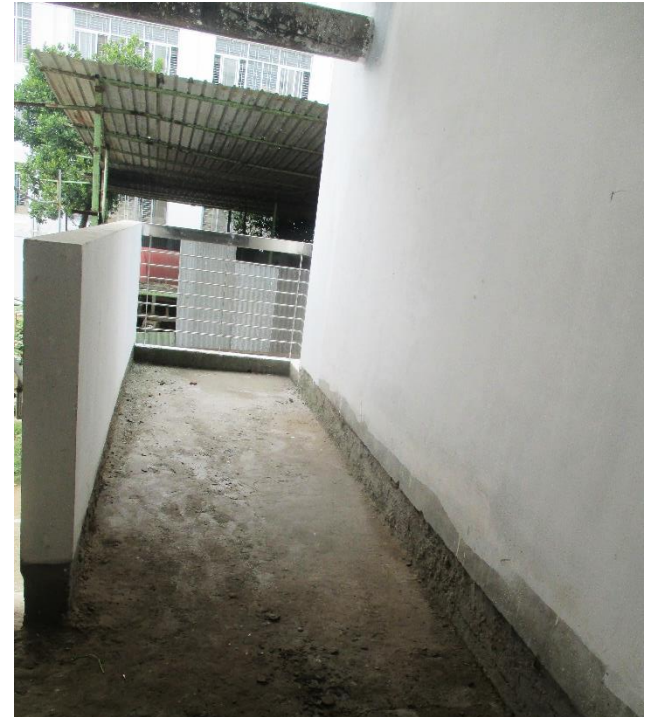
Signage of water ingress observed on 1st floor slab.

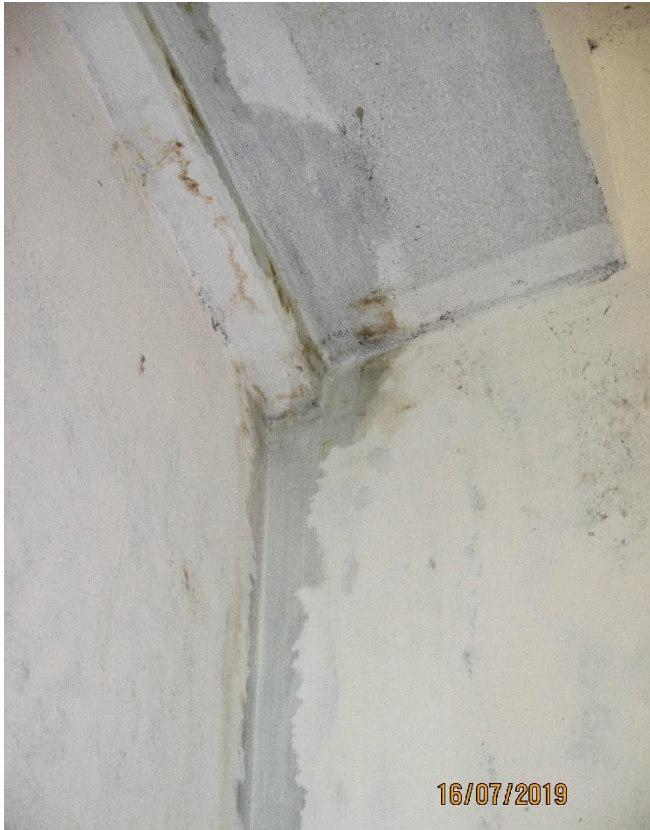
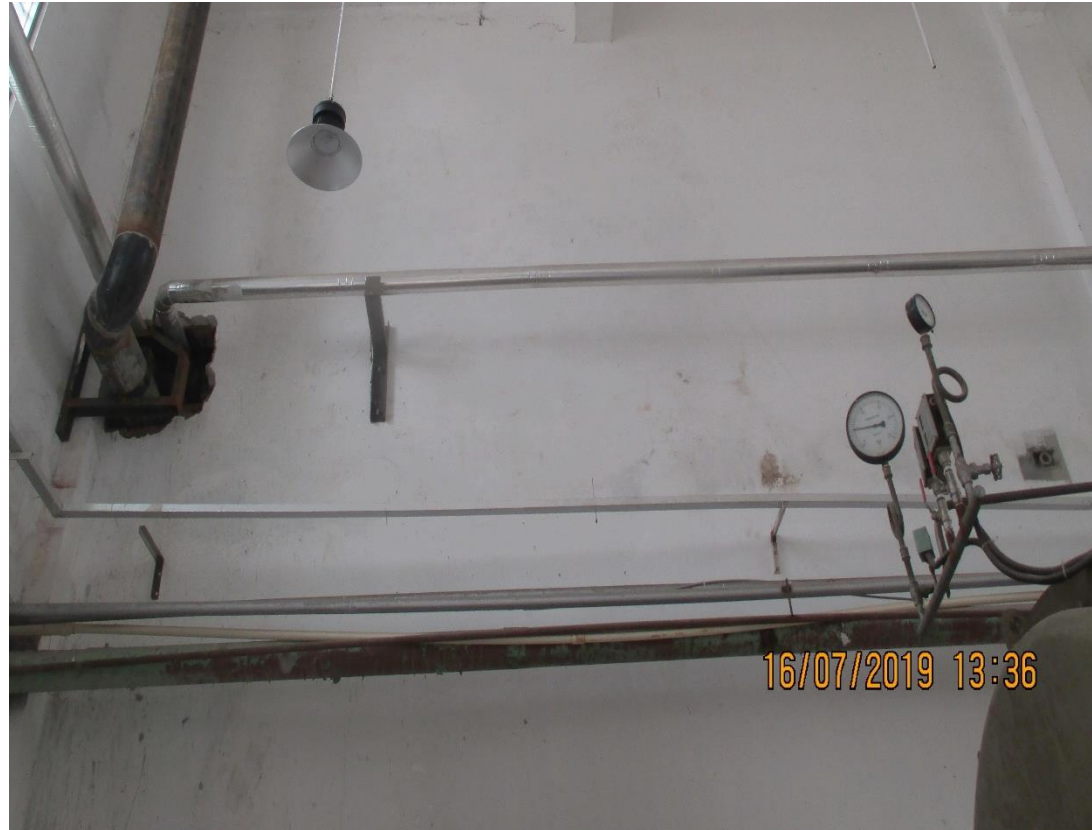
Dampness was observed on beam and wall due to water seepage through outline of two parts.
Factory is required to carry out required measures to remove dampness.
