# Colors & Stitches Ltd.

JL no 6, Dogri, Mirzapur, Gazipur Sadar, Gazipur

30<sup>th</sup> July 2019

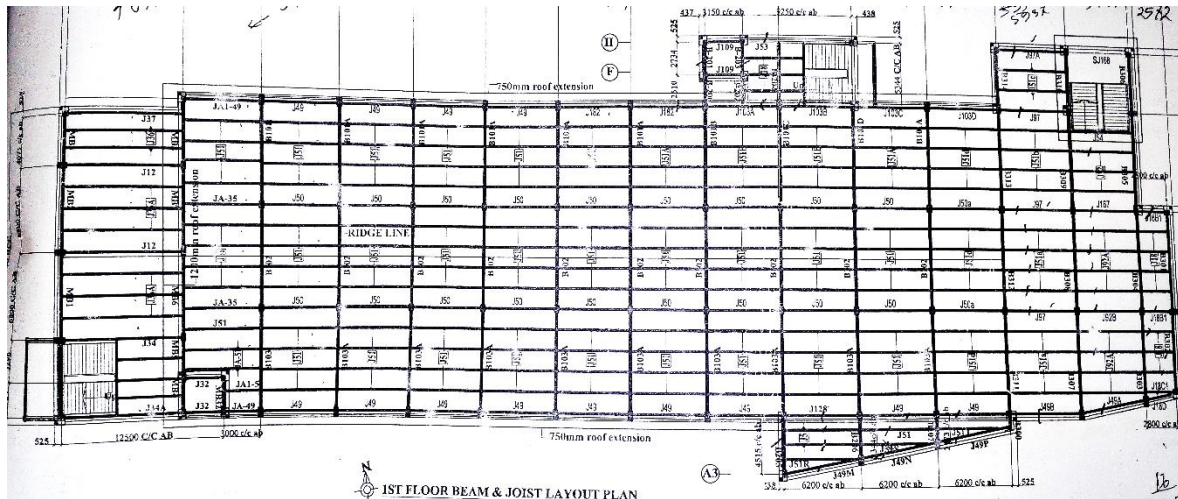
Beam & Joist layout plan

During inspection as-built drawings were available on site. But the dimensions of joists were not available. Again, locations of portal bracings were shown but dimensions were incorporated for any of the bracings. No connection details were provided for joists or bracings.

| Item No. | Observation | Recommended Action Plan | Recommended Timeline |
|---|---|---|---|
| 1 | Incomplete as-built drawing. (Main Production Building) | Building Engineer to survey the whole structure and prepare accurate as-built drawings with proper connection details. | 6-weeks |

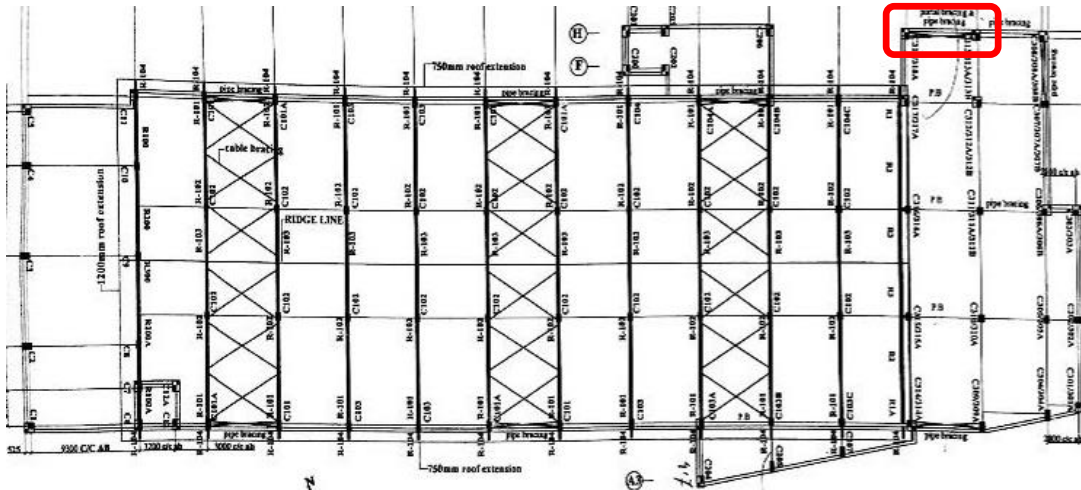
Bracing layout plan

As per provided as-built drawing, there should have a portal bracing between grid G-13 & G-14. But no portal bracing was found in that grid on site. Moreover, no connection details were provided for bracings. Factory is required to check for lateral stability and connection adequacy.

| Item No. | Observation | Recommended Action Plan | Recommended Timeline |
|---|---|---|---|
| 2 | Lateral stability and connection adequacy check. (Main Production Building) | Factory engineer is required to check the stability of the building against lateral loading. | 6-weeks |
| 3 | Lateral stability and connection adequacy check. (Main Production Building) | Factory engineer is required to check the adequacy of the connections. | 6-weeks |
| 4 | Lateral stability and connection adequacy check. (Main Production Building) | Implement the recommendation of engineering assessment. | 6-months |

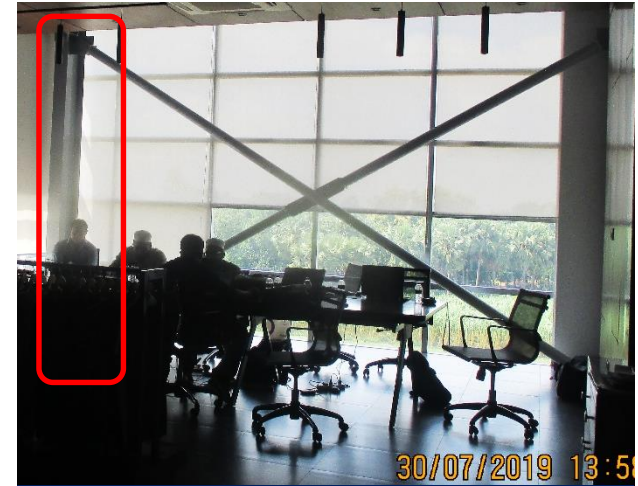
Bracing on 1<sup>st</sup> floor missing

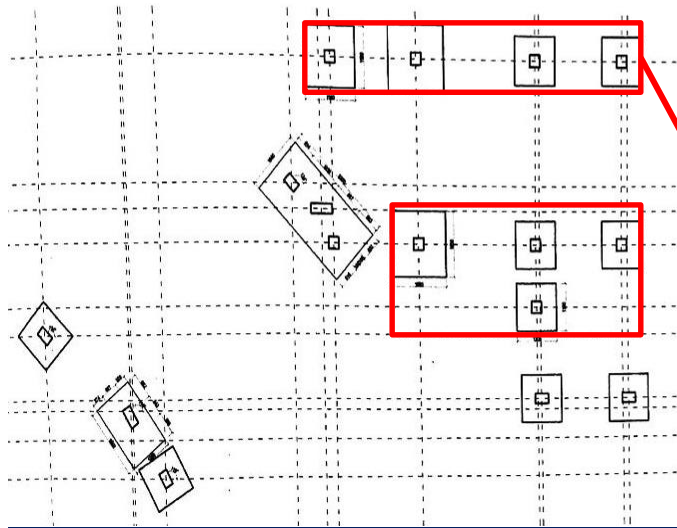
Footing layout plan of Security Post

No structural details were incorporated in the provided as-built drawings. Dimensions of slab and beams were not provided.

Factory is required to update as-built drawings of Security Post and Child Care & Medical.

| Item No. | Observation | Recommended Action Plan | Recommended Timeline |
|---|---|---|---|
| 5 | Incomplete as-built drawing. (Security Post and Child Care & Medical) | Building Engineer to survey the whole structure and prepare accurate as-built drawings. | 6-weeks |

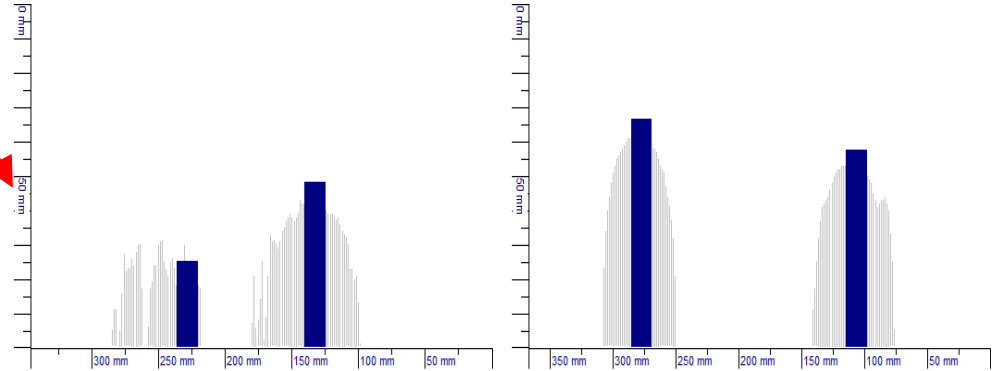
C1 type columns of supposed to have 6-16 mm diameter rebars but on site ferro scanning indicates that C1 type columns have 4 rebars.

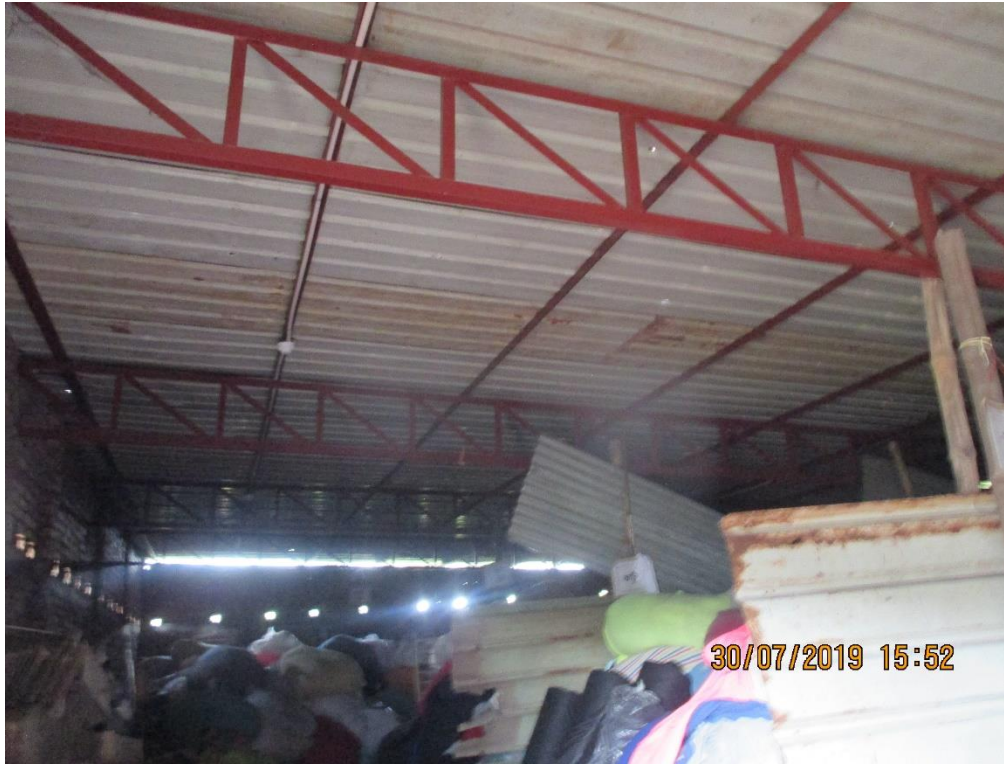
Light weight roof supported on peripheral wall

Apparently non-engineered Wastage Shed. Roof truss is embedded in peripheral brick wall. Building engineer to check the stability of the lightweight roof structure against lateral loading and if inadequate then replace the structure with an engineered one.

| Item No. | Observation | Recommended Action Plan | Recommended Timeline |
|---|---|---|---|
| 6 | Apparently non-engineered shed. (Wastage Shed) | Building engineer to check the lateral stability against uplift forces. | 6-weeks |
| 7 | Apparently non-engineered shed. (Wastage Shed) | Carry out remedial works resulting from engineering assessment if necessary. | 6-months |

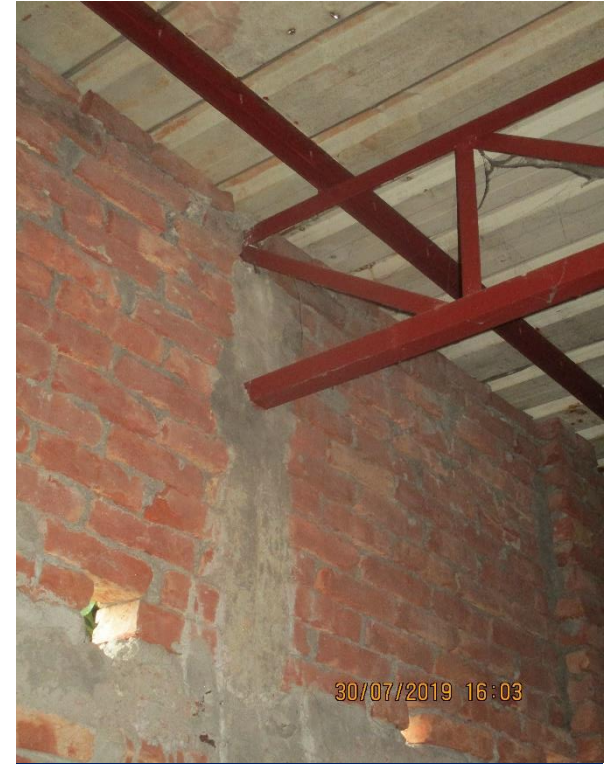
Non-engineered connection
