# ALIB Composite Ltd

Vannara, Mouchak, Kaliakoir, Gazipur  
(24.036871N, 90.296459E)

17<sup>th</sup> February 2020

# Observations

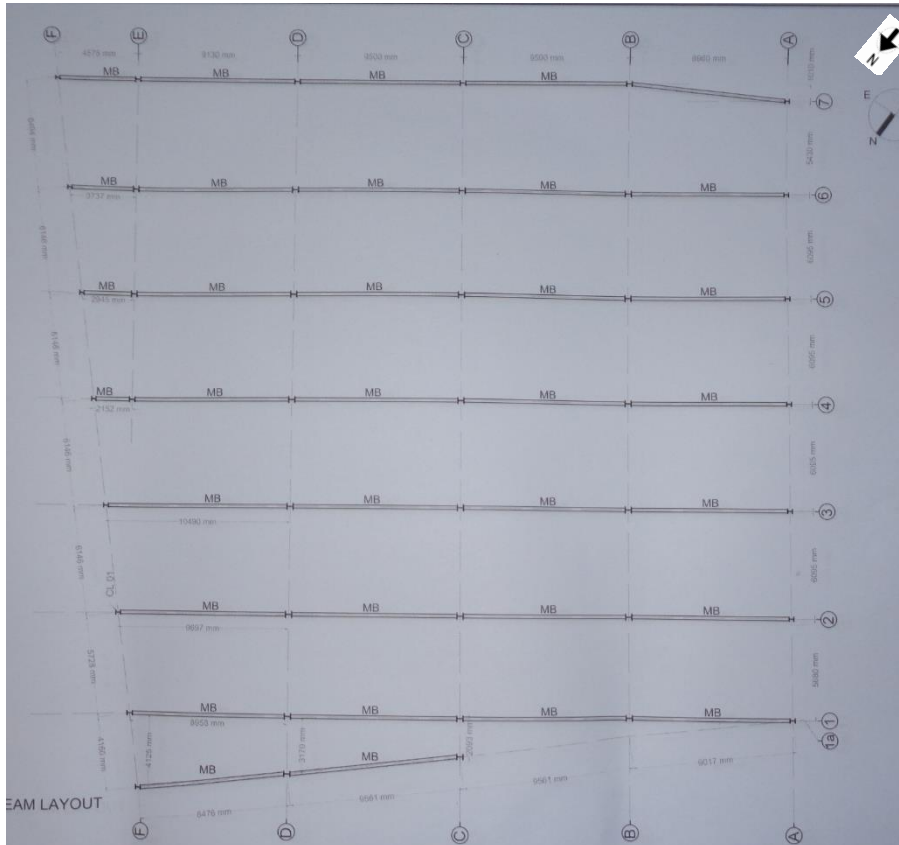
Typical beam layout plan

Moment resisting frame action acting on N-S direction only.

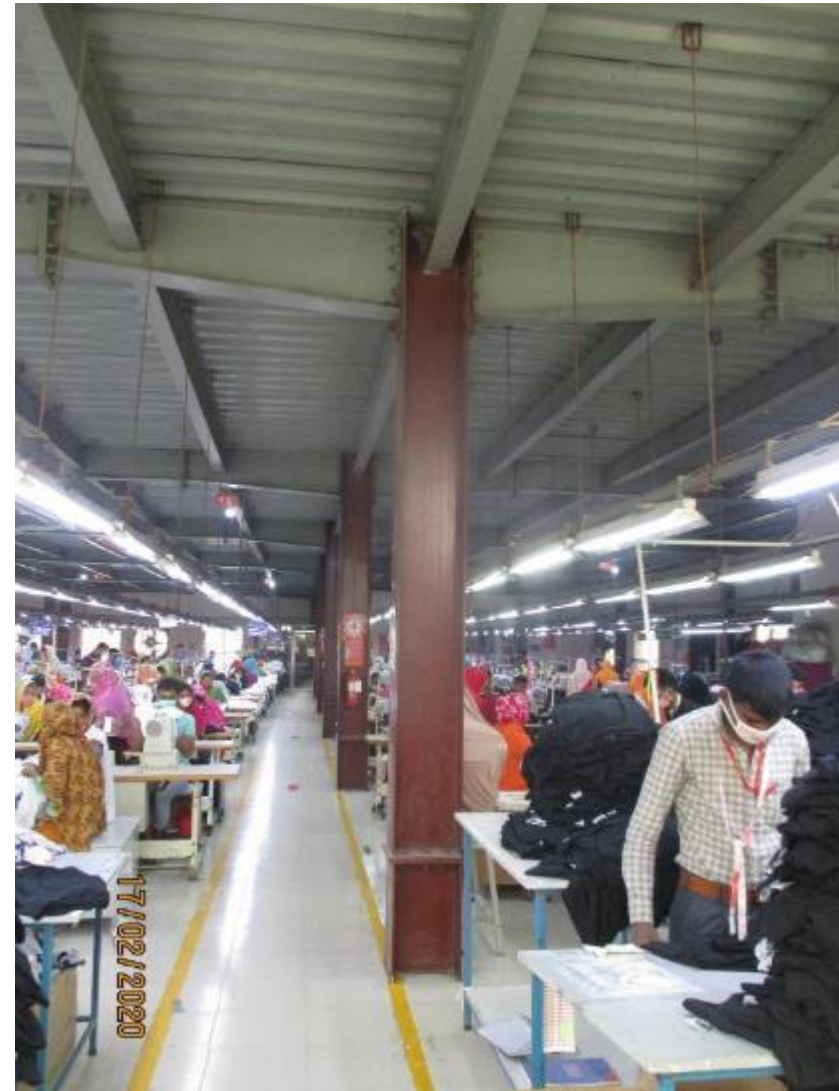
Beams with fixed connection in N-S direction

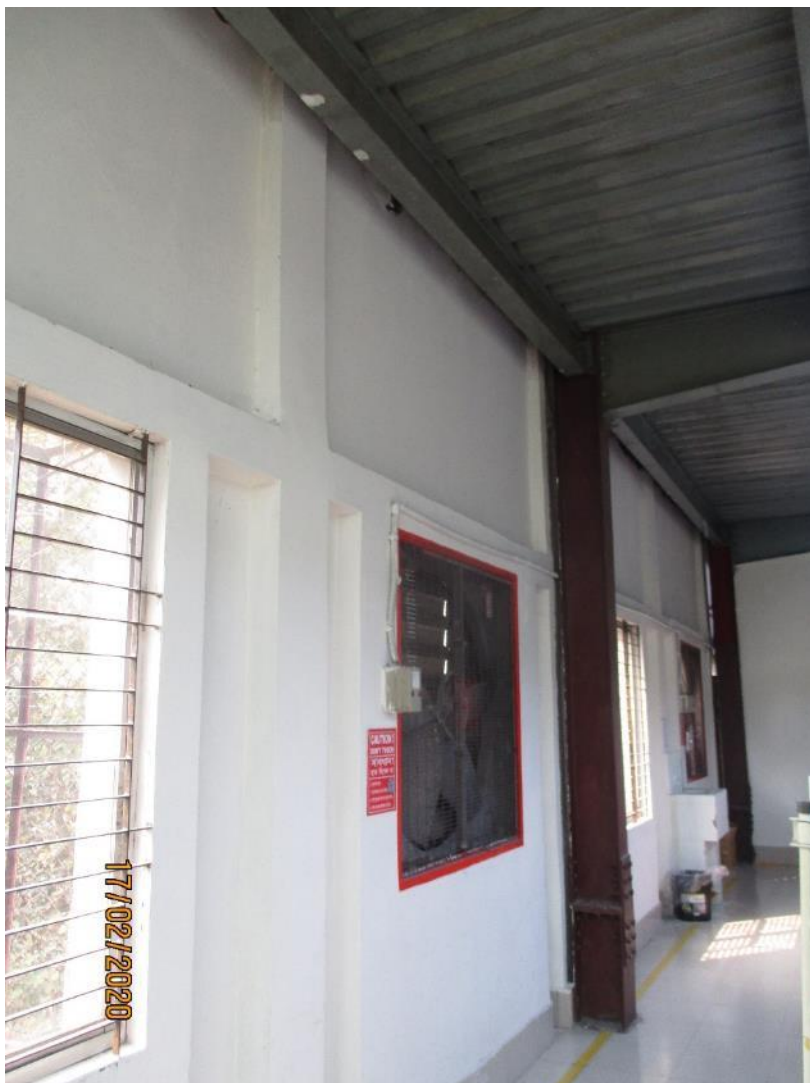
No vertical bracing/lateral load resting system in any long direction.

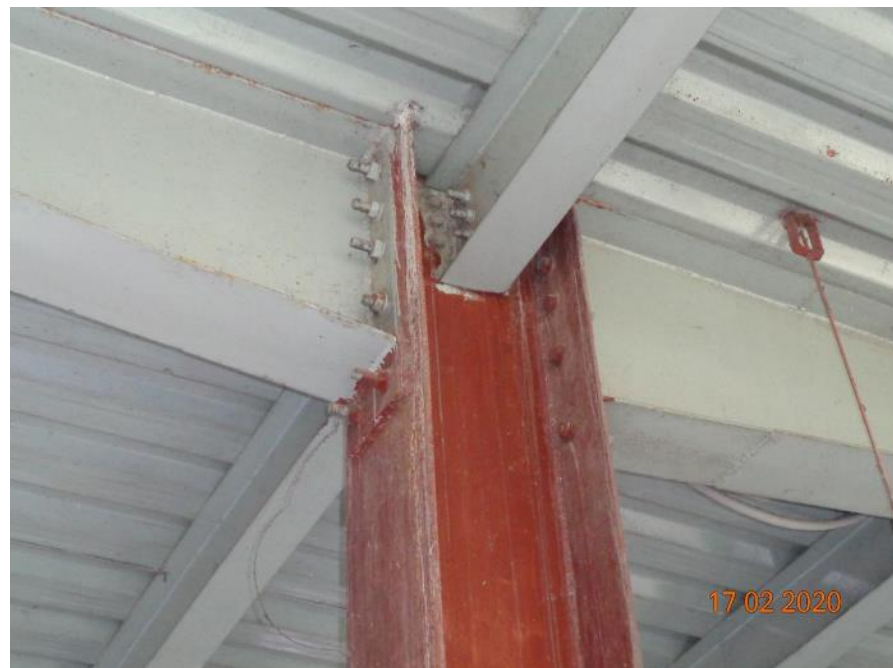
Apparently partial moment resisting frame action at E-W direction that may affect the stability.

Building engineer is required to check the overall stability system.

| Item No. | Observation | Recommended Action Plan | Recommended Timeline |
|---|---|---|---|
| 1 | Lateral stability system in Short direction(E-W direction) | Building engineer is required to check the overall lateral stability system of the building. | 6-weeks |
| 2 | Lateral stability system in Short direction(E-W direction) | Carry out remedial works where required. | 6-months |

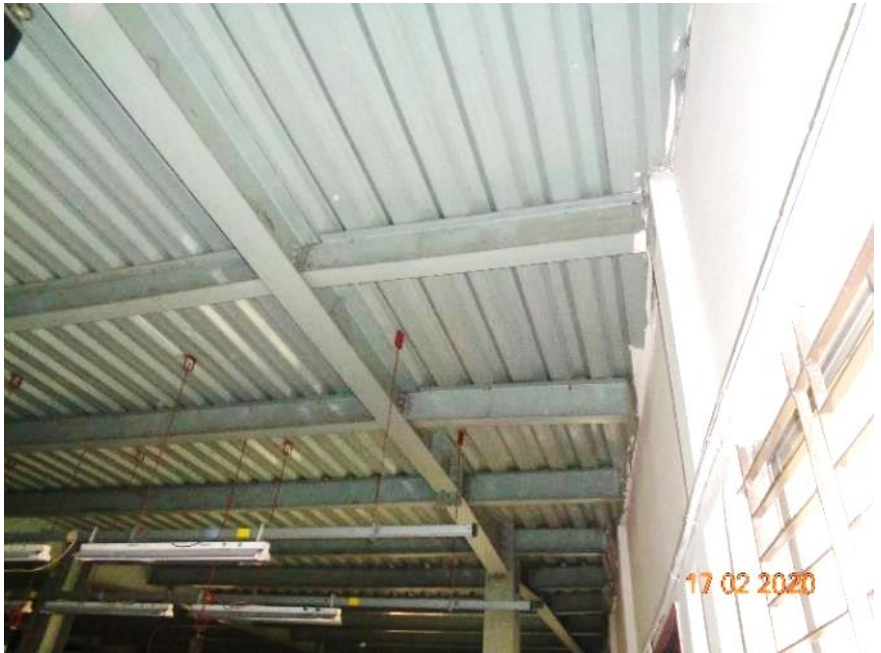
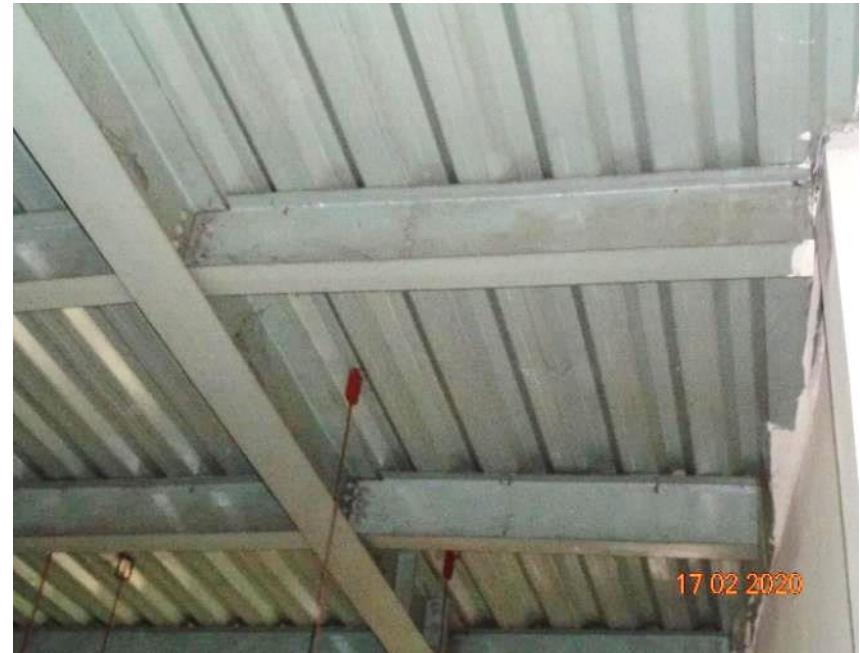
Shear connection of Cantilever Sub-beams to main beams at West direction (Grid 1-A~C). These sub-beams were found in slightly deflected. Building engineer is required to check the adequacy of the connections and the deflections.

| Item No. | Observation | Recommended Action Plan | Recommended Timeline |
|---|---|---|---|
| 4 | Adequacy of the connections | Building engineer is required to check the cantilever beam connections adequacy and the deflections. | 6-weeks |
| 5 | Adequacy of the connections | Carry out remedial works where required. | 6-months |

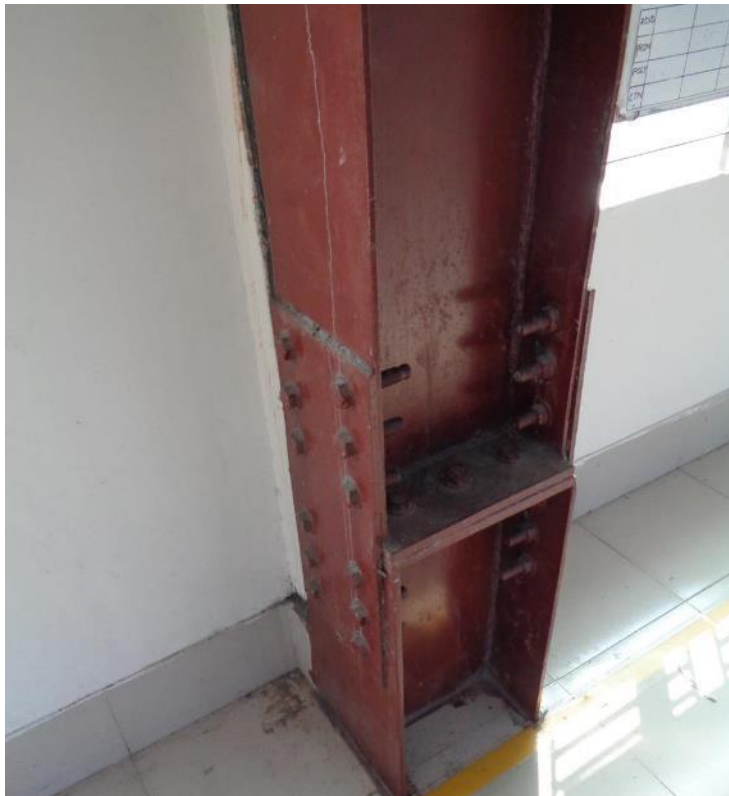
Most of the columns are bolted column splice (moment connection).

Apparently, some of the column-column welded joints are inadequate for resisting moment. Building engineer is required to check the adequacy of these connections considered in the design review.

| Item No. | Observation | Recommended Action Plan | Recommended Timeline |
|---|---|---|---|
| 3 | Adequacy of the connections | Building engineer is required to check the adequacy of column splice joint connection considered in design review. | 6-weeks |

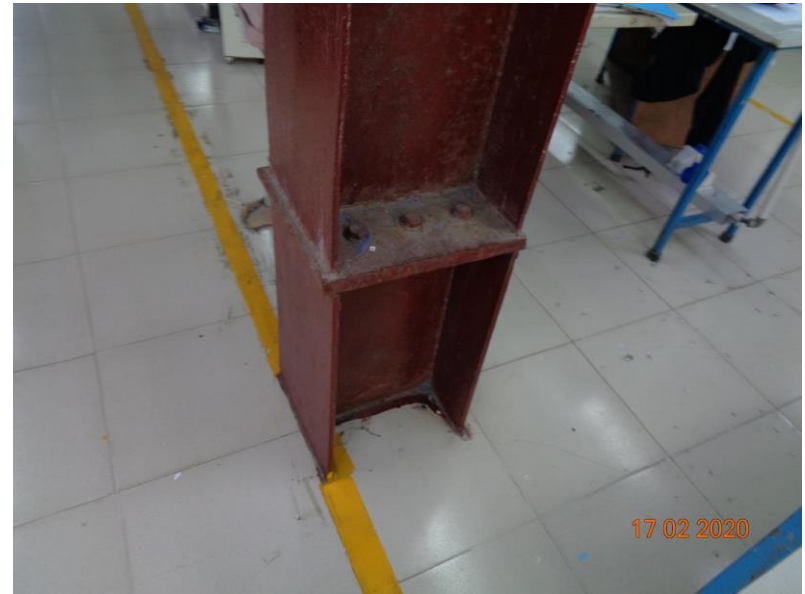
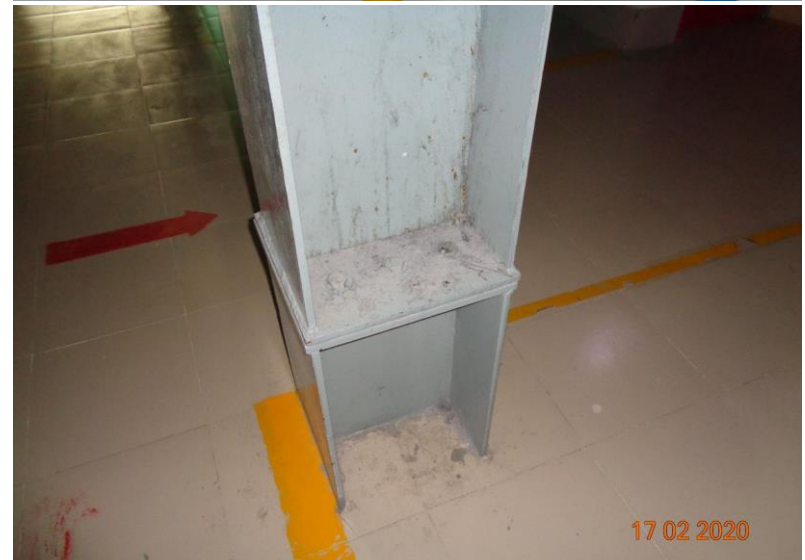
Welded column without splice

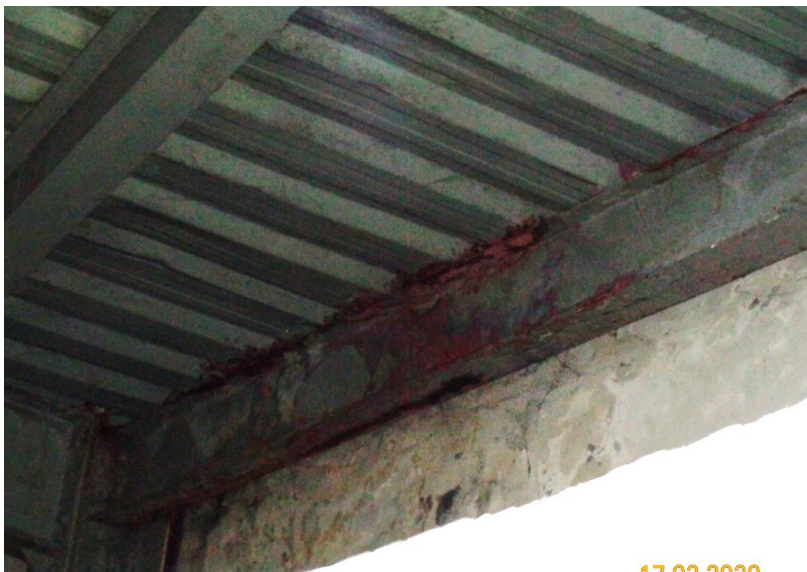
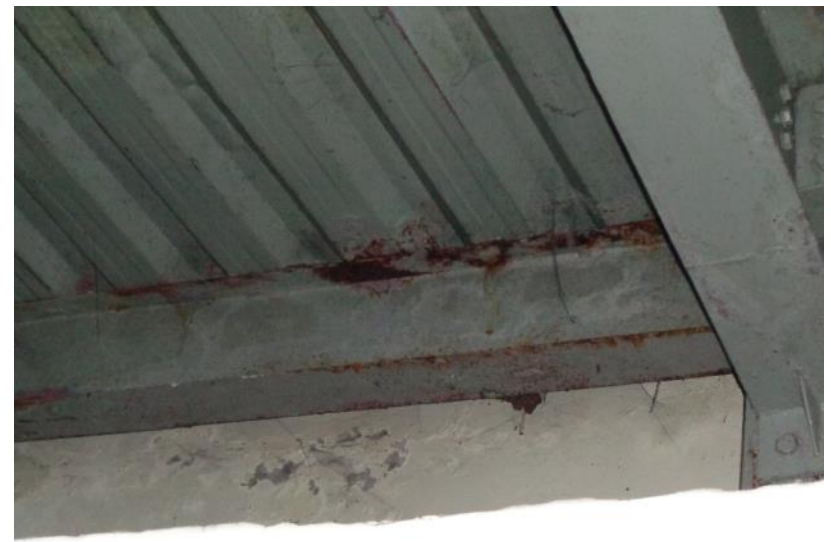
Corrosion in steel beam at toilet Zone.

Severe corrosion in steel members was observed at toilet area. The extent of corrosion to be investigated by a qualified structural engineer.

| Item No. | Observation | Recommended Action Plan | Recommended Timeline |
|---|---|---|---|
| 6 | Corrosion in steel members | Building engineer is required to take necessary action to prevent further corrosion and repair the corroded steel members with suitable method. | 6-weeks |

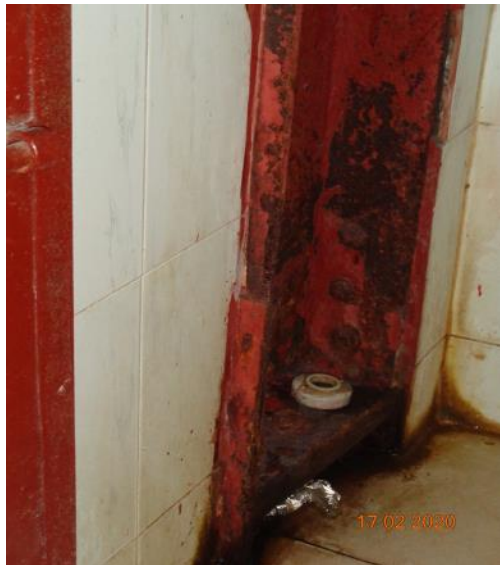
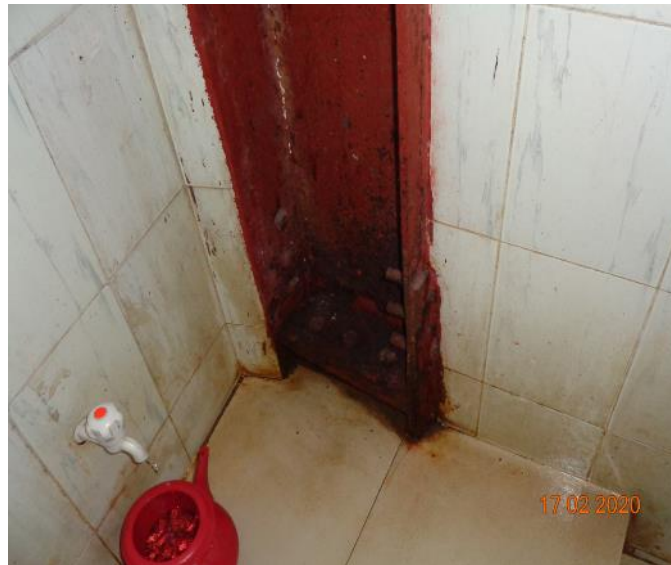
Corrosion in steel column at toilet Zone.

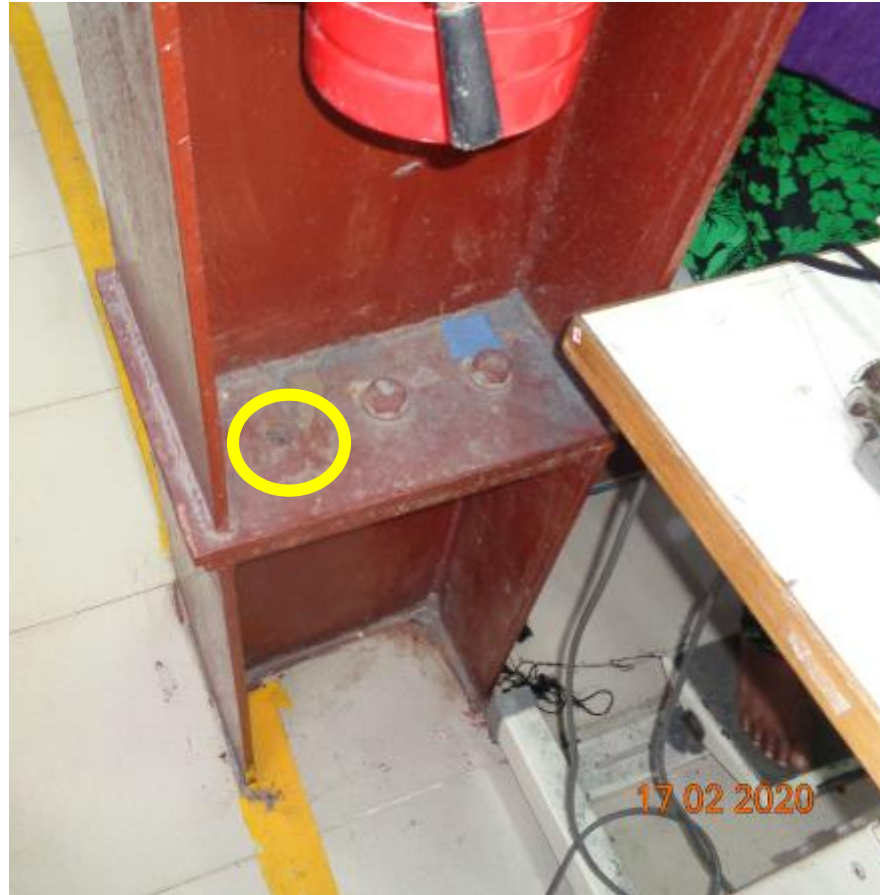
Bolt was found missing. Building engineer is required to reinstall the bolts.

| Item No. | Observation | Recommended Action Plan | Recommended Timeline |
|---|---|---|---|
| 7 | Bolt missing in connection | Building engineer is required to identify the missing bolt locations and install them. | 6-weeks |

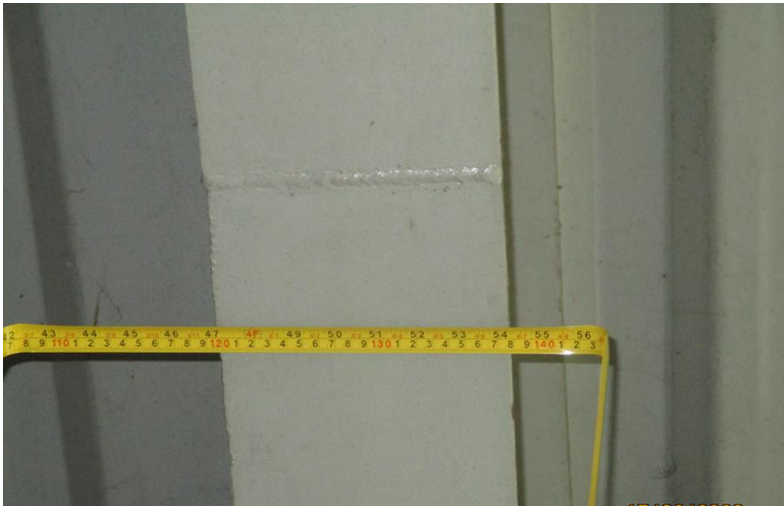
## Typical frame section

Bottom flange of some beams  
measure 175 mm instead of 200 mm

| Item No. | Observation | Recommended Action Plan | Recommended Timeline |
|---|---|---|---|
| 8 | Discrepancies in as-built drawings | Building engineer is required to survey the structure and prepare an accurate as-built drawings. | 6-weeks |

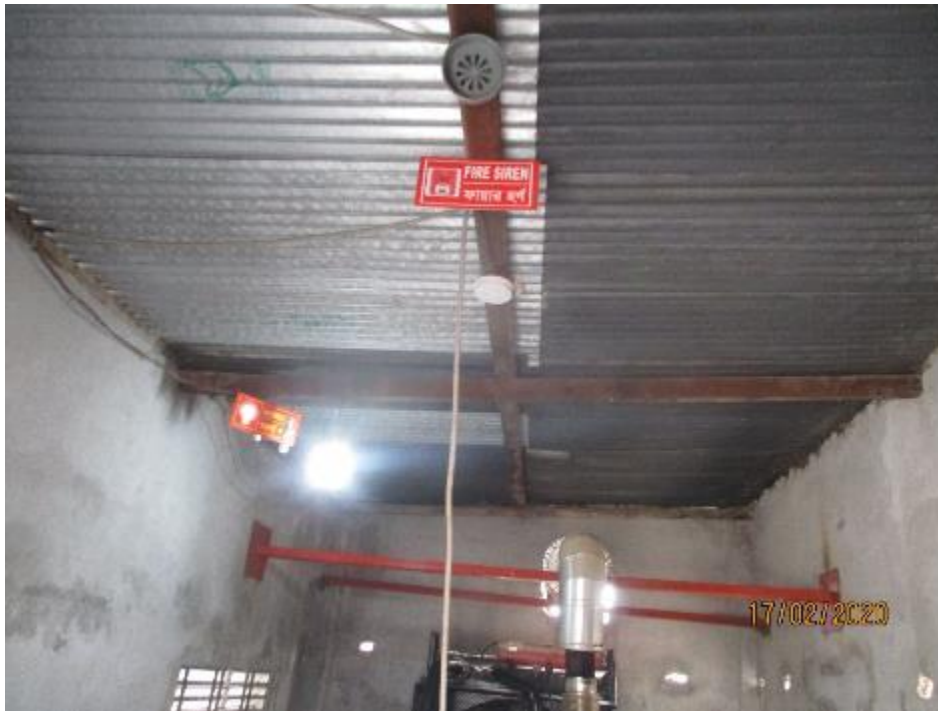
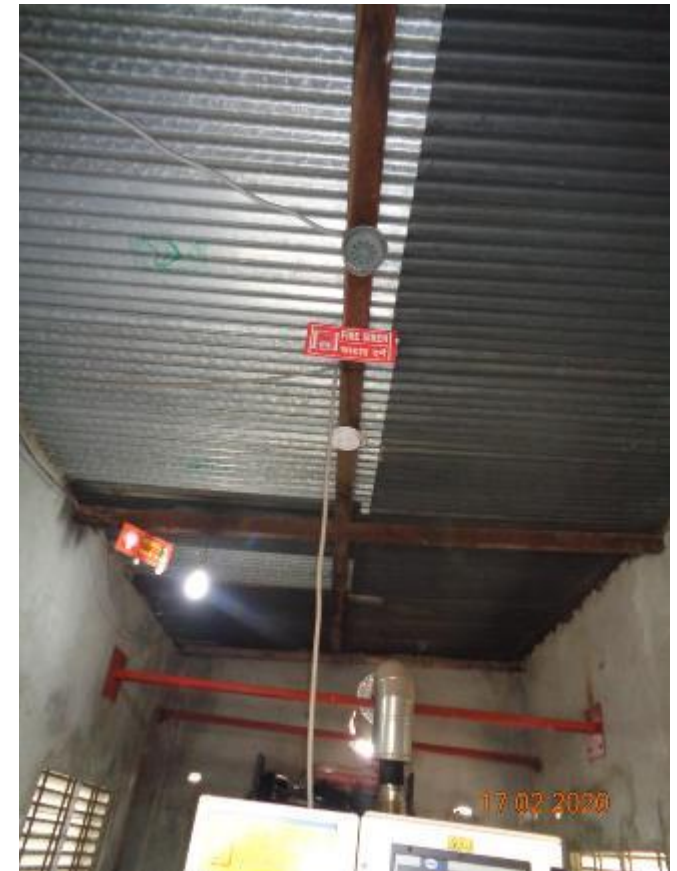
Non-engineered roof observed on utility shed. Building engineer is required to replace the non-engineered shed.

| Item No. | Observation | Recommended Action Plan | Recommended Timeline |
|---|---|---|---|
| 9 | Non-engineered roof of utility shed | Building engineer is required to replace the non-engineered shed. | 6-weeks |
