# Dhaka Garments & Washing Ltd

Dakkhin Vangnahati, Sreepur, Gazipur-1740  
(24.192597, 90.457385)

30<sup>th</sup> December 2019 & 3<sup>rd</sup> February 2020

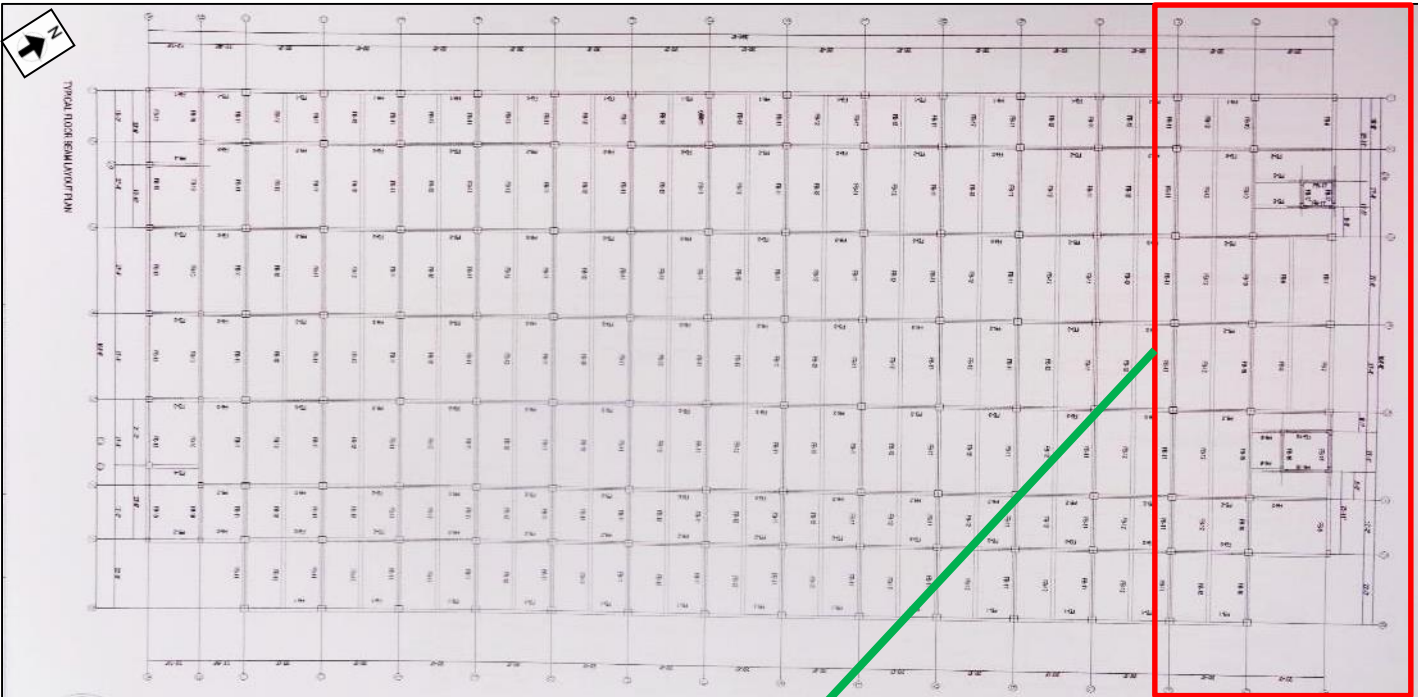
Beam layout plan

Details of the beam FB-16 & 17 (yellow marked) has not been shown in drawing.

| Item No. | Observation | Recommended Action Plan | Recommended Timeline |
|---|---|---|---|
| 1 | Discrepancy in as-built drawing in Main Building | Factory engineer is required to survey the structure and update the as-built drawing. | 6-weeks |

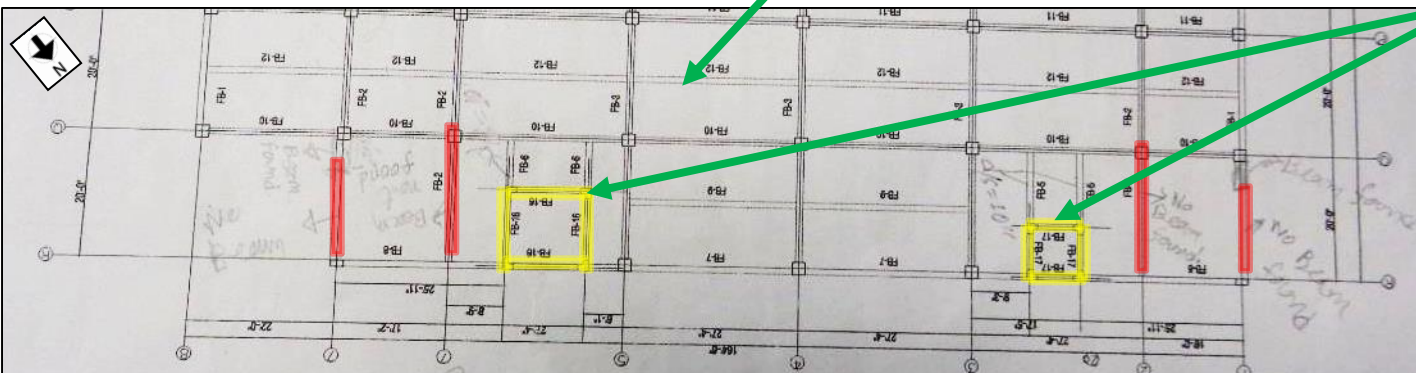
Beam was not found at factory site (Red marked). But in as-built drawing, beam has been shown in drawing.

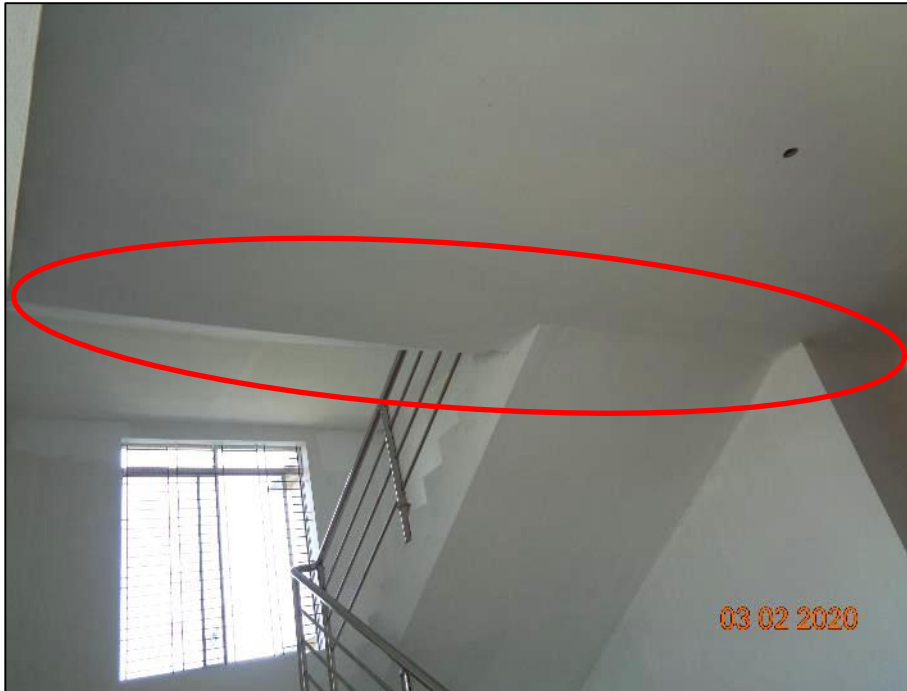
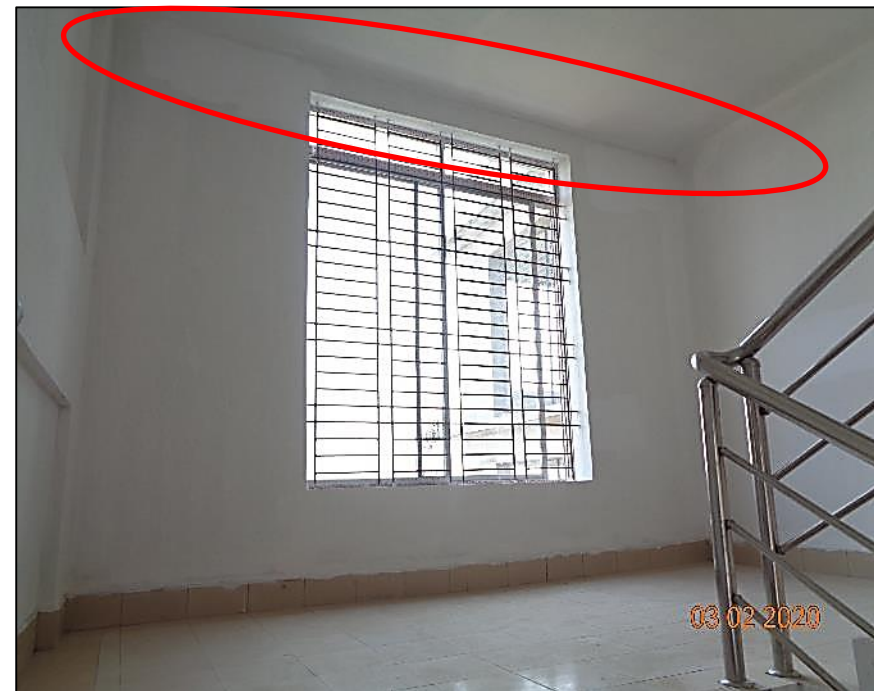
Beam was not found at site condition but shown in as-built drawing

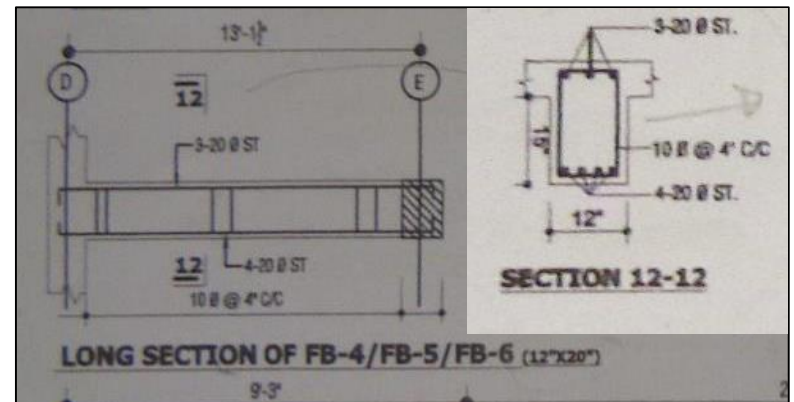
D/S depth has been shown 375mm

In as built, drawing the D/S depth of FB-5 & FB-6 has been shown 375mm. But at factory site, the D/S depth of the Beam was found 250mm.

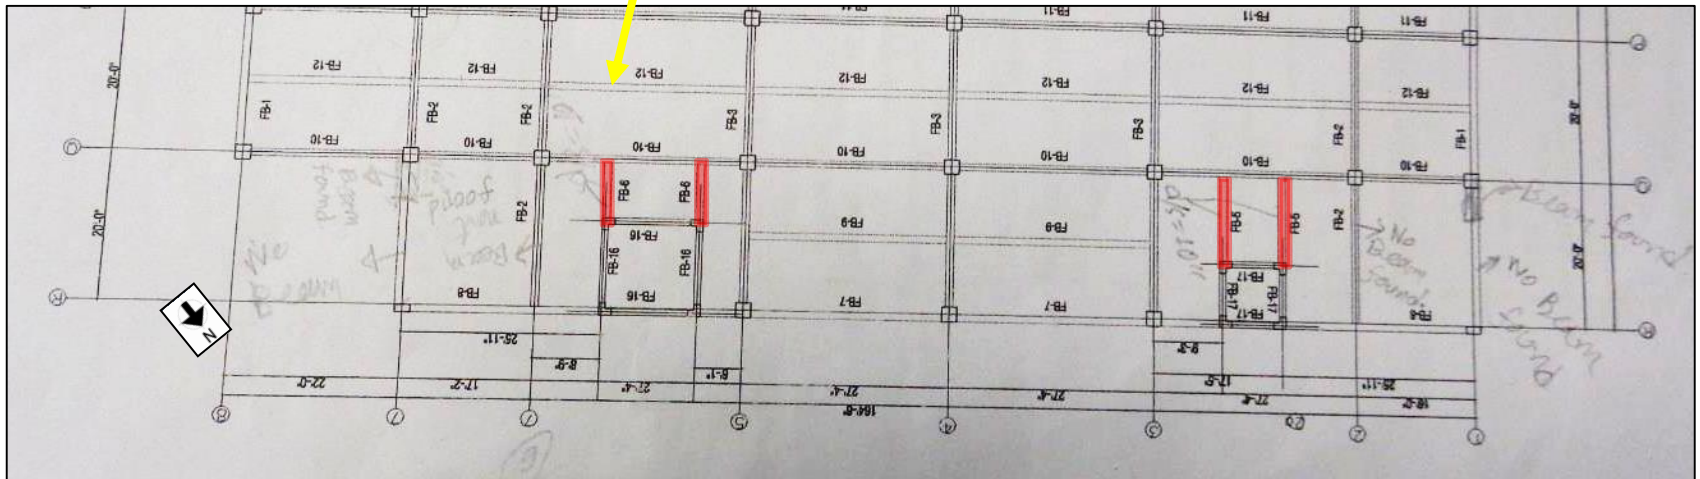
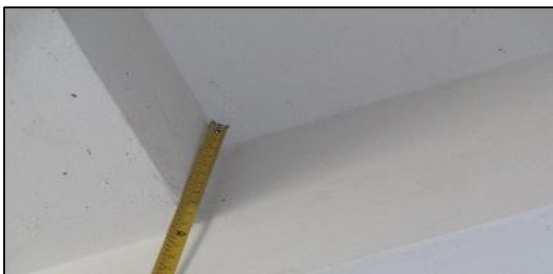
D/S depth was found 250 mm

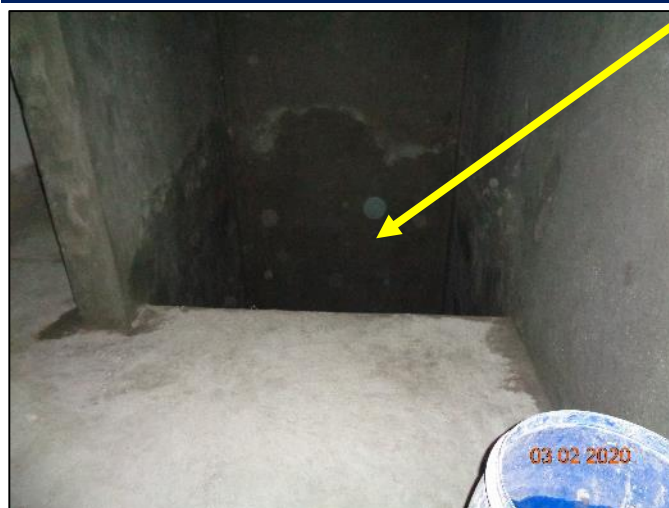
Slab perforation was found at 1<sup>st</sup> floor for the installation of cargo lift. But no information has been provided in the as built drawing.

| Item No. | Observation | Recommended Action Plan | Recommended Timeline |
|---|---|---|---|
| 2 | Discrepancy in as-built drawing in Main Building | Factory engineer is required to check the capacity of the slab panel considering the perforation. | 6-weeks |

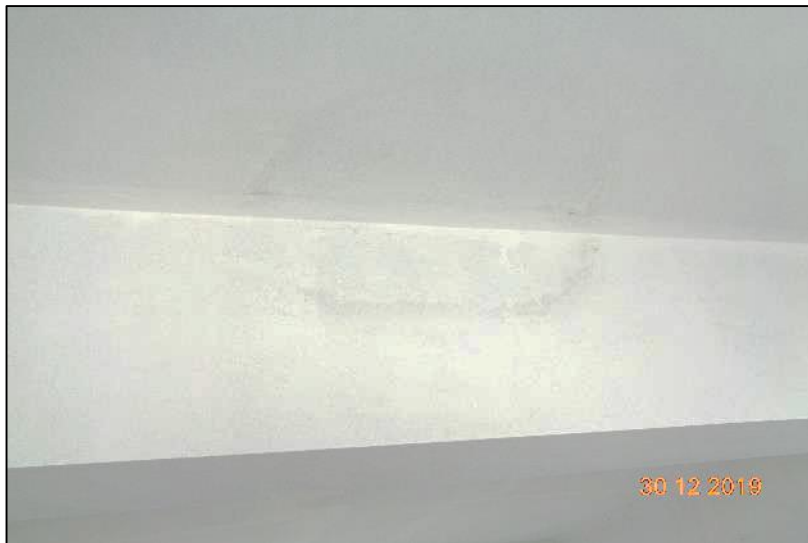
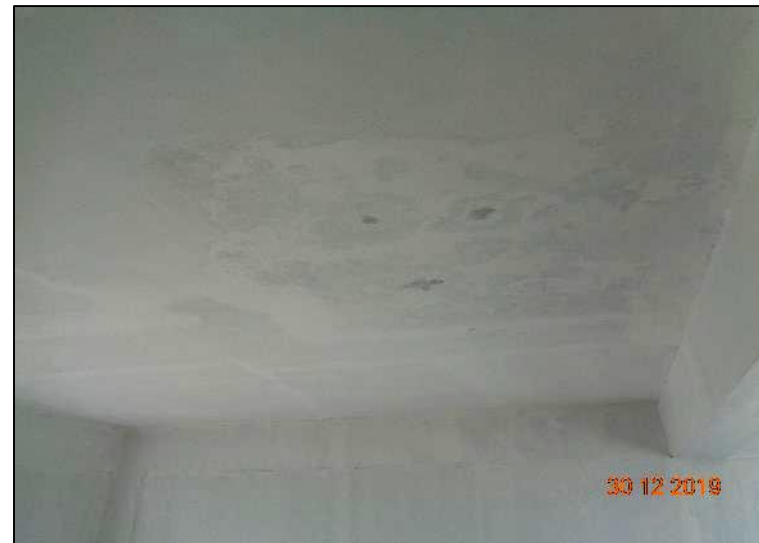
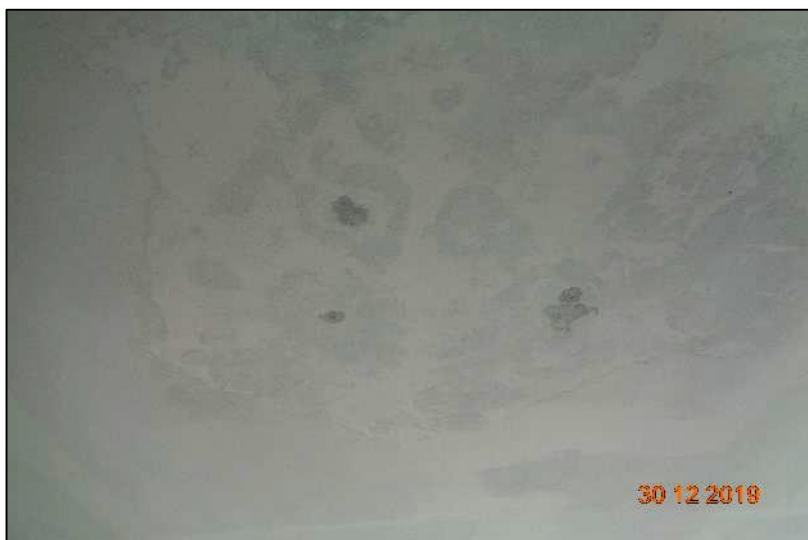
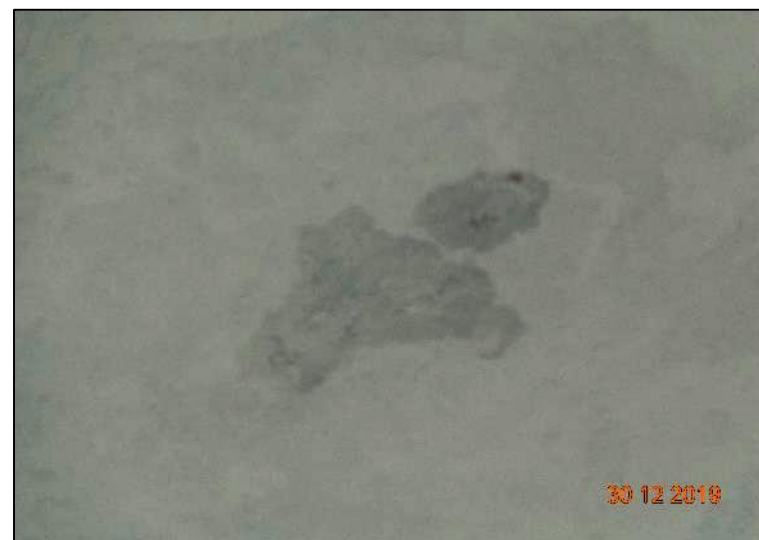
Dampness was found in bottom slab of overhead RC water tank (Northern side). Factory engineer is required to investigate the reason for the seepage of moisture and suggest remedial action.

| Item No. | Observation | Recommended Action Plan | Recommended Timeline |
|---|---|---|---|
| 3 | Dampness in bottom slab of water tank (Main Building) | Factory engineer is required to produce an investigation report including the reason for moisture seepage, impact and suggest the remedial action. | 6-weeks |
| 4 | Dampness in bottom slab of water tank (Main Building) | Implement the remediation if required. | 6-months |

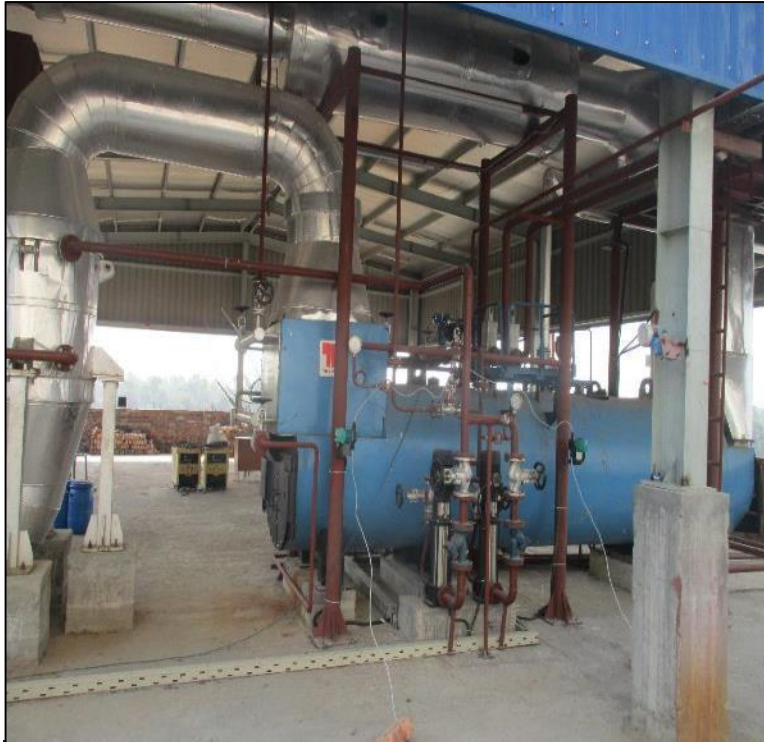
Heavy Boiler machine placed on roof slab

Factory engineer is required to carry out the flexural adequacy check of the roof slab. Suggest any implementation of remediation where required.

| Item No. | Observation | Recommended Action Plan | Recommended Timeline |
|---|---|---|---|
| 5 | Heavy loading on roof slab (Utility Building) | Factory engineer is required to check the the flexural adequacy of the roof slab. | 6-weeks |
| 6 | Heavy loading on roof slab (Utility Building) | Produce and actively manage load plan according to the floor capacity. | 6-weeks |
| 7 | Heavy loading on roof slab (Utility Building) | Implement any remediation work if required. | 6-months |

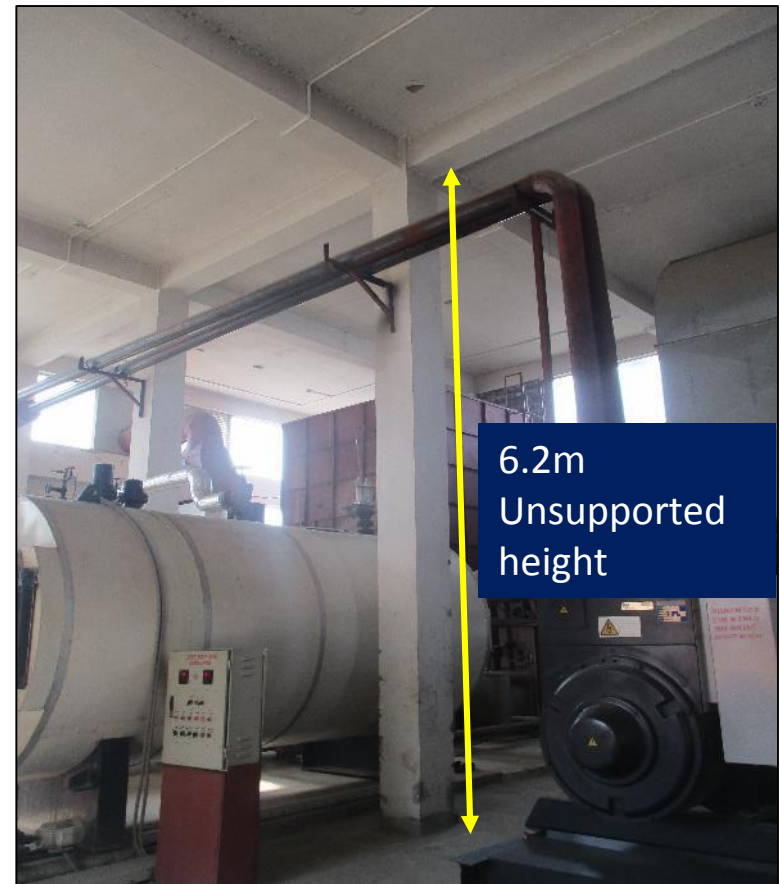
6.2m  
Unsupported  
height

Column appeared to be slender with long  
unsupported length

Factory engineer is required to carry out  
the adequacy check of the columns and  
implement remediation if required.

| Item No. | Observation | Recommended Action Plan | Recommended Timeline |
|---|---|---|---|
| 8 | Column appeared to be slender (Utility Building) | Factory engineer is required to carry out the adequacy of the slender columns. | 6-weeks |
| 9 | Column appeared to be slender (Utility Building) | Implement remediation work if required. | 6-months |

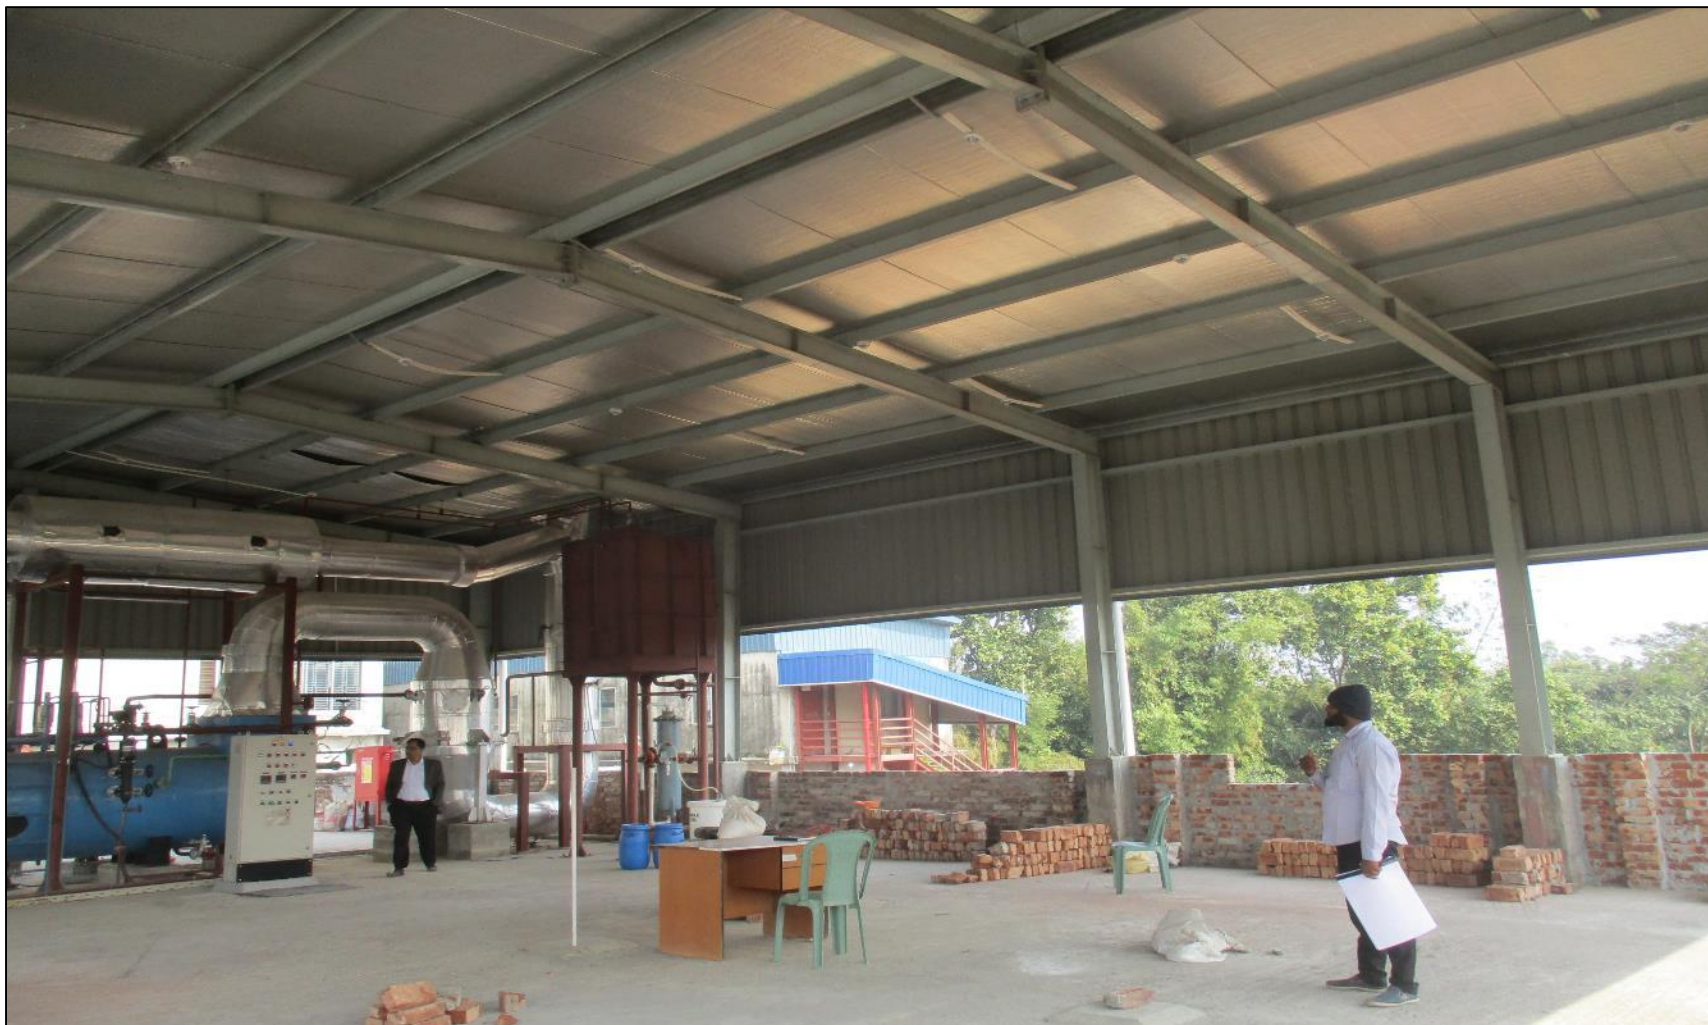
No horizontal/roof bracing/compression strut is provided in any direction. Lack of lateral stability system in both short and long direction. Factory engineer is required to check the lateral stability of this structure.

| Item No. | Observation | Recommended Action Plan | Recommended Timeline |
|---|---|---|---|
| 10 | Lack of lateral stability in roof shed (utility Building) | Factory engineer is required to carry out lateral stability check of the roof shed. | 6-weeks |
| 11 | Lack of lateral stability in roof shed (utility Building) | Implement remediation work if required. | 6-months |

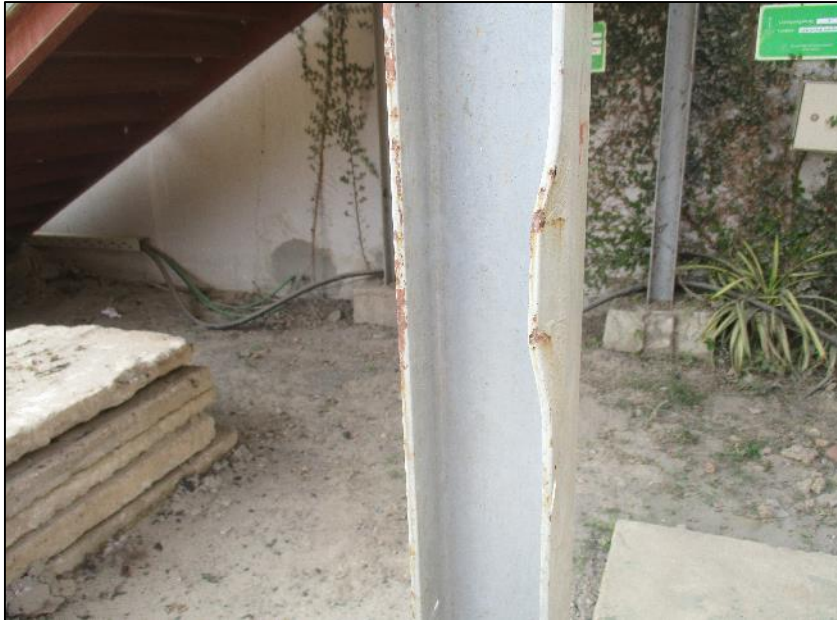
Distorted steel column at external steel stair

Factory engineer is required to carry out the member adequacy & stability and implement remediation where required.

| Item No. | Observation | Recommended Action Plan | Recommended Timeline |
|---|---|---|---|
| 12 | Distorted steel column and lack of lateral stability at external steel stair (utility Building) | Factory is required to repair the distorted column. | 6-weeks |
| 13 | Distorted steel column and lack of lateral stability at external steel stair (utility Building) | Factory engineer is required to carry out member adequacy & lateral stability check of the steel stair. | 6-weeks |
| 14 | Distorted steel column and lack of lateral stability at external steel stair (utility Building) | Implement remediation work if required. | 6-months |

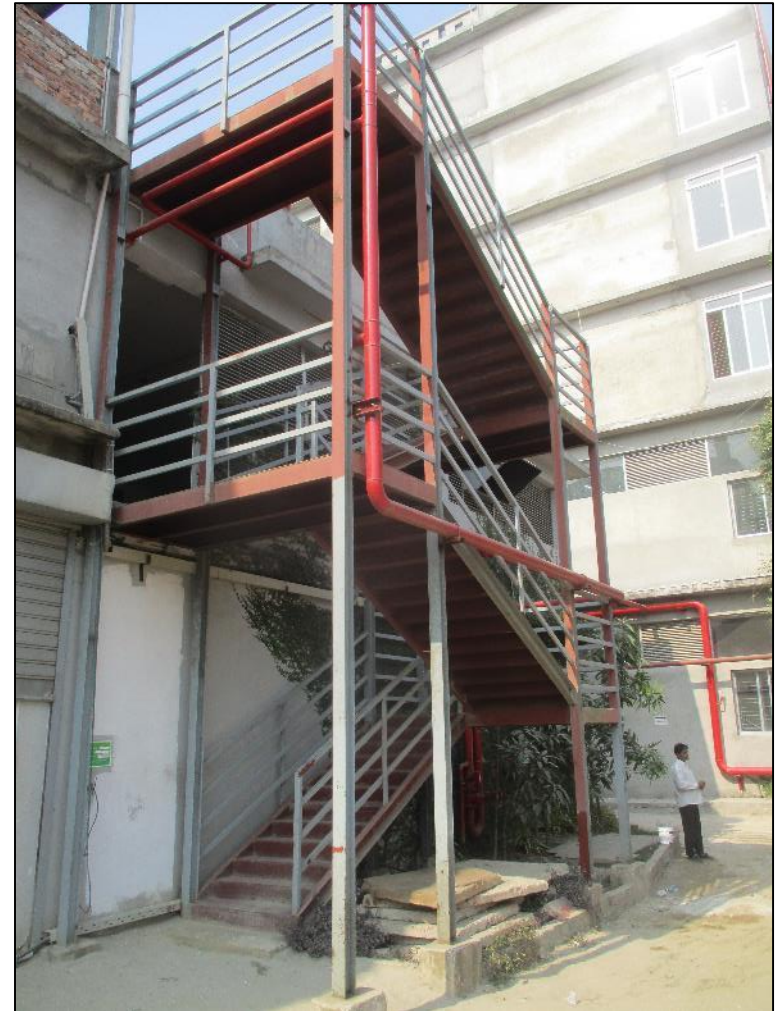
Apparently inadequate steel member size and no stability system provided.

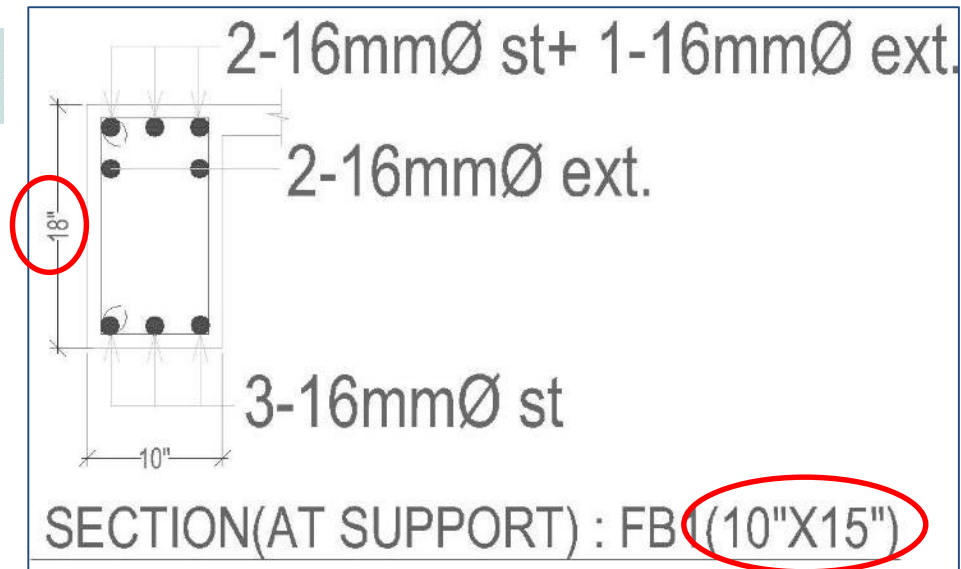
In sectional drawing, the dimension of RCC beam is written 18 inch but in site the dimension was found 15 inch

| Item No. | Observation | Recommended Action Plan | Recommended Timeline |
|---|---|---|---|
| 15 | Discrepancy in as-built drawing & lack of as-built drawing in RMS Guard Room | Factory engineer is required to survey the structure and update the as-built drawing. | 6-weeks |

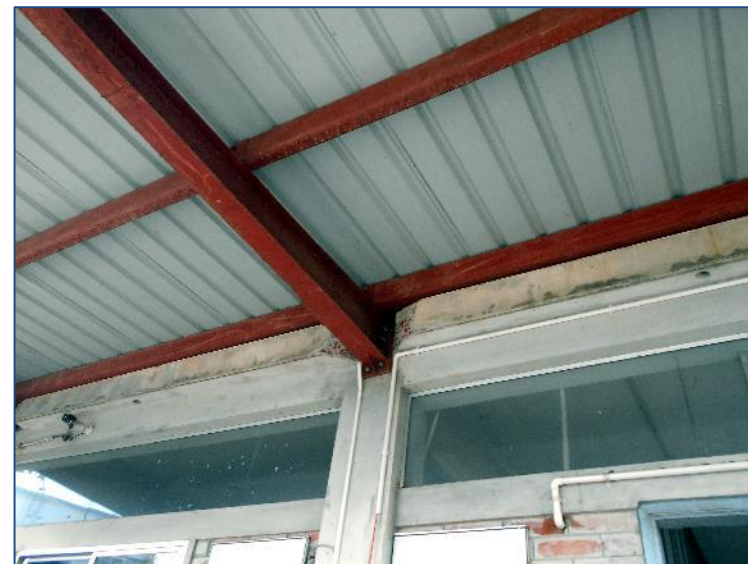
No drawing for canopy was available

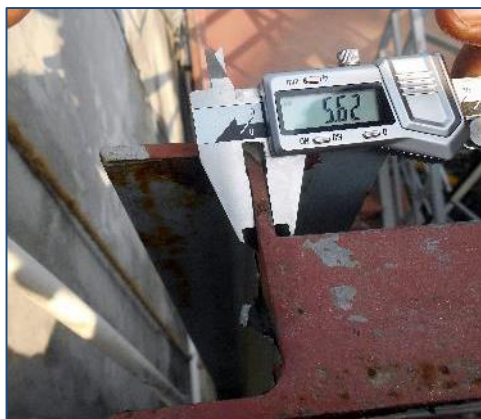
Thickness of web section  
5 mm

Discrepancy was found between as-built drawing. The dimension of web of I column was found to be 100 mm instead of 130 mm. the thickness was also found lesser than mentioned.

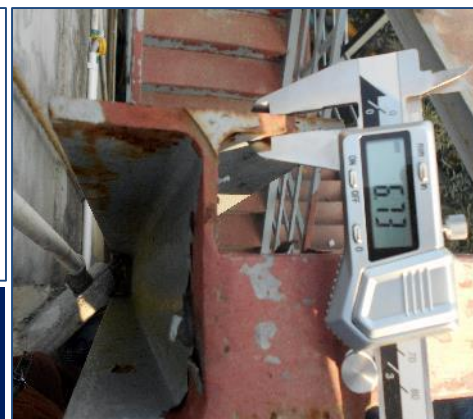
Thickness of flange  
section 6mm

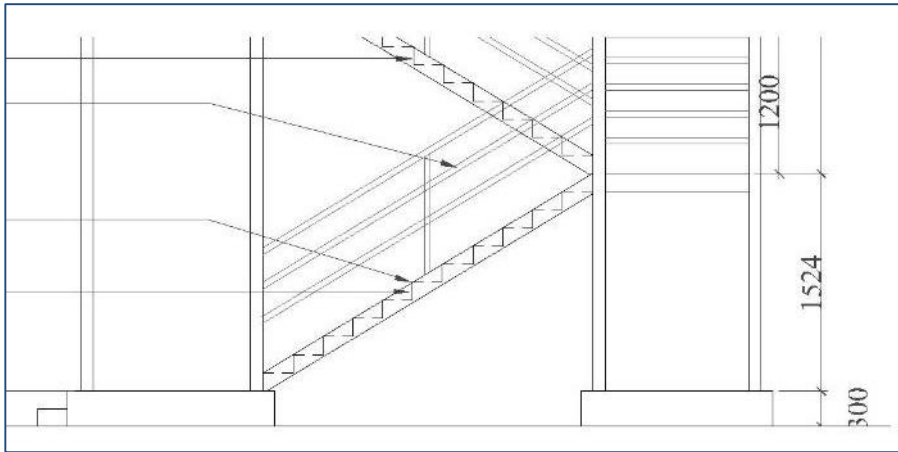
Stair column on self support

| Item No. | Observation | Recommended Action Plan | Recommended Timeline |
|---|---|---|---|
| 17 | Lack of fixity in support of steel stair (RMS Guard Room) | Factory is required to provide / establish fixity to the support of the steel column. | 6-weeks |

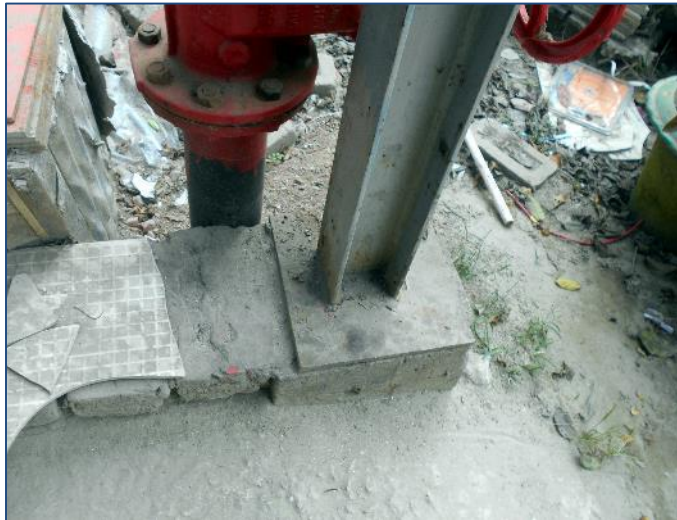
No fixity (pin or fix) between baseplate and short column was observed.

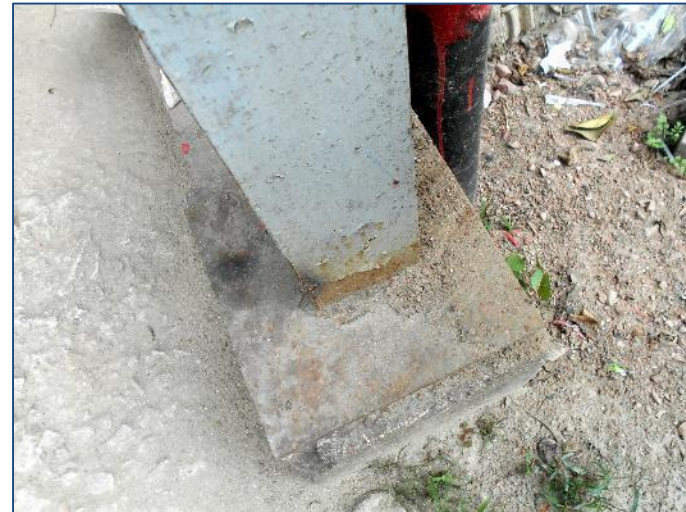
No fixity (pin or fix) between baseplate and short column was observed.

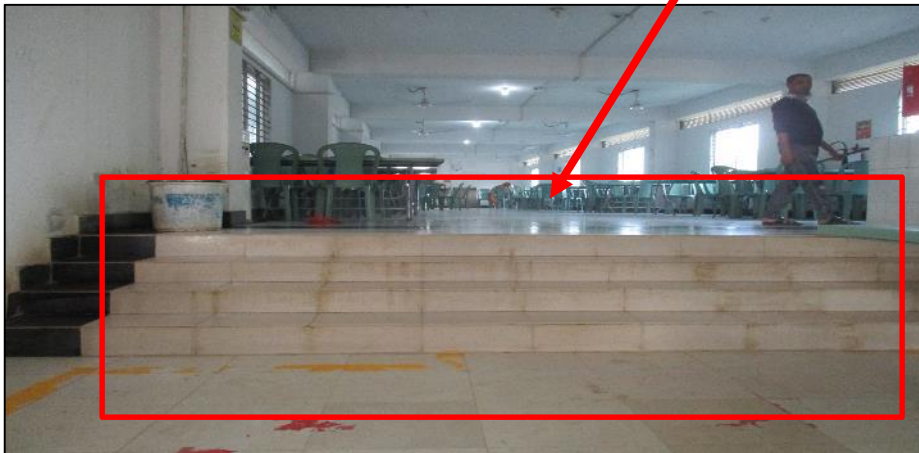
Expansion joint filled with rigid material

Factory is required to fill the expansion joint with any flexible material so that two structure can expansion/move against thermal expansion or lateral movement

| Item No. | Observation | Recommended Action Plan | Recommended Timeline |
|---|---|---|---|
| 19 | Expansion joint filled with rigid material in WTP-1 & WP-2 | Factory is required to fill the expansion joint with any flexible material. | 6-weeks |

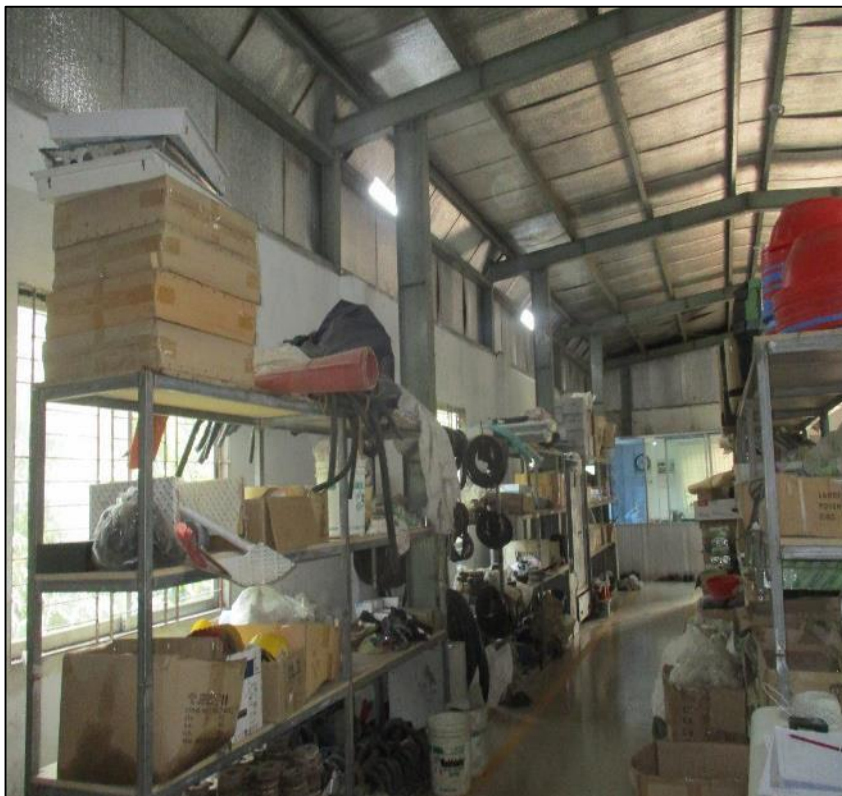
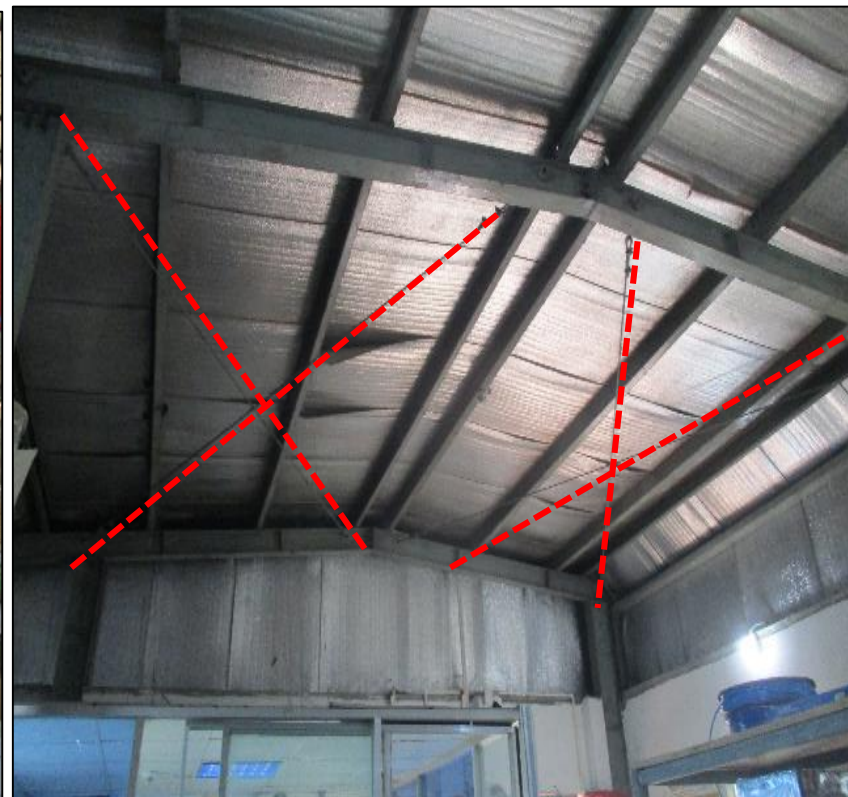
Roof bracing provided along short direction

No vertical bracings/tie beam/compression struts were provided in the long direction. Only roof bracings are provided along the short direction, lateral stability along the long direction is appeared to be incomplete. The building engineer is required to check the lateral stability system of the shed.

| Item No. | Observation | Recommended Action Plan | Recommended Timeline |
|---|---|---|---|
| 20 | Lack of lateral stability in Roof sheds (WTP-1 & WP-2) | Factory engineer is required to carry out lateral stability check of the roof sheds. | 6-weeks |

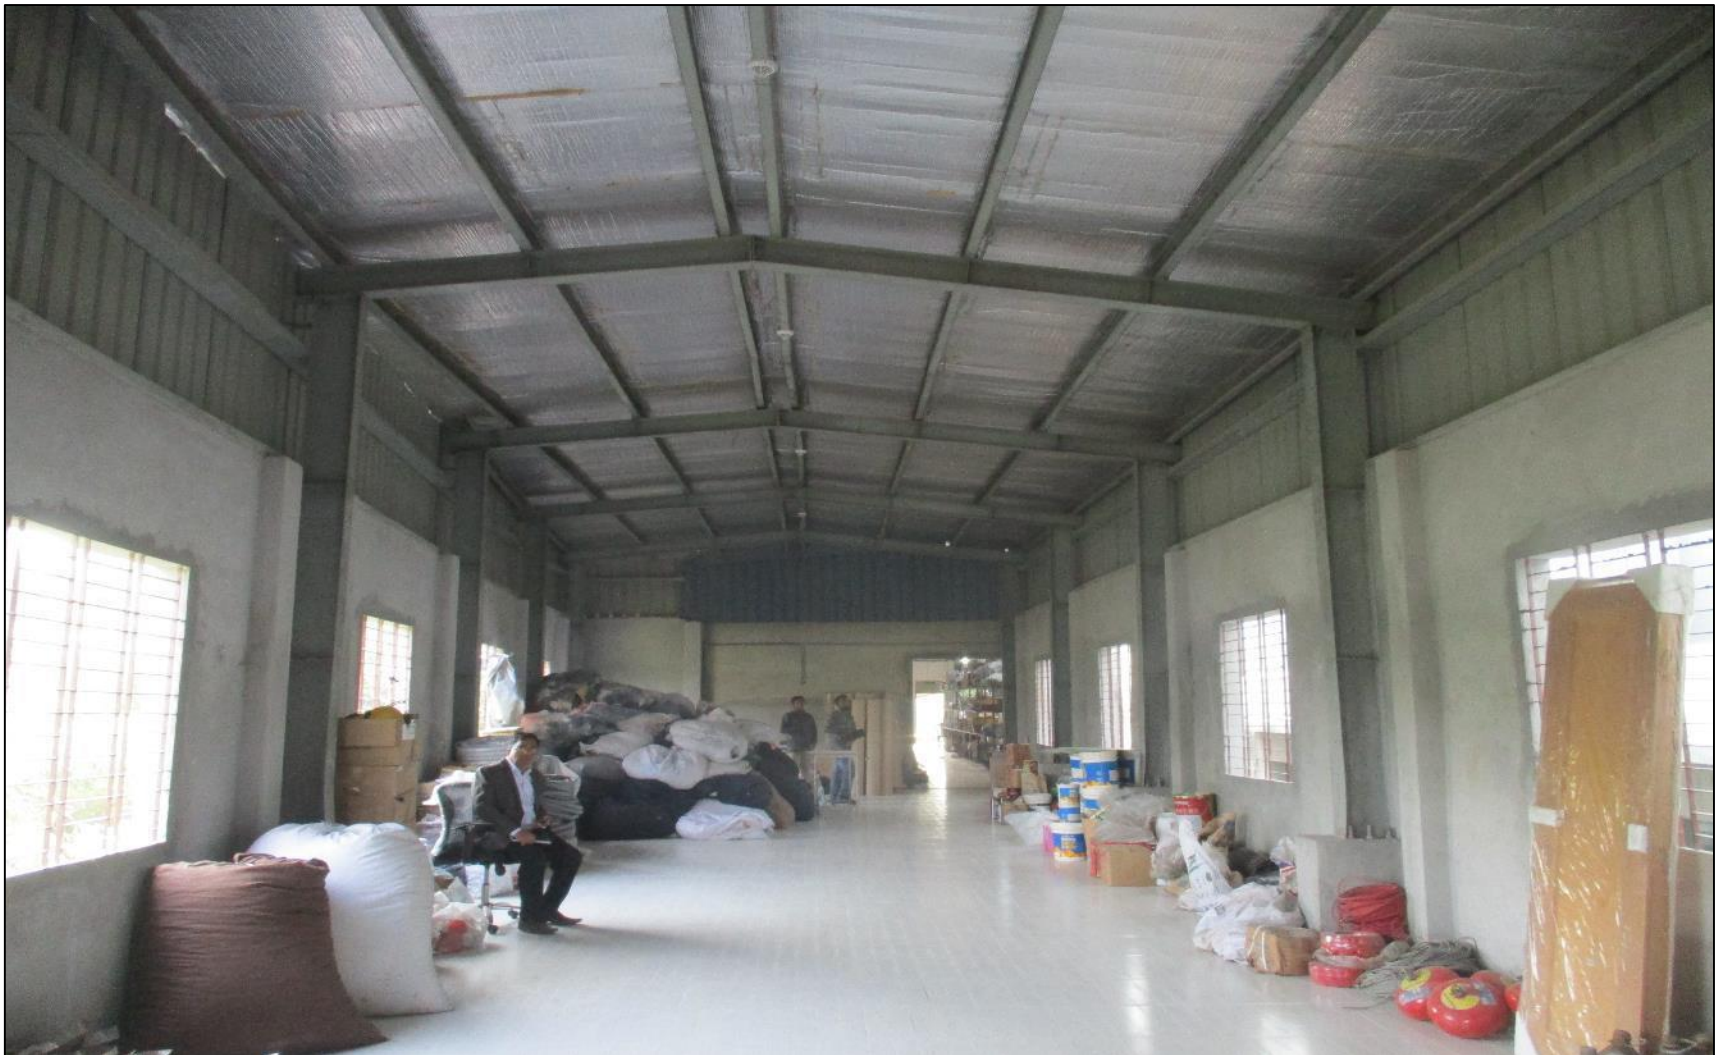
No horizontal/roof bracing/compression strut is provided in any direction. Lack of lateral stability system in both short and long direction. Factory engineer is required to check the lateral stability of this structure.

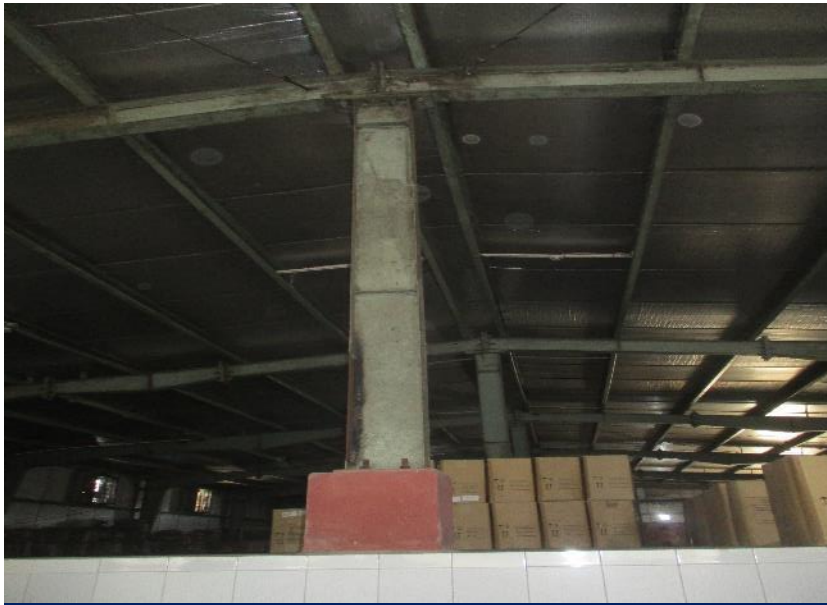
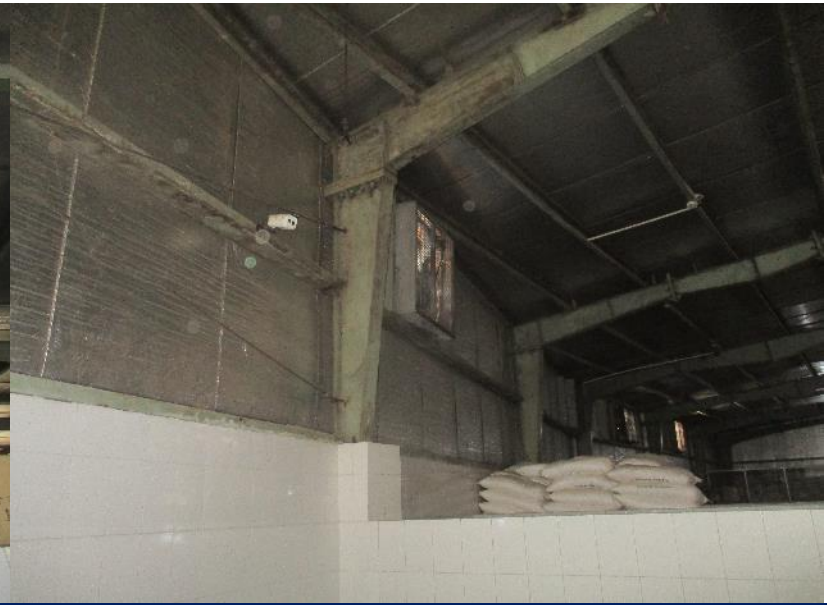
No eave beam/compression strut along long direction

Only tension bracing provided for long and short direction for lateral stability. No compression member provided in long direction. Building engineer is required to check the lateral stability system of the shed.

| Item No. | Observation | Recommended Action Plan | Recommended Timeline |
|---|---|---|---|
| 22 | Lack of lateral stability<br>(Store : Chemical Warehouse) | Factory engineer is required to carry out lateral stability check of the shed. | 6-weeks |

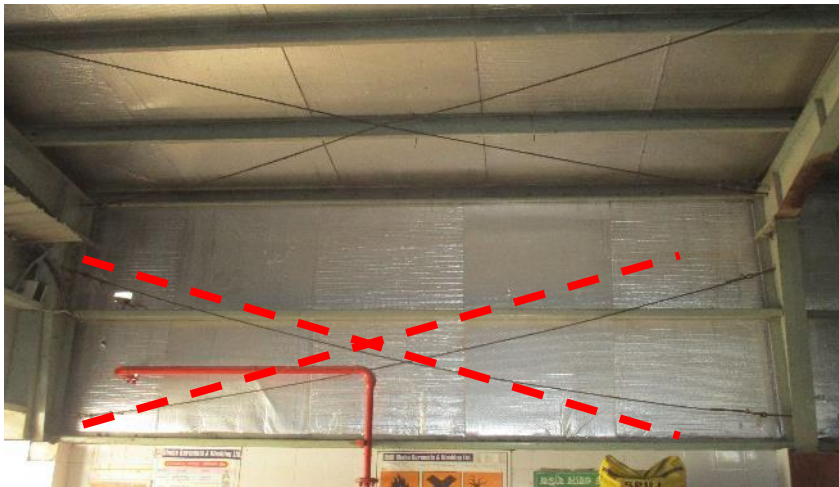
Vertical bracing provided at half height only

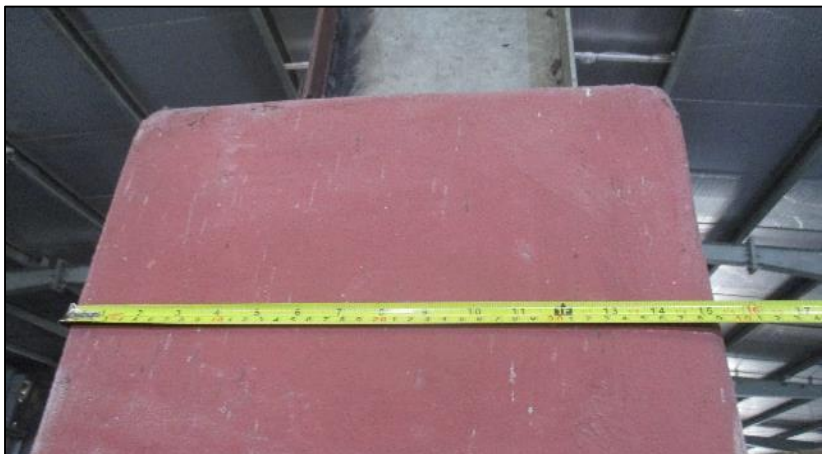
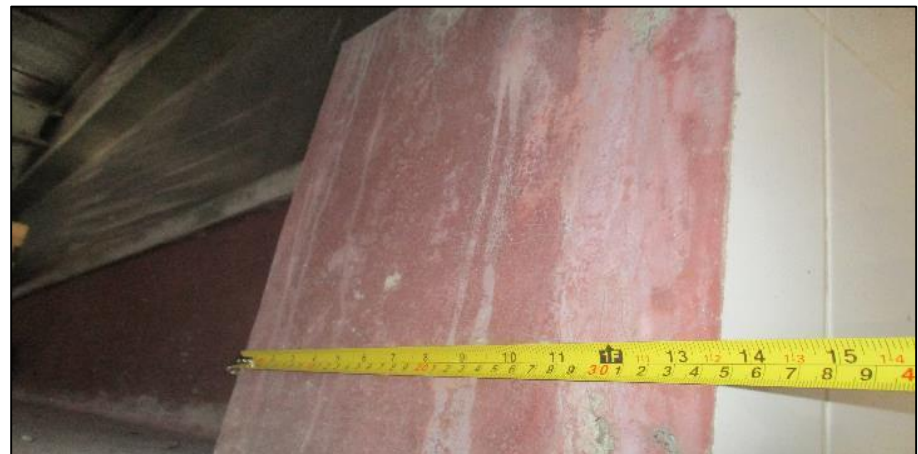
Dimension of pedestal column was measured as 350mmX 300mm without render instead of 400mmX350mm. Also orientation of all internal columns were found 90 degree rotated from original position

Factory engineer is required to carry out the adequacy considering the changes and update as-built drawing

| Item No. | Observation | Recommended Action Plan | Recommended Timeline |
|---|---|---|---|
| 24 | Discrepancy between as-built drawing & as-built condition (Store: Chemical Warehouse) | Factory engineer is required to carry out the adequacy check of the shed considering the changes in as-built drawing. | 6-weeks |

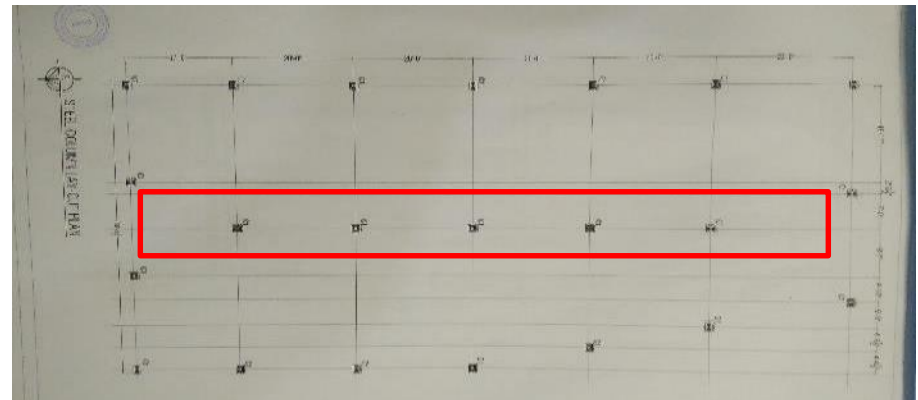
All internal pedestal column found 90 degree rotated

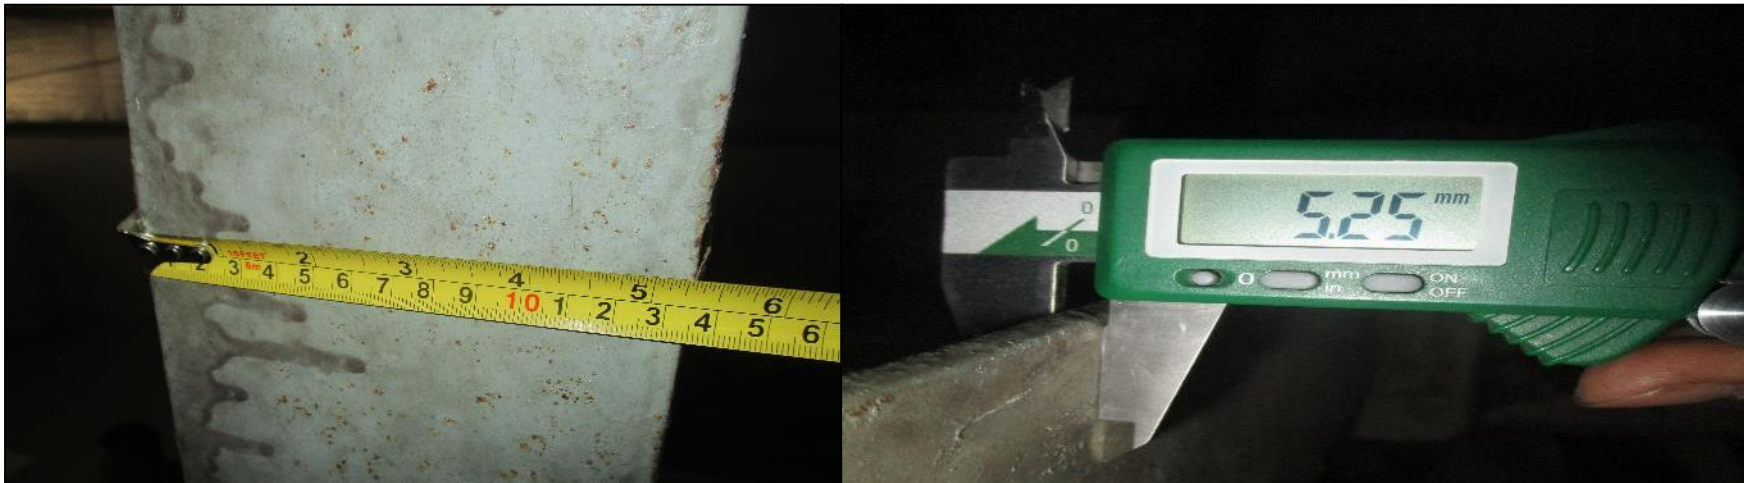
Flange dimension and thickness of all internal steel columns were measured as 135mmX5mm instead of 150mmX6mm

Factory engineer is required to update as-built drawing and carry out the adequacy of the shed considering the changes.

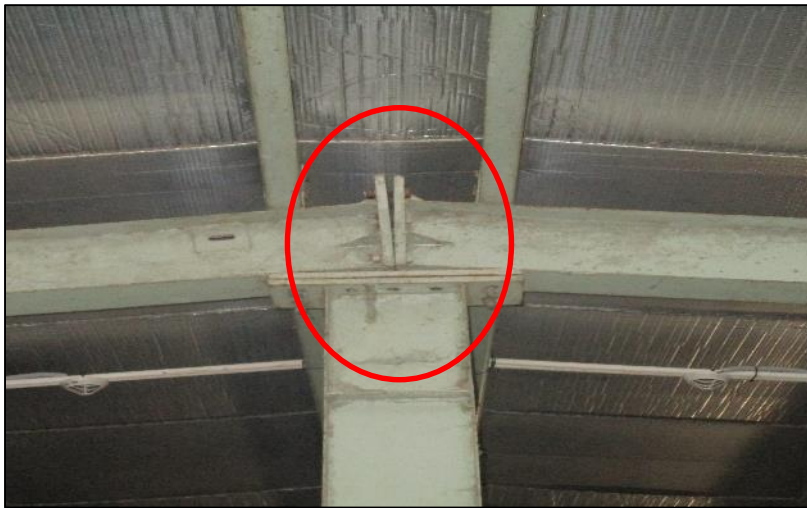
Gap in rafter to rafter connection

Loose bracing and connection gap were found at several locations. Factory is required to tighten the loose bracing & repair the gaps with a suitable method suggested by the factory engineer.

| Item No. | Observation | Recommended Action Plan | Recommended Timeline |
|---|---|---|---|
| 27 | Loose bracing & connection gap (Store : Chemical Warehouse) | Repair the connection gaps with a suitable method. | 6-weeks |
