# Dhaka Garments & Washing Ltd

Dakkhin Vangnahati, Sreepur, Gazipur-1740  
(24.192597, 90.457385)

30<sup>th</sup> December 2019 & 3<sup>rd</sup> February 2020

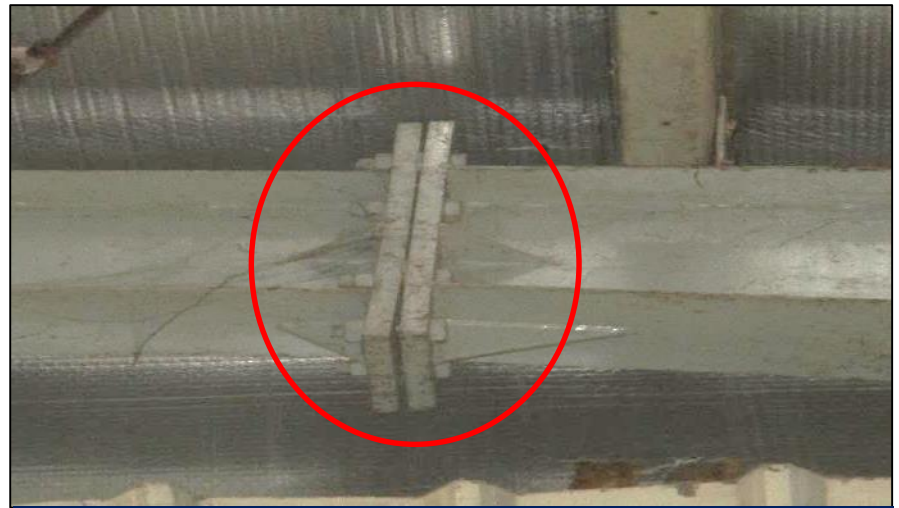
Gap in rafter to rafter connection

Loose bracing and connection gap were found at several locations. Factory is required to tighten the loose bracing & repair the gaps with a suitable method suggested by the factory engineer.

| Item No. | Observation | Recommended Action Plan | Recommended Timeline |
|---|---|---|---|
| 27 | Loose bracing & connection gap (Store : Chemical Warehouse) | Repair the connection gaps with a suitable method. | 6-weeks |

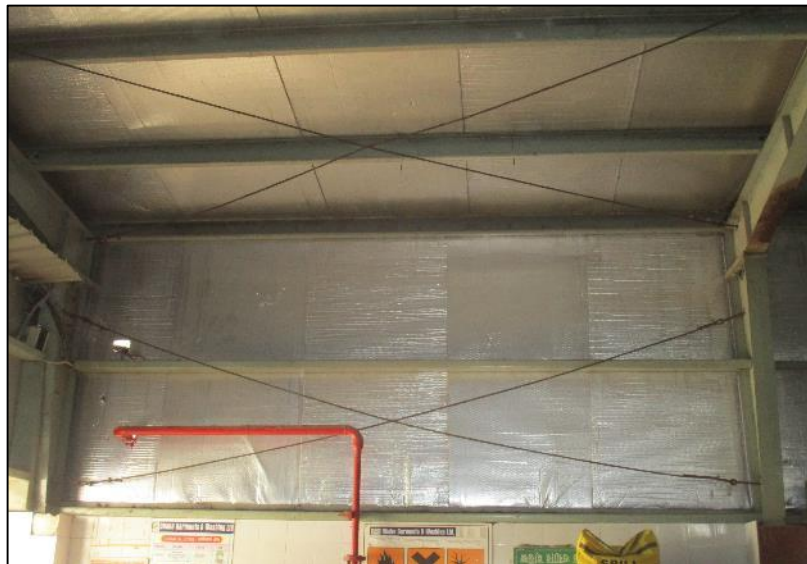
Loose vertical & roof bracing

| Item No. | Observation | Recommended Action Plan | Recommended Timeline |
|---|---|---|---|
| 28 | Loose bracing & connection gap (Store : Chemical Warehouse) | Tighten all loose bracings. | 6-weeks |

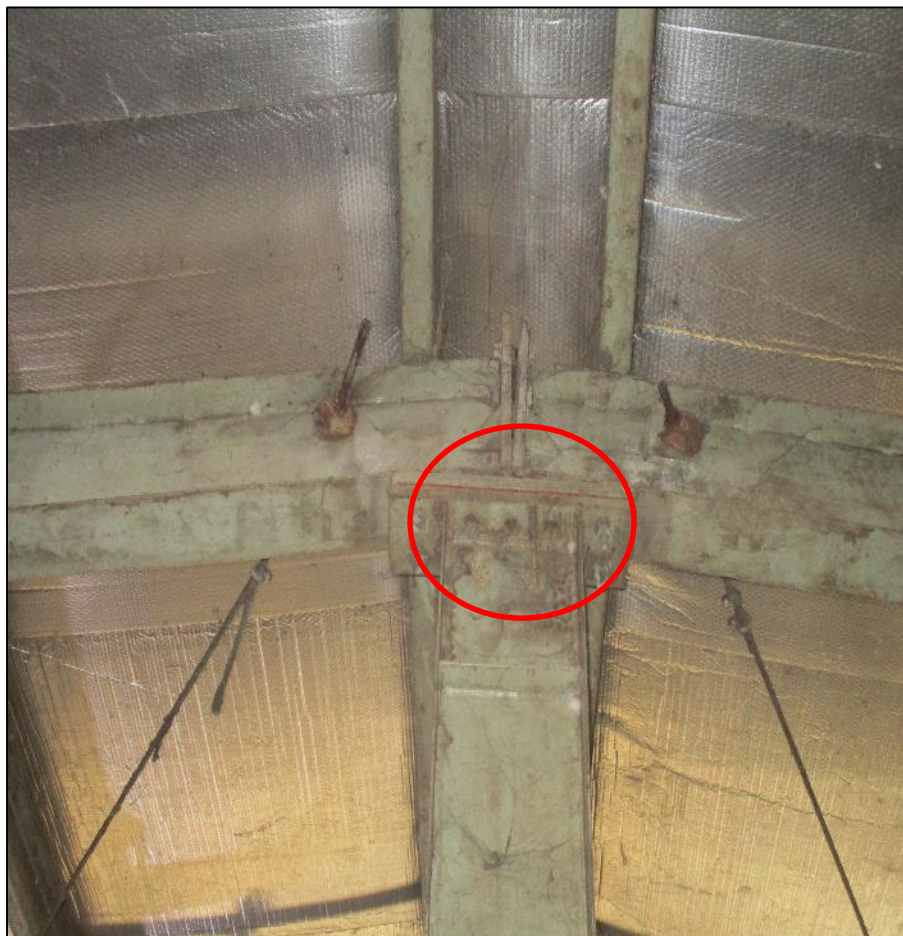
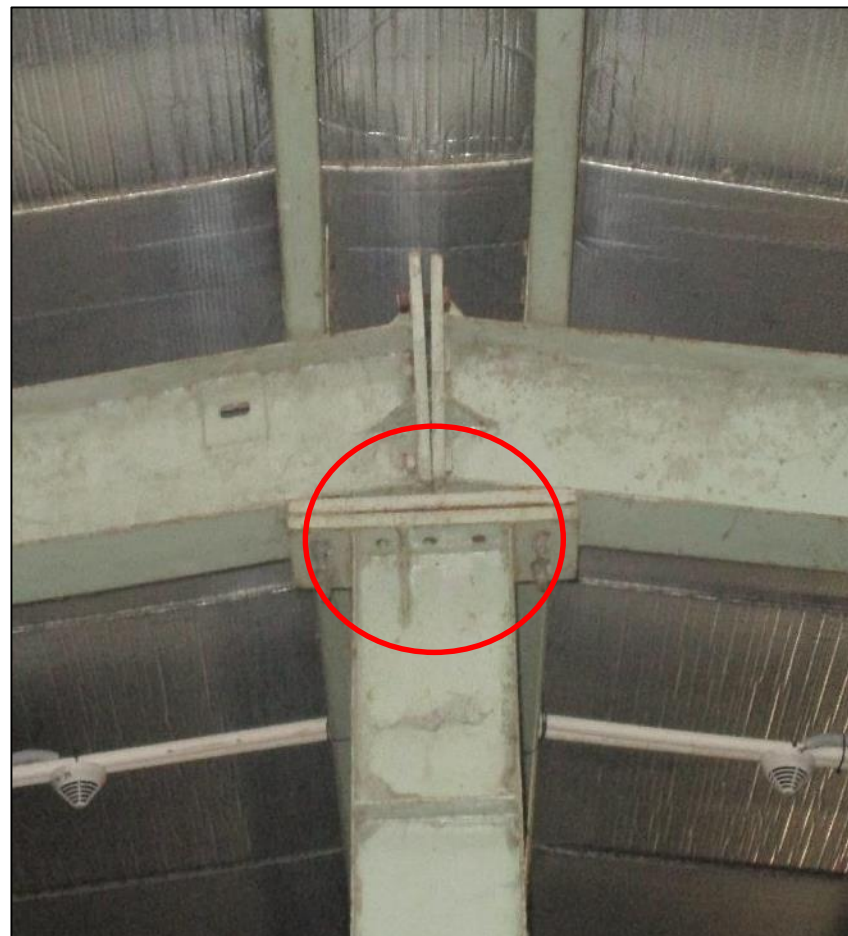
Bolts were missing at several locations

| Item No. | Observation | Recommended Action Plan | Recommended Timeline |
|---|---|---|---|
| 29 | Missing bolts (Store : Chemical Warehouse) | Install all missing bolts. | 6-weeks |

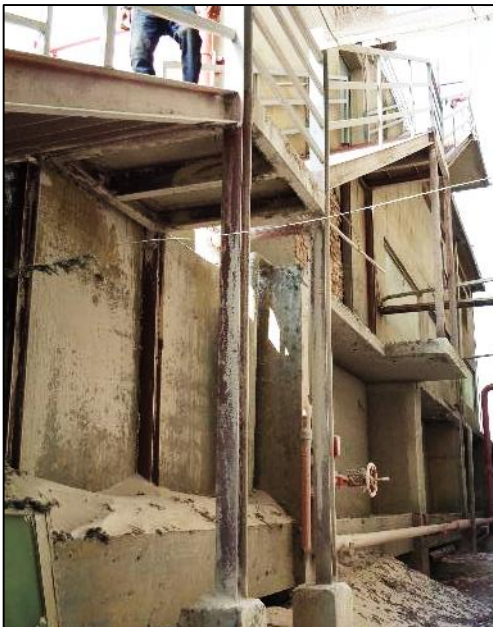
Steel stair found at south side of the ETP building from ground floor to roof level. No as built-structural drawing was available at site. The stability of the stair is ambiguous. Factory engineer is required to prepare “as constructed” drawings with complete structural information. The factory engineer is also required to carry out Engineering Assessment for the steel stair including connection adequacy check.

| Item No. | Observation | Recommended Action Plan | Recommended Timeline |
|---|---|---|---|
| 30 | Lack of as-built drawing (ETP Building) | Prepare “as constructed” drawings with complete structural information. | 6-weeks |
| 31 | Lack of as-built drawing (ETP Building) | The factory engineer is required to carry out an Engineering Assessment for the steel stair. | 6-weeks |

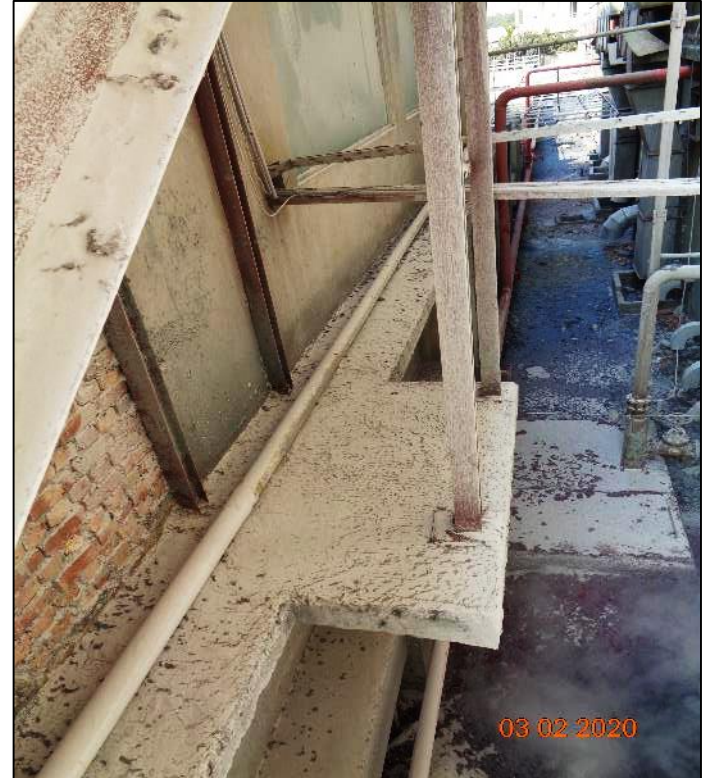
Pier resting on cantilever slab

Pier of steel stair resting on RCC cantilever slab of the ETP building. No design documents found to confirm the capacity of the cantilever slab to bear the load from the steel pier. Factory engineer is required to check the capacity of the RCC cantilever slab.

| Item No. | Observation | Recommended Action Plan | Recommended Timeline |
|---|---|---|---|
| 33 | Pier of steel stair resting on RCC cantilever slab (ETP Building) | Factory engineer is required to check the capacity of the RCC cantilever slab. | 6-weeks |
