# Network Apparels Ltd. (Extended Building)

228/3, Shahid Rawshan Sharak, Chandana, Gazipur-1702

4<sup>th</sup> August 2019

# Observations

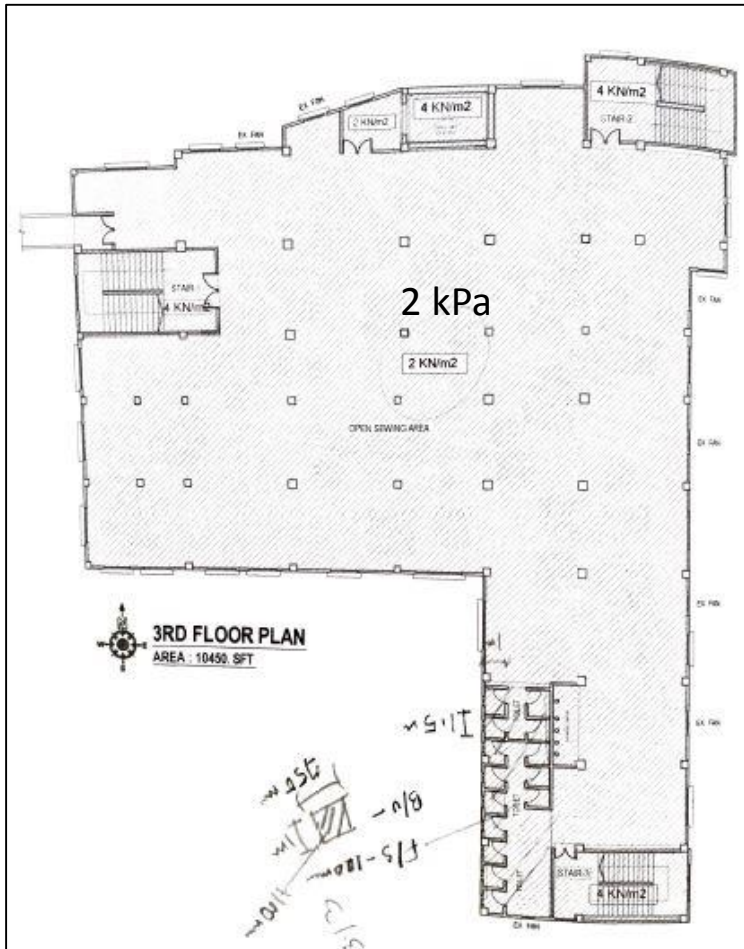
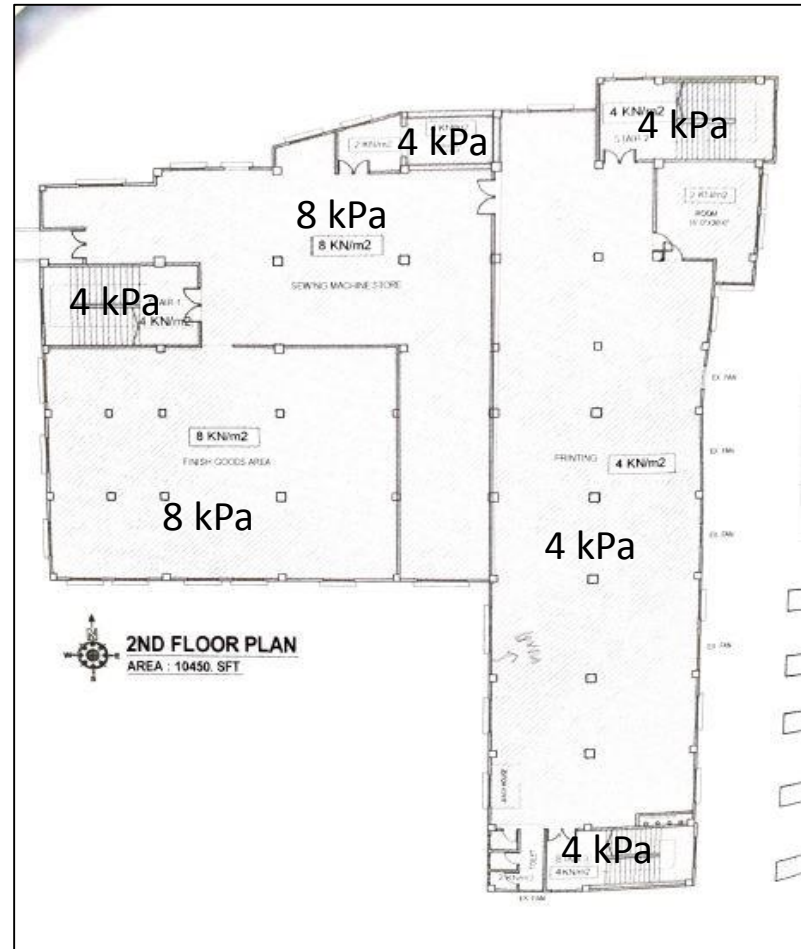
Prepared live load plan

**Internal columns are stressed above normal design limit considering prepared load plan**

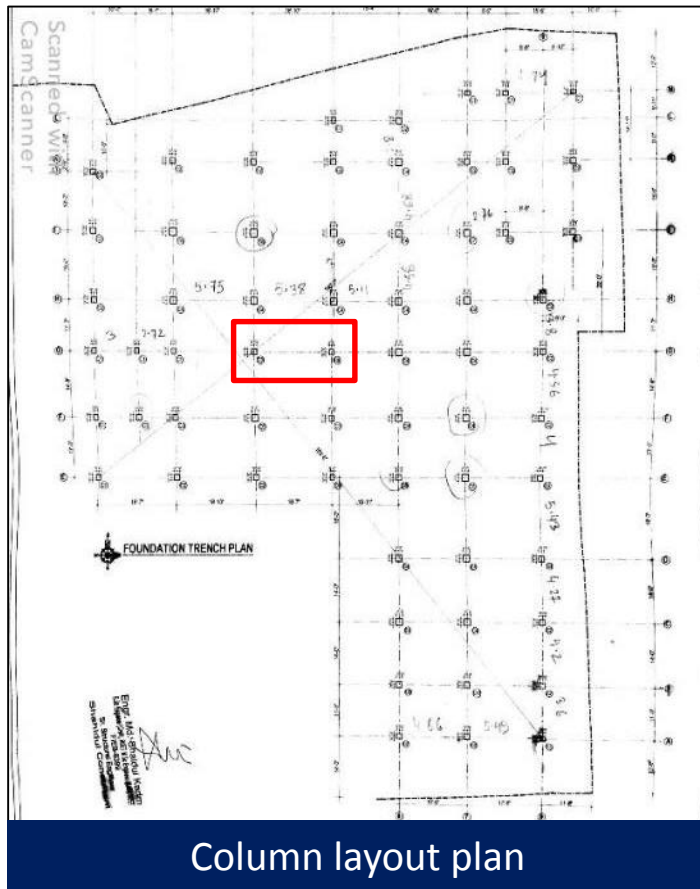
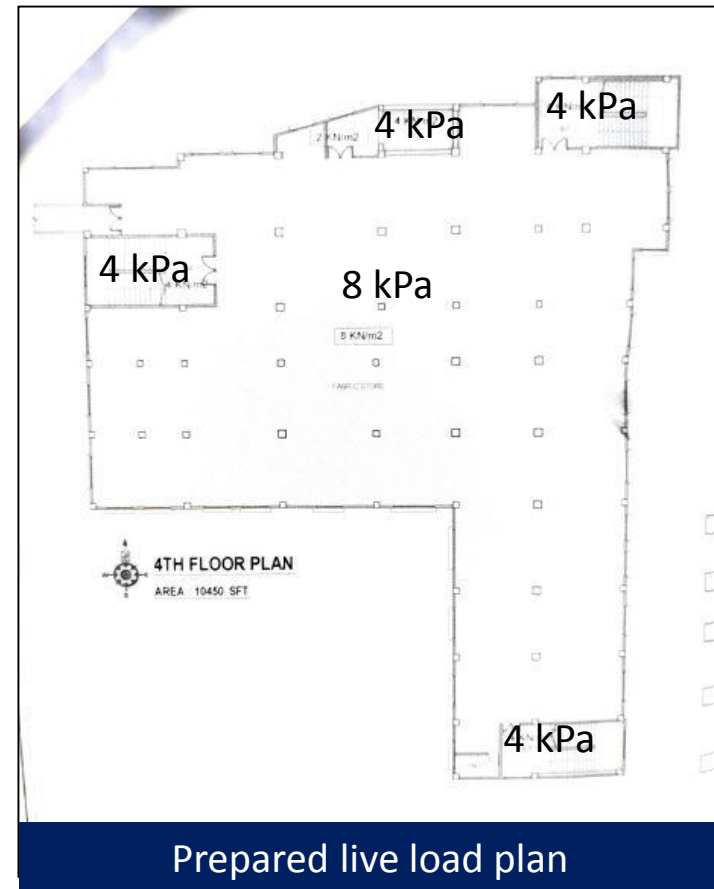
The prepared load plan indicates 2~4 kPa live load on general floor and 8 kPa on storage (2nd , 4th & 5th floor). Cursory calculation indicates the marked internal columns are stressed above normal design limit considering prepared live load plan. Building engineer is required to produce allowable load plan according to BNBC.

| Item No. | Observation | Recommended Action Plan | Recommended Timeline |
|---|---|---|---|
| 1 | Internal columns are stressed above normal design limit considering prepared load plan | Maintain loading below 3 kPa until further review. | 6-weeks |
| 2 | Internal columns are stressed above normal design limit considering prepared load plan | Factory Engineer to review design, loads and columns stresses in area identified above. | 6-weeks |
| 3 | Internal columns are stressed above normal design limit considering prepared load plan | Verify in situ concrete stresses either by 100mm dia. Cores(Min. 4 nos) or existing cylinder strength data. | 6-weeks |
| 4 | Internal columns are stressed above normal design limit considering prepared load plan | Produce and actively manage a loading plan for all floor plates within the factory giving consideration to floor capacity and column capacity. Also comply the loading according to BNBC. | 6-weeks |
| 5 | Internal columns are stressed above normal design limit considering prepared load plan | Carry out remedial works arise from Engineering Assessment where necessary. | 6-months |

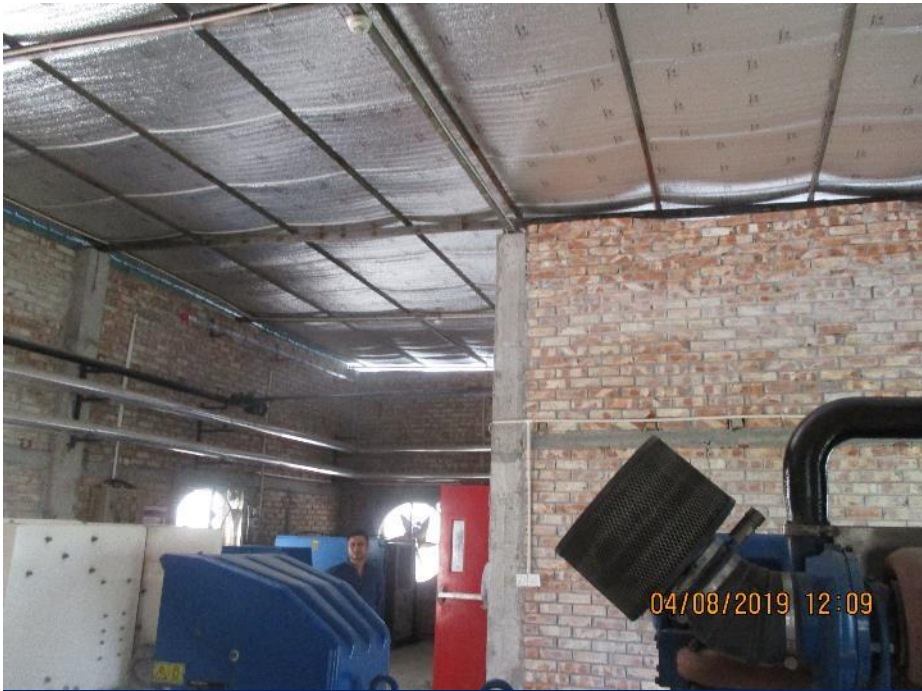
## Apparently non engineered roof

- Apparently inadequate roof framing.
  - Poor connection details.
- Building engineer is required to check the connection and member adequacy against the uplift forces.

| Item No. | Observation | Recommended Action Plan | Recommended Timeline |
|---|---|---|---|
| 6 | Apparently non engineered roof | Building engineer is required to check the connection and member adequacy against the uplift forces. | 6-weeks |
| 7 | Apparently non engineered roof | Carry out any repair work according to suggestion of building engineer or make any alteration works suggest by building engineer. | 6-months |

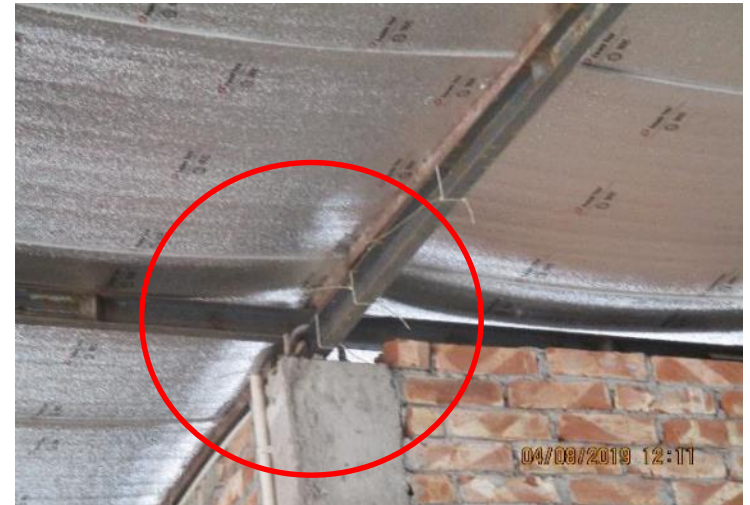
Poor connection details

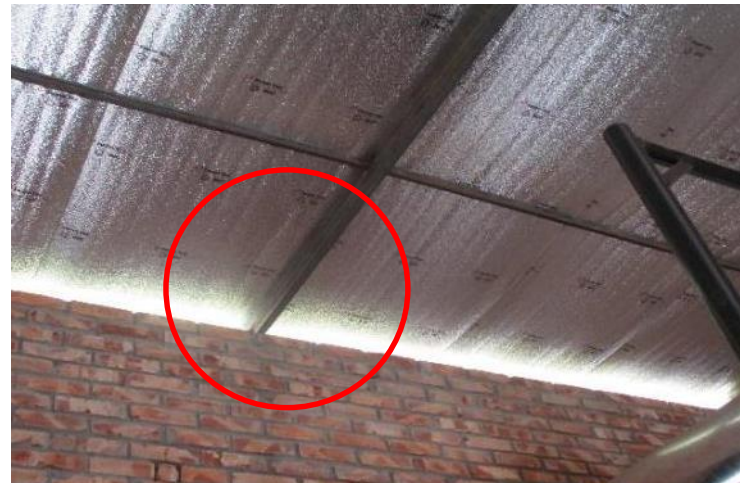
Steel frame rest on masonry wall without adequately anchored.
