# Maxcom International (BD) Ltd. (New Building)

37 Hemayatpur, Savar, Dhaka-1340  
(23.793695, 90.266931)

25<sup>th</sup> August 2019

**Observations : New Building**

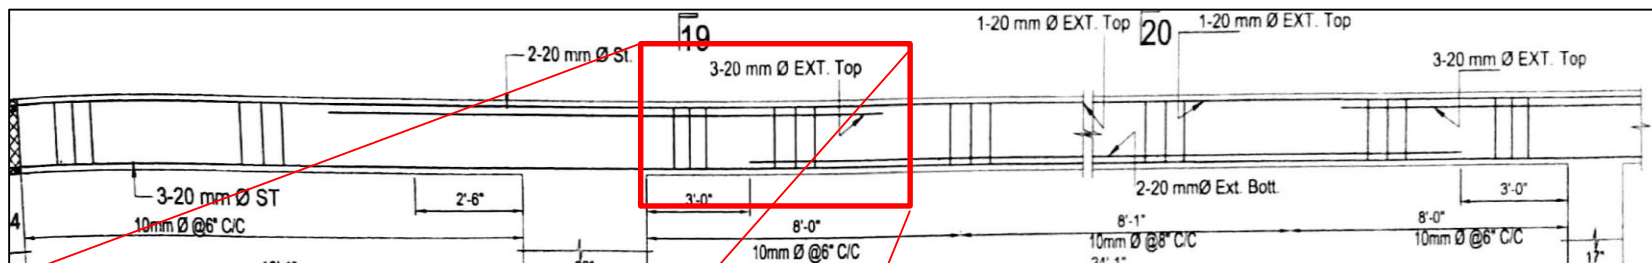
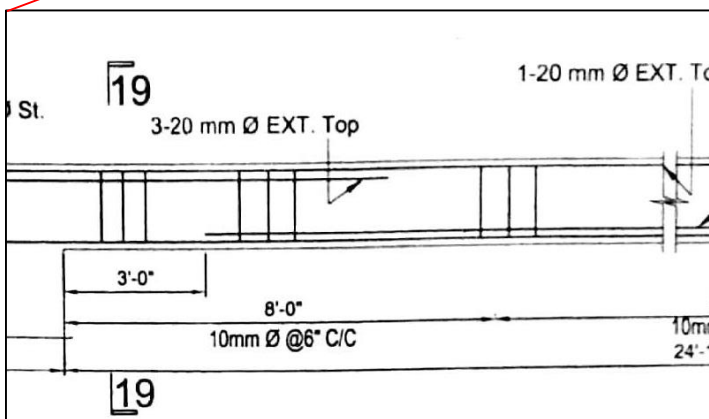
Reinforcement details

The reinforcement details in provided structural drawing indicate that the building frame system is OMRF for which the response modification factor, R would be 5.0. But R= 8.0 is used in the DEA report without any clarifications.

| Item No. | Observation | Recommended Action Plan | Recommended Timeline |
|---|---|---|---|
| 1 | Prepared DEA report required to be reviewed | Revise the DEA report and complete the review with ACCORD. | 6-weeks |

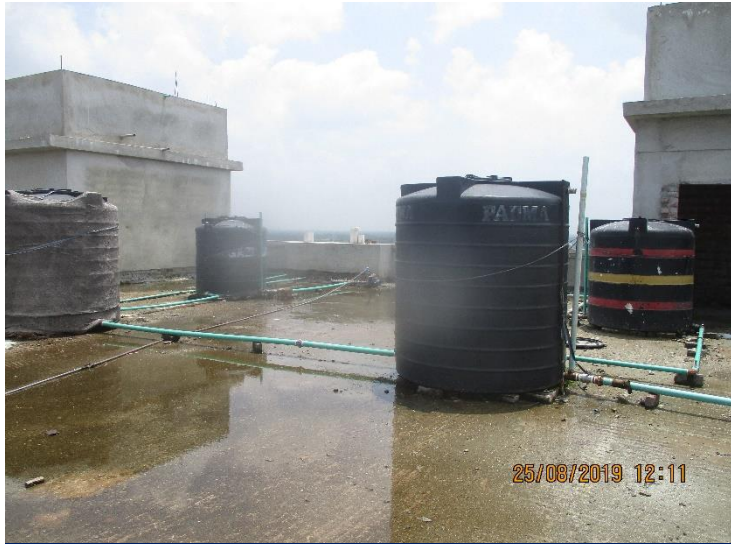
Sign of water Clogging was observed on roof. Also, proper drainage system was not installed.

Sign of water clogging

| Item No. | Observation | Recommended Action Plan | Recommended Timeline |
|---|---|---|---|
| 4 | Insufficient drainage system on roof | Factory is required to improve the water drainage system by providing necessary slope to avoid water clogging. | 6-weeks |

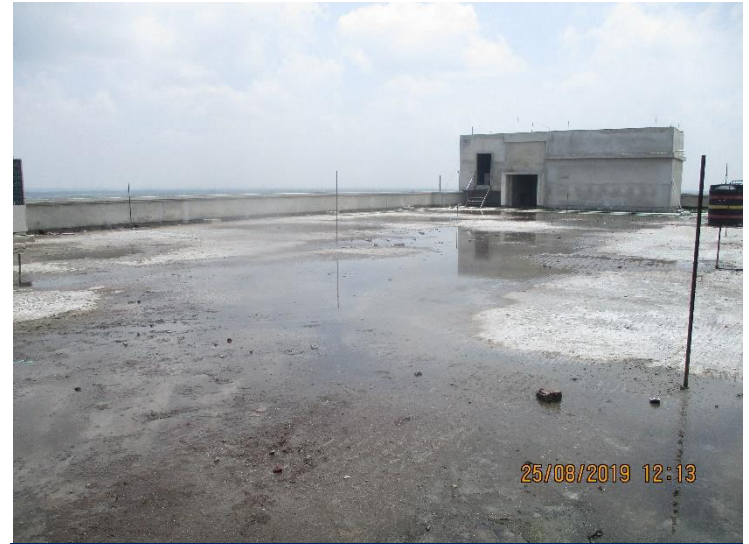
Improper roof drainage system
