# Roar Fashion Ltd.

Ward # 09, Kathali, Bhaluka, Mymensingh.

01 March 2020

# Observations

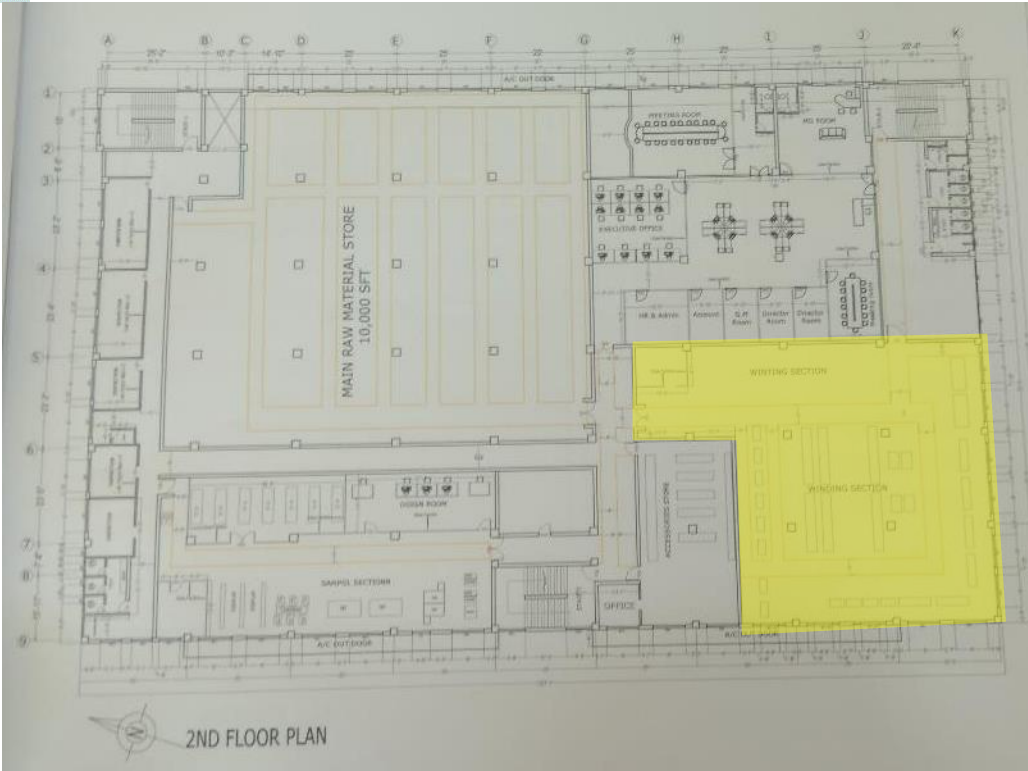
2<sup>nd</sup> floor layout plan

## Signification vibration observed at 2<sup>nd</sup> floor (Winding section)

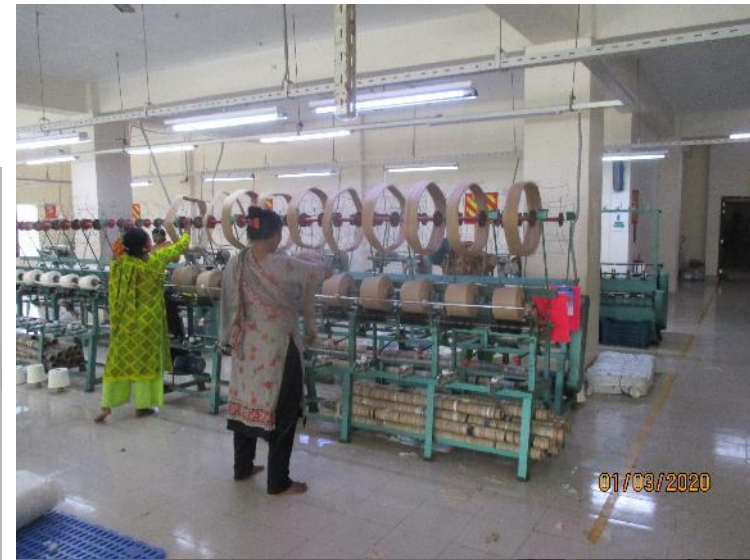
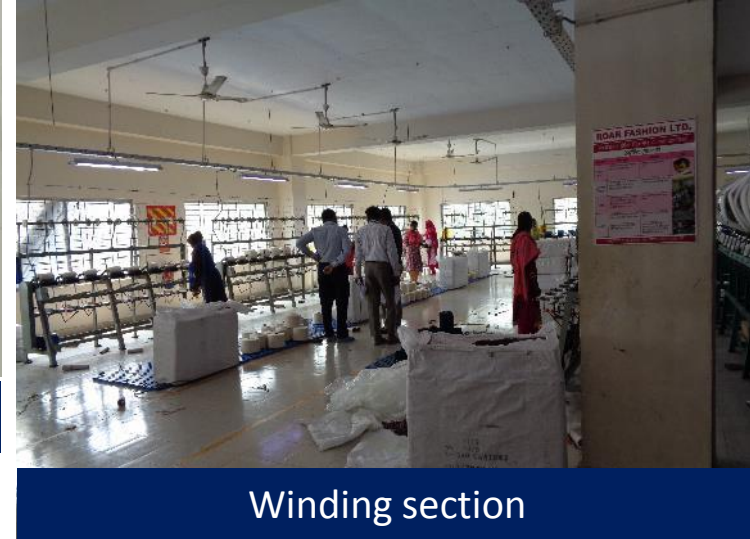
Winding section

Signification vibration was observed at winding section on 2<sup>nd</sup> floor which may cause the long-term fatigue effect. Building engineer is required to investigate the long-term effect of the vibration and suggest remediation.

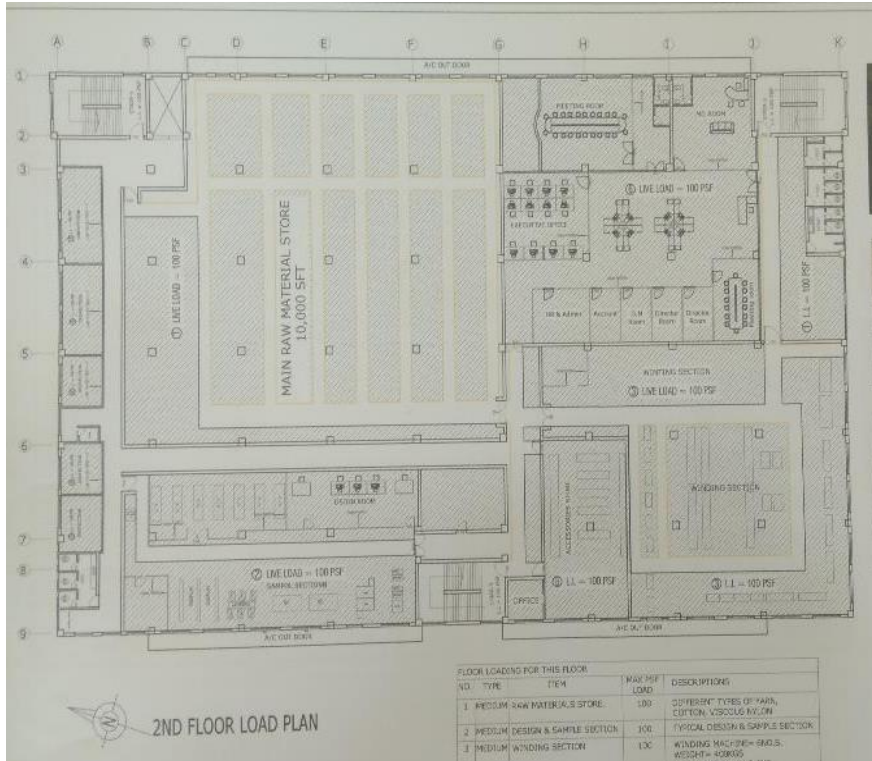
Prepared load plan was found considering 5 KPa

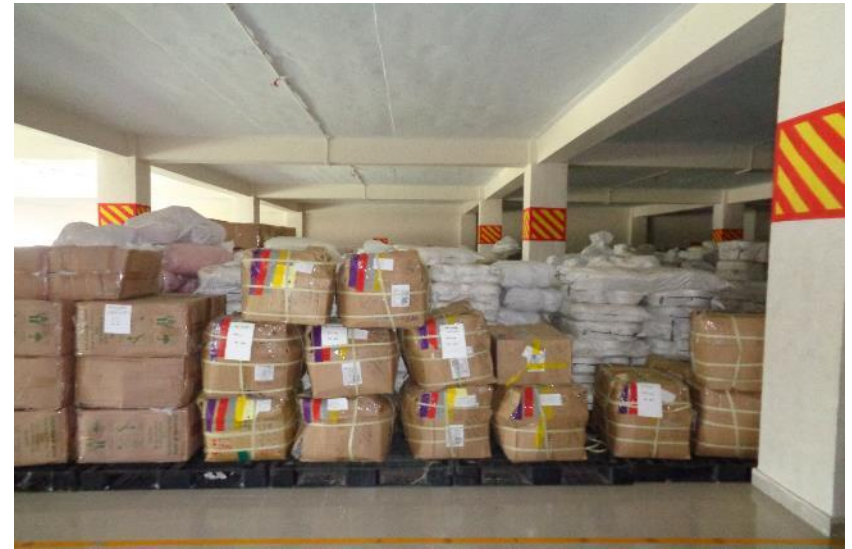
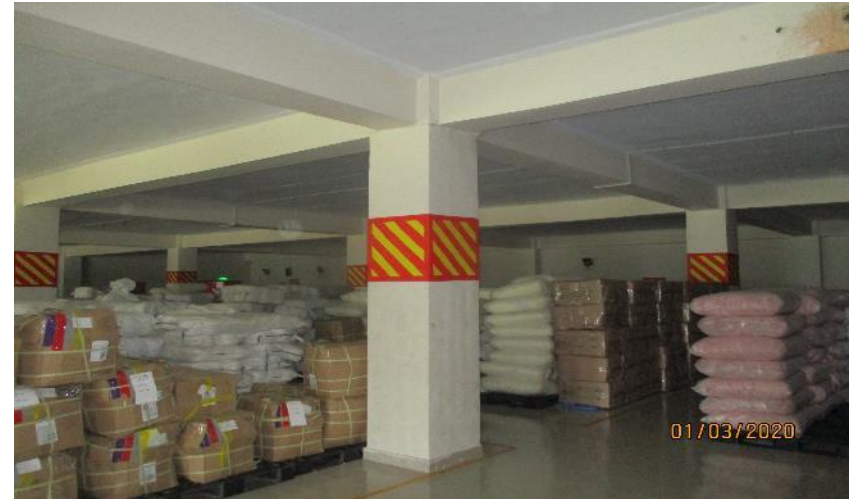
Load management program was not implemented. Building engineer is required to implement the floor load management program by posting load plan, providing signage, load restriction height marking on storage area, record keeping of the loading.

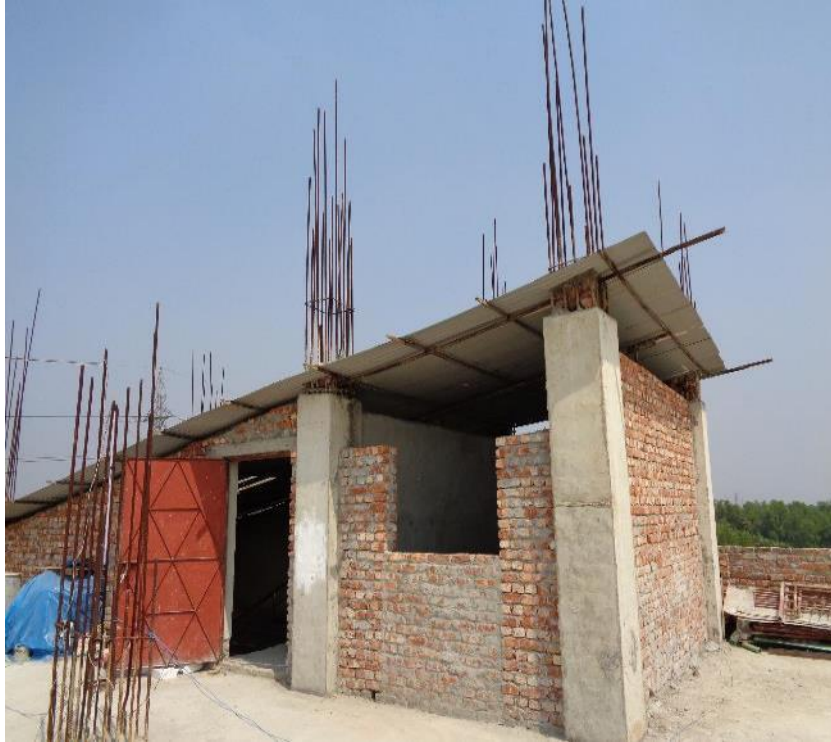
Non engineer steel roof at north stair

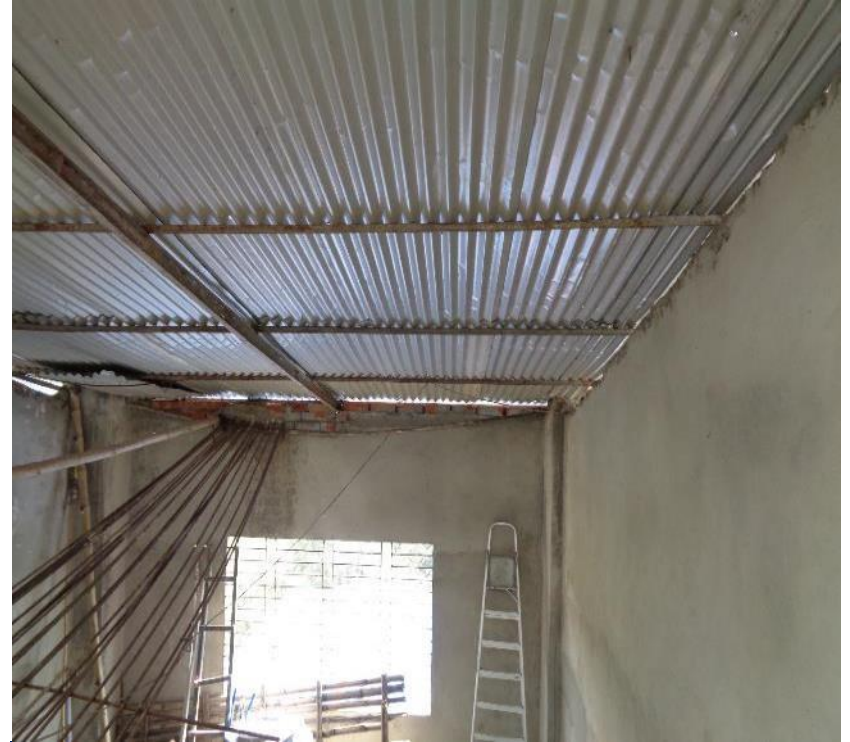
Non engineer steel roof at south stair

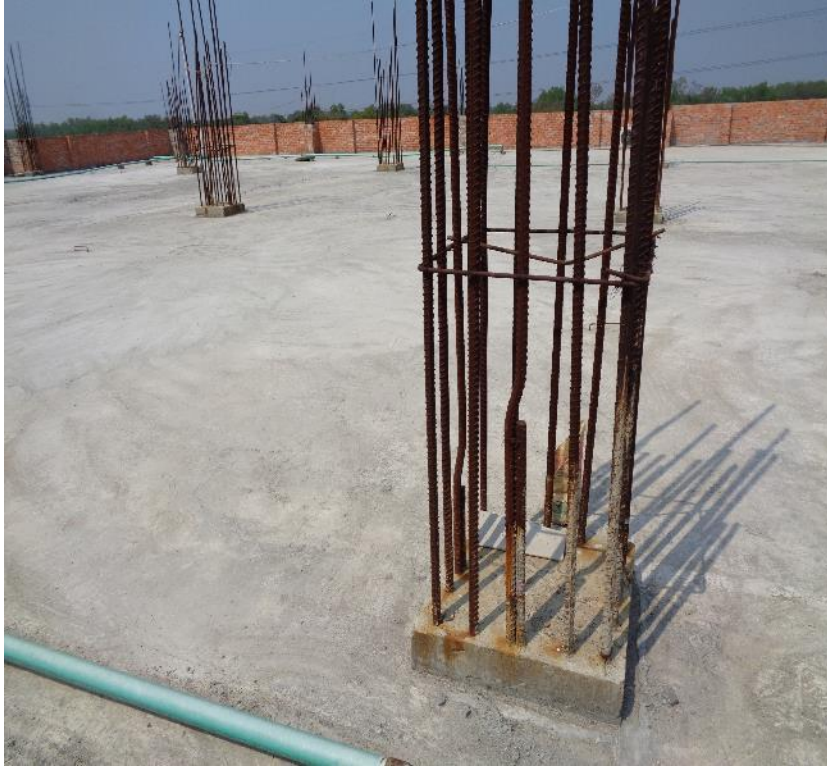
Corrosion in exposed rebar

Corrosion found in exposed rebar at roof level. Building engineer is required to provide rust proof paint to prevent further corrosion.

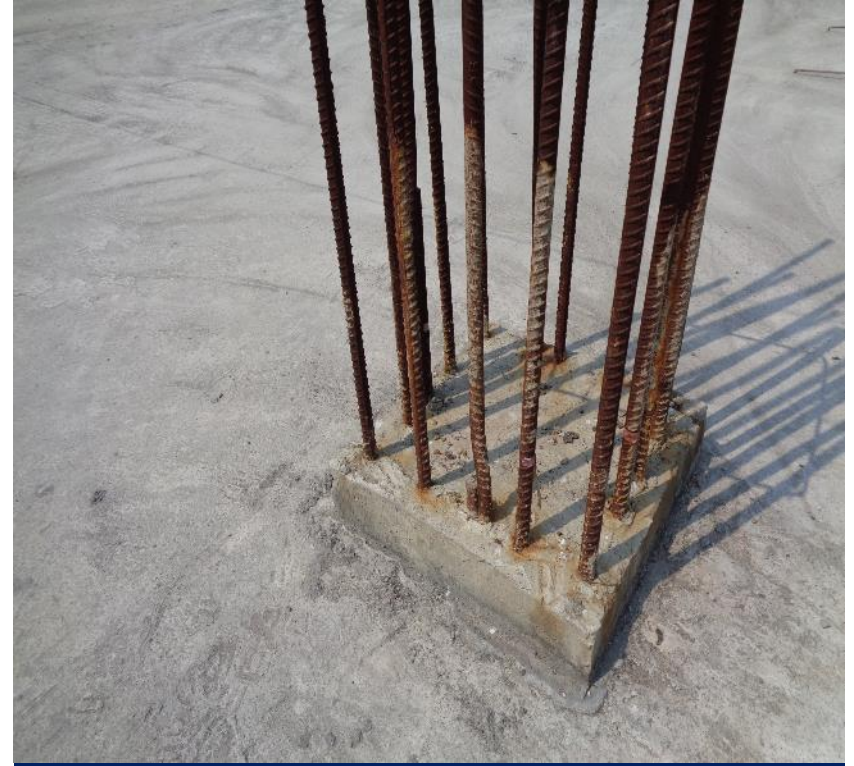
Corrosion in exposed rebar

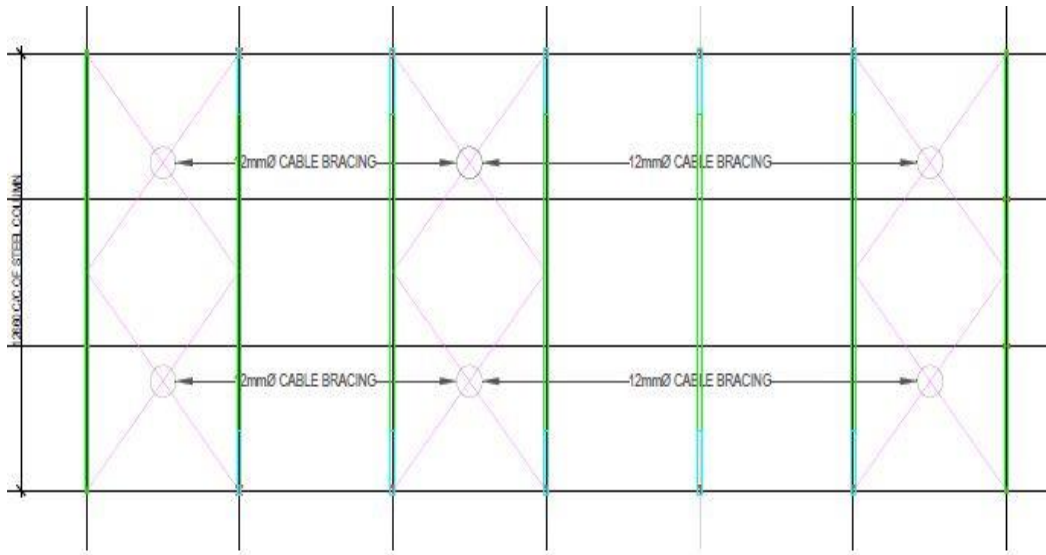
Bracing layout plan

No vertical bracings/tie beam/compression struts were provided in the long direction. Only roof bracings are provided along the short direction, lateral stability along the long direction is appeared to be incomplete. The building engineer is required to check the lateral stability system of the shed.

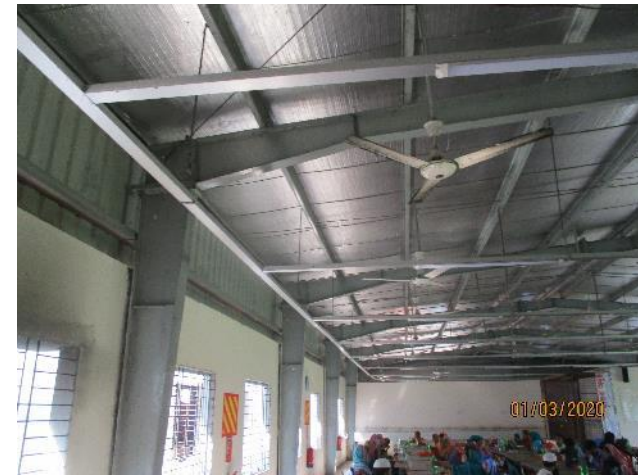
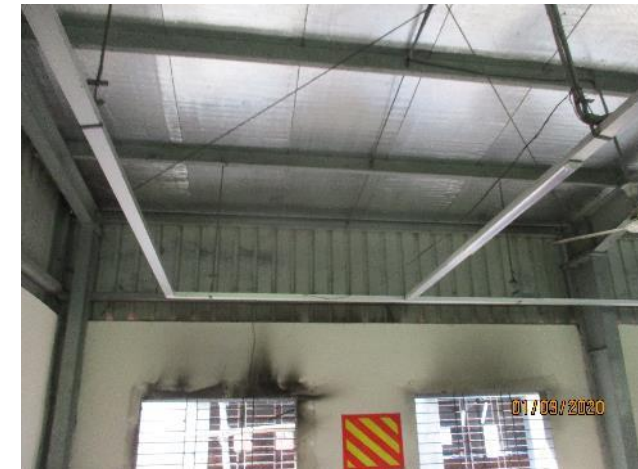
Absence of load transfer member in long direction

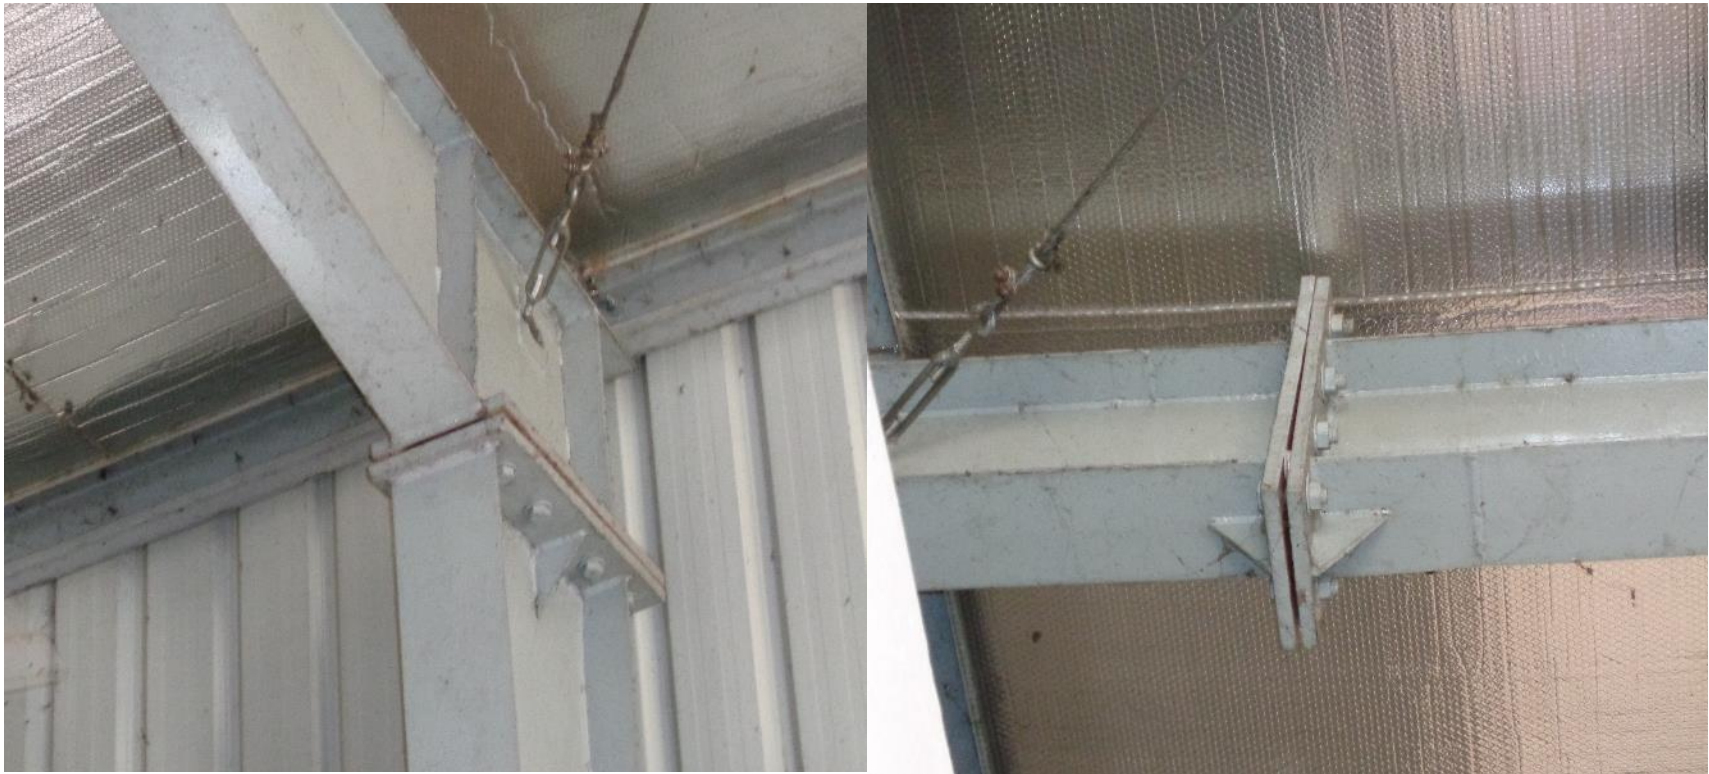
Significant connection gap was found in several location

Significant connection gap was found in several location which may reduce the moment capacity of the connections. The building engineer is required to fill the gaps with a suitable method.

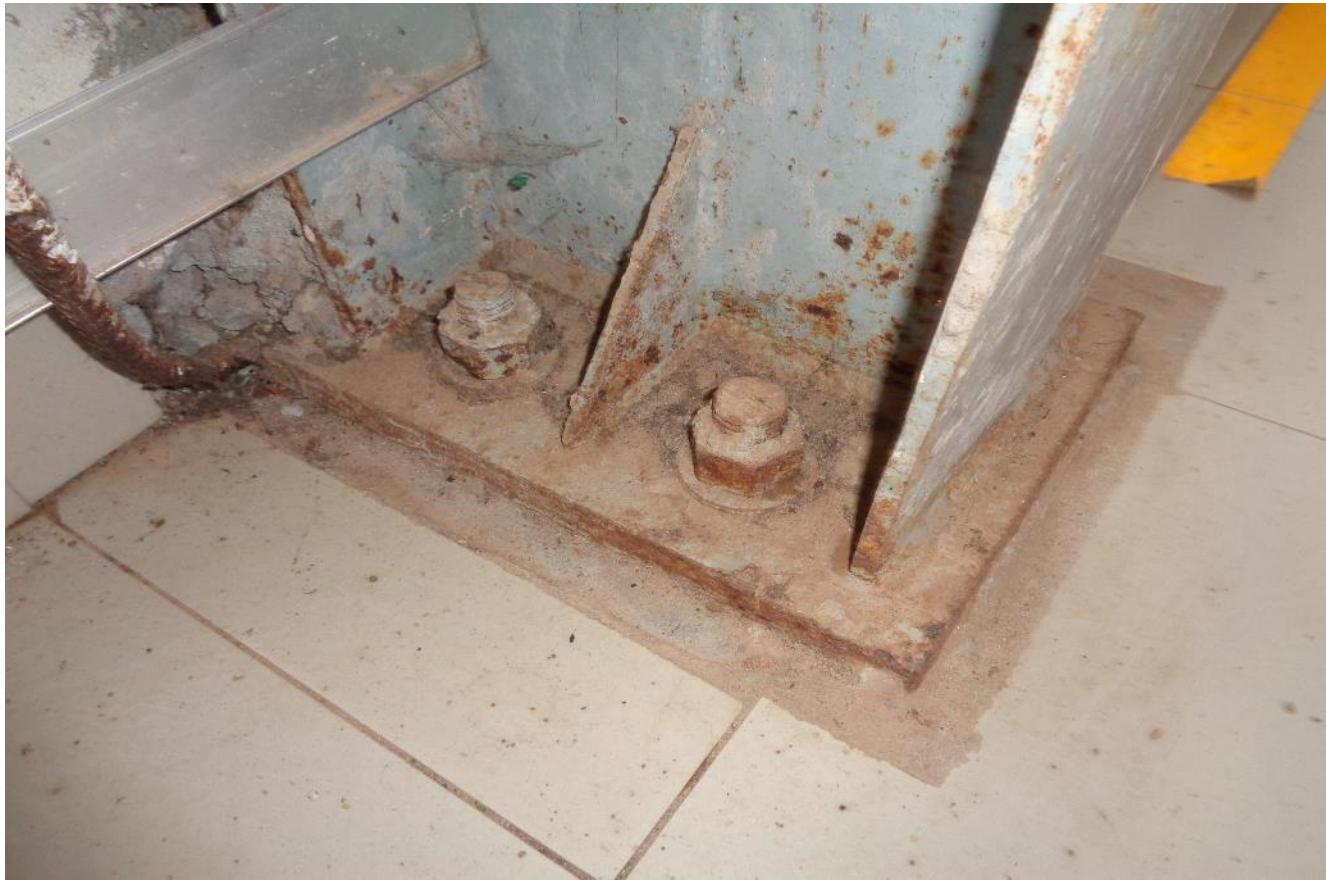
Corrosion found in steel members

Building engineer is required to provide rust proof paint or any other protective measure to prevent further corrosion.
