# Fashion Forum Ltd-Extension

53-54, Jamgora, Ashulia, Savar, Dhaka-1349, Bangladesh.

1<sup>st</sup> August 2019

# Observations

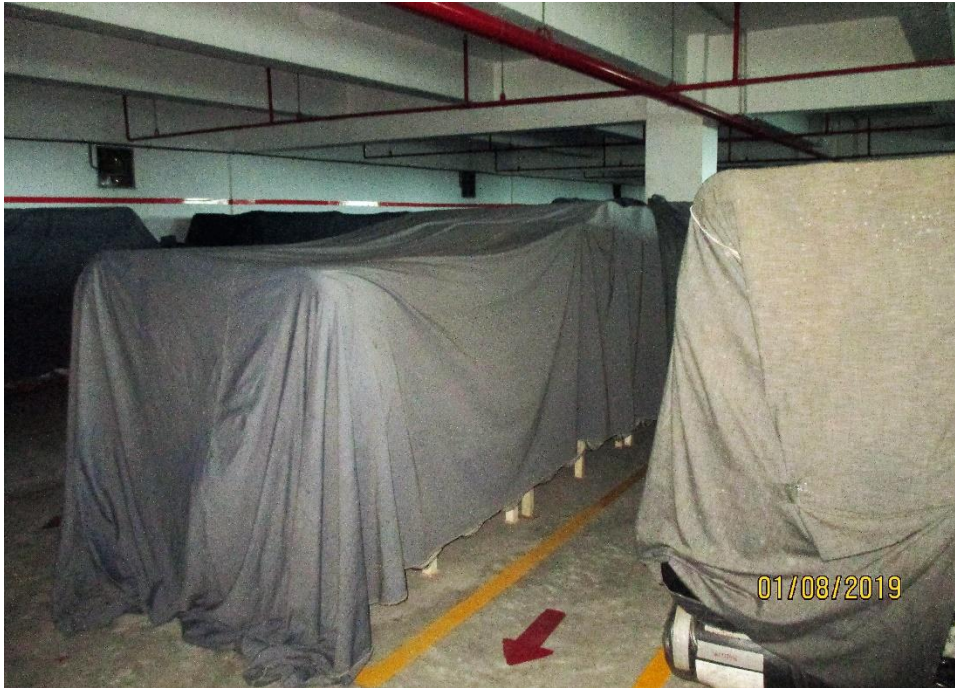
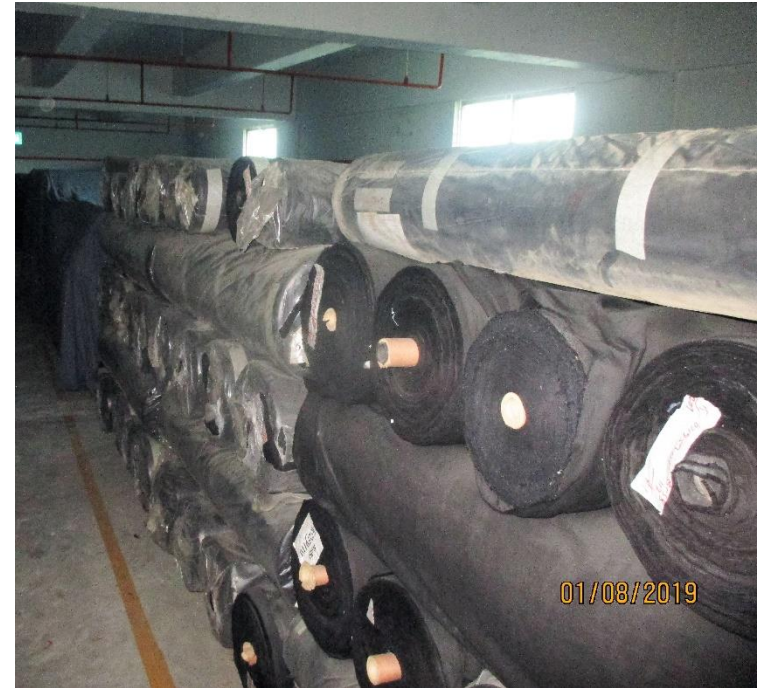
## **Implement floor load management program**

Uncontrolled loading.

The load plan was prepared by the factory considering 3 Kpa floor live loading for typical floors. The column stress has been checked considering prepared floor load plan and found satisfactory. Load restriction height marking was observed in storage areas. The floor loading in the storage area was calculated and found to be around 5 kPa. Factory is required to reduce the floor loading to 3 kPa. If the factory intends to maintain floor loading more than 3 kPa on storage areas, Engineering Assessment is required to be carried out for the factory building.

| Item No. | Observation | Recommended Action Plan | Recommended Timeline |
|---|---|---|---|
| 1 | Implementation of floor load management program | Reduce the floor loading to 3 kPa. | 6-weeks |
| 2 | Implementation of floor load management program | Provide load height marking according to load capacity. | 6-weeks |
| 3 | Implementation of floor load management program | Implement provided loading plan for all floor plates. | 6-weeks |
| 4 | Implementation of floor load management program | Engineering assessment is required to be carried out If the factory intends to maintain floor loading more than 3 kPa | 6-months |
| 5 | Implementation of floor load management program | Continue to implement load plan. | 6-months |

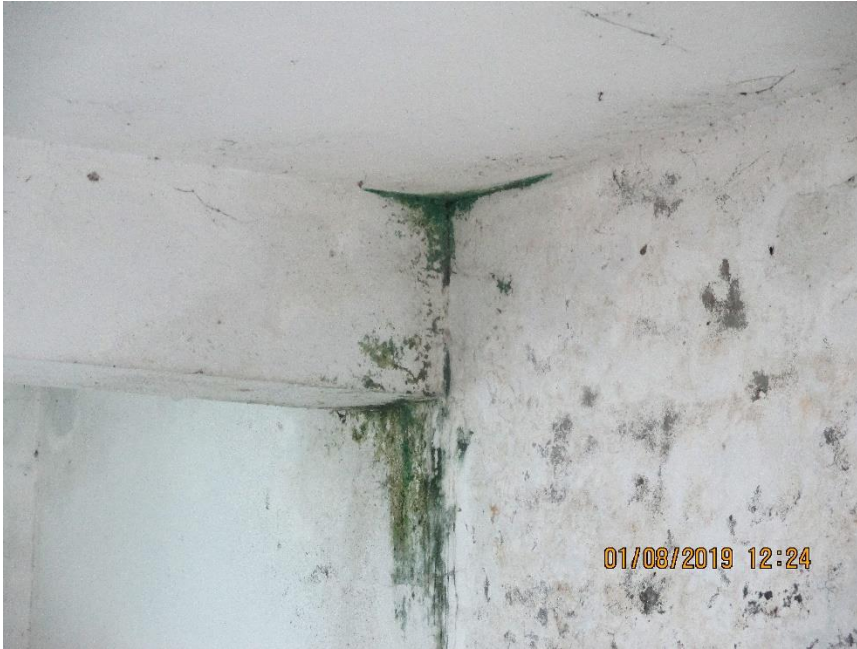
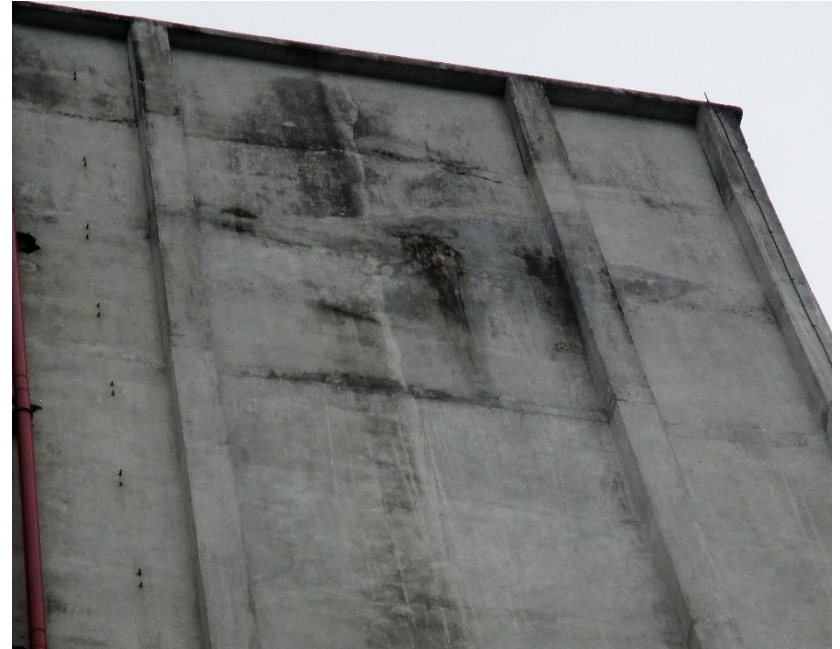
## Water damage at several locations

Dampness was observed on the beam, slab and peripheral wall below the Water tank. Water damage also observed on some of walls in the washroom zone.

| Item No. | Observation | Recommended Action Plan | Recommended Timeline |
|---|---|---|---|
| 6 | Water damage at several locations | Investigate the cause of dampness on the beam below water tank. | 6-weeks |
| 7 | Water damage at several locations | Carry out required measures to remove dampness on beams & walls as per recommendation of factory engineer. | 6-months |
