# Zoom Sweaters Ltd. (9741)

## Irene Knitwear (9742)

**ACCORD**  
on Fire and Building Safety in Bangladesh

# Identified Priority 1 Concerns

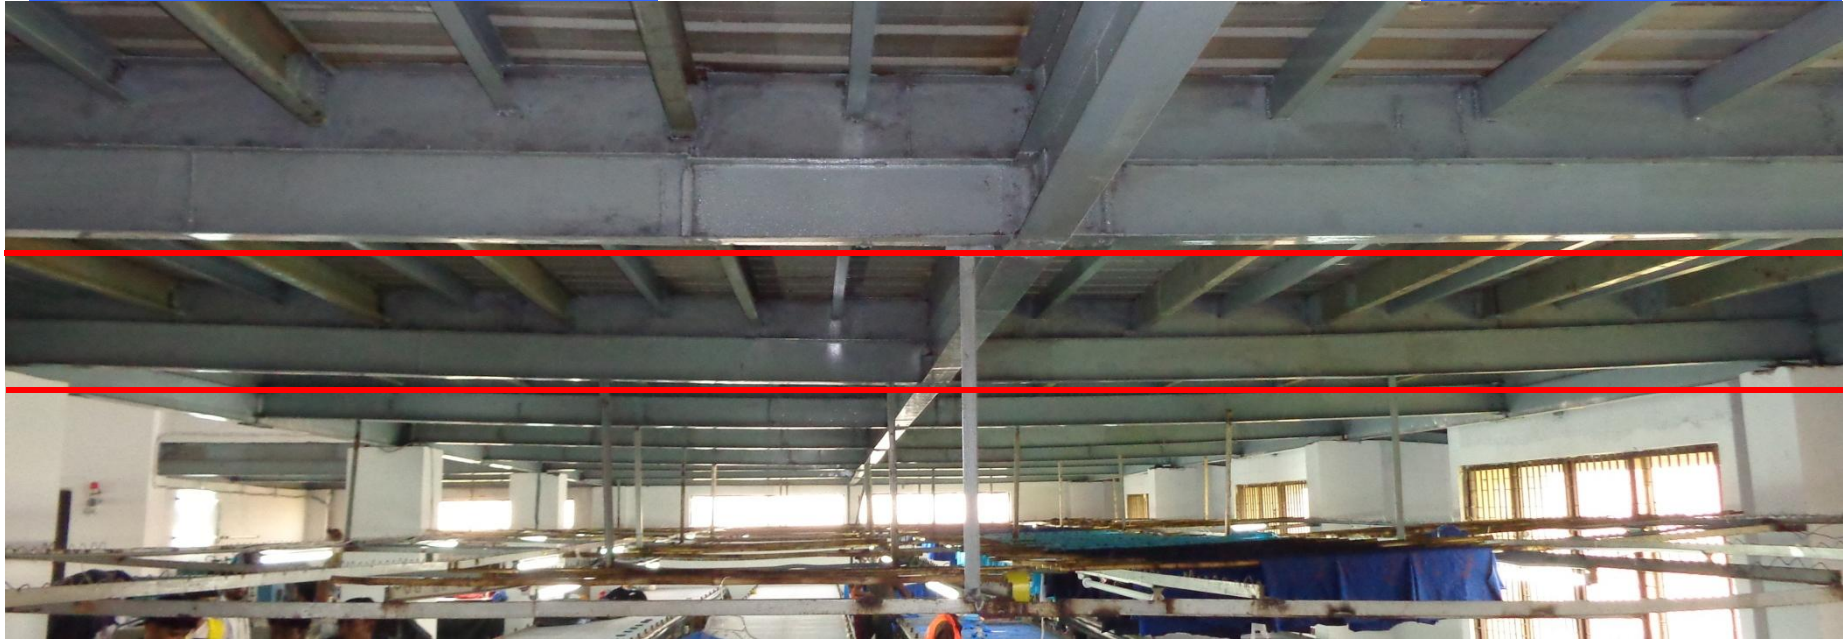
## 8<sup>th</sup> Storey Steel Roof Framing

There was present at the roof level a steel roof structure, portions of which were concrete topped. The steel framing displayed signs of overloading and was poorly detailed and poorly constructed. Most notably there was an alarming amount of observable deflection in the steel framing underneath the concrete topped portion.

**ITEM 1: (Priority 1) The steel roof structure was poorly constructed. Steel was observed to be, in part, recycled sections combined in a piecemeal fashion. Connection details were inconsistent and suspect in their capacity. Excessive deflection was observed under the portion of roof with concrete topping.**

The steel roof structure displays signs of overloading and is constructed in a poor fashion.

- A detailed engineering assessment is to be performed upon the steel roof structure.

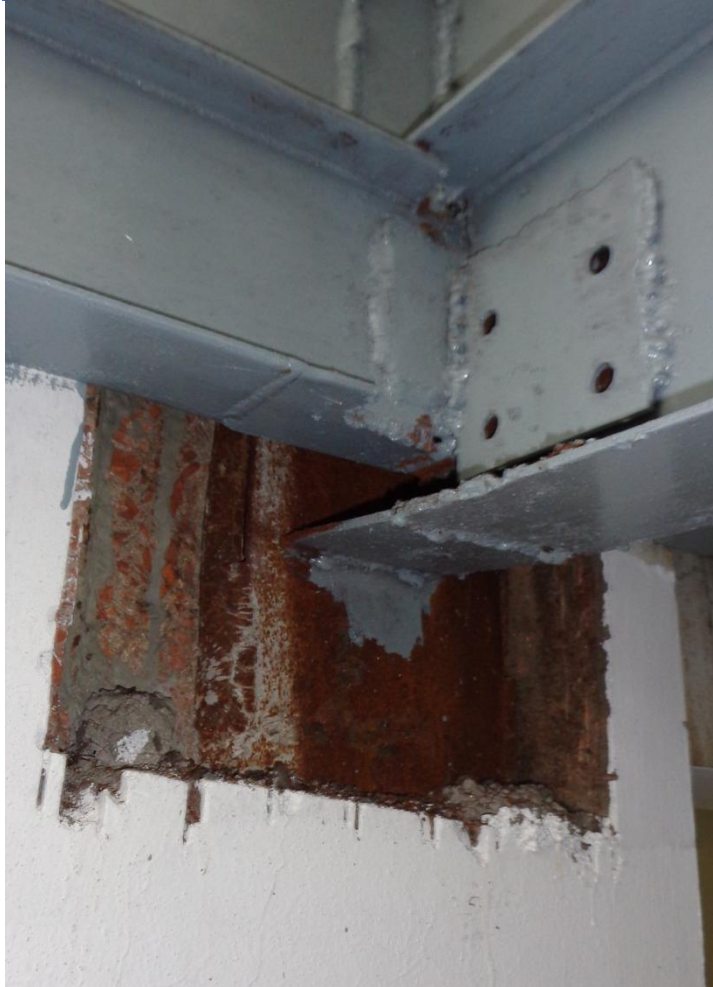
Steel to Concrete  
Connection at 8<sup>th</sup> Floor

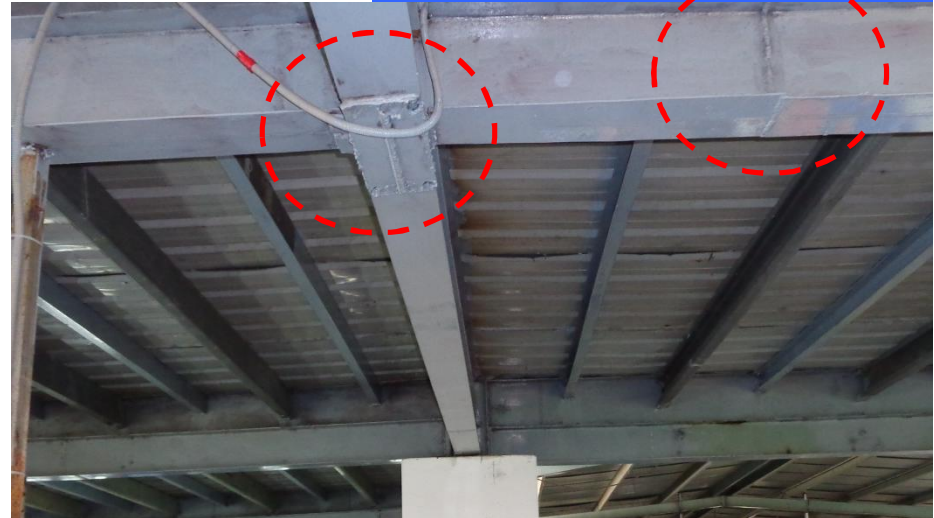
Poorly Detailed Recycled  
Steel Framing

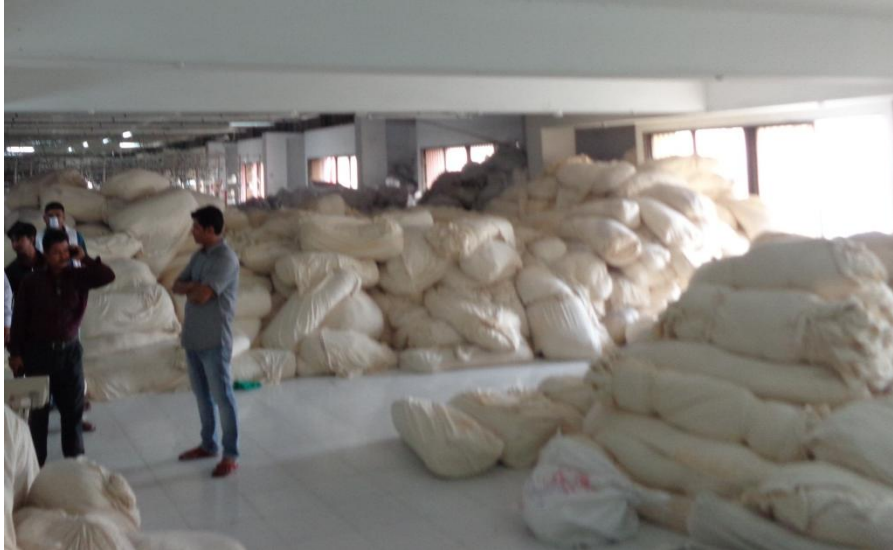
Stacked Garment Bags Over a Large Portion of the Floor

As determined using the observed steel reinforcement ratio and the strength appropriate for stone aggregate concrete, the column working stress safety factor was less than desirable.

**ITEM 2: (Priority 2) Storage of highly stacked thread rolls and the presence of industrial spinning machines was observed over the majority of the area of the 6<sup>th</sup> floor. Also, the 4<sup>th</sup> floor contained highly stacked sacs of fabric. The floors are not specially designated for loading higher than the typical factory floor loads. Resulting column loading/capacity checks indicate less than desirable safety factors.**

Storage loading has not been explicitly accounted for on the 4<sup>th</sup> & 6<sup>th</sup> floors. Storage loading was present over a large portion of the floor area on the 6<sup>th</sup> floor and in localized areas on the 4<sup>th</sup> floor. Column load/capacity checks indicate low safety factors.

- Factory engineer to review design loads and column stresses

- Produce and actively manage a loading plan for all floors within the factory giving consideration to the floor capacity and column capacity.

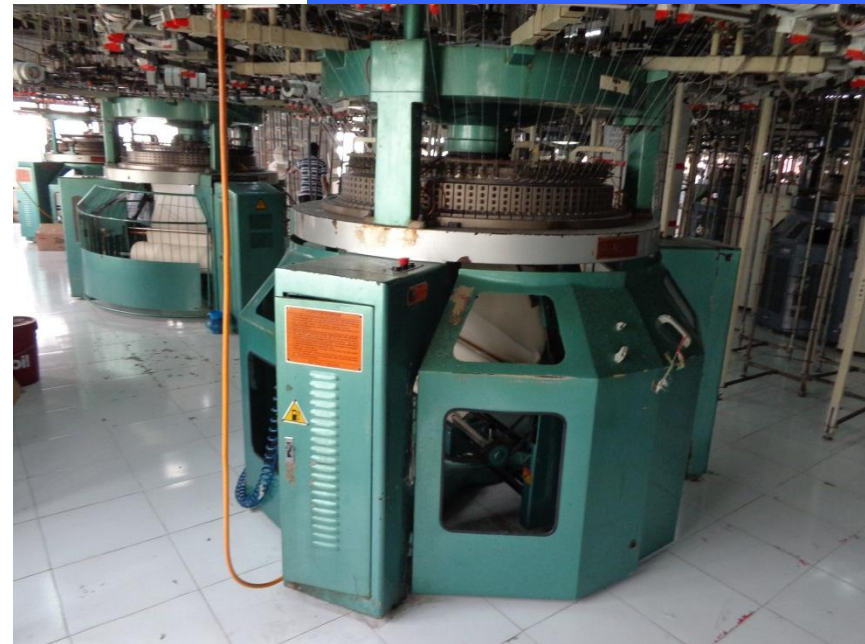
## Storage and Machinery at 6<sup>th</sup> Level

Textile Machinery Over a Large Portion of the Floor
