# EVITEX DRESS SHIRT LTD.

Shirirchala, Bhabanipur, Joydevpur, Gazipur-1704, Bangladesh  
(24.170253, 90.442684)

22 January & 25 February 2020

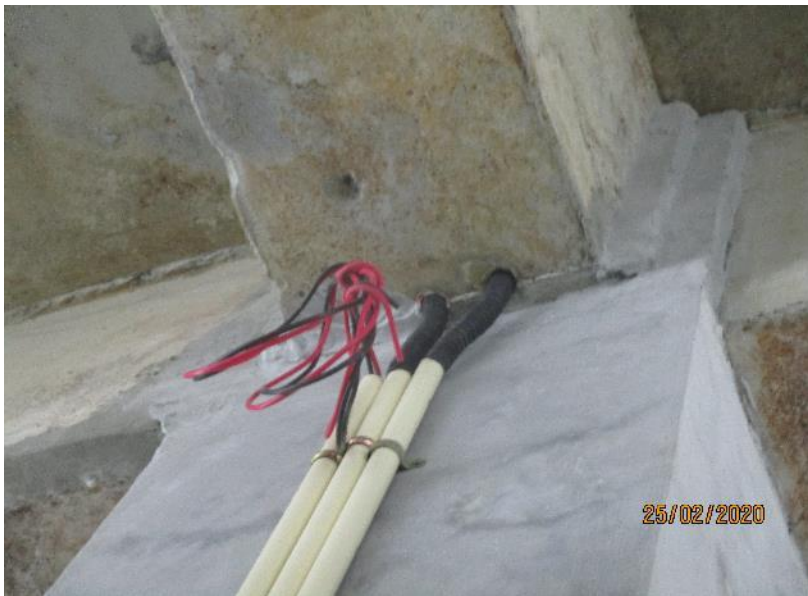
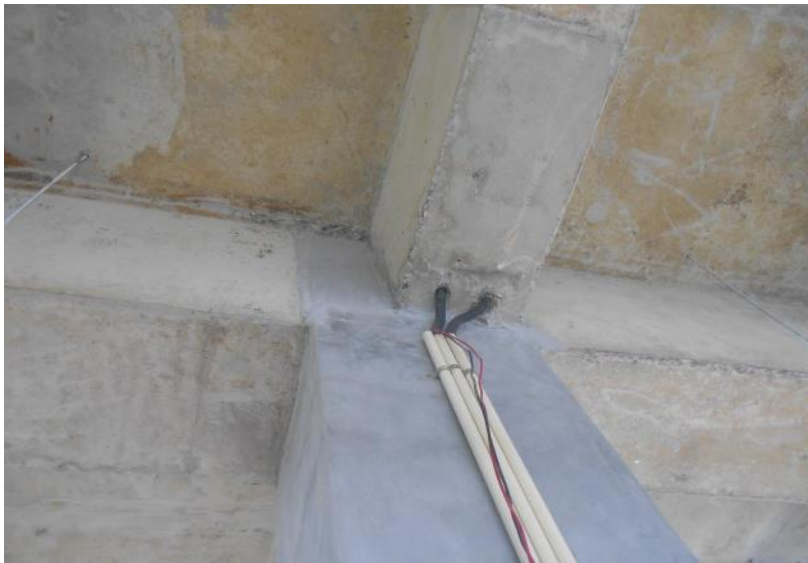
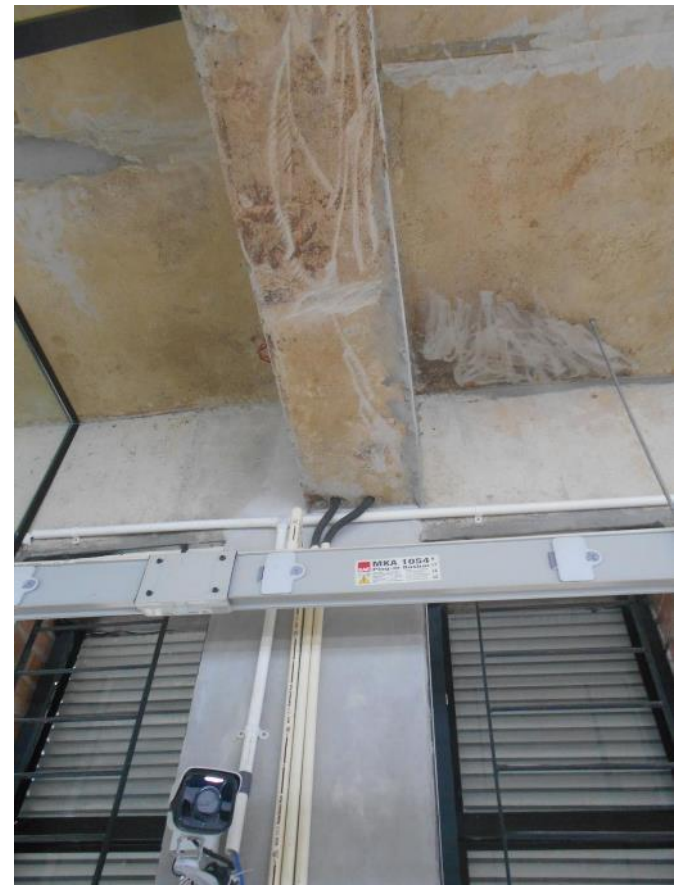
**Electrical cables cut into and pass through main structural beams.**

Electrical cable pass through beams.

Electrical Cables have been cut into and pass through main structural beams throughout various floor levels of the factory. Structural Engineer to Investigate and report on this matter to verify the Structural Integrity of the beams are not compromised.

| Item No. | Observation | Recommended Action Plan | Recommended Timeline |
|---|---|---|---|
| 1 | Electrical cables cut into and pass through main structural beams. (Factory Complex) | Building Engineer to Investigate and report on this matter to verify the Structural Integrity of the beams are not compromised. | 6-weeks |
| 2 | Electrical cables cut into and pass through main structural beams. (Factory Complex) | Carry out any remedial works where necessary | 6-months |

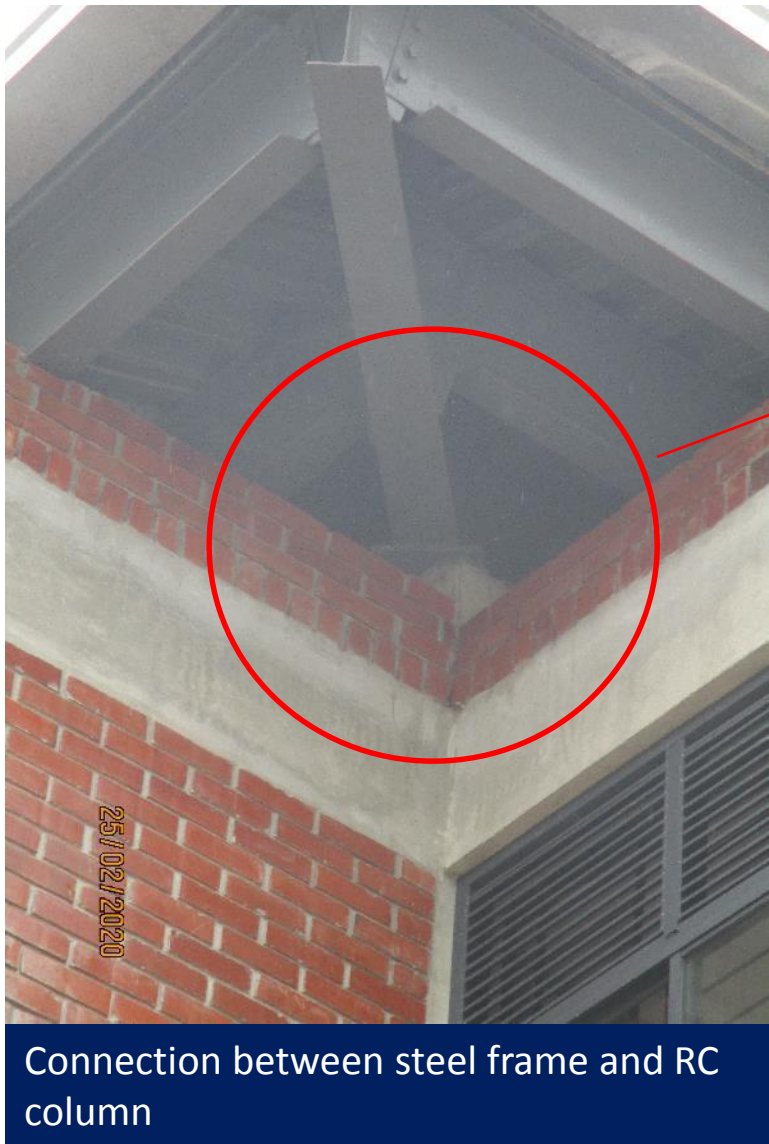
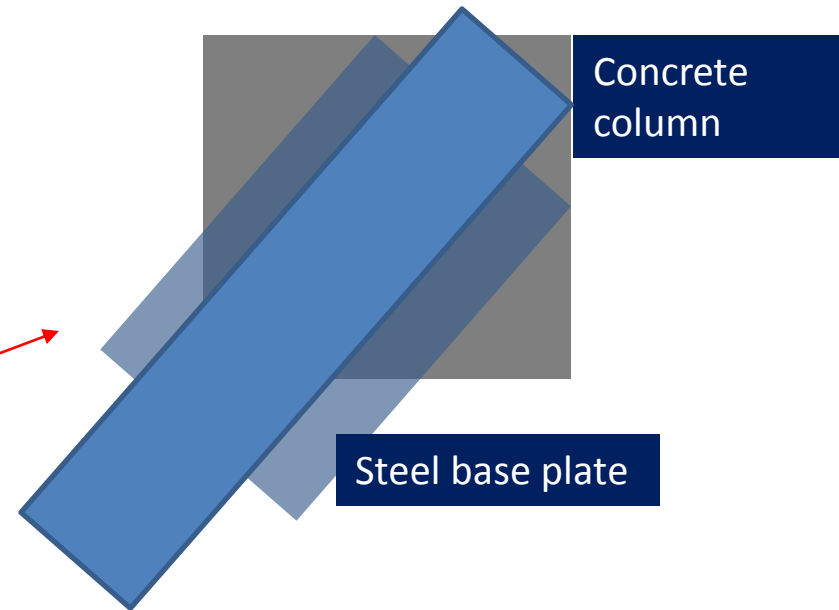
**Observation : Admin Building**

**Apparently inadequate concrete area in joints**

The steel hip rafter is resting on base plate which is partially hanging. Building engineer is required to check the connection adequacy.

| Item No. | Observation | Recommended Action Plan | Recommended Timeline |
|---|---|---|---|
| 3 | Apparently inadequate concrete area in joint. (Admin Building) | Building engineer is required to check the connection adequacy of the base plate partially resting on RC column. | 6-weeks |
| 4 | Apparently inadequate concrete area in joint. (Admin Building) | Carry out any remedial works where necessary | 6-months |
