# Farkantex Ltd.(New Shed)

SECTOR # 5(A), PLOT #1&2, C.E.P.Z , CHATTOGRAM-4223

26<sup>th</sup> September 2019

# Observations

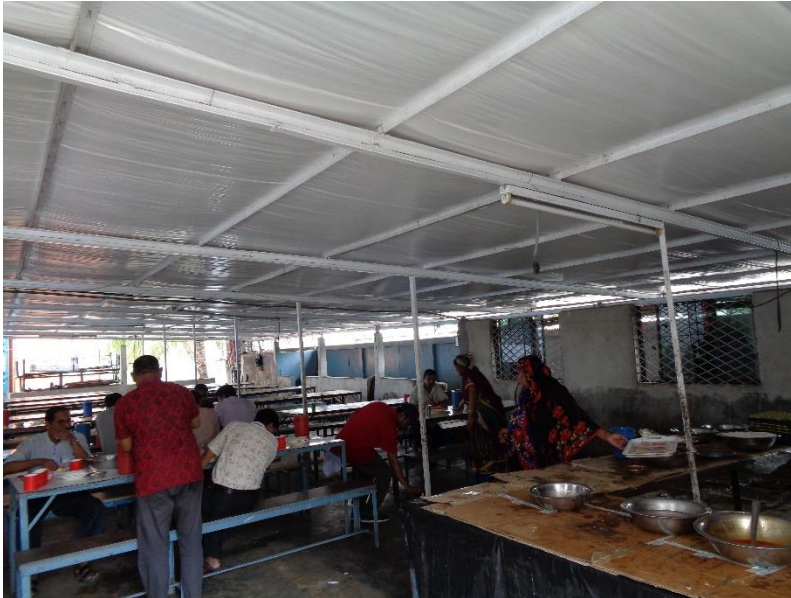
Dining Shed

Apparently non-engineered Dining shed. Factory engineer is required to replace the shed with an engineered shed.

| Item No. | Observation | Recommended Action Plan | Recommended Timeline |
|---|---|---|---|
| 3 | Non-engineered Shed (Dining Shed) | Factory engineer is required to replace the shed with an engineered shed. | 6-weeks |

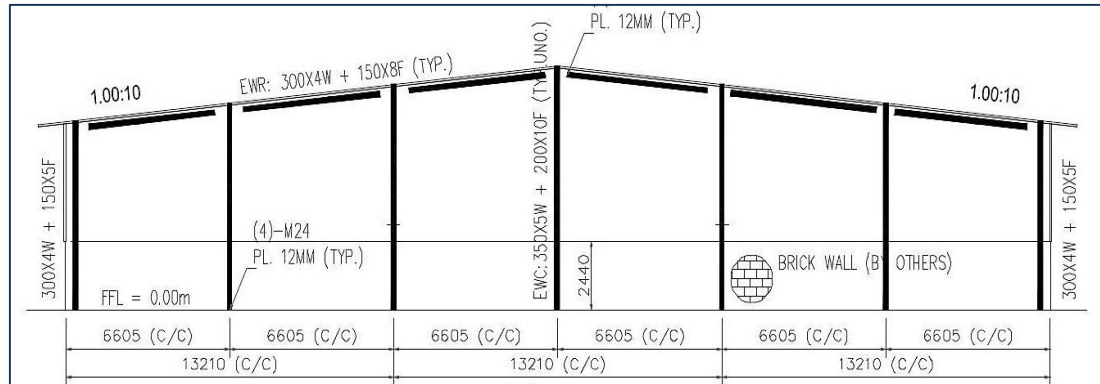
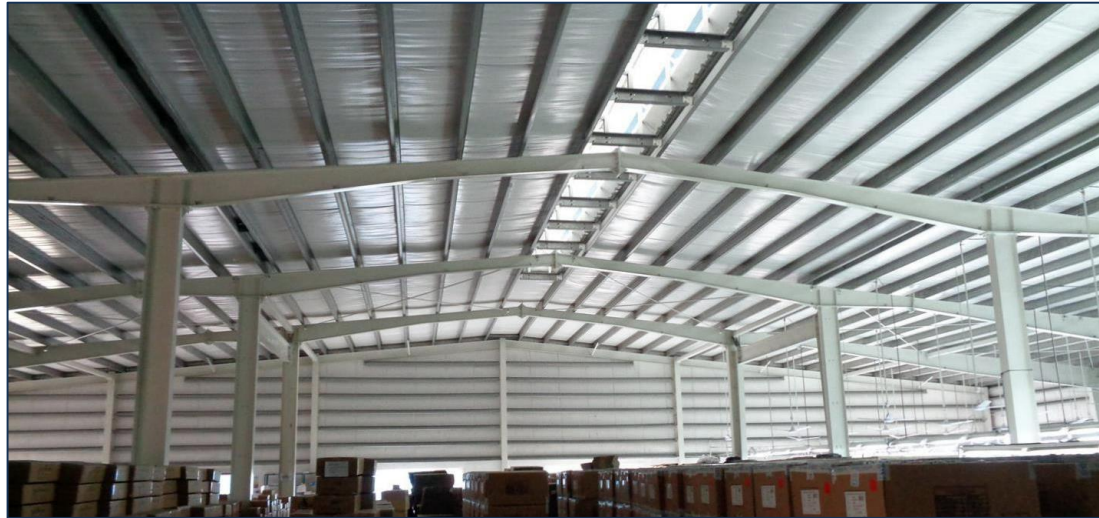
No proper as built structural or architectural drawings were available for Shed 2(New).  
Factory Engineer is required to produce as built structural and architectural drawings  
for the Shed 2 (New).

| Item No. | Observation | Recommended Action Plan | Recommended Timeline |
|---|---|---|---|
| 4 | Lack of As built drawings (Shed 2(New) & Utility Room ) | Factory Engineer is required to produce as built structural and architectural drawings for Shed 2 (New). | 6-weeks |

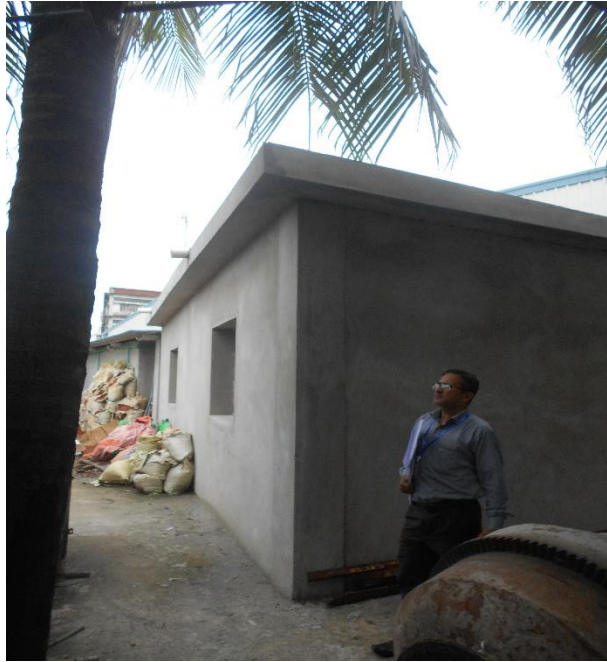
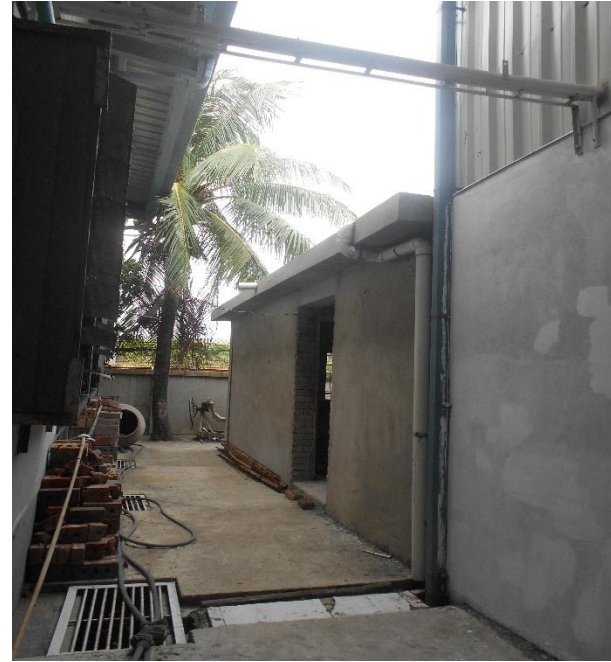
No documents or drawings were available for utility room. Factory Engineer is required to produce as built drawings for the utility room

| Item No. | Observation | Recommended Action Plan | Recommended Timeline |
|---|---|---|---|
| 5 | Lack of As built drawings (Shed 2(New) & Utility Room ) | Factory Engineer is required to produce as built drawings for the utility room. | 6-weeks |
