Disney Sweater Ltd. (Extension)

Barpa, Rupshi, Rugganj, Narayanganj, Bangladesh.
(23.747123, 90.535561)
29th July 2019

Observations: Shed-11 (Finished Goods-2)

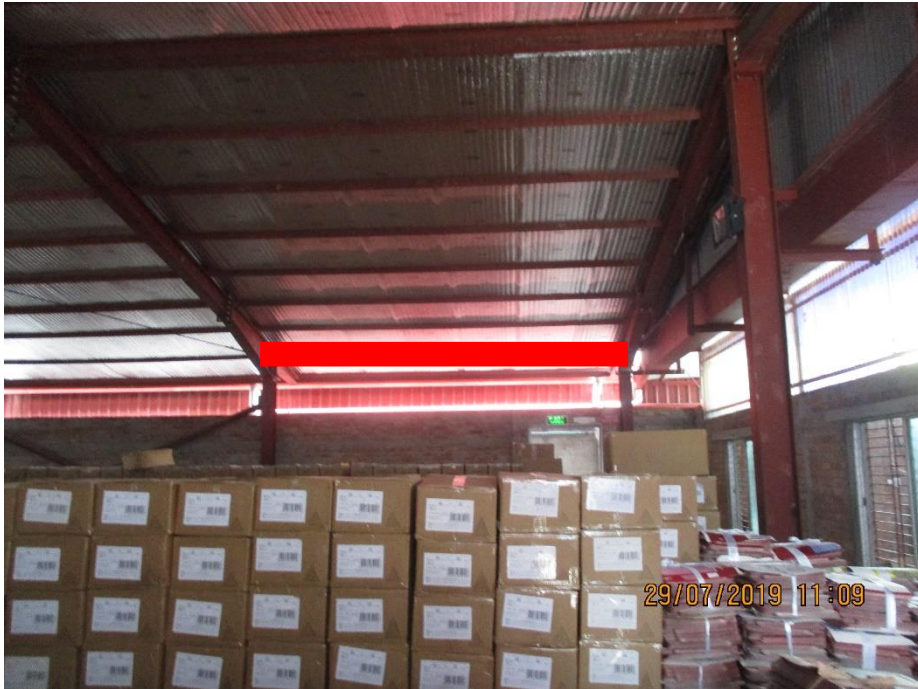
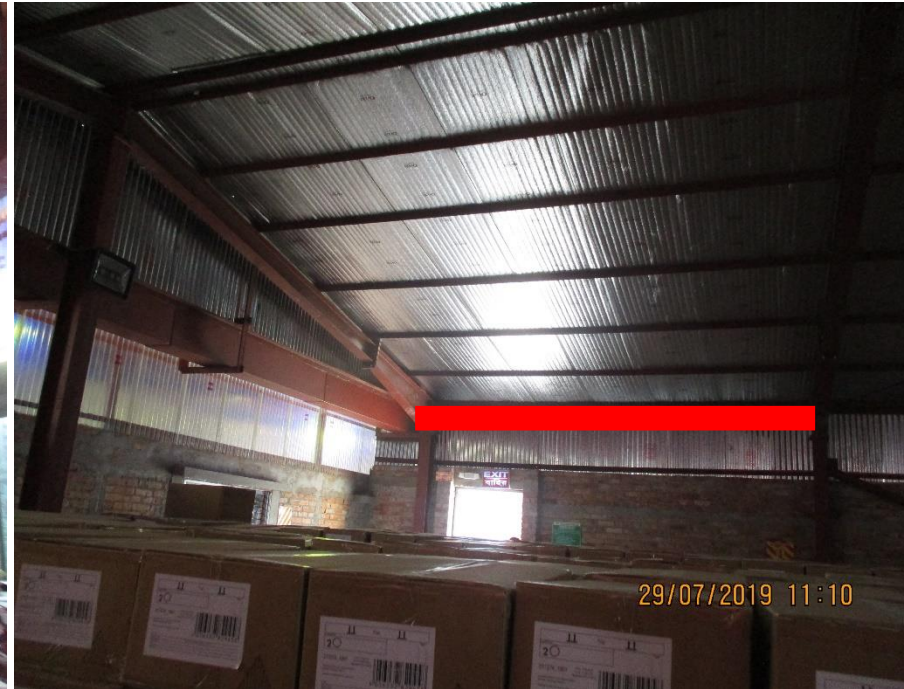
Missing compression strut at end bay

Compression strut member/lateral load transfer member not provided at end bay. Building engineer is required to review the design and load transfer system of the shed.

Item No.	Observation	Recommended Action Plan	Recommended Timeline
1	Missing compression strut at end bay. (Shed-11-Finished Goods-2)	Building engineer is required check the requirement of stability system and lateral load transfer medium.	6-weeks
2	Missing compression strut at end bay. (Shed-11-Finished Goods-2)	Carry out remedial works where necessary.	6-months
3	Discrepancies in as-built drawings. (Shed-11-Finished Goods-2)	Building engineer is required to produce accurate as-built drawings which reflects the site condition.	6-weeks
4	Discrepancies in as-built drawings. (Shed-11-Finished Goods-2)	Building engineer is required to review the design based on accurate as-built drawings.	6-weeks
5	Apparently poor connection & inadequate member. (Shed-10-Dining & Prayer)	Building engineer is required to check the stability of the shed or replace the shed by an engineered shed.	6-weeks
6	Apparently poor connection & inadequate member. (Shed-10-Dining & Prayer)	Carry out remedial works as per recommendation of engineering assessment report.	6-months

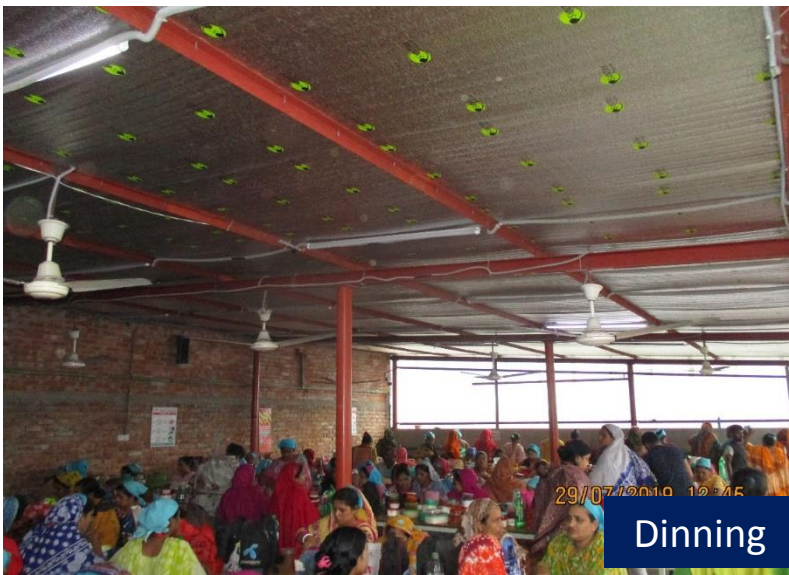
Dinning

Apparently poor connection & inadequate member

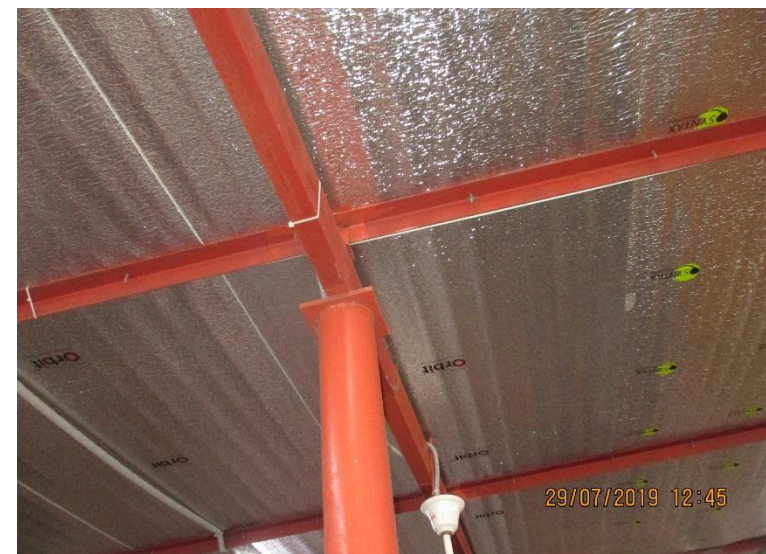
Connection between frame and column

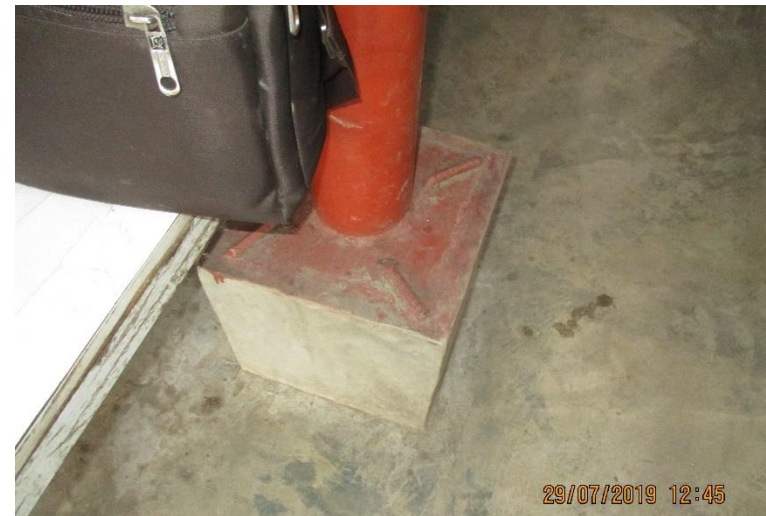
Connection between M/S column and pedestal column

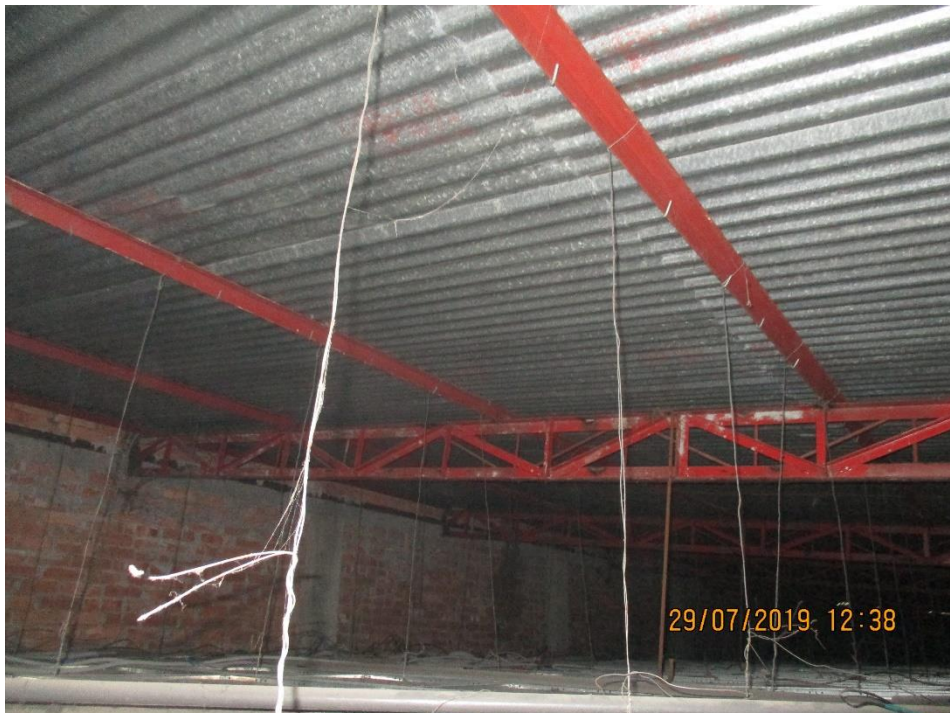
Connection & load path not obvious

Apparently poor connection and inadequate member observed. Building engineer is required to check the stability of the shed.

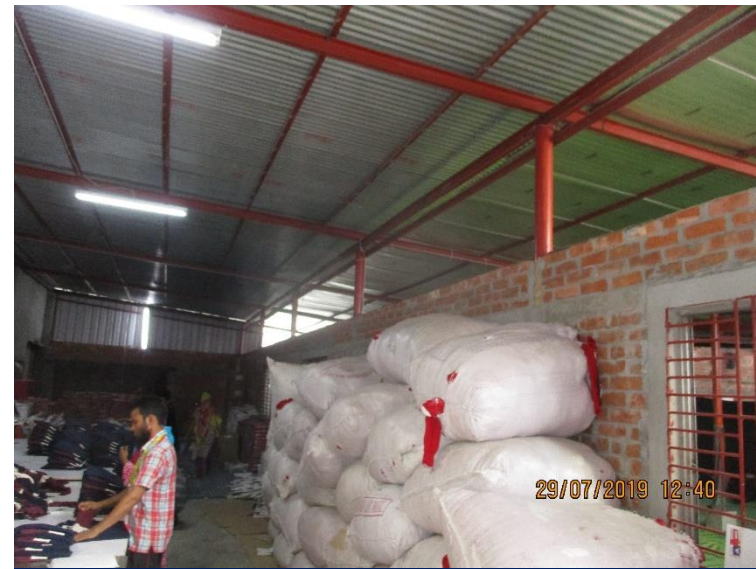
Inadequate member

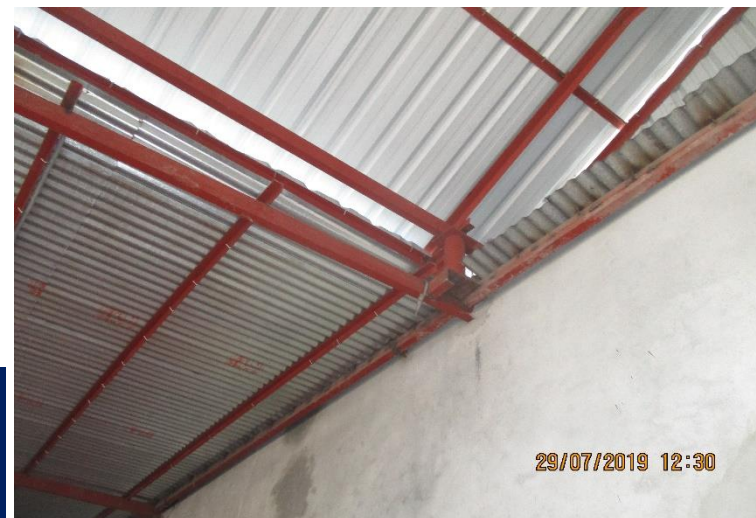
Non-engineered connection

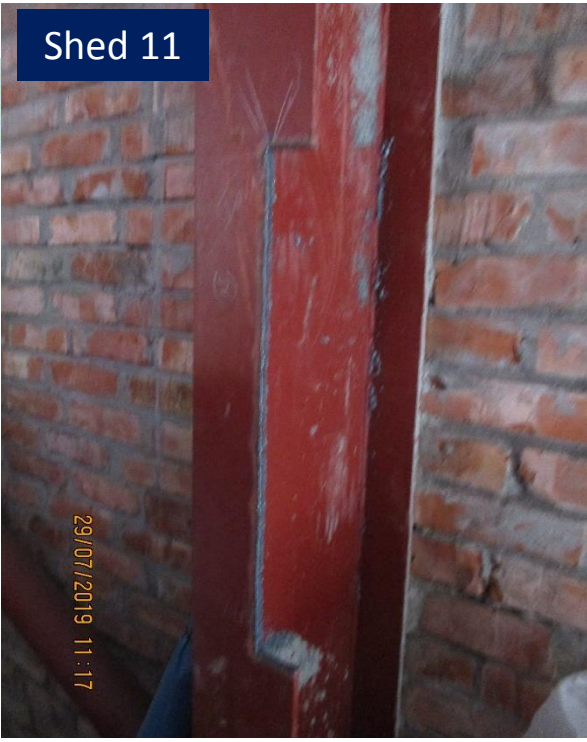
Shed 11

Sample taken from column for tensile test of M/S plate but not refit with identical member.

Item No.	Observation	Recommended Action Plan	Recommended Timeline
7	As-built documents.(Shed-9 Finishing)	Building engineer is required to prepare as-builts drawings which reflects the site condition.	6-weeks
8	As-built documents.(Shed-9 Finishing)	Building engineer is required to check the stability of the shed or replace the shed by an engineered shed.	6-weeks
9	As-built documents.(Shed-9 Finishing)	Carry out remedial works as per recommendation of engineering assessment report.	6-months
10	Steel plate sampling from column.(Shed-2,6,7 &11)	Building engineer is required to refit the columns by identical members.	6-weeks
