Hop Yick (Bangladesh) Ltd Unit-2 (New)

Plot # 44-46, DEPZ (West Zone), Ganakbari, Ashulia Savar
(23.949019N, 90.270028E)
22th December 2016

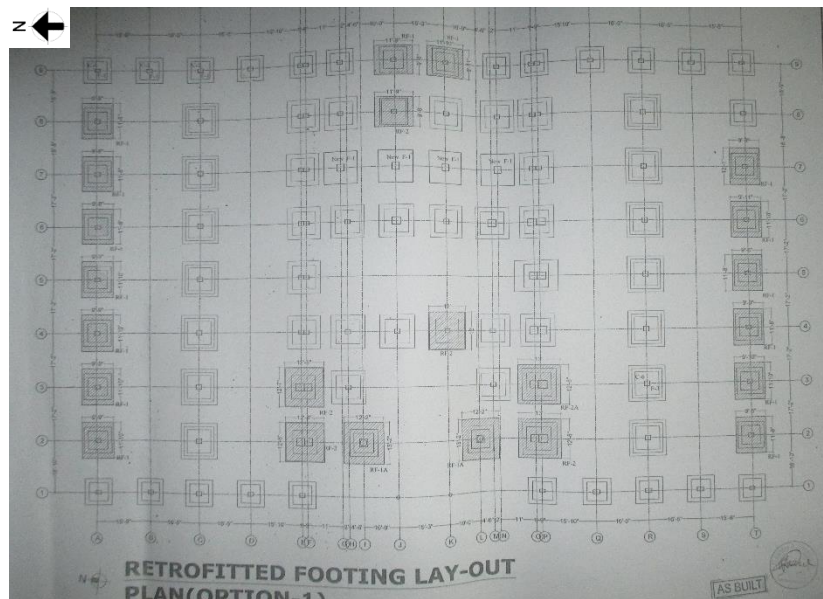
Proposed retrofitting footing layout in provided DEA report

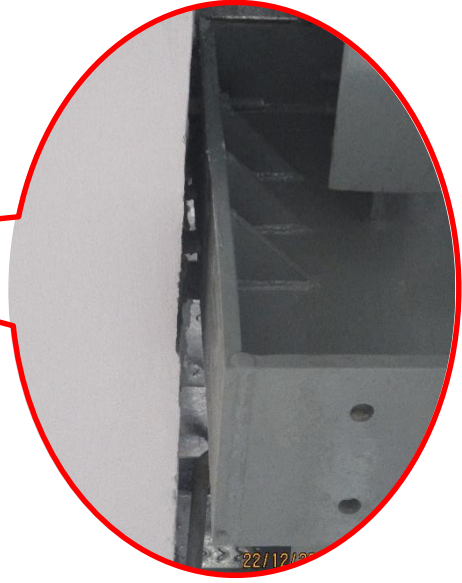
Some columns, beams and slab found retrofitted in RC part according to the retrofitting scheme. Moreover, steel part is found connected by bolt with RC part. The factory is required to engage an engineer to evaluate the connection between two part and evaluate the whole structure to consider the horizontal and vertical load.

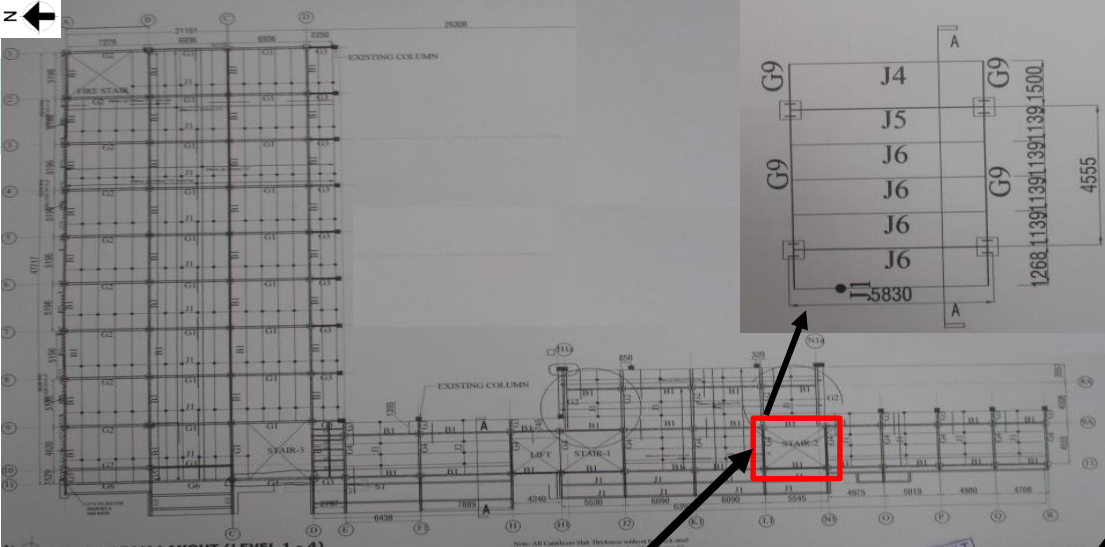
Typical beam layout plan

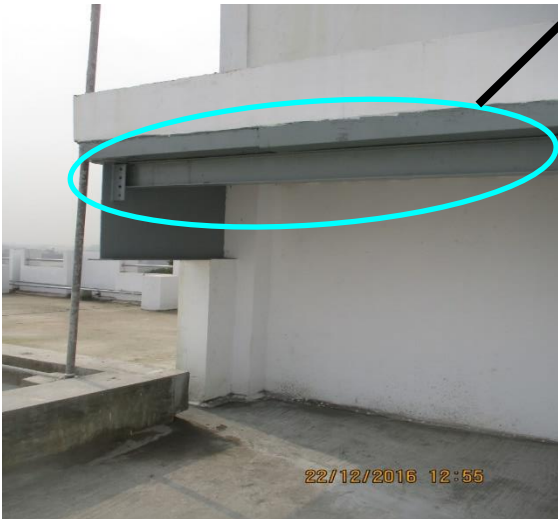
The marked beam was absent in beam layout but that beam was observed under the top slab of stair case-2

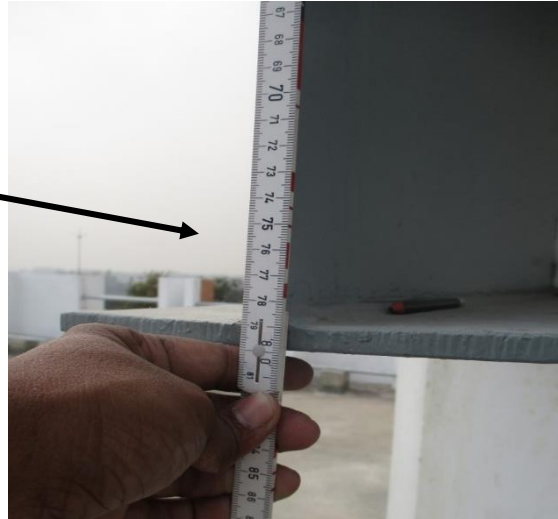
Depth of 'H' section G9 beam was found 800mm instead of 600mm which was in beam

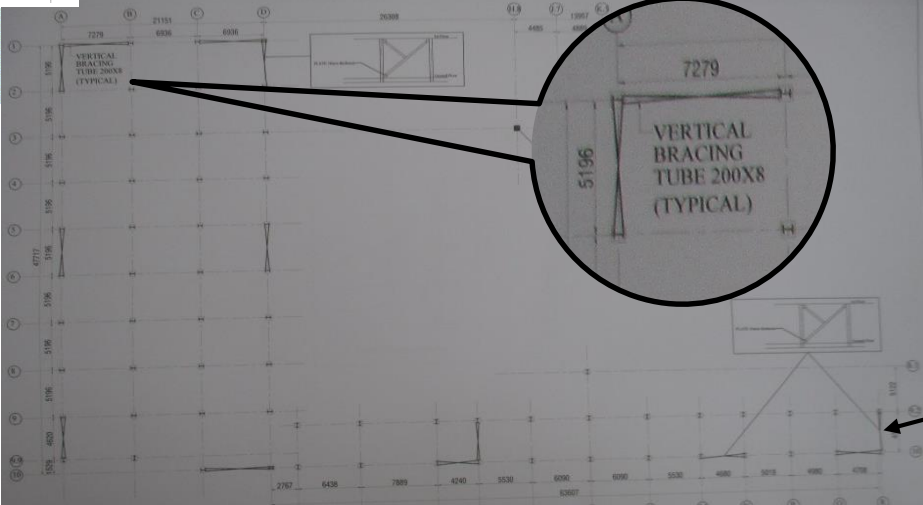
Bracing layout of Ground floor

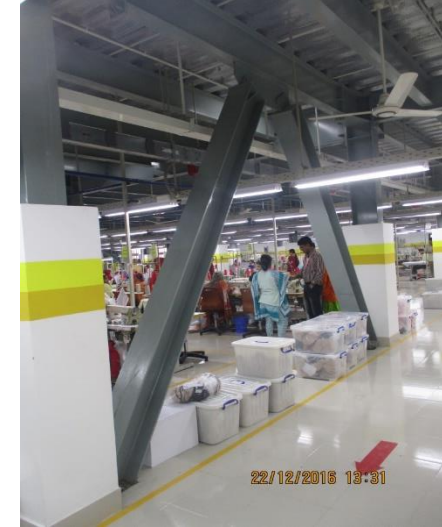
'Inverted 'V' bracing was observed on 1st and 2nd floor on the marked zone but position of such bracing was not mention in provided drawing. Only bracing detail was found in drawing.

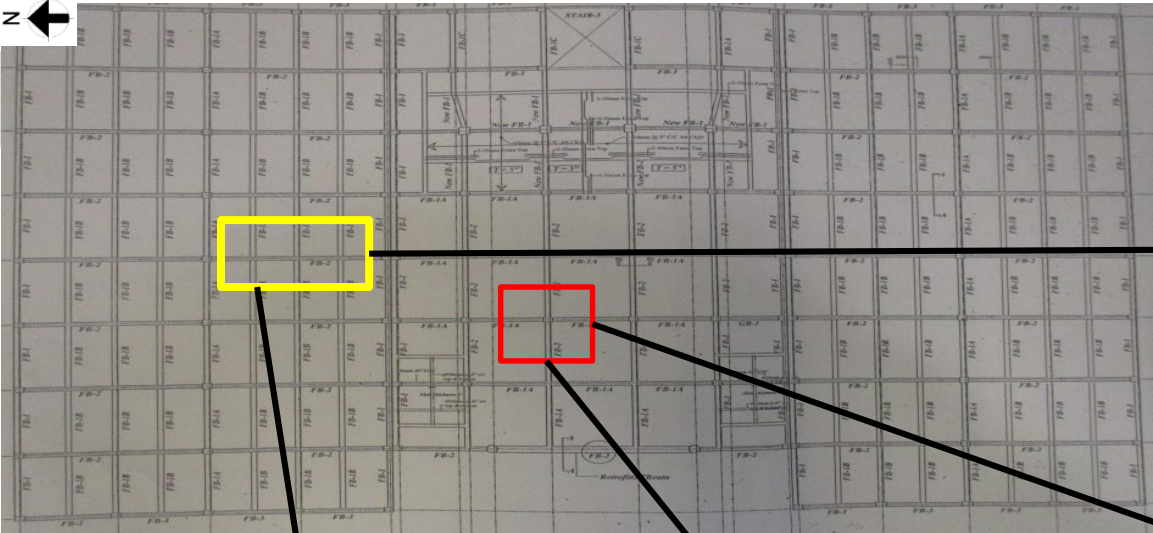
Typical floor beam layout plan

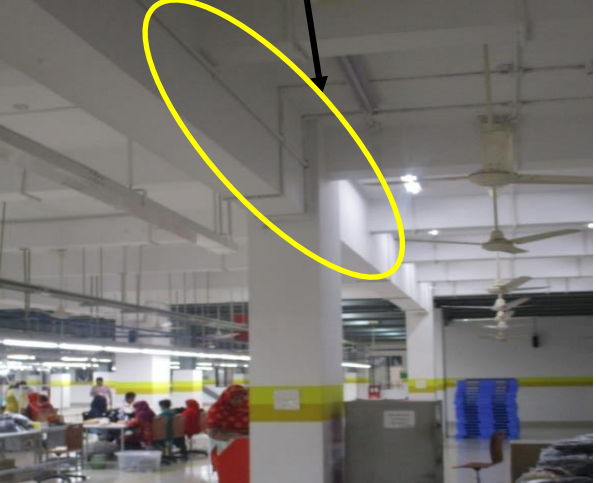
Variation in depth of FB-1B was found in yellow marked area whereas all FB-1B beam depth was 21" including slab in provided drawing

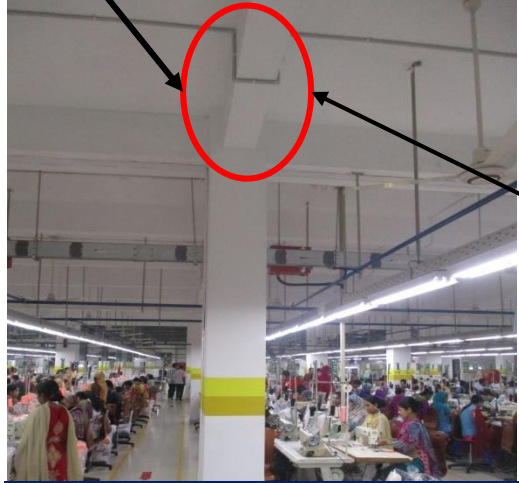
Width of FB-1A beam in red marked area was found 9" instead of 10" in beam schedule

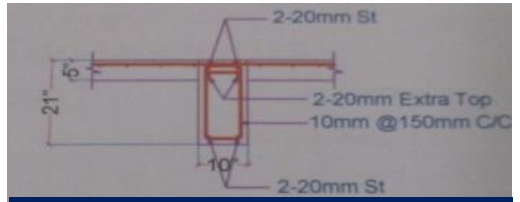
FB-1B beam schedule in provided drawing

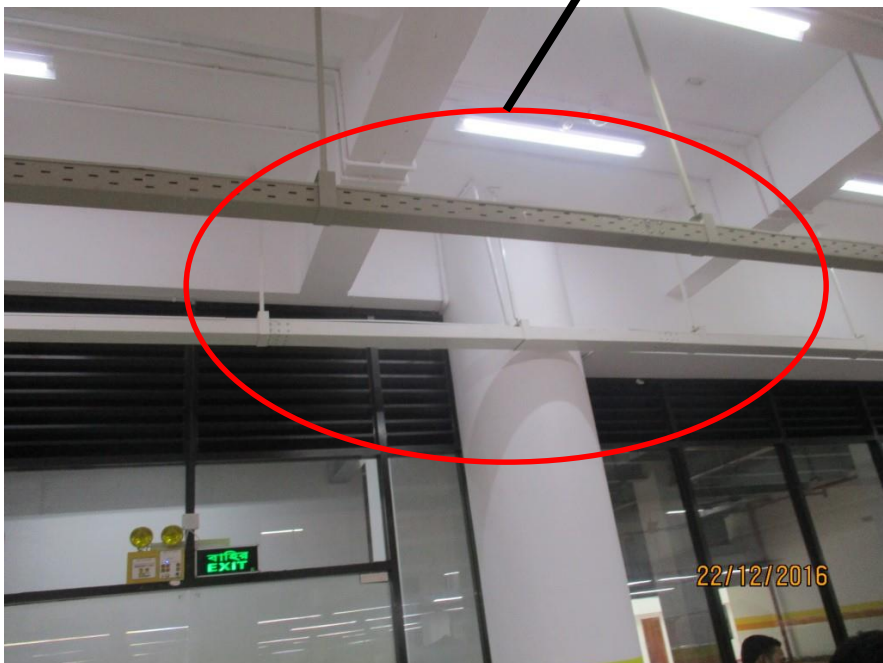
In provided drawing, same depth was written for retrofitted and non retrofitted FB-2 beam whereas during inspection, depth was found different.

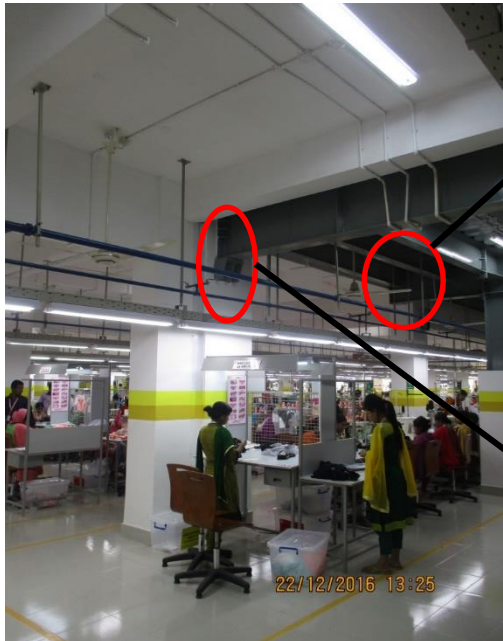
Beam connection between Steel and RCC part

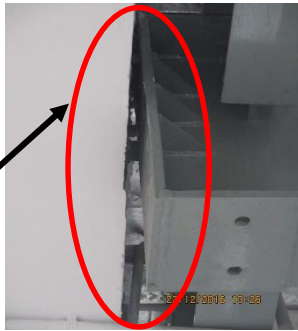
Observed large gap in steel-RCC beam connection

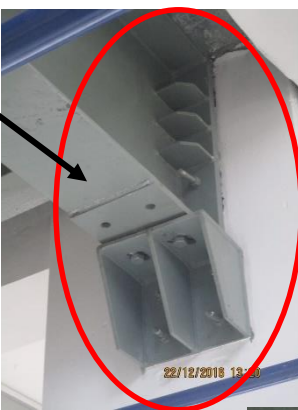
No connection detail was found with corbel connection

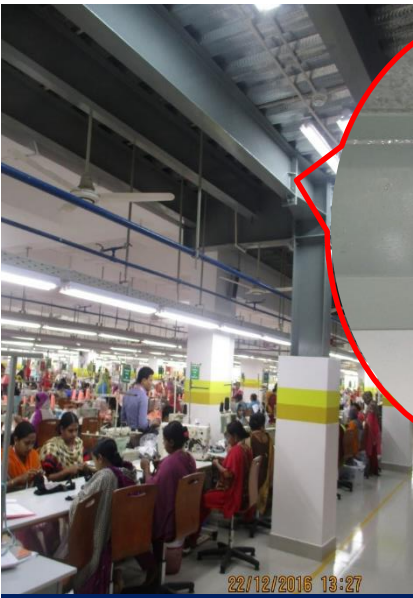
Loose connection observed at beam joint on several area

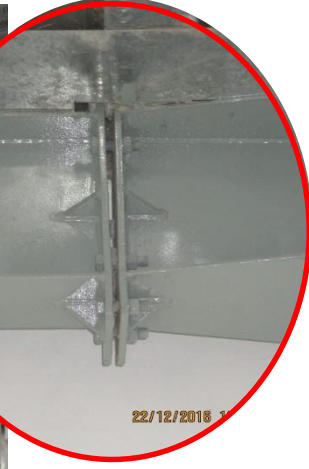
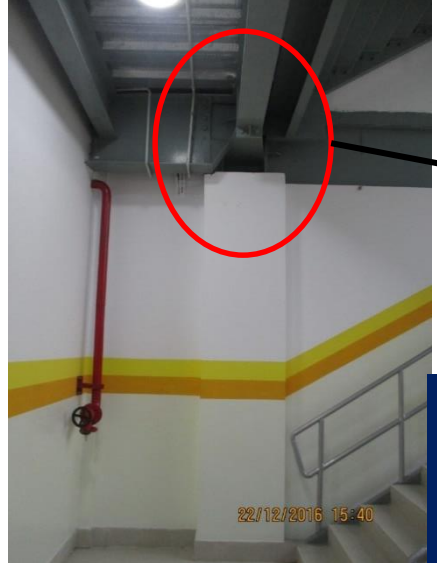
No connection detail was found for the fire stair beam connection

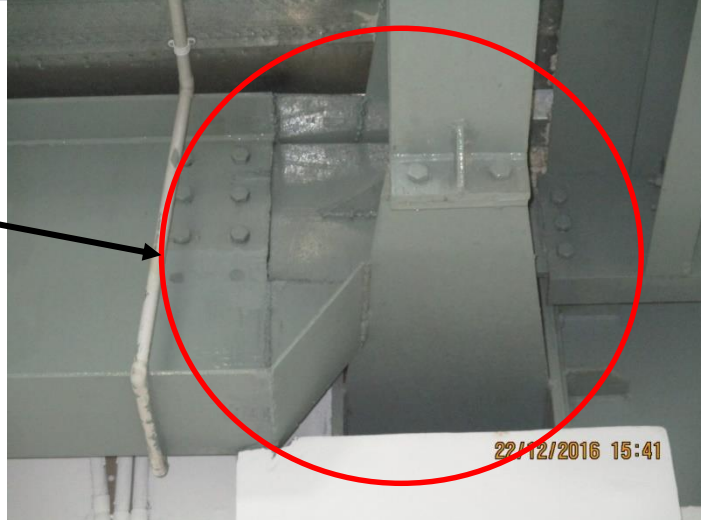
Top flange of beam was found welded with top flange of another beam

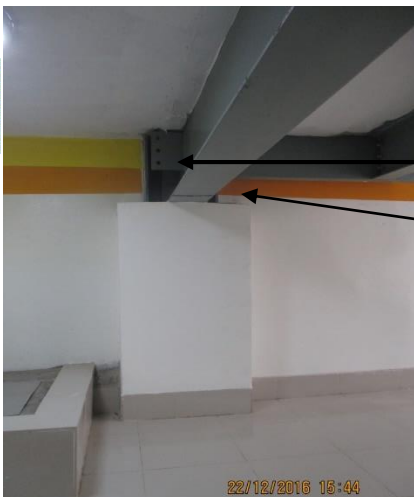
Apparently very poor connection between Column and Beam of Stair-3

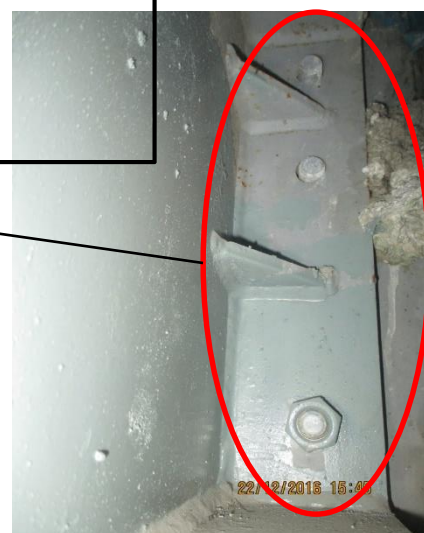
Missing bolts were observed on Column connection

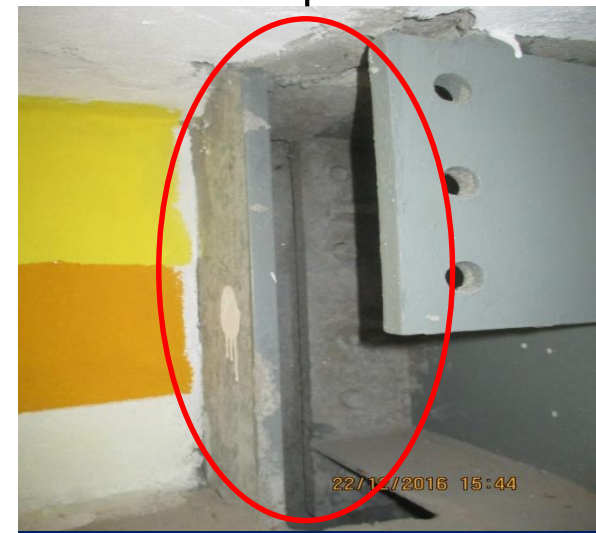
At Column beam connection, no bolt was found

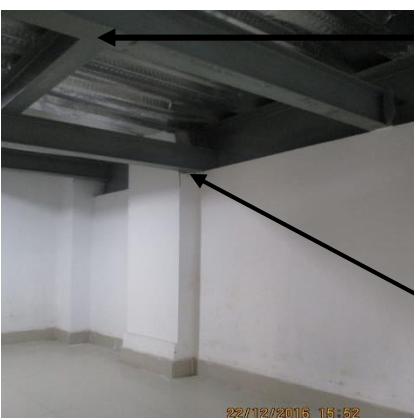
Apparently non engineered connection between two structural members

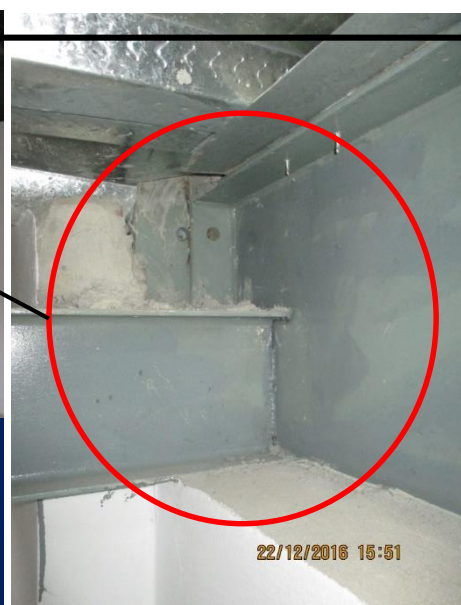
No proper connection was observed among secondary & main beam with column

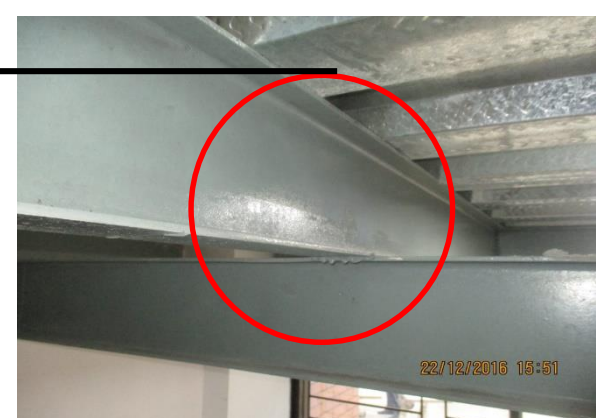
Welded connection was found between main & secondary beam

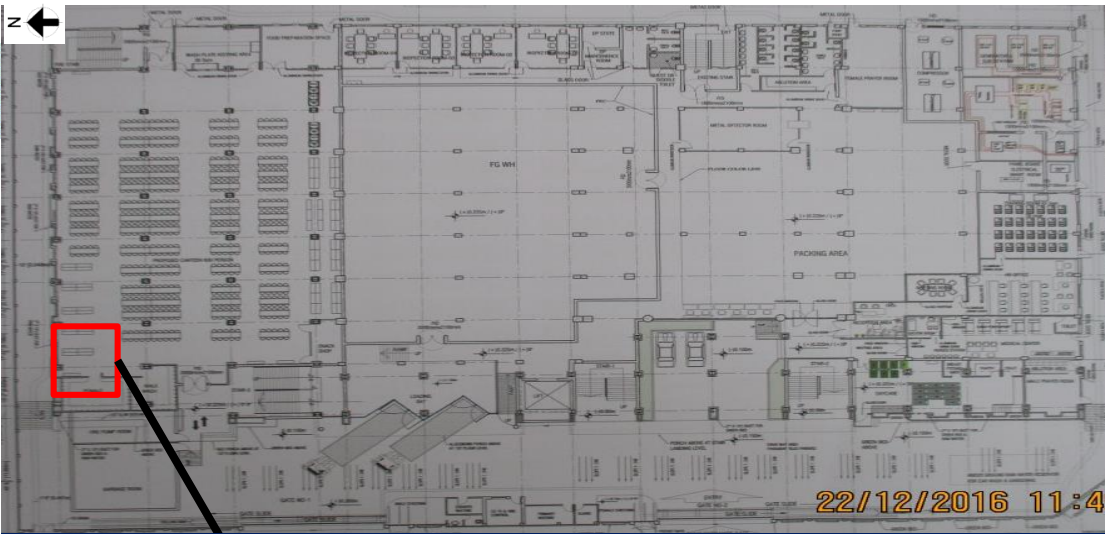
Typical beam layout plan

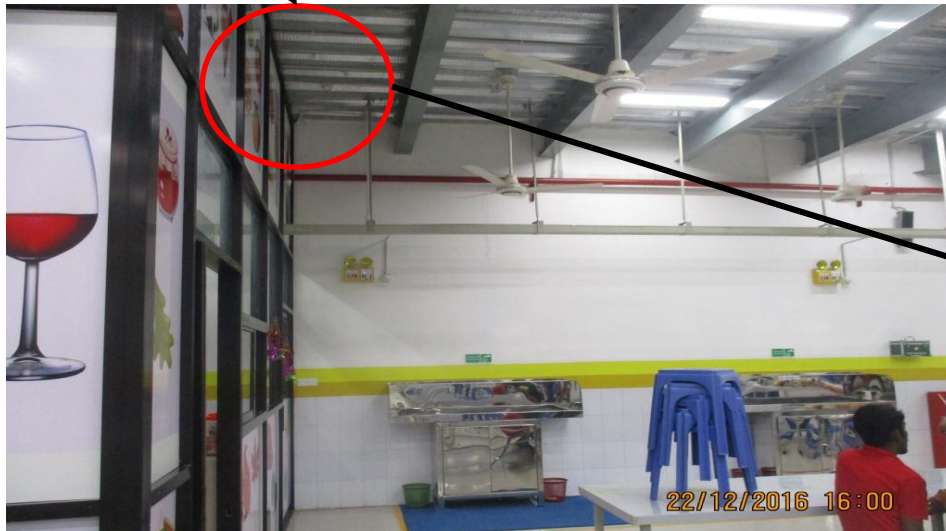
Damage of deck metal sheet was observed near the dining area on ground floor

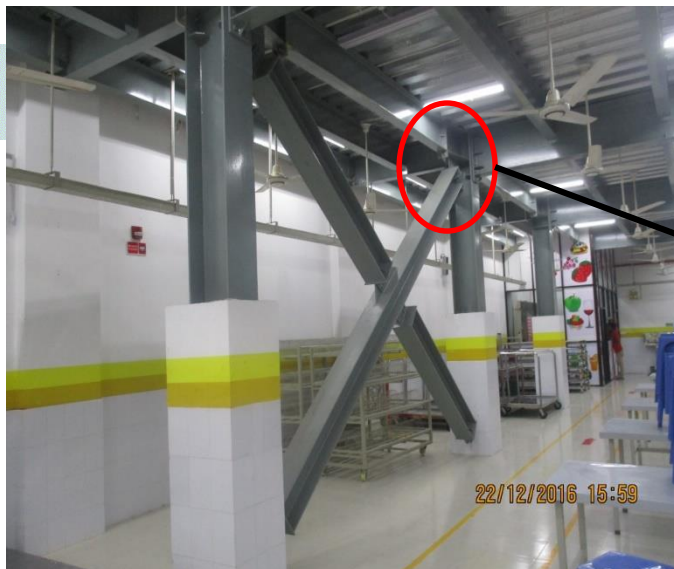
Corrosion was observed at joint of 'X' bracing with column on ground floor

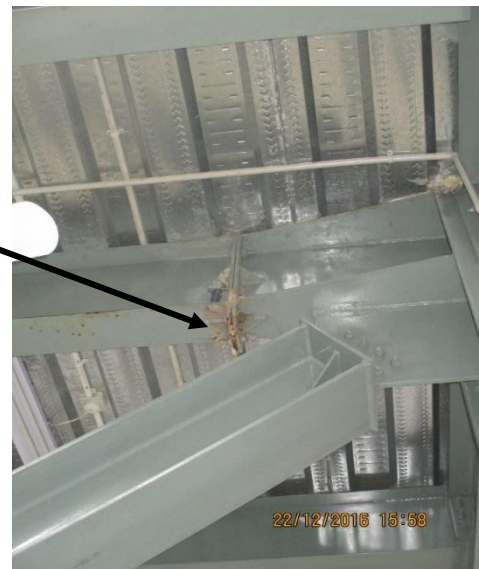
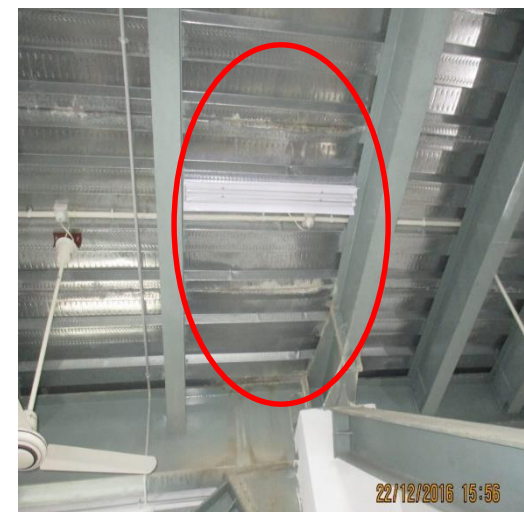
Corrosion was observed on ground floor deck sheet

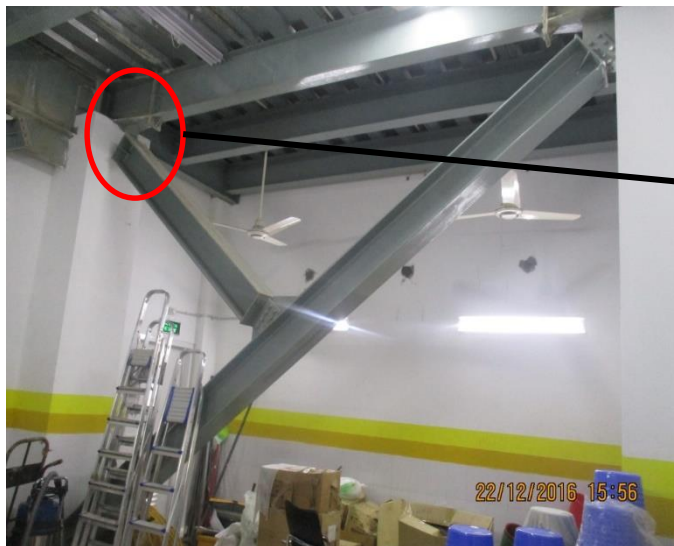
Corrosion was observed at joint of eccentric bracing with column on ground floor

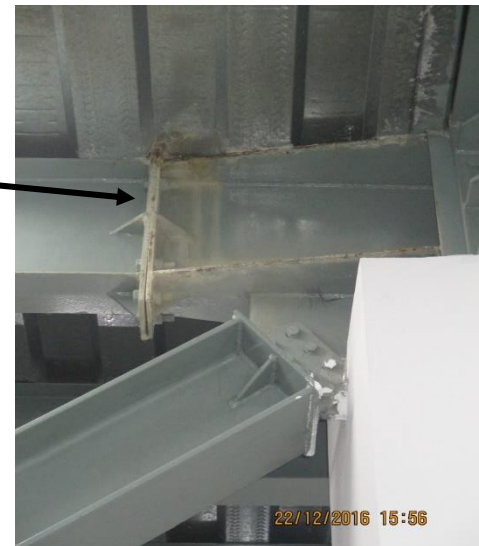
Corrosion was observed on several area on ground floor steel part .Factory is required to identified the reason and repair with appropriate method
