# Cotton Club (BD) Ltd.

## Cotton Clout (BD) Ltd.

South Jarun, Kashimpur, Gazipur, Dhaka  
(+23.990928N, 90.321769E)

05 October 2013

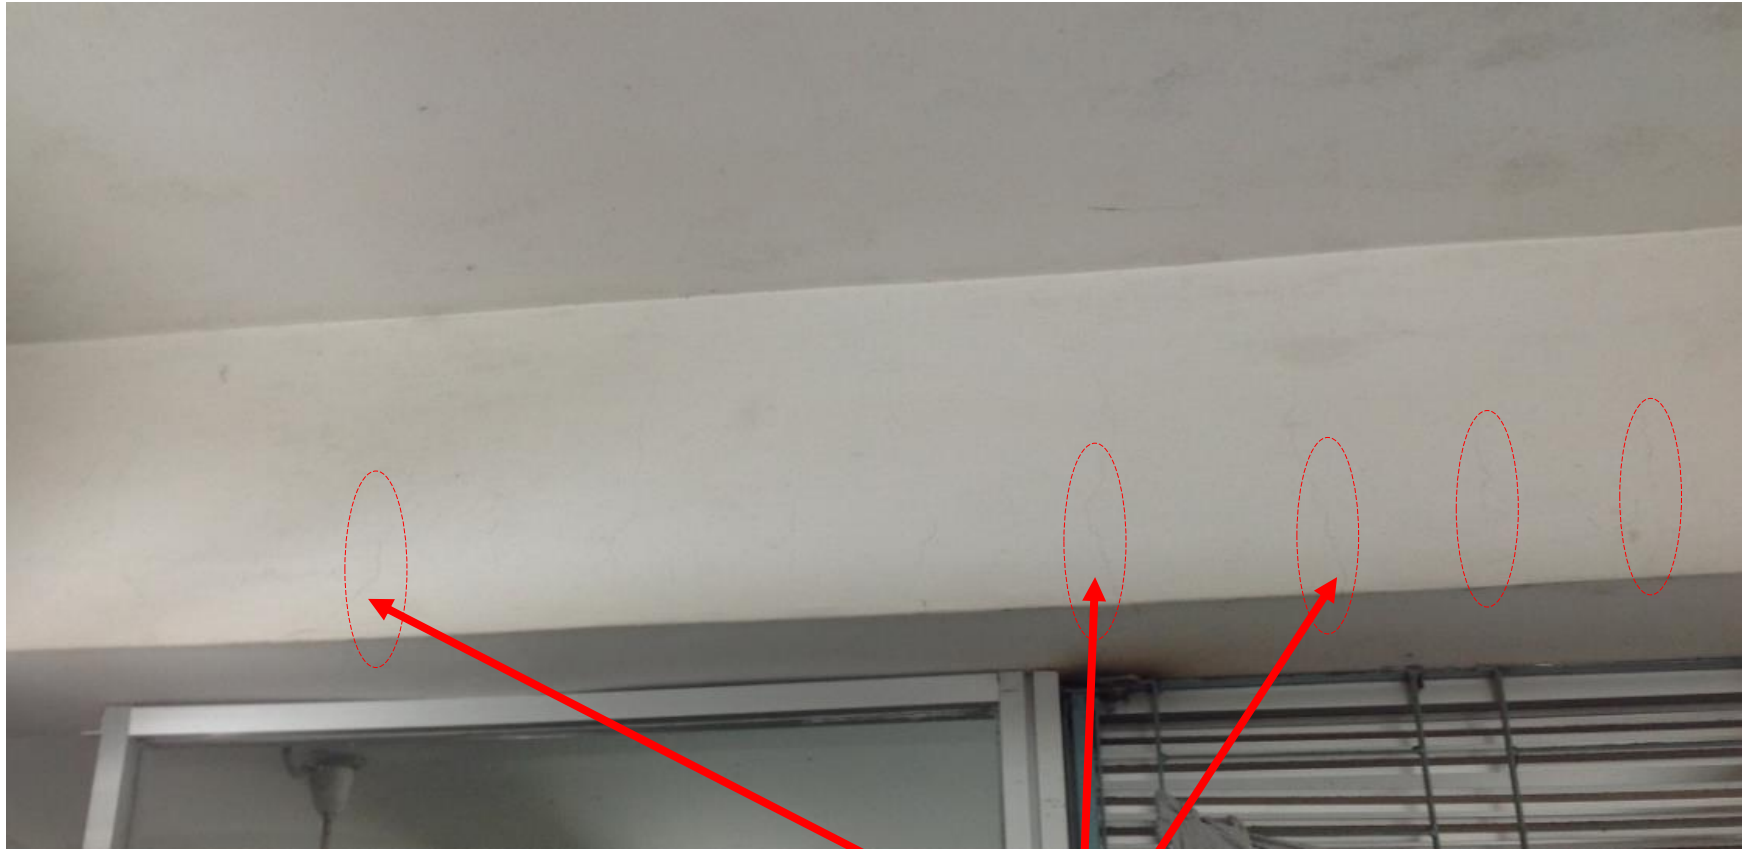
# Hairline Cracks at slab and beams

**Hairline Cracks in Beams**

## **Hairline Cracks at beam and Slabs**

1. Uncontrolled loading on all floors from stacked bags of fabric
2. Hairline cracks in most beams and some slab soffits
3. Cracking to screed on top of slabs in a number of locations
4. Holes made through beam for electrical cables
5. Secondary buildings connected to main building at second and third floors but not at first

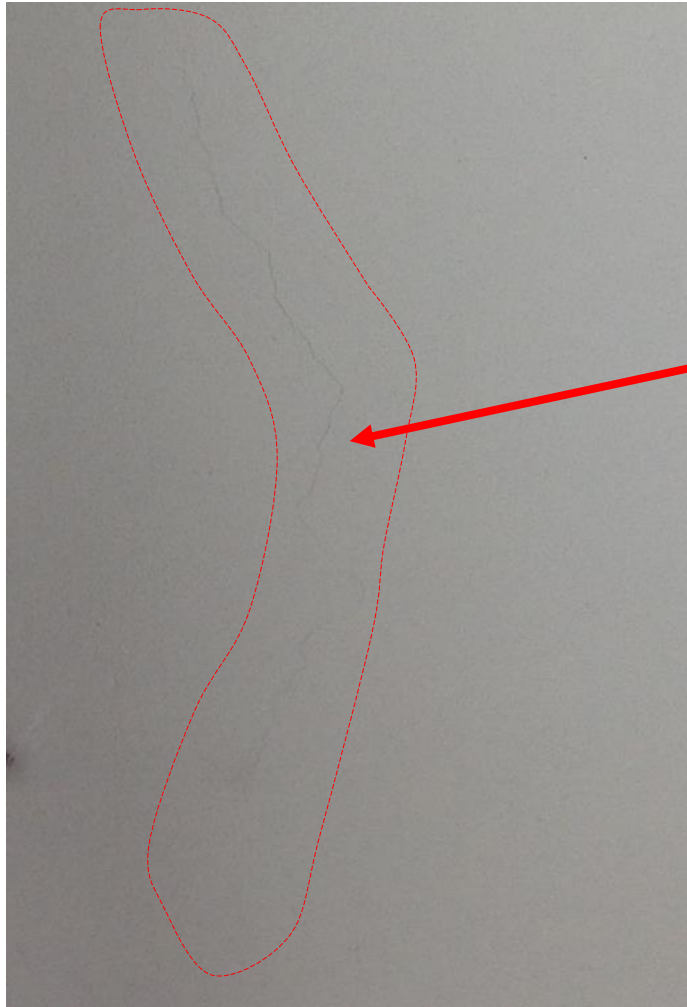
**Hairline Cracks in Underside  
of Slab**

**Hairline Cracks at Beam and Slabs**

| Item No. | Observation | Recommended Action Plan | Recommended Timeline |
|---|---|---|---|
| 4 | Hairline cracks in most beams and some slab soffits | Break out small area of cracked screed to check if cracks are also in structural slab. If cracks are in slab consult the Factory structural engineer for required action. The engineer is undertake this action giving consideration to Item 1 actions. | 6-weeks |

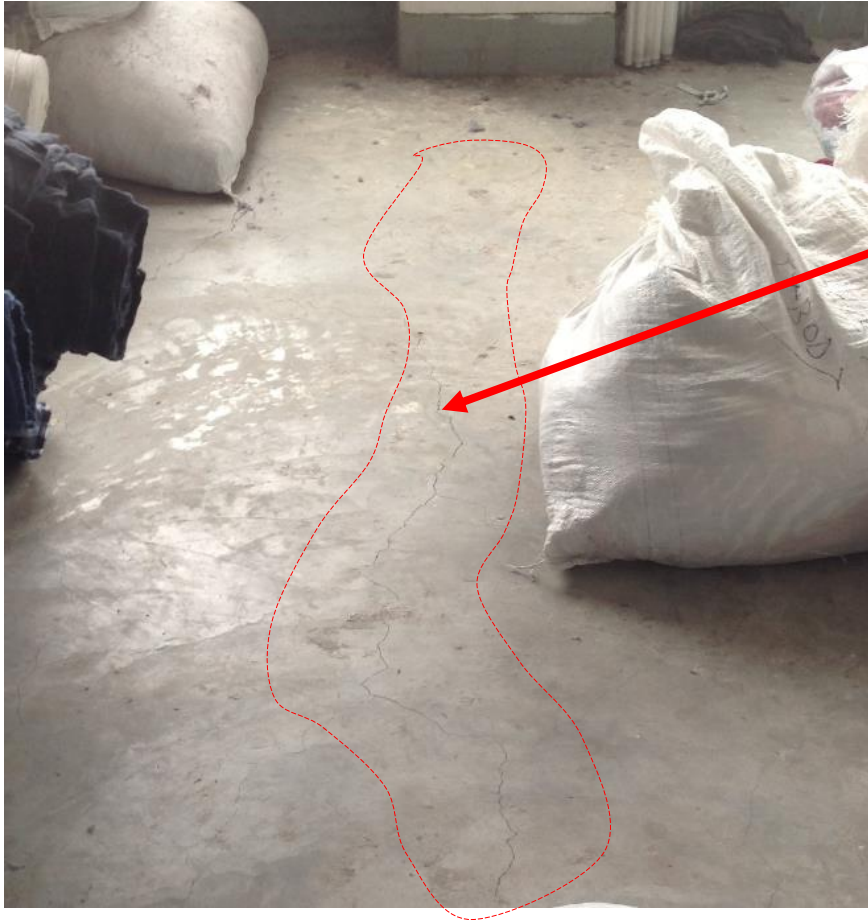
# Cracks in Screed

**Cracks in Screed**

| Item No. | Observation | Recommended Action Plan | Recommended Timeline |
|---|---|---|---|
| 5 | Cracking to screed on top of slabs in a number of locations | Engineer to monitor cracking to ensure it does not worsen. | 6-weeks |
| 6 | Cracking to screed on top of slabs in a number of locations | Engineer to consider cracking when undertaking action for item 1. | 6-months |

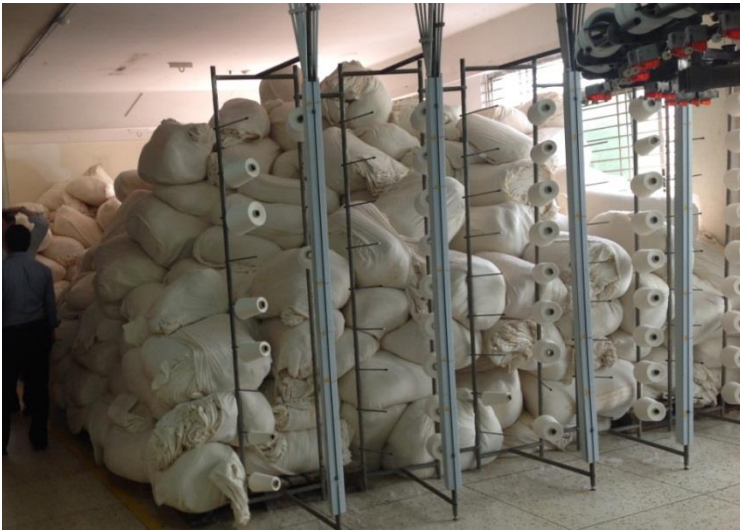
**Uncontrolled loading  
from bagged fabric on a  
limited number of floors.**

**Load Management is  
required**

| Item No. | Observation | Recommended Action Plan | Recommended Timeline |
|---|---|---|---|
| 1 | Uncontrolled loading on all floors from stacked bags of fabric | Reduce stack heights to 1.5m | 6-weeks |
| 2 | Uncontrolled loading on all floors from stacked bags of fabric | Ensure that stacks of materials within the main factory building and fabric store are separated by a 0.5m gap all around | 6-weeks |
| 3 | Uncontrolled loading on all floors from stacked bags of fabric | Building Engineer to create controlled loading plans for all floors designating where storage can be placed and can not be placed taking consideration of capacity of double height column at ground level. Engineer to take into consideration the existing hairline cracking noted in item 2 & 3. | 6-months |

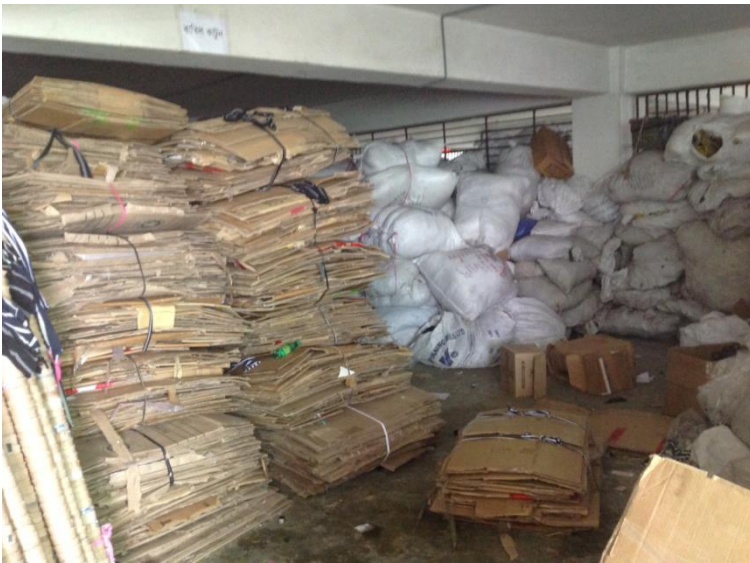
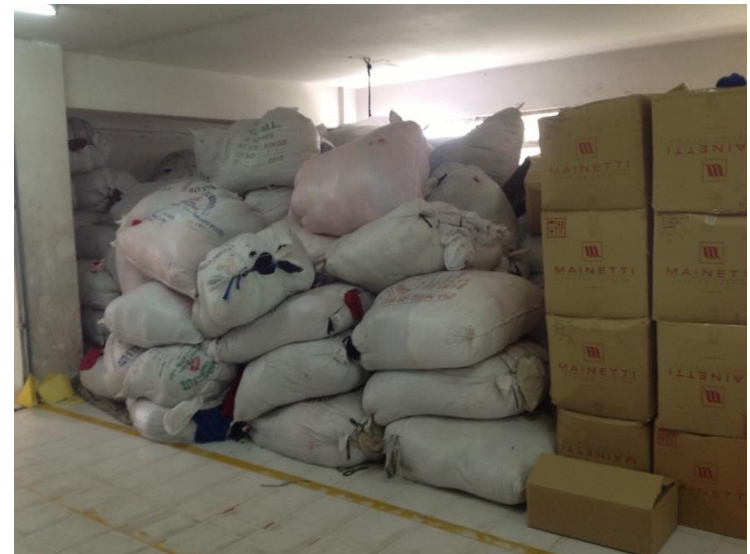
**Load Management**

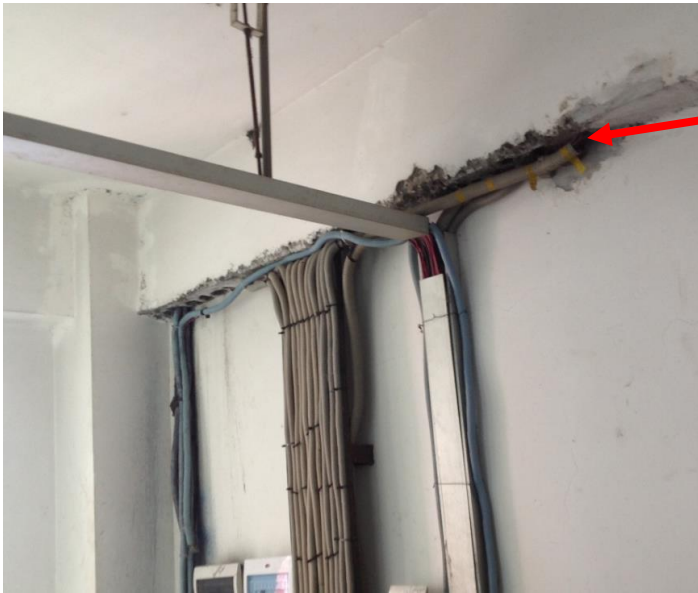
# Holes made through beam for electrical cables

**Holes through beam**

**Holes through slab**

| Item No. | Observation | Recommended Action Plan | Recommended Timeline |
|---|---|---|---|
| 7 | Holes made through beam for electrical cables | Engineer to review penetrations made as part of recent electrical upgrade to ensure structural beams/ slabs have not been affected. | 6-months |

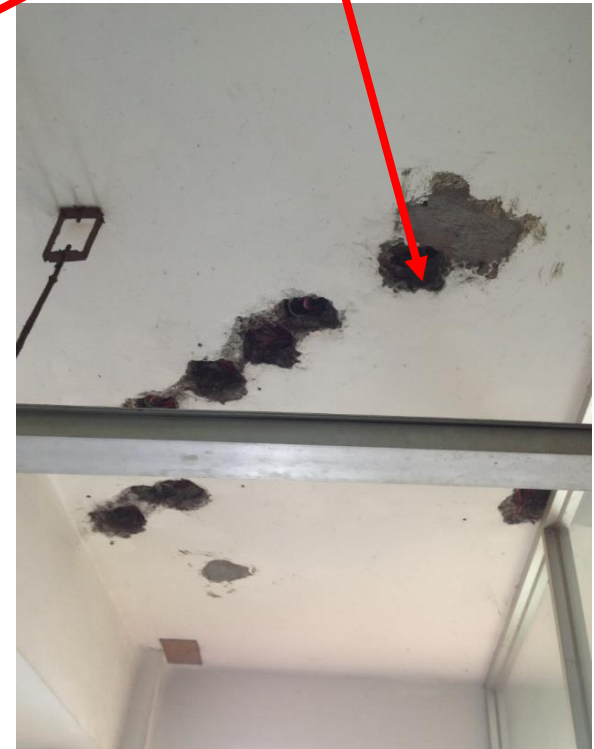
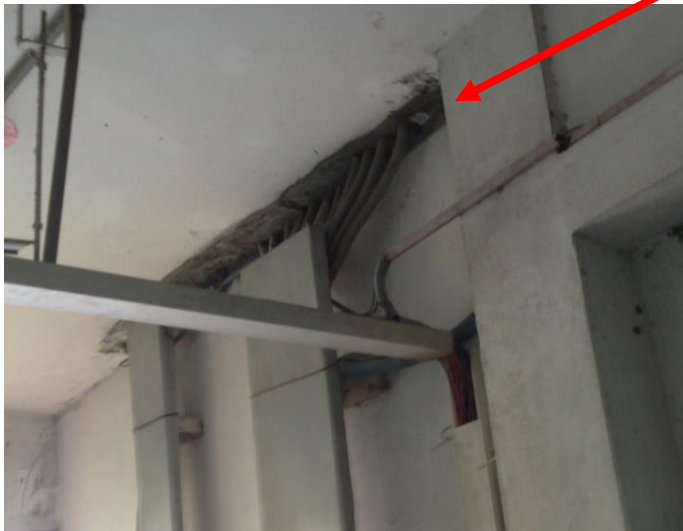
**Holes through slabs and beams**

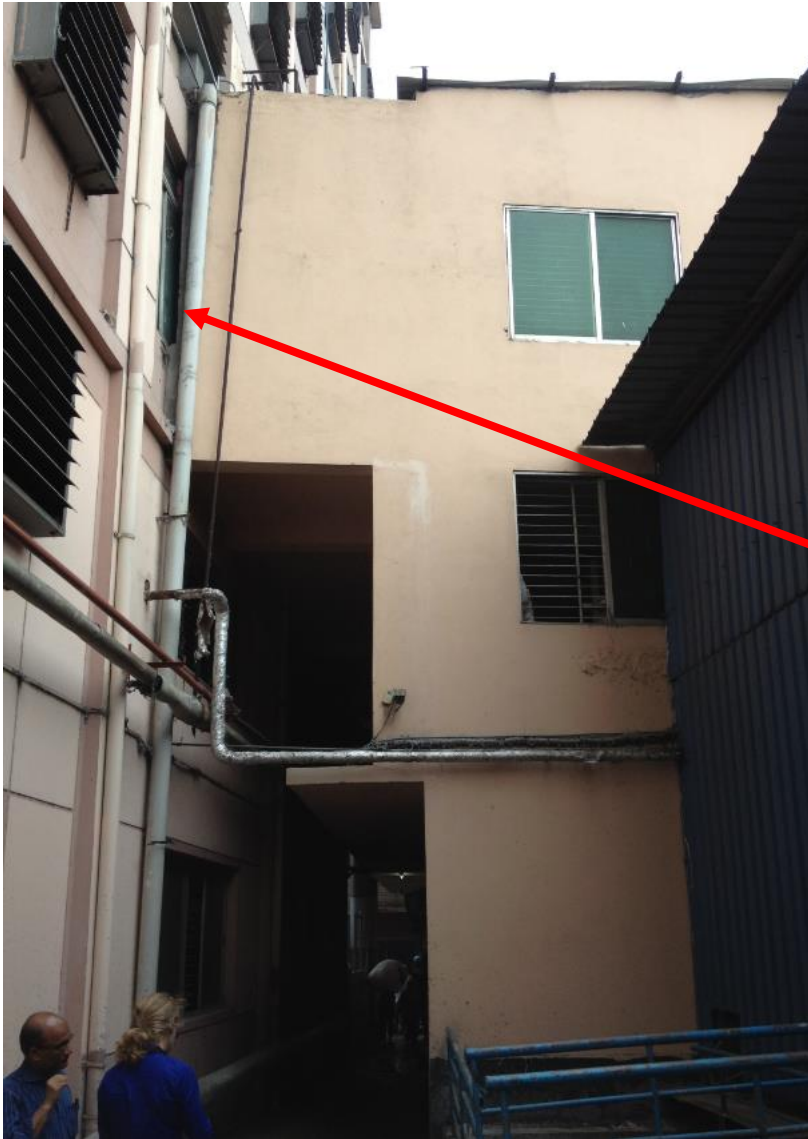
**Secondary buildings connected to main building  
at second and third floors but not at first**

**Secondary Building  
connected to Main  
Building at third floor**

**No structural drawings  
for secondary building.  
How buildings are joined  
could not be confirmed**

## **Secondary Building Connection**
