# UTAH Knitting & Dyeing Ltd. (Extension)

Bokran-Monipur, Hotapara, Gazipur, Bangladesh  
(24.125801, 90.389984)

06<sup>th</sup> January and 4<sup>th</sup> & 19<sup>th</sup> Feb 2020

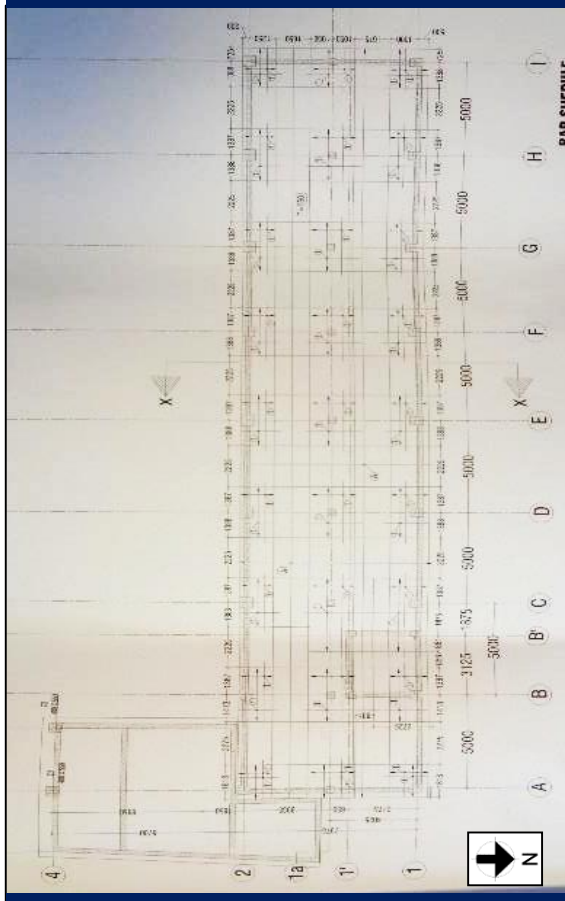
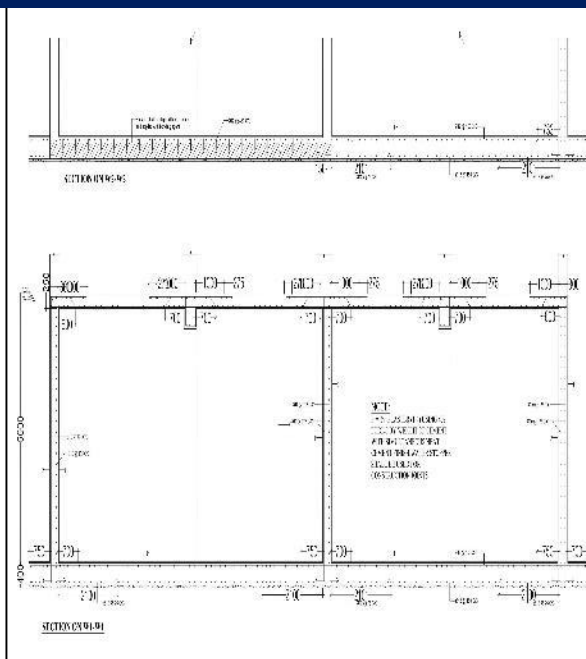
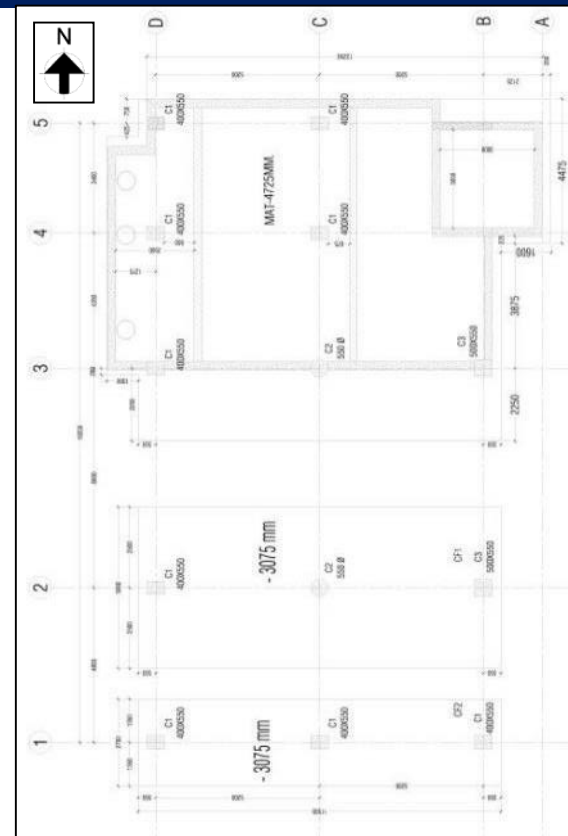
No geotechnical investigation report was found for the Building-9 Chemical Building (New), Building-10 (Thermo Oil Building) and Building-11 (Washing Extension Building). The factory management stated that, the geotechnical evaluation was done for the mentioned buildings based on the previous geotechnical investigation report that was produced for the factory buildings under ACCORD ID: 9533. But no bore hole sample for Building-9, 10 & 11 has been taken in the previous geotechnical investigation report . Thus, new geotechnical investigation report for the mentioned buildings is required to confirm the foundation adequacies for bearing.

| Item No. | Observation | Recommended Action Plan | Recommended Timeline |
|---|---|---|---|
| 1 | No geotechnical investigation report.<br>(Building-9, 10 and 11) | Carryout geotechnical investigation. | 6-weeks |
| 2 | No geotechnical investigation report.<br>(Building-9, 10 and 11) | Check the foundation adequacies and prepare a report regarding the adequacy check. | 6-weeks |
| 3 | No geotechnical investigation report.<br>(Building-9, 10 and 11) | Carry out remedial works where necessary. | 6-months |

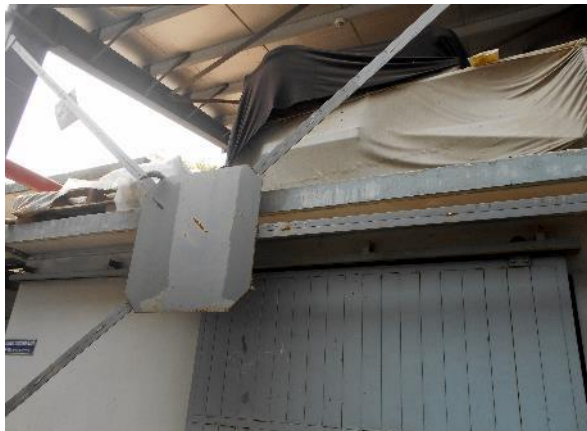
Bracing on site

Some bracing has not been installed as per drawings. Details of bracing connection is missing in the drawing. Lateral load transfer mechanism between braced frames is not clear.

| Item No. | Observation | Recommended Action Plan | Recommended Timeline |
|---|---|---|---|
| 4 | Improper bracing system.<br>(Building-8: ETP Shed) | Prepare “as constructed” drawings with complete structural information. | 6-weeks |
| 5 | Improper bracing system.<br>(Building-8: ETP Shed) | Engineering assessment is required to be carried out to confirm the lateral stability. | 6-weeks |
| 6 | Improper bracing system.<br>(Building-8: ETP Shed) | Carry out remedial works where necessary. | 6-months |

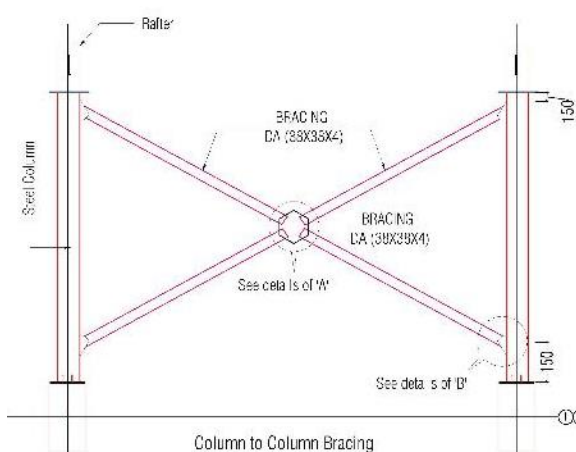
Bracing in drawing

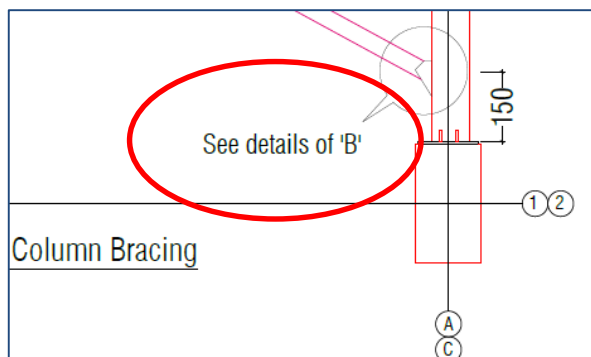
No details of "B" was found

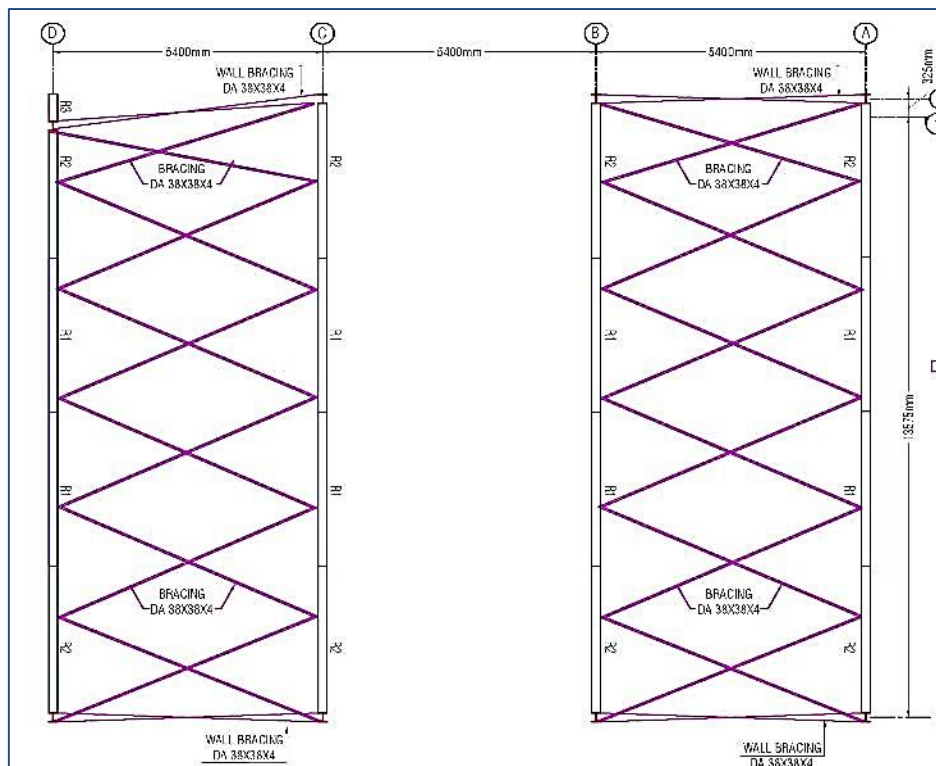
Compression strut missing between grid B and C

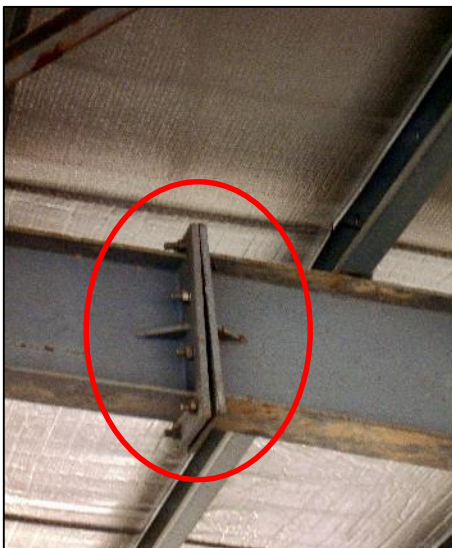
Gap in connection plate

Significant gap found between connection plates in several locations. The factory engineer to take remedial actions to repair the connections where required.

| Item No. | Observation | Recommended Action Plan | Recommended Timeline |
|---|---|---|---|
| 7 | Gap between connection plates. (Building-8: ETP Shed) | The factory engineer to investigate the connections and repair with proper remedial method. | 6-weeks |

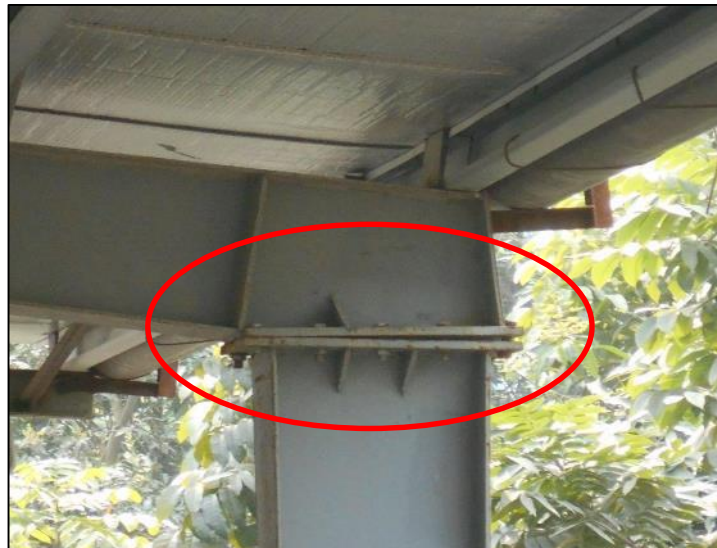
Gap in connection plate

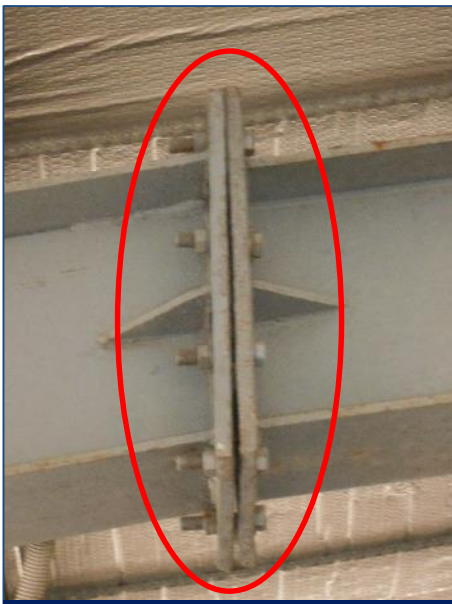
Gap in connection plate

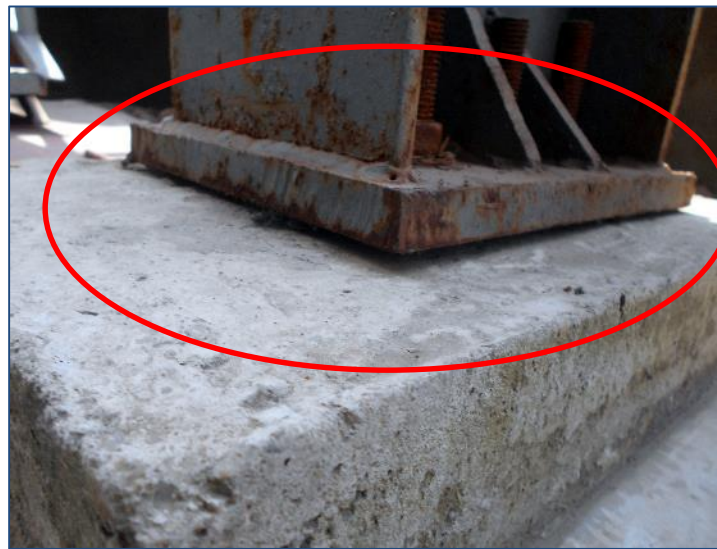
Gap between baseplate and concrete short column

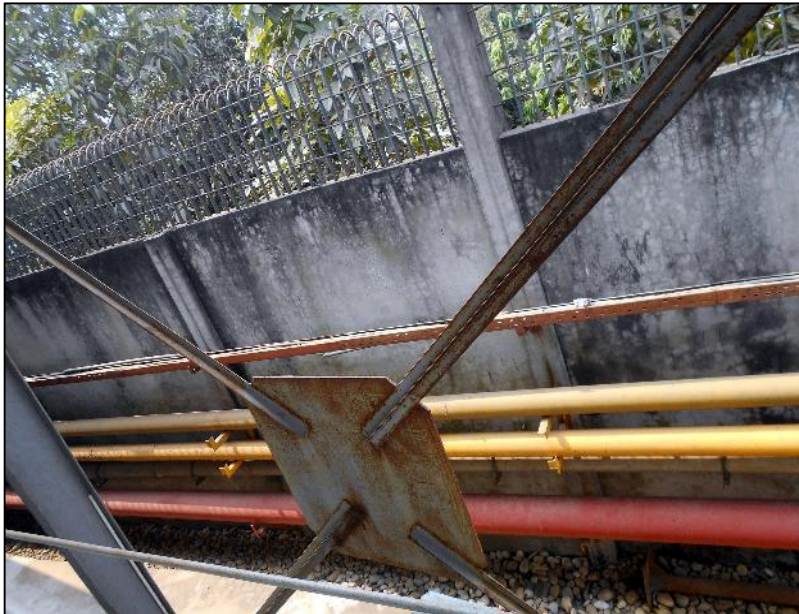
Corrosion in bracing

Corrosion found in column, bolt and bracing members. The factory engineer to investigate the reason & extent of corrosion and suggest proper remedial measure accordingly.

| Item No. | Observation | Recommended Action Plan | Recommended Timeline |
|---|---|---|---|
| 8 | Corrosion in steel member.<br>(Building-8: ETP Shed) | The factory engineer to investigate the reason & extent of corrosion and implement proper remedial measure accordingly. | 6-weeks |

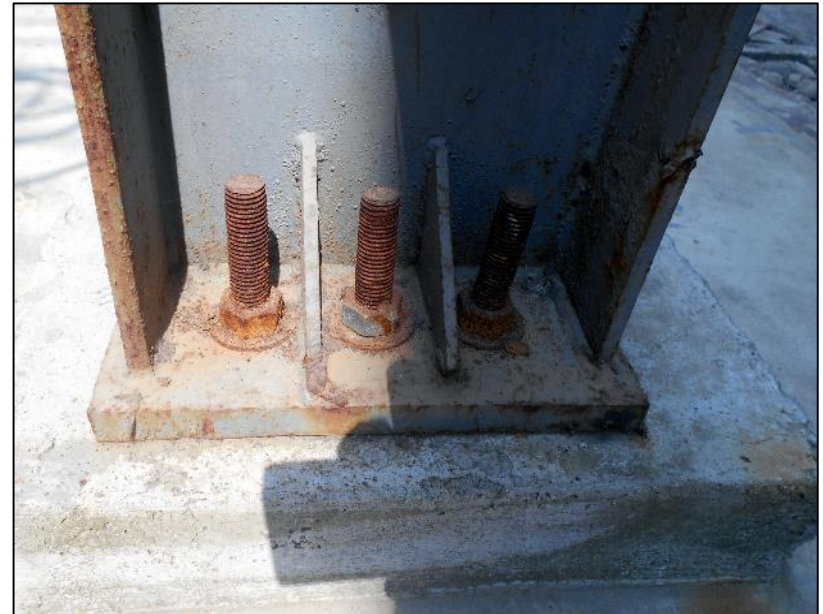
Corrosion in column and bolt

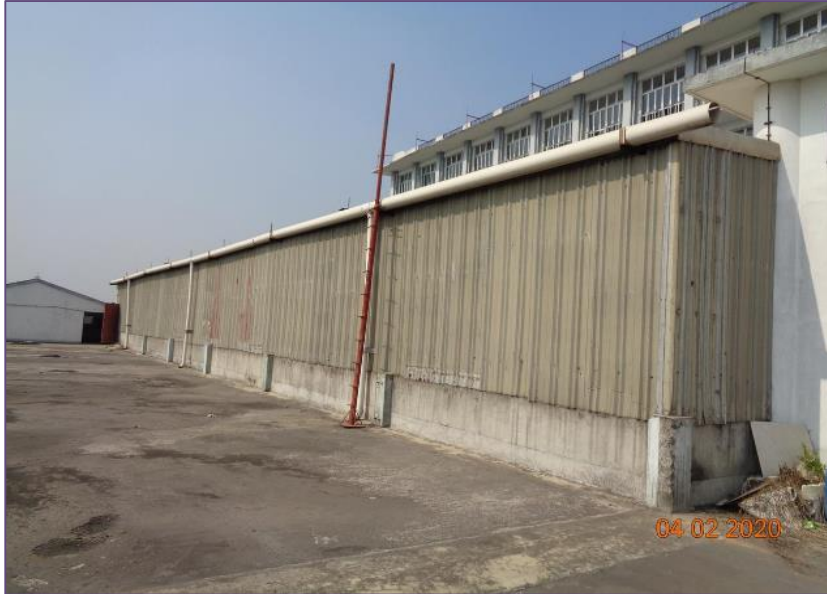
Steel shed at roof

Steel shed was found on the roof of the chemical building (New). As-built drawing and design documents for the steel shed was not available. Factory engineer is required to prepare “as-built” drawings with complete structural information.

| Item No. | Observation | Recommended Action Plan | Recommended Timeline |
|---|---|---|---|
| 9 | Lack of drawing of steel shed at roof. (Building-9: Chemical Building New) | Prepare as-built drawings with complete structural information. | 6-weeks |

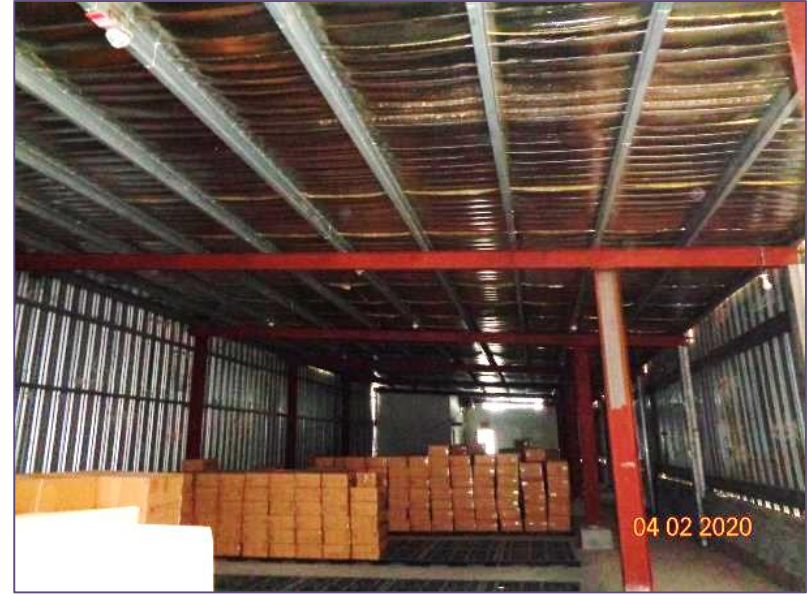
Interior of steel shed

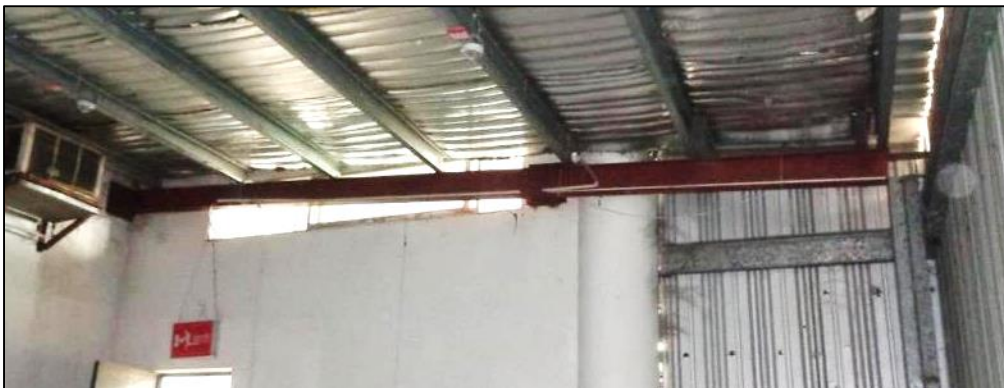
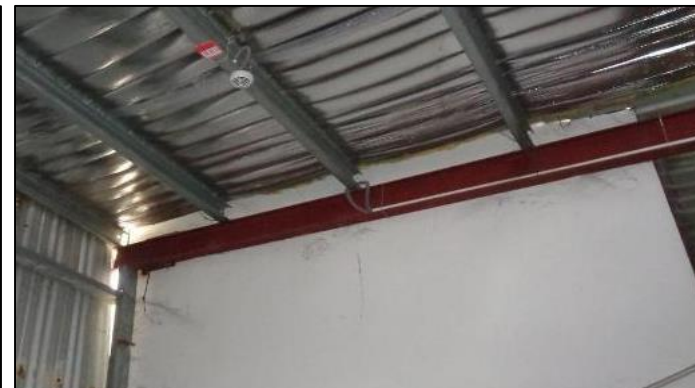
Connection of rafter with wall

Along the long direction of the roof shed, no load transfer mechanism was found except some purlins. The factory engineer is required to check the lateral stability of the shed as part Engineering Assessment.

| Item No. | Observation | Recommended Action Plan | Recommended Timeline |
|---|---|---|---|
| 10 | Lack of lateral stability of steel shed at roof. (Building-9: Chemical Building New) | The factory engineer is required to carry out an Engineering Assessment (EA) for the steel shed. | 6-weeks |
| 11 | Lack of lateral stability of steel shed at roof. (Building-9: Chemical Building New) | Implement the recommendation of EA. | 6-months |

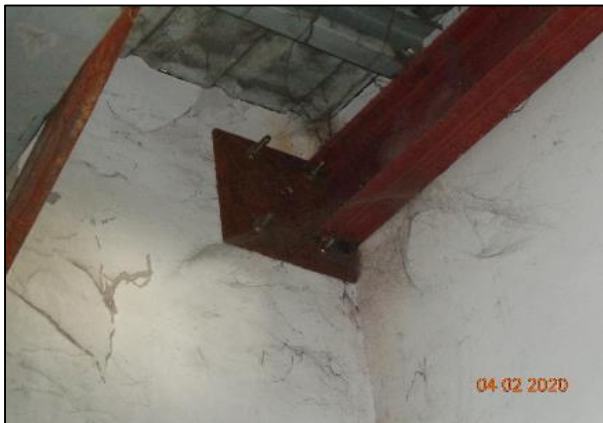
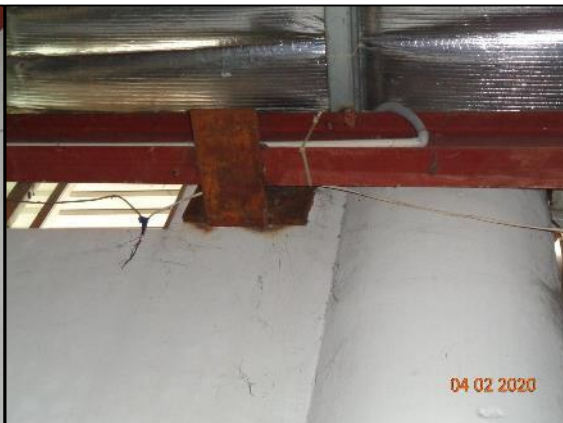
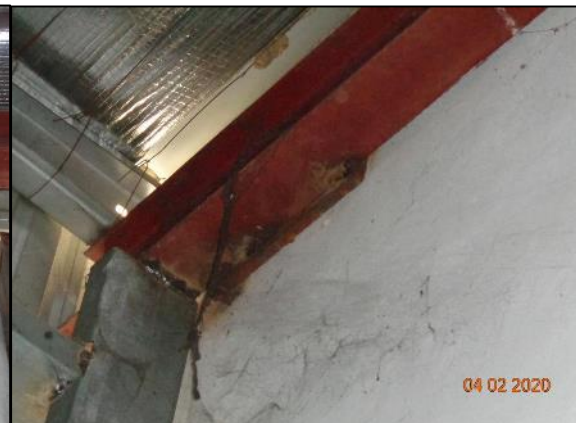
Connections of steel sheds

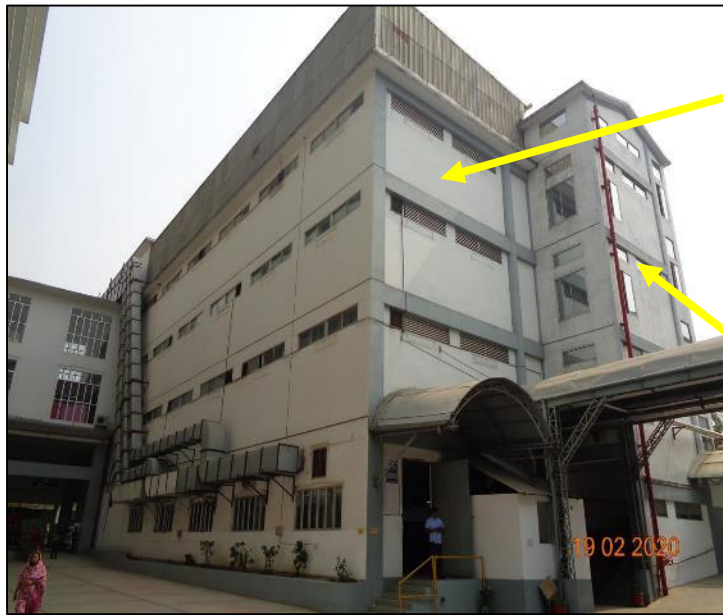
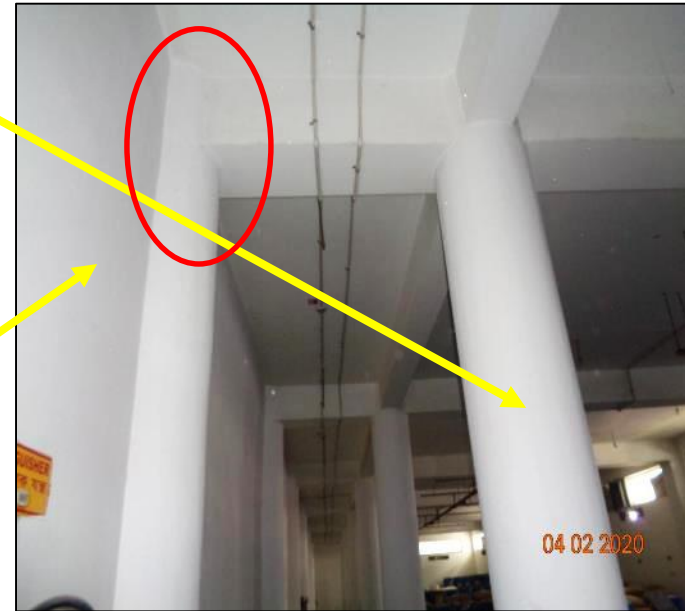
No gap provided between the old and new part of Chemical Building. The factory engineer is required to assess the maximum displacement of the building for the critical loadings and take necessary actions accordingly.

| Item No. | Observation | Recommended Action Plan | Recommended Timeline |
|---|---|---|---|
| 12 | Lack of expansion gap between old and new Chemical Building. (Building-9) | The factory engineer is required to assess the maximum displacement of the building for the critical loadings. | 6-weeks |
| 13 | Lack of expansion gap between old and new Chemical Building. (Building-9) | Provide the expansion gap between the New & Old building as required. | 6-months |

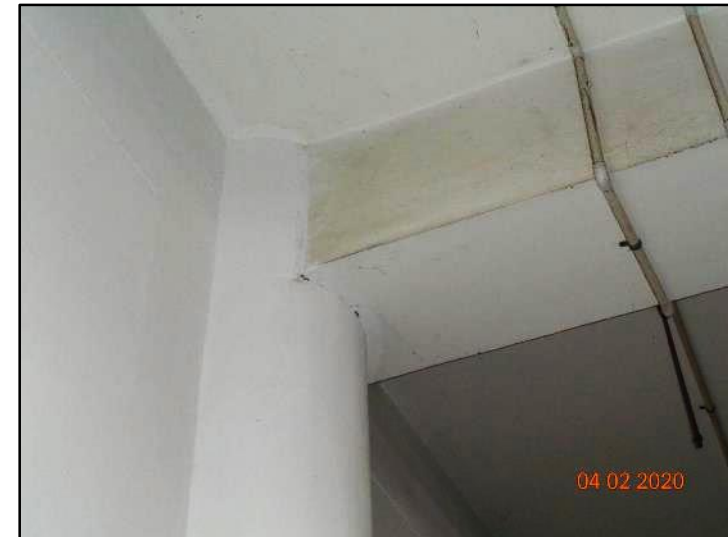
No gap has been provided

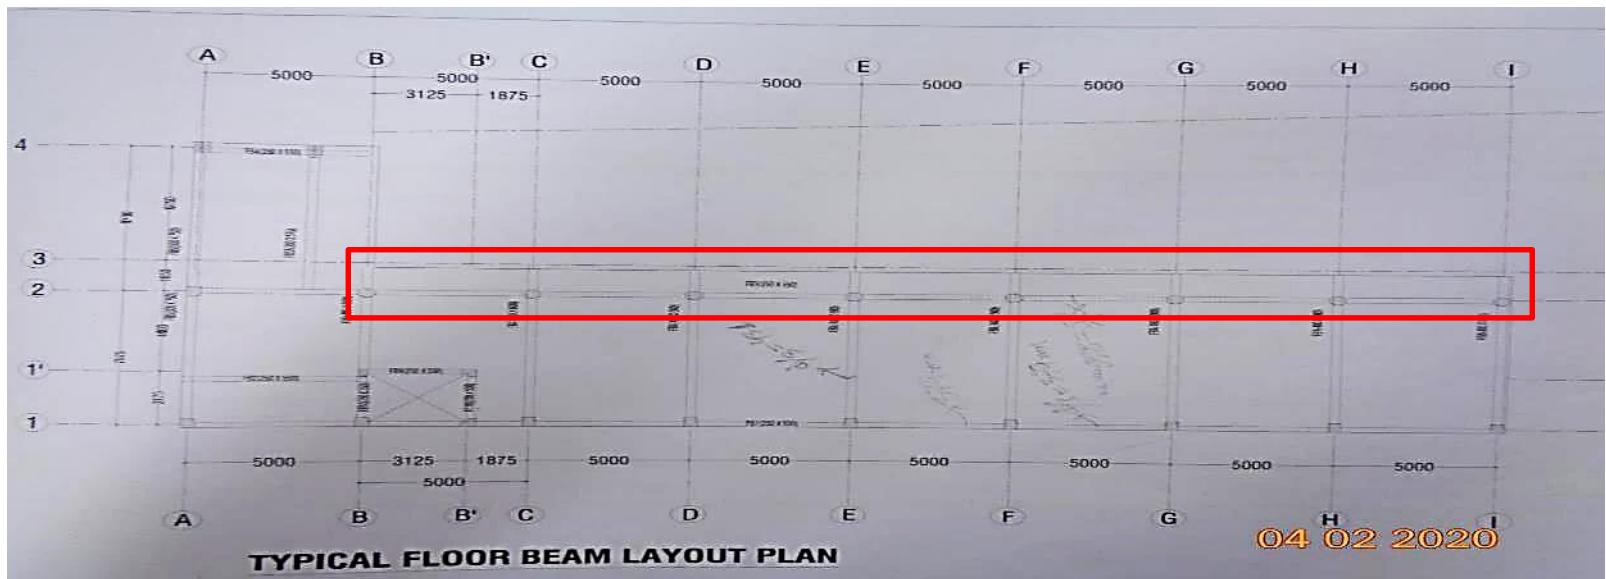
Cantilever beam in the layout drawing

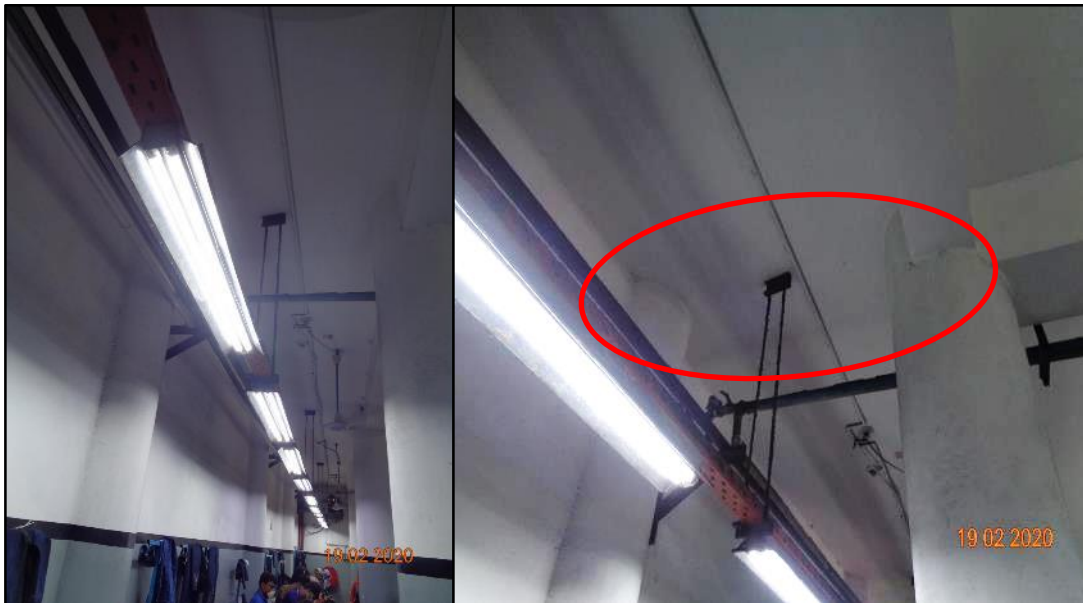
Cantilever beam was not found at 1st floor level

Cantilever beam was shown in the provided drawings but was not found on site at 1<sup>st</sup> floor level. The factory engineer is required to prepare “as-built” drawings with complete structural information.

| Item No. | Observation | Recommended Action Plan | Recommended Timeline |
|---|---|---|---|
| 14 | Discrepancies between drawing and as-built condition. (Building-9: Chemical Building New) | The factory engineer is required to survey the structure and develop as-built drawings which reflect the on-site condition. | 6-weeks |
| 15 | Discrepancies between drawing and as-built condition. (Building-9: Chemical Building New) | Check the capacity of the RC cantilever slab. | 6-weeks |

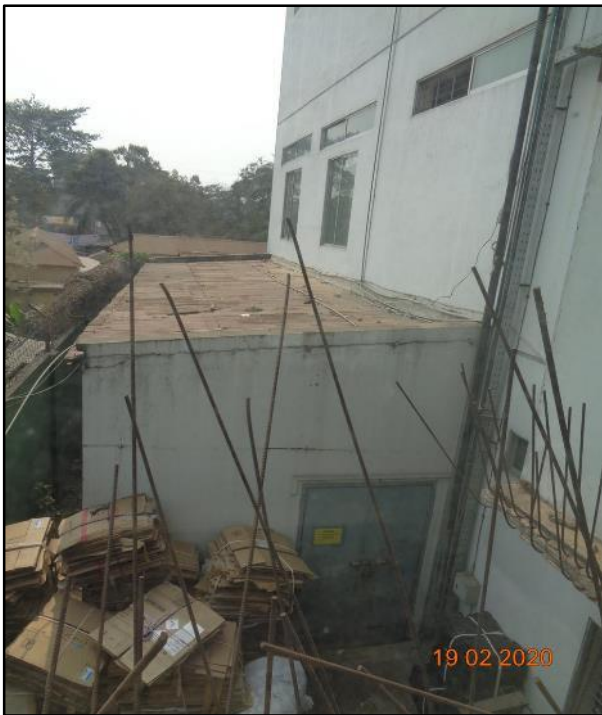
Waste store

Undocumented waste store was found at east side on ground floor of the building. The trusses are connected to the beam of the main building. Factory engineer is required to prepare “as-built” drawings with complete structural information. Also, the adequacy of trusses to be checked for gravity and lateral forces.

| Item No. | Observation | Recommended Action Plan | Recommended Timeline |
|---|---|---|---|
| 16 | Undocumented waste store at ground floor level. (Building-9: Chemical Building New) | Produce as-built drawings with complete structural information. | 6-weeks |
| 17 | Undocumented waste store at ground floor level. (Building-9: Chemical Building New) | The factory engineer to check the adequacy of roof trusses for the gravity and lateral forces. | 6-weeks |
| 18 | Undocumented waste store at ground floor level. (Building-9: Chemical Building New) | Carryout remedial works if required. | 6-months |

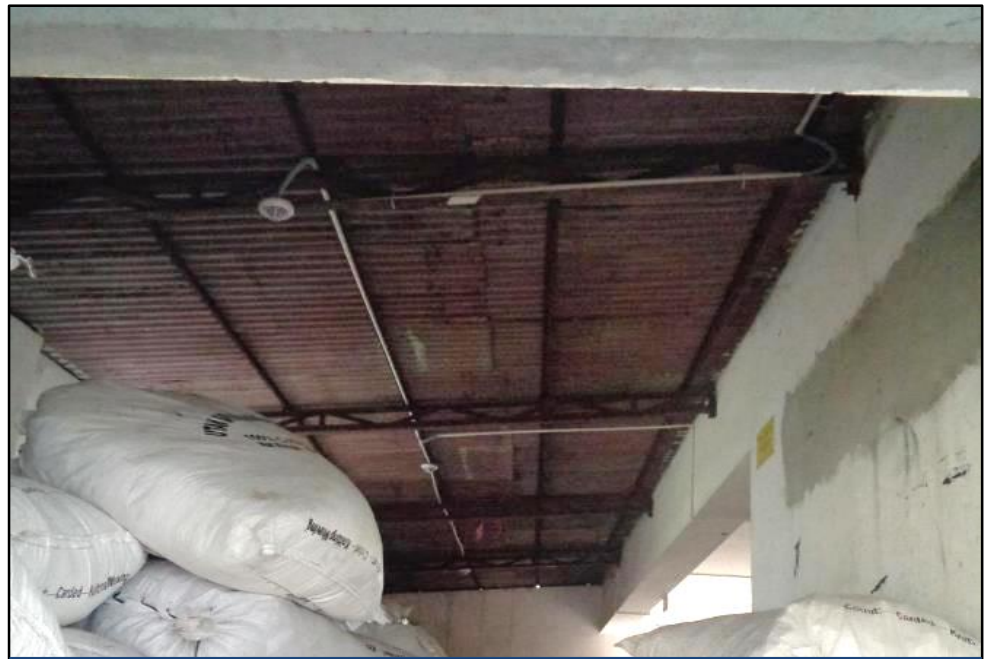
Trusses are connected to the beam of main building

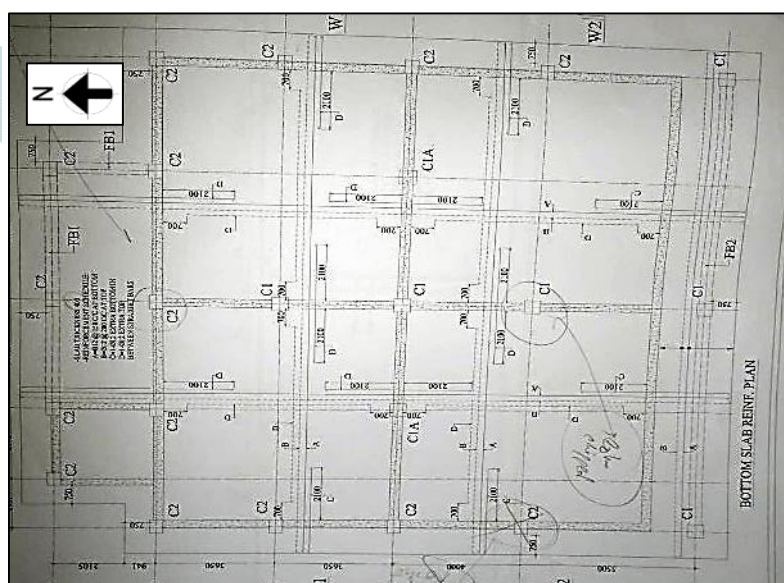
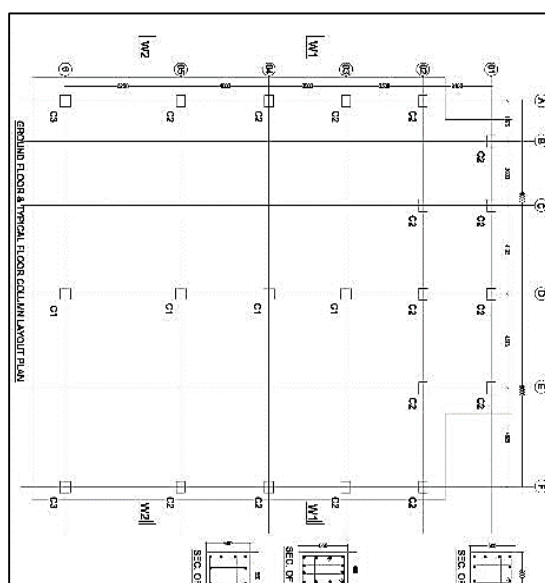
Mat Bottom slab reinforcement plan with column layout of thermo Oil Building

Column layout of thermo Oil Building

Mat slab reinforcement detail does not match with column layout of Thermo oil building.

| Item No. | Observation | Recommended Action Plan | Recommended Timeline |
|---|---|---|---|
| 19 | Inconsistencies in drawings. (Building-10 & 11: Thermo Oil Building & Washing Extension Building ) | Prepare as-built drawings with complete structural information. | 6-weeks |

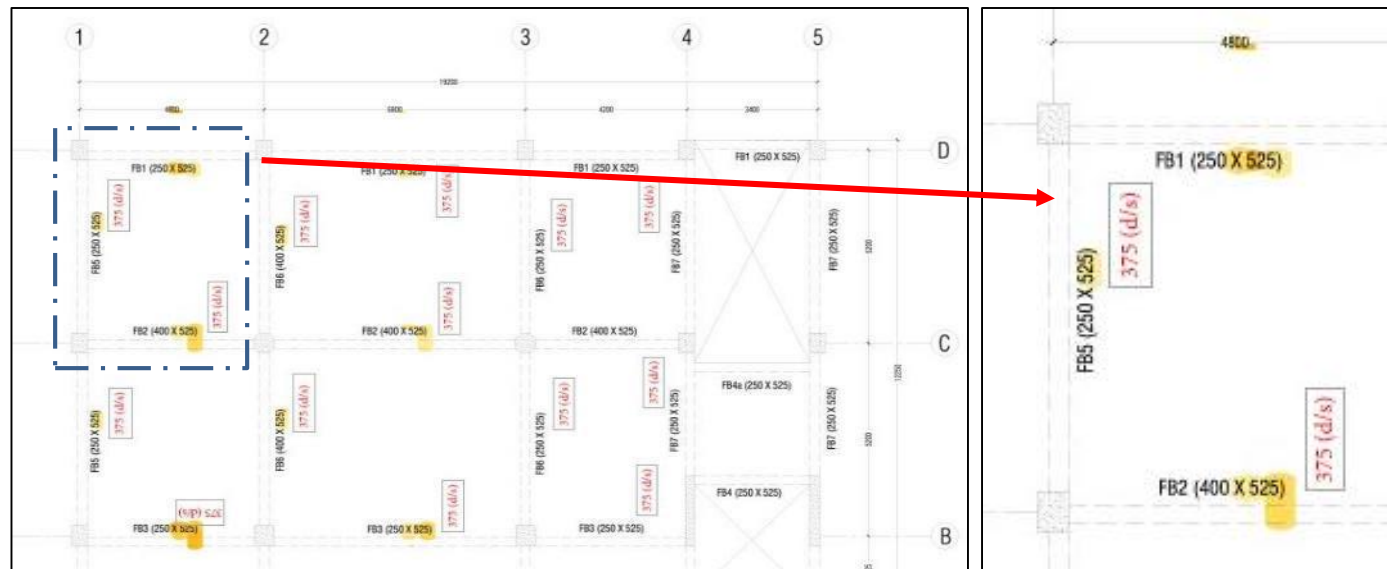
Beam layout of Washing Oil Building and Beam Dimension

Beam down stand of Washing building found 375 mm instead of 325 mm. The Slab thickness of washing building was found 200 mm instead of 150 mm. Some drawing as such lift core section, slab layout found missing. Revision of As-built drawing is required.

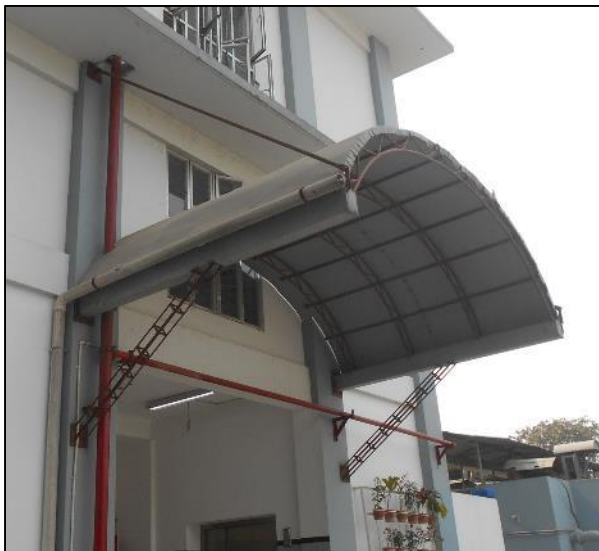
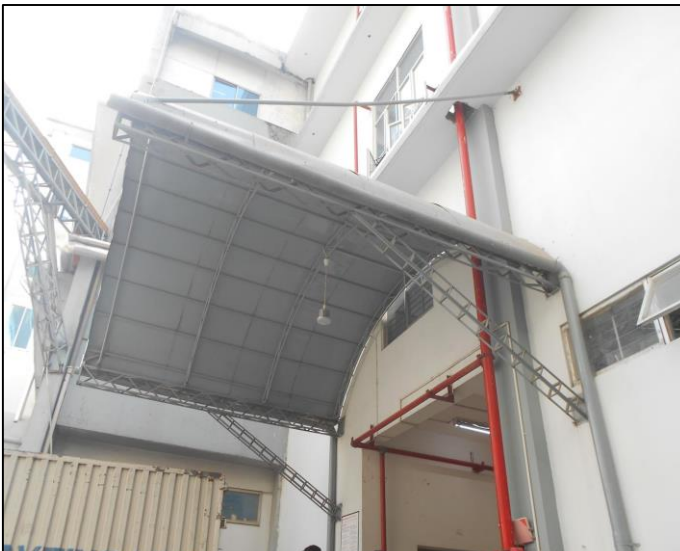
Porch was found in both Thermo Oil Building and Washing Building

Drawing of porch was not available.  
The porch connected to brick wall. Verification of the connection is required.

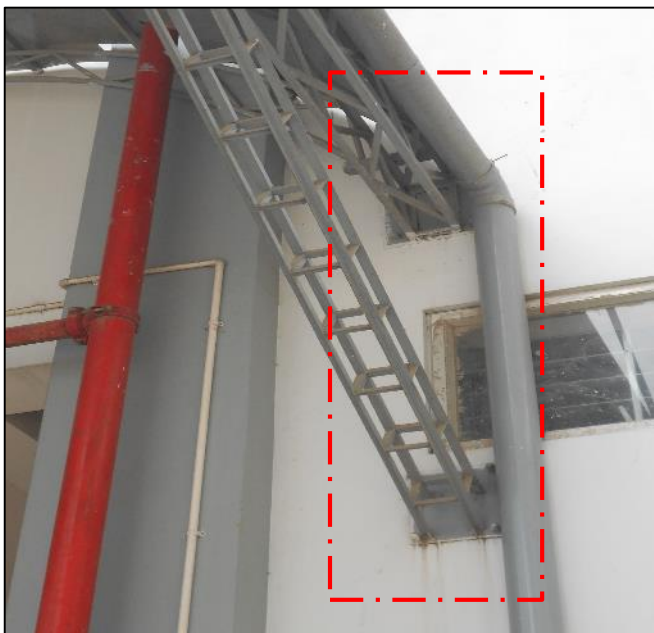
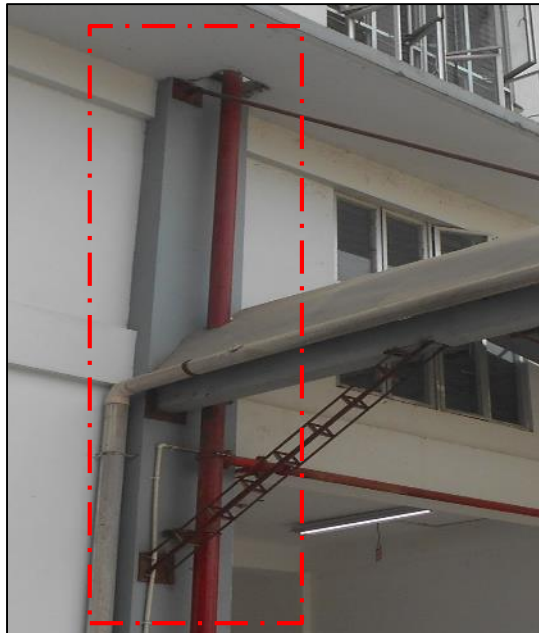
Porch connected to the wall of the buildings

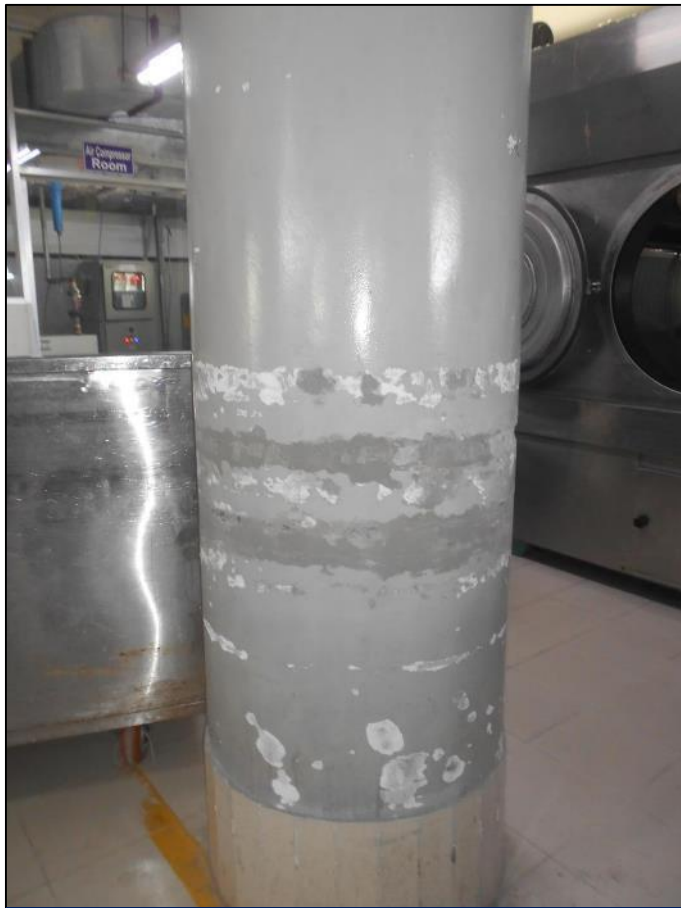
Columns are susceptible to impact loading from trolley. Signs of damage in columns were observed. Protection to be provided to the columns.

| Item No. | Observation | Recommended Action Plan | Recommended Timeline |
|---|---|---|---|
| 20 | Column susceptible to impact load. (Building-10 & 11: Thermo Oil Building & Washing Extension Building ) | Construct and maintain protection to critical columns. | 6-weeks |

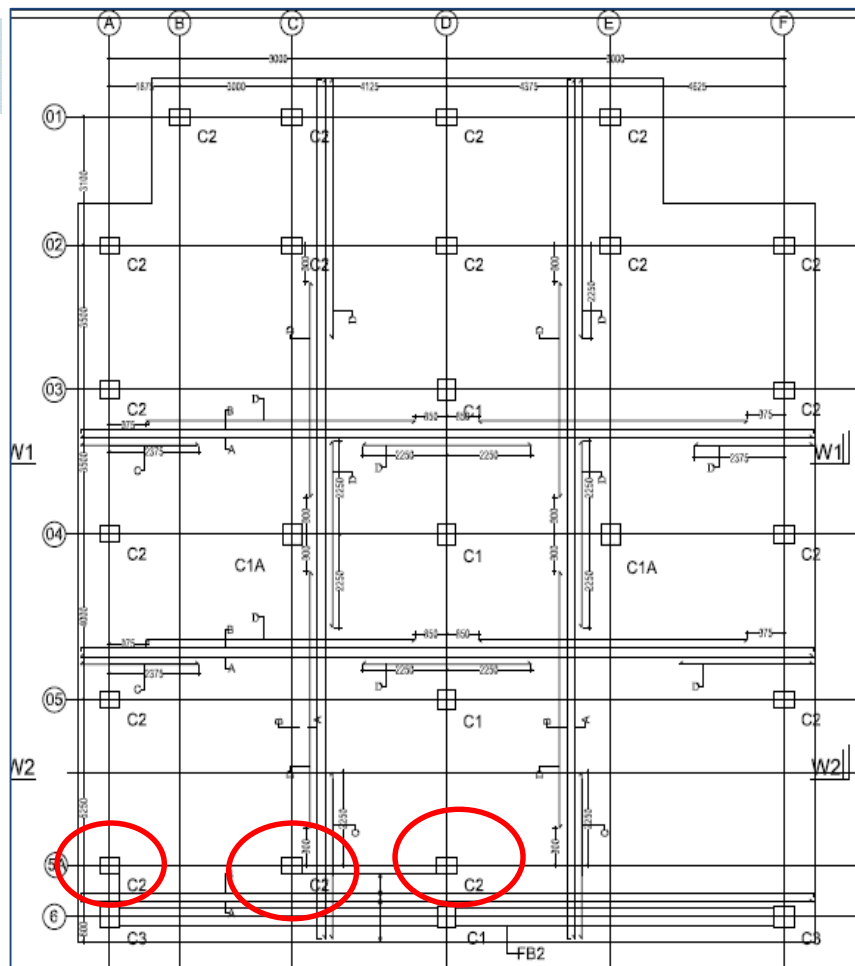
Column Layout in provided drawing

Marked Columns at basement level is shown in the drawing was not found in the provided FEA model that. The FEA model is required to be updated properly.

| Item No. | Observation | Recommended Action Plan | Recommended Timeline |
|---|---|---|---|
| 21 | Mismatch between drawings and FEA model. (Building-10: Thermo Oil Building) | The FEA model is required to be updated properly and submitted to Accord for further review. | 6-weeks |
| 22 | Mismatch between drawings and FEA model. (Building-10: Thermo Oil Building) | Carry out remedial works where necessary. | 6-months |

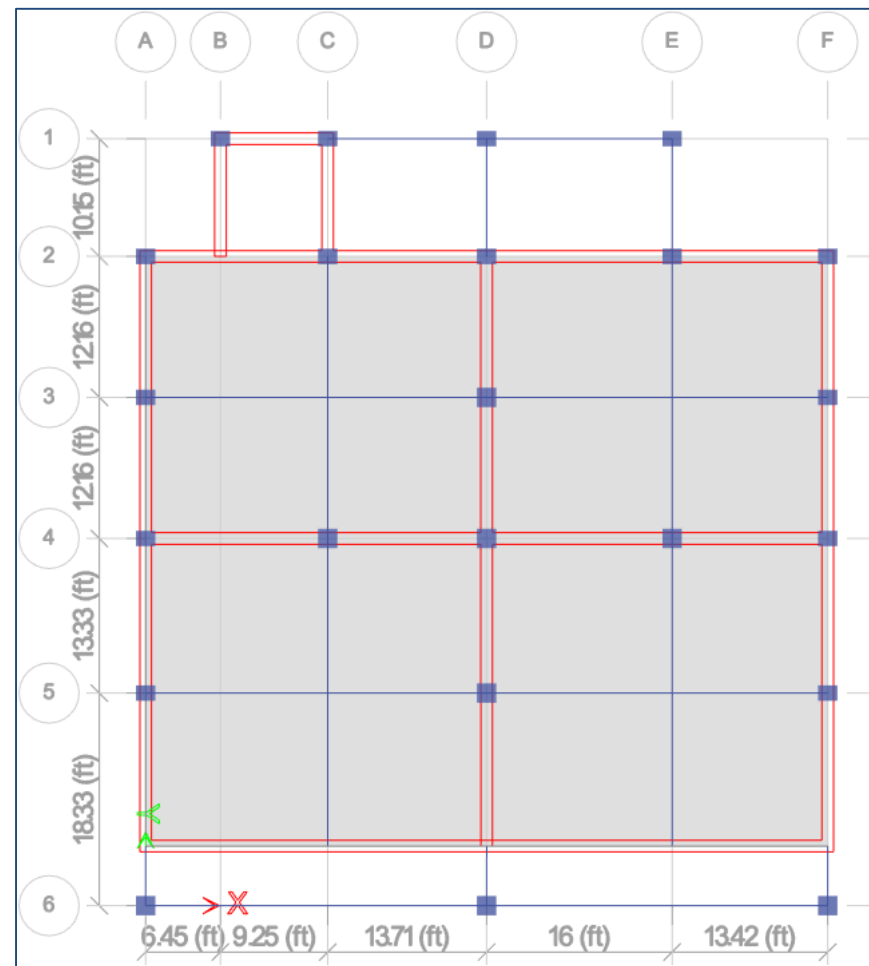
Column Layout in FEA model

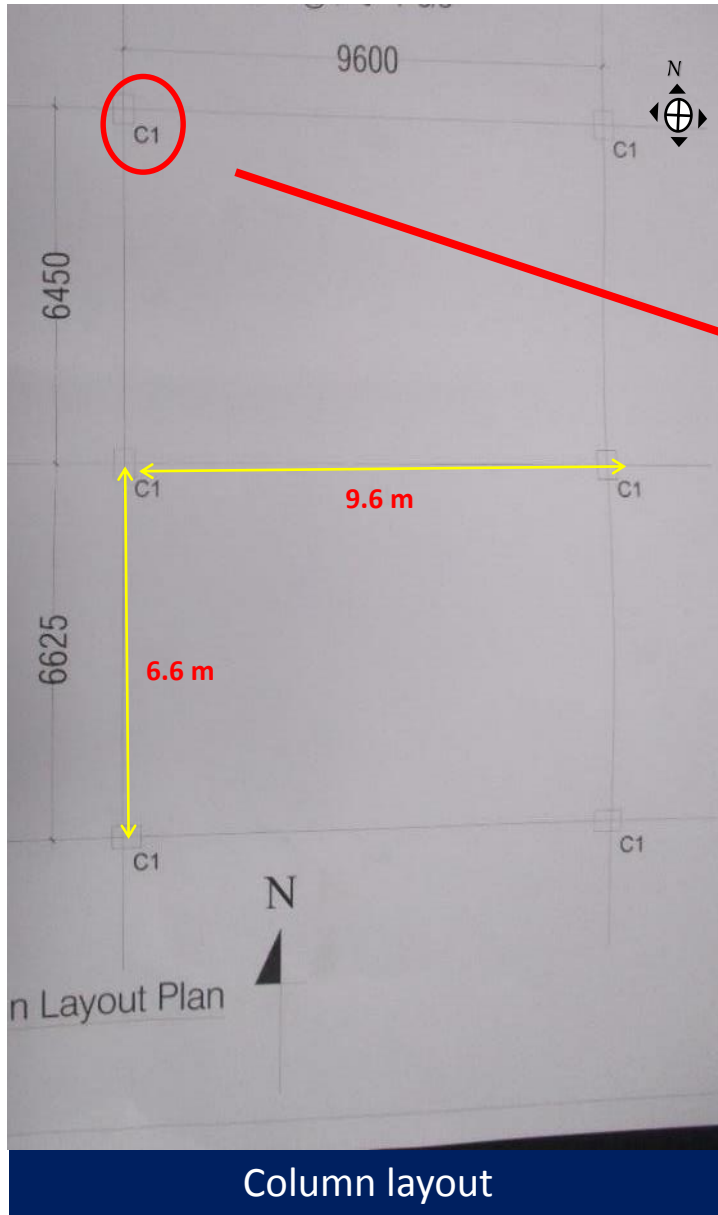
Column layout

Crack found in concrete surface in the column at north-west corner (marked). The factory engineer is required to investigate the causes of crack and repair with a suitable method immediately.

| Item No. | Observation | Recommended Action Plan | Recommended Timeline |
|---|---|---|---|
| 23 | Crack in column (Building-12: Boiler Building) | Factory consultant is required to investigate the cause of crack and prepare an investigation report with a repair methodology. | Immediate - Now |
| 24 | Crack in column (Building-12: Boiler Building) | Repair the crack as per investigation report | Immediate - Now |

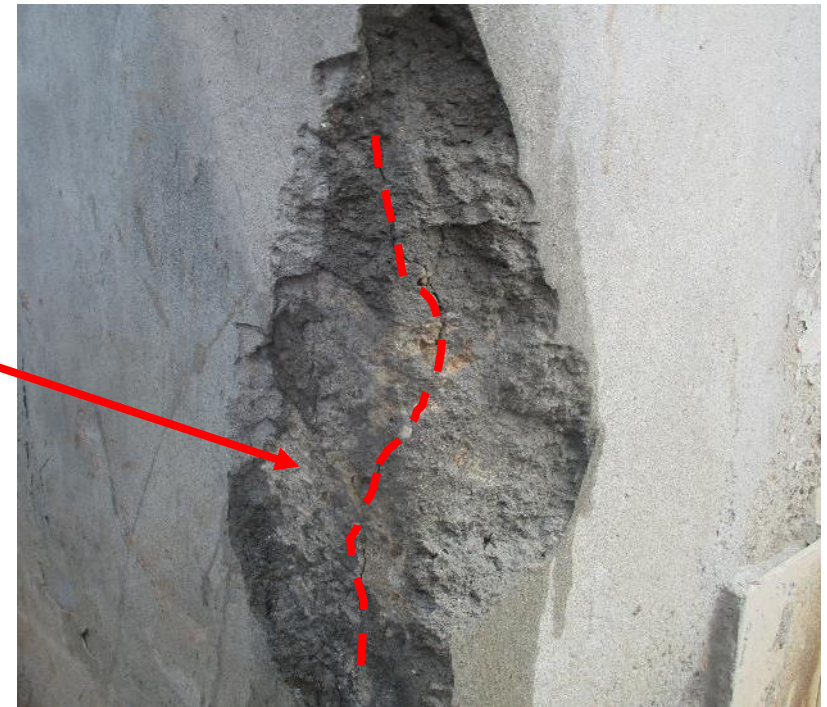
Crack found in concrete surface

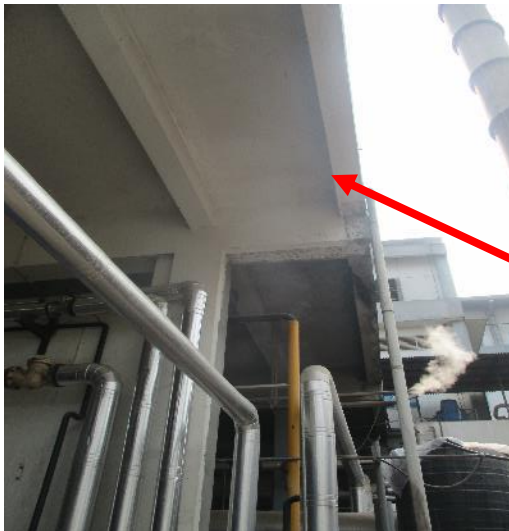
Undocumented cantilever

Provided beam-column layout didn't match with onsite condition. One extra bay was found connected with another building. The factory engineer is required to produce accurate as-built drawing and carryout Detail Engineering Assessment.

| Item No. | Observation | Recommended Action Plan | Recommended Timeline |
|---|---|---|---|
| 25 | Discrepancy between provided drawing and as-built condition<br>(Building-12: Boiler Building) | The factory engineer is required to re-survey the whole building and produce accurate as-built drawing. | 6-weeks |
| 26 | Discrepancy between provided drawing and as-built condition<br>(Building-12: Boiler Building) | Carryout Detail Engineering assessment (DEA) considering the deviation in drawing. | 6-weeks |
| 27 | Discrepancy between provided drawing and as-built condition<br>(Building-12: Boiler Building) | Implement remediation work if required. | 6-months |

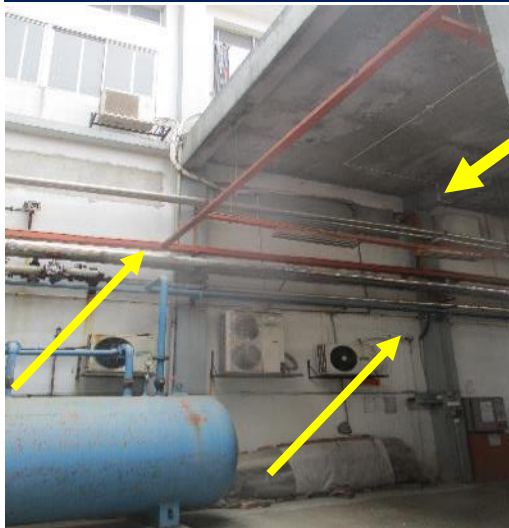
One extra bay connected with another building

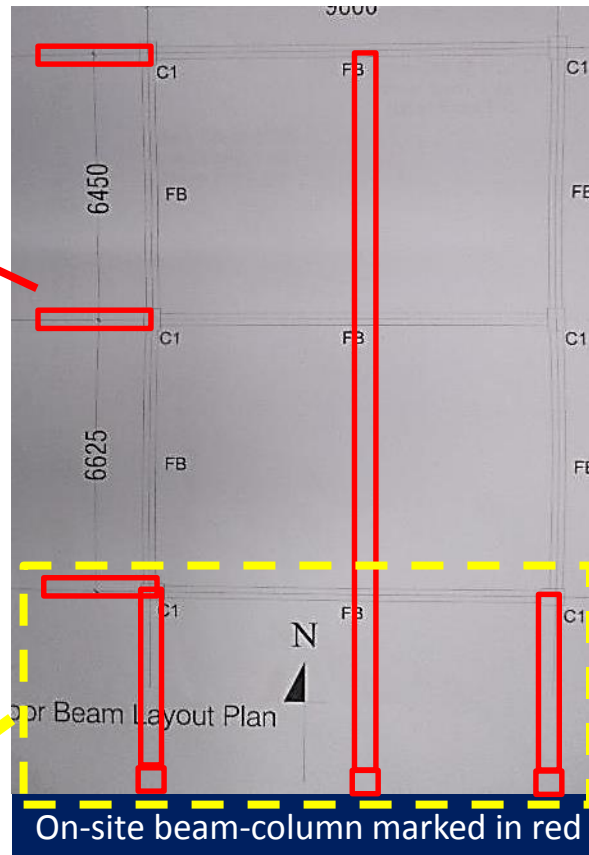
On-site beam-column marked in red

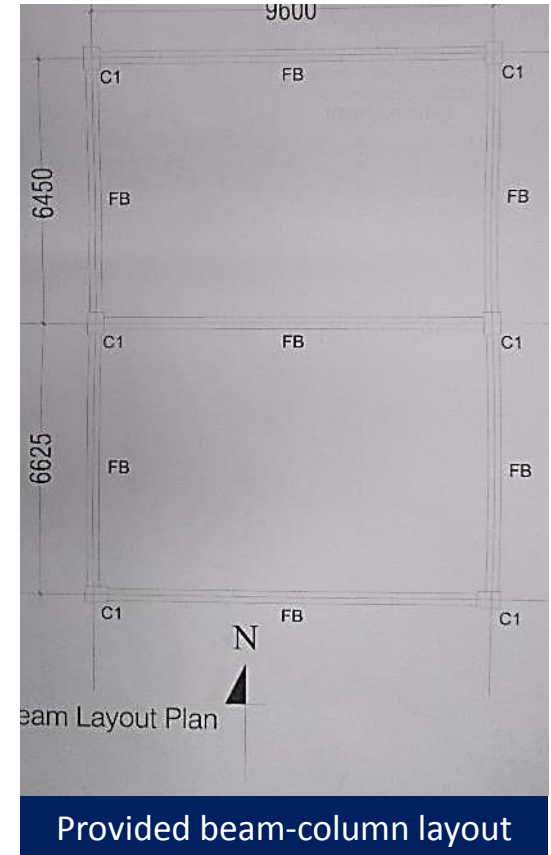
Provided beam-column layout
