# UTAH Knitting & Dyeing Ltd. (Extension)

Bokran-Monipur, Hotapara, Gazipur, Bangladesh  
(24.125801, 90.389984)

06<sup>th</sup> January and 4<sup>th</sup> & 19<sup>th</sup> Feb 2020

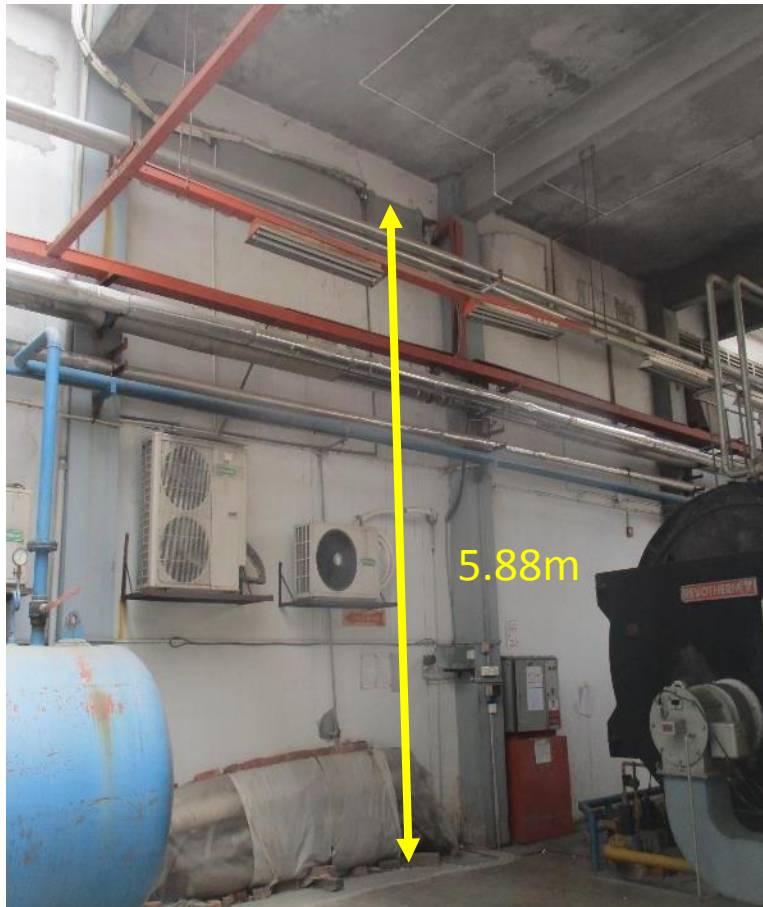
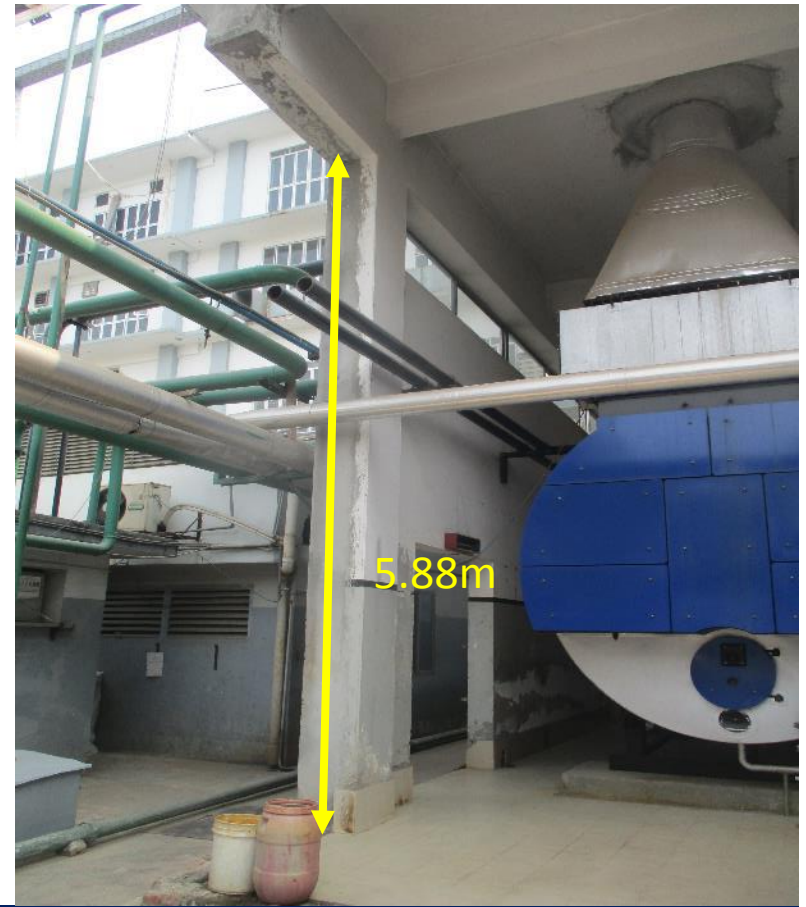
The column size is 500mm x 400mm and unsupported length is 5.88 m

The factory engineer is required to check the adequacy of the long columns as a part of Detail Engineering Assessment.

| Item No. | Observation | Recommended Action Plan | Recommended Timeline |
|---|---|---|---|
| 28 | Unsupported long column<br>(Building-12: Boiler Building) | Factory engineer is required to carryout the adequacy check of the unsupported long columns. | 6-weeks |
| 29 | Unsupported long column<br>(Building-12: Boiler Building) | Implement remediation work if required. | 6-months |

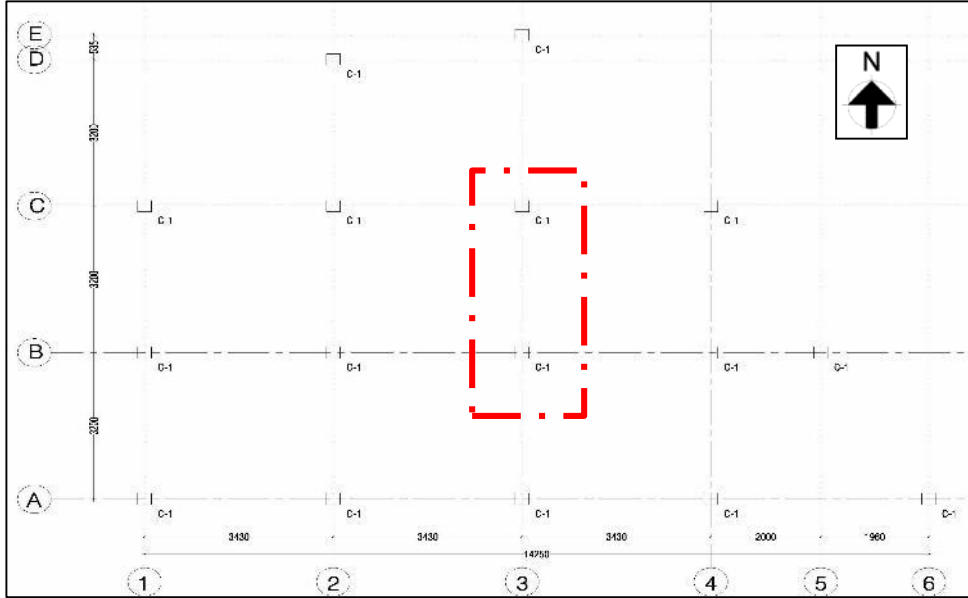
Columns have shown in the drawing

The factory engineer to survey the structure and update the as-built structural drawings accurately.

| Item No. | Observation | Recommended Action Plan | Recommended Timeline |
|---|---|---|---|
| 30 | Inconsistencies in the provided drawings (Building-13: Child Care ) | Prepare as-built drawings with complete structural information. | 6-weeks |

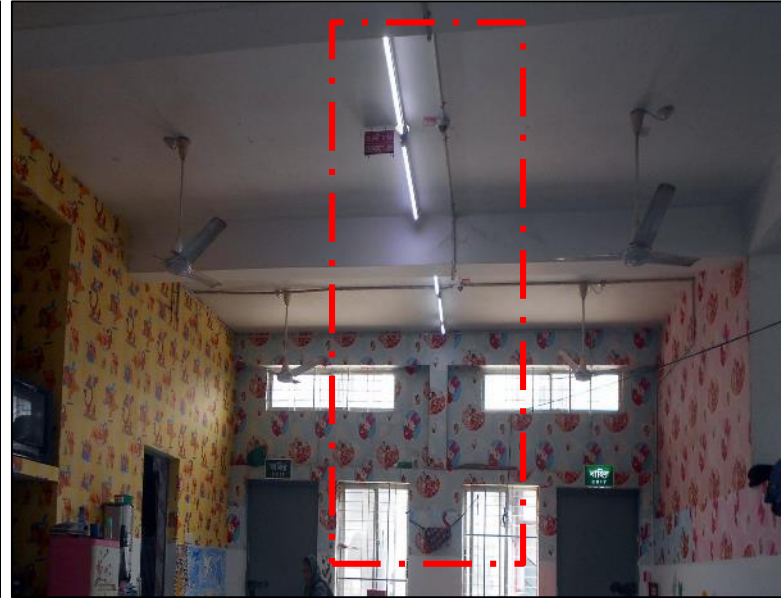
No columns and beam found in the marked location

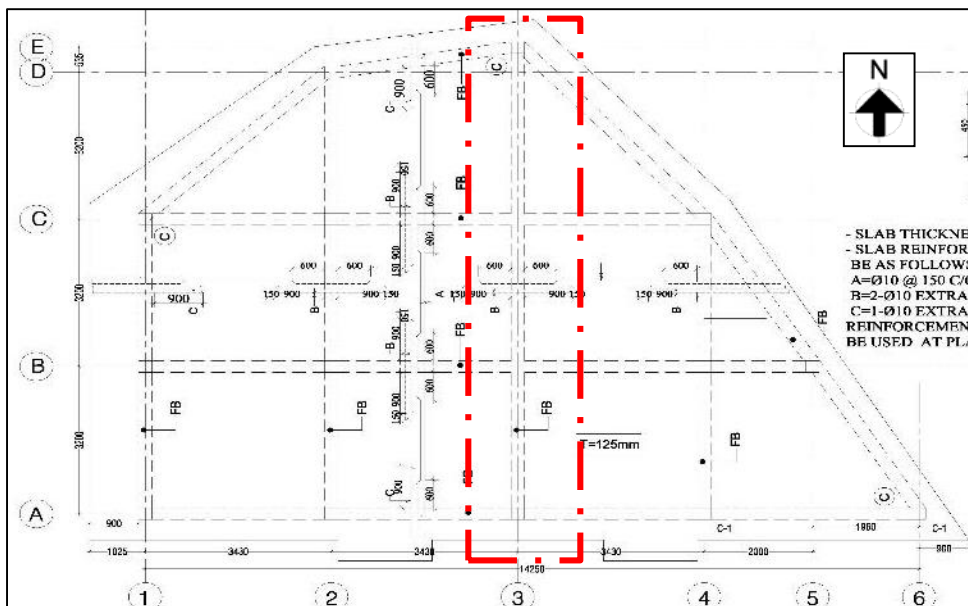
Beam has shown in the drawing

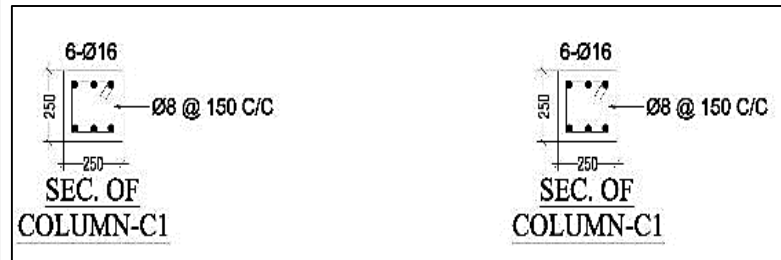
6 rebars have shown in the column schedule where 4 rebars found onsite.

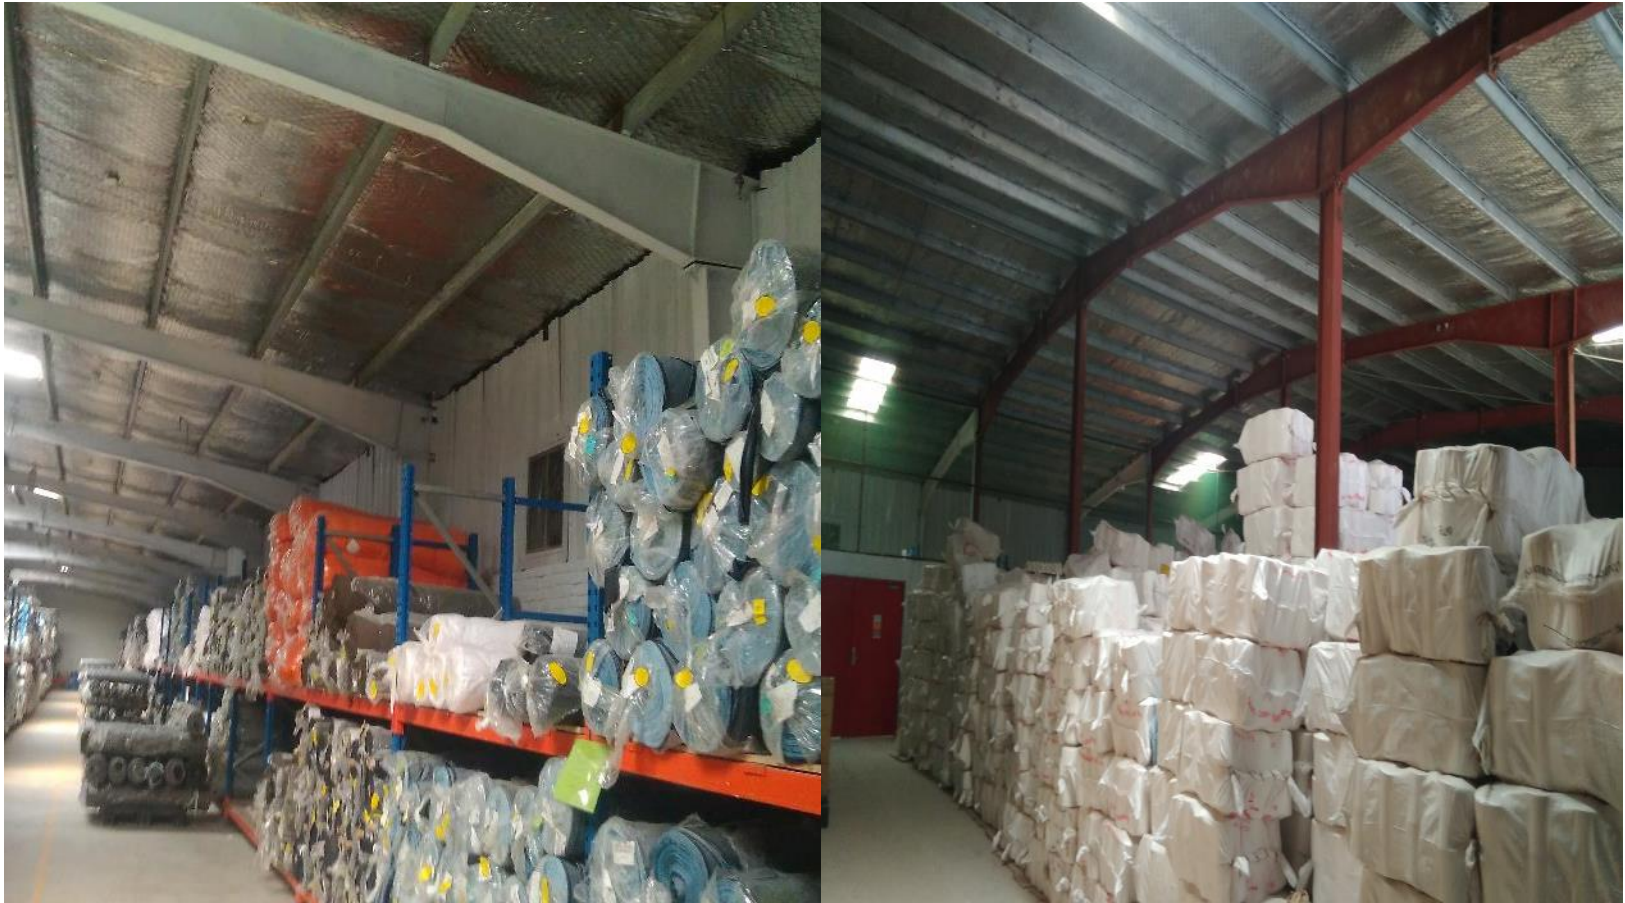
No vertical bracing/tie beam/compression strut provided along long direction

Lateral load transfer mechanism along long direction was absence. The factory engineer to carryout engineering assessment and design the lateral stability system for the structure.

| Item No. | Observation | Recommended Action Plan | Recommended Timeline |
|---|---|---|---|
| 31 | Absence of lateral load transfer media (Building-20: Steel Shed Go-down) | The factory engineer to carryout engineering assessment (EA) and design the lateral stability system for the structure. | 6-weeks |
| 32 | Absence of lateral load transfer media (Building-20: Steel Shed Go-down) | Implement remediation work suggested in EA. | 6-months |

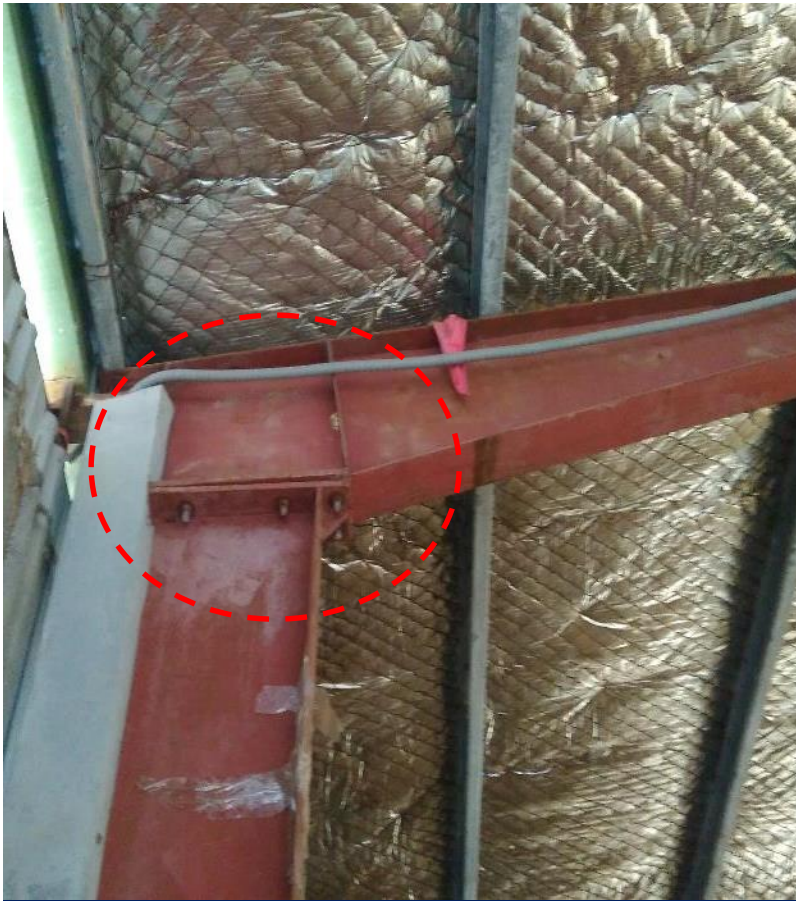
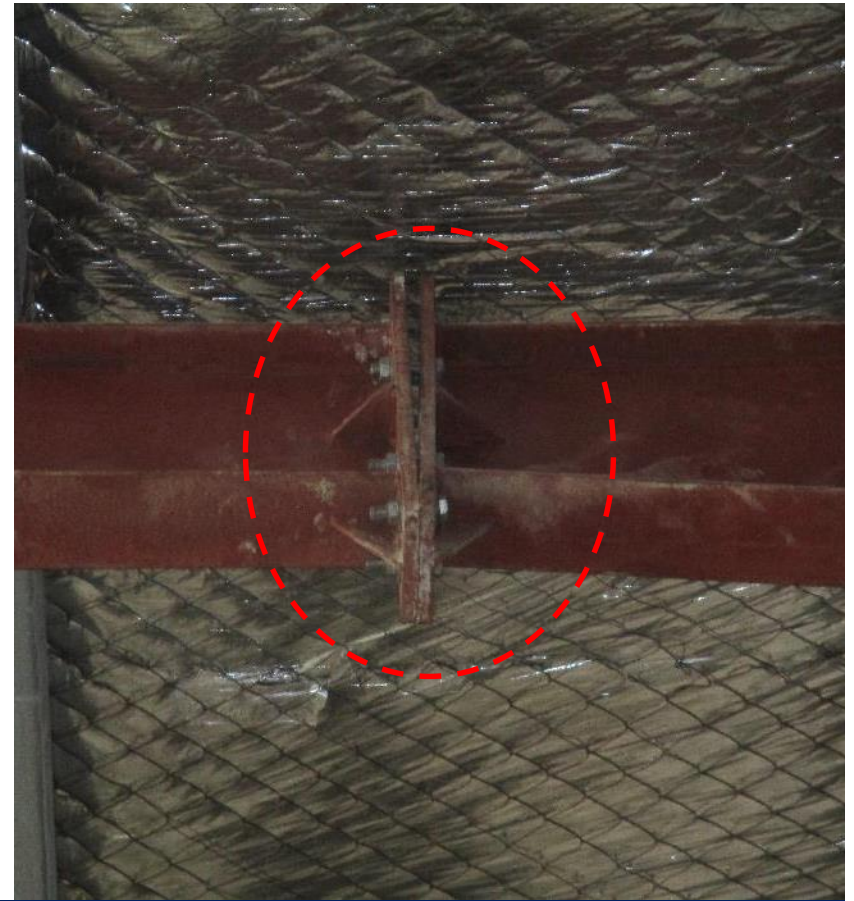
Gap between connections plates

The factory engineer is required to repair the connections.

| Item No. | Observation | Recommended Action Plan | Recommended Timeline |
|---|---|---|---|
| 33 | Gap between connection plates (Building-20: Steel Shed Go-down) | The factory engineer to investigate the connections and repair with proper remedial method. | 6-weeks |

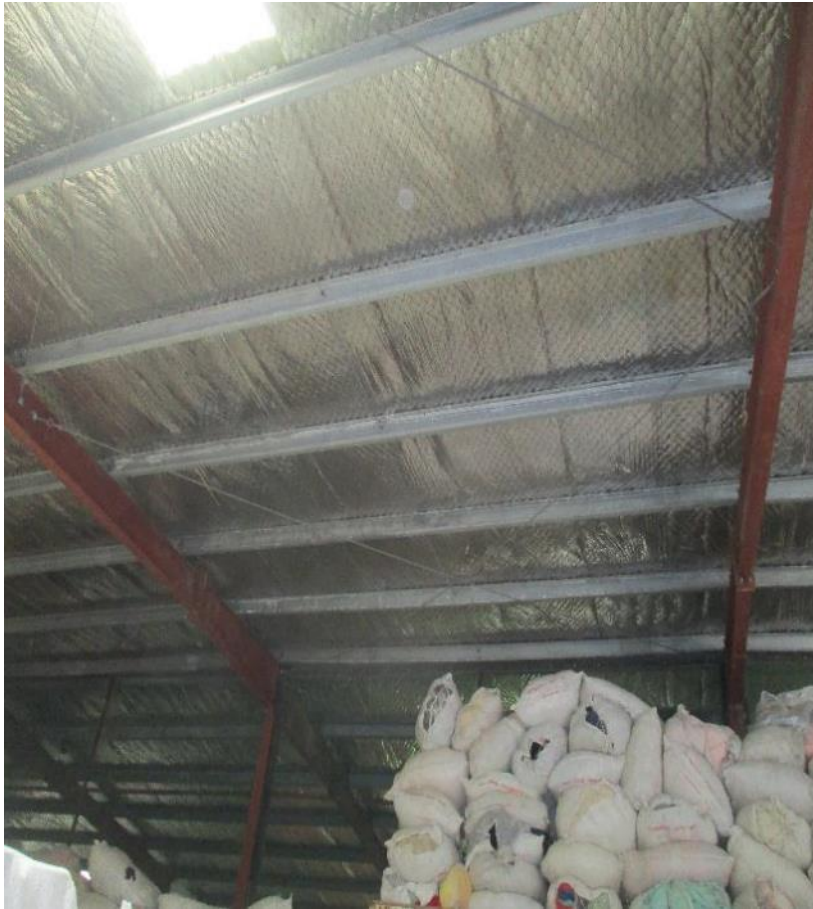
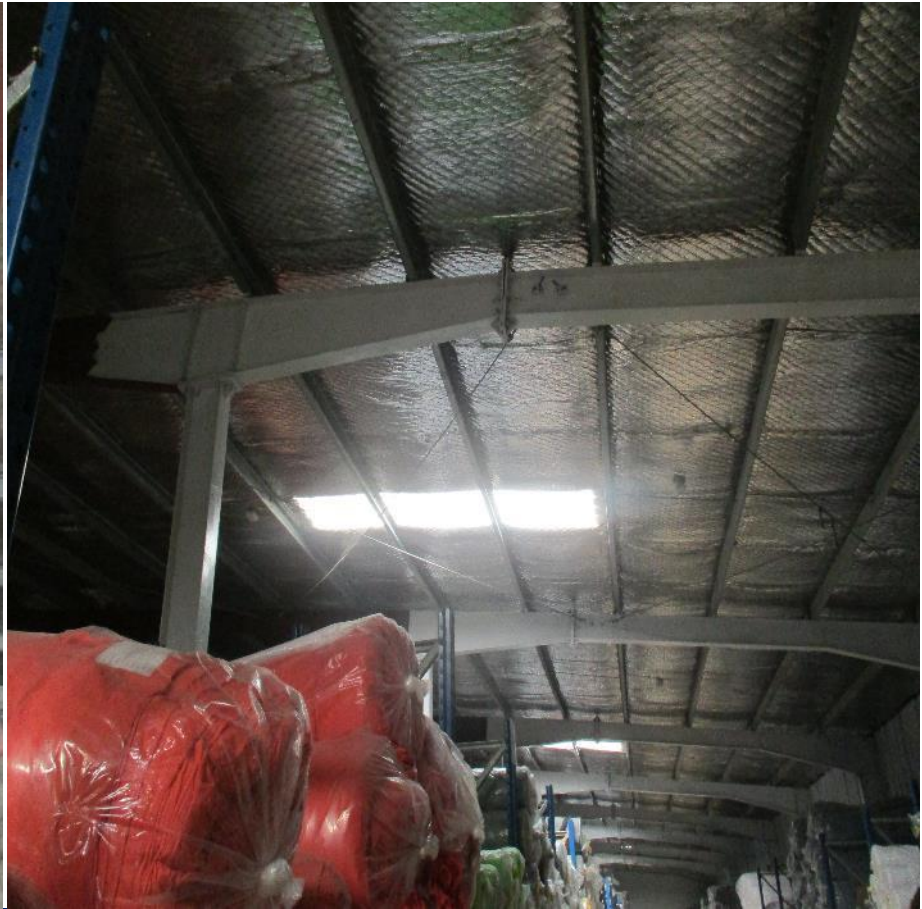
Roof cable bracing was found loose in several locations

| Item No. | Observation | Recommended Action Plan | Recommended Timeline |
|---|---|---|---|
| 34 | Loose cable bracing (Building-20: Steel Shed Go-down) | The factory engineer is required to tighten the loose bracings properly. | 6-weeks |

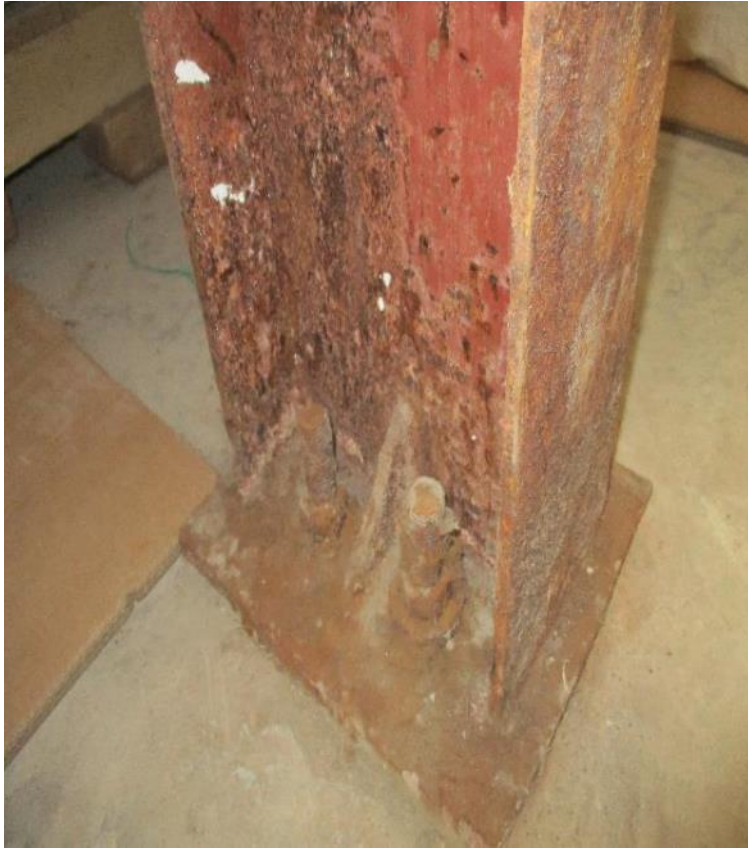
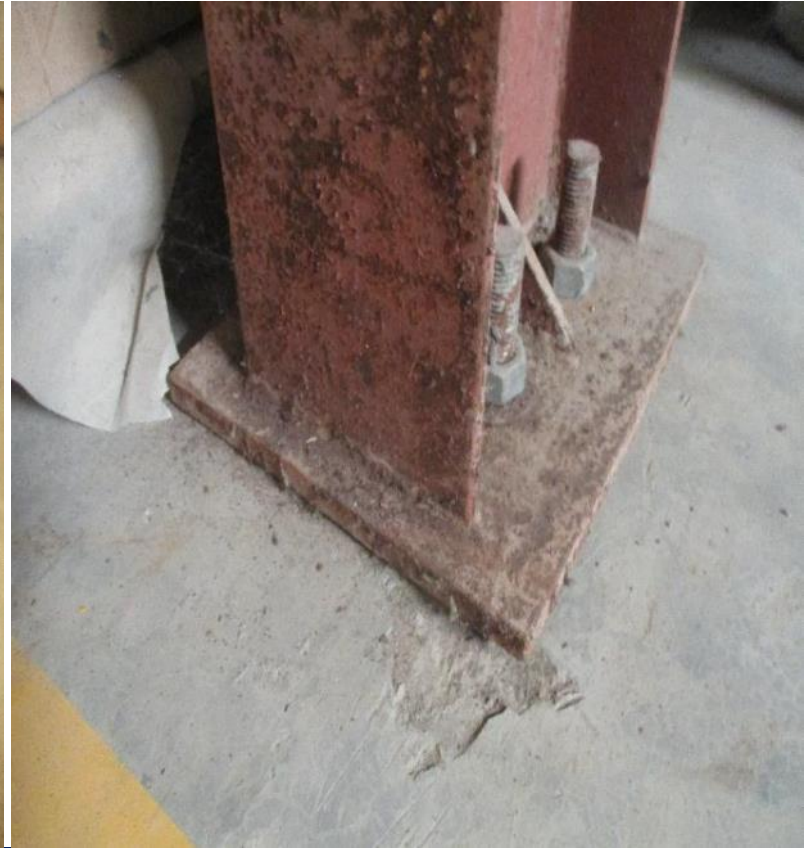
Corrosion found in steel members in several locations

The factory to take protective measures to protect the steel columns from corrosion.

| Item No. | Observation | Recommended Action Plan | Recommended Timeline |
|---|---|---|---|
| 35 | Corrosion in steel members<br>(Building-20: Steel Shed Go-down) | The factory is required to take protective measure to protect steel column/rafter from corrosion. | 6-weeks |

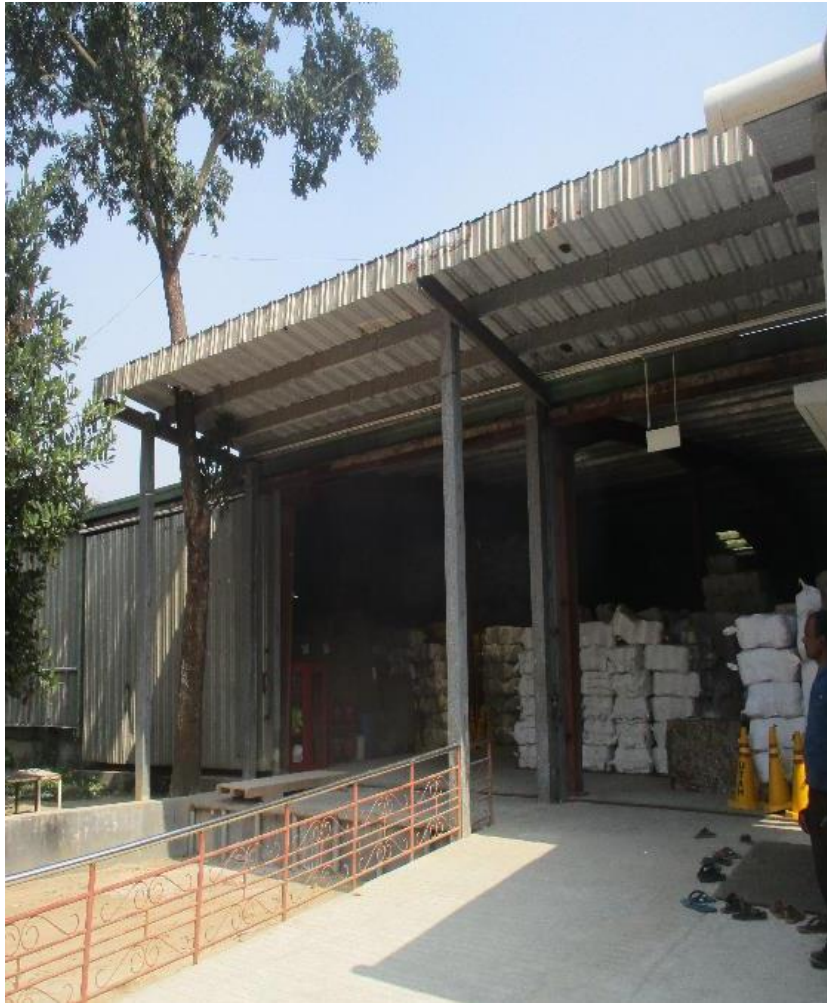
Canopy at front side of the shed

| Item No. | Observation | Recommended Action Plan | Recommended Timeline |
|---|---|---|---|
| 36 | Undocumented canopy<br>(Building-20: Steel Shed Go-down) | The factory engineer to develop as-built drawing as part of engineering assessment (EA). | 6-weeks |
| 37 | Undocumented canopy<br>(Building-20: Steel Shed Go-down) | Implement remedial actions if required. | 6-months |

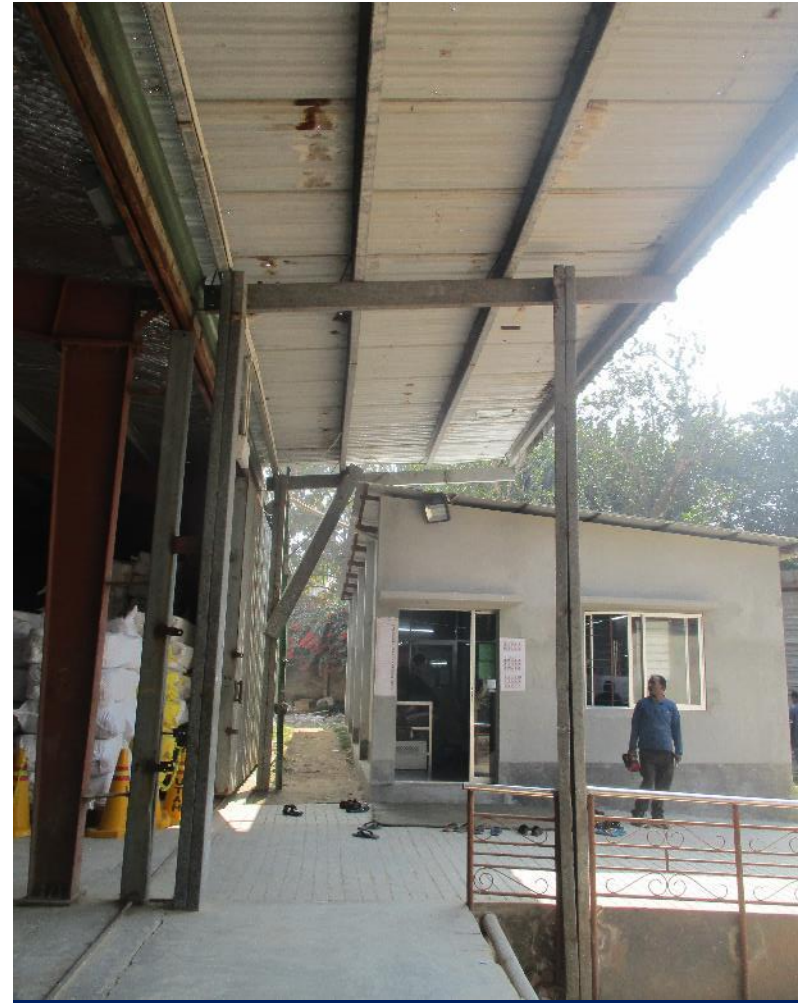
No bracing system
