# Tamishna Fashion Wear Ltd (new building)

Plot # 247, Bhadam, Nishatnagar, Tongi, Gazipur  
(23.898755, 90.358666)  
8th July 2019

# Observations

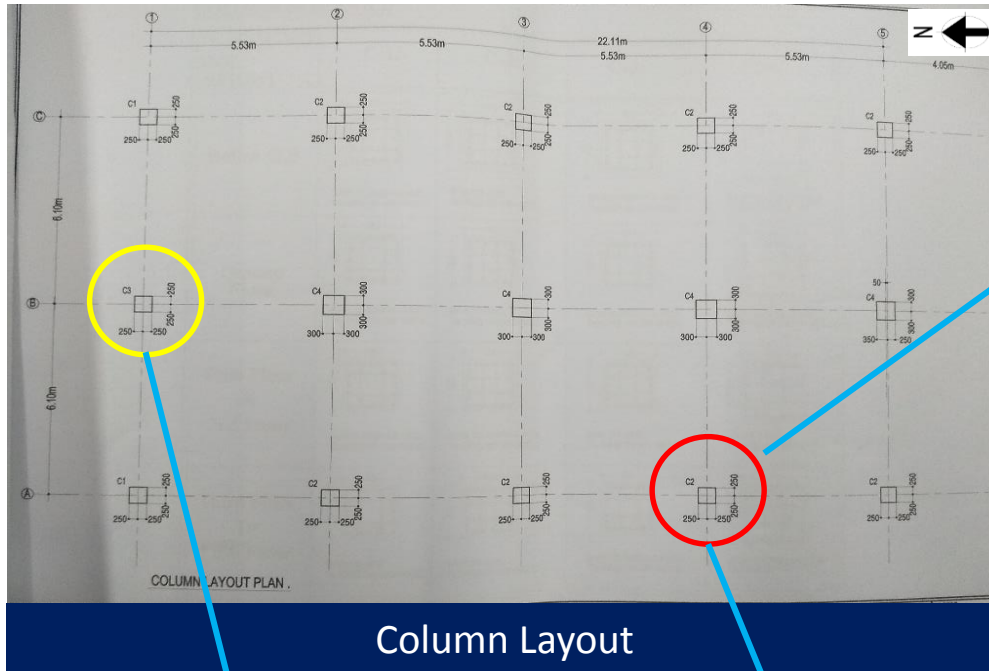
Column Layout

Number of rebar in C-3 and C-2 type column didn't match with column schedule. In C-3 column 4 rebars were counted by ferro scanning in one direction instead of 6 rebars. In C-2 column 5 rebars were counted by ferro scanning in one direction instead of 7 rebars.

| Item No. | Observation | Recommended Action Plan | Recommended Timeline |
|---|---|---|---|
| 1 | Discrepancy in as-built drawing | Building Engineer to confirm the number of rebar in all column and prepare accurate as-built structural drawing. | 6-weeks |

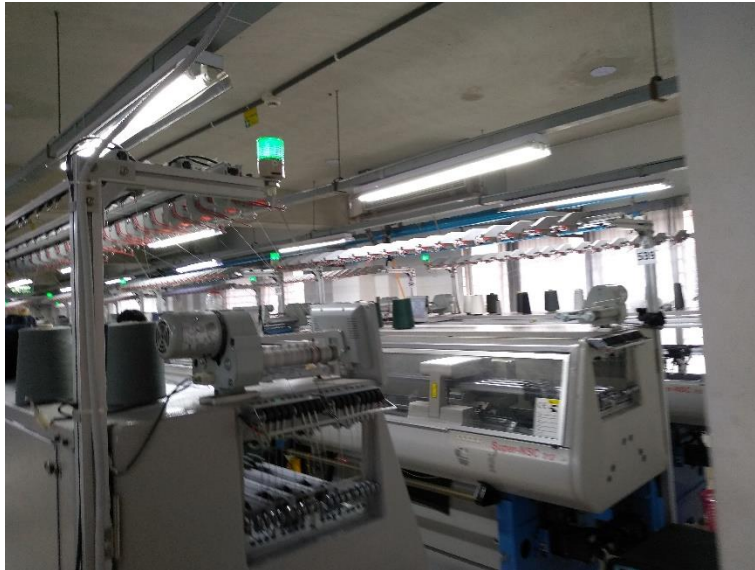
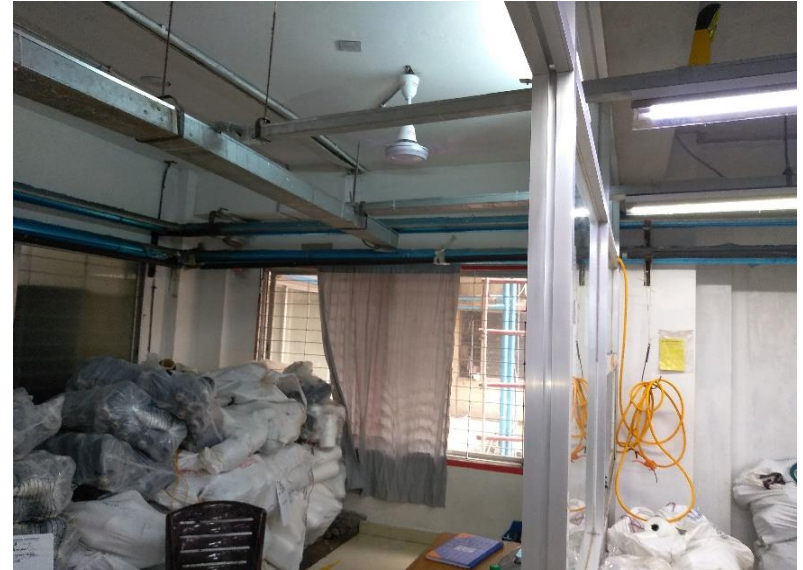
Current floor loading

No load management program was visible on-site. We have checked the column capacity considering 3 kPa floor live load and minimum concrete strength. The column stresses was found within normal design limit. Follow 3 kPa floor live load on typical floors of the building and make sure that the workers understand the loading requirements.

| Item No. | Observation | Recommended Action Plan | Recommended Timeline |
|---|---|---|---|
| 2 | Implement floor load management program | Implement floor load management program considering 3 kPa floor live load on typical floors. | 6-weeks |
| 3 | Implement floor load management program | Produce and actively manage a loading plan for all floor plates within the factory giving consideration to floor capacity and column capacity if loading above 3kpa is considered. | 6-weeks |
| 4 | Implement floor load management program | Continue to implement loading plan. | 6-months |
