# GMS Textiles Ltd.

Tansutrapur, Kaliakoir, Gazipur

13<sup>th</sup> January, 16<sup>th</sup> February and 3<sup>rd</sup> March 2020

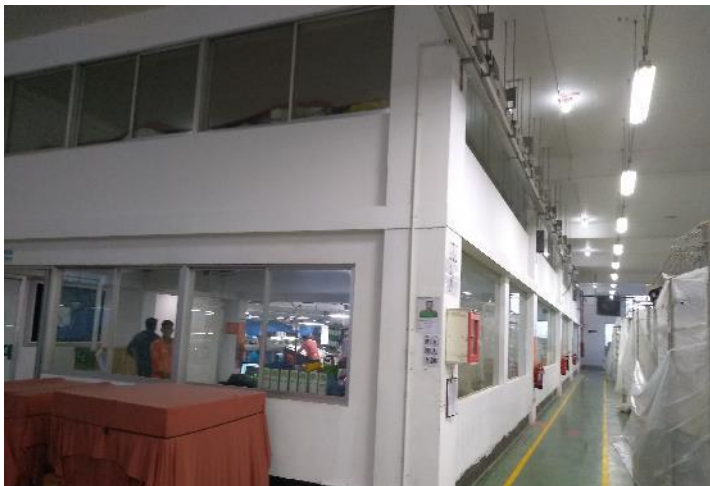
Mezzanine

The location of marked stair is found mismatch in as-built structural/architectural drawings. The factory engineer is required to revise the location of the stair in the as-built drawings.

| Item No. | Observation | Recommended Action Plan | Recommended Timeline |
|---|---|---|---|
| 1 | Mismatch in provided as-built documents (B-2) | The factory engineer is required to survey the structure and develop accurate as-built structural drawings for the mezzanine floor and the stair. | 6-weeks |

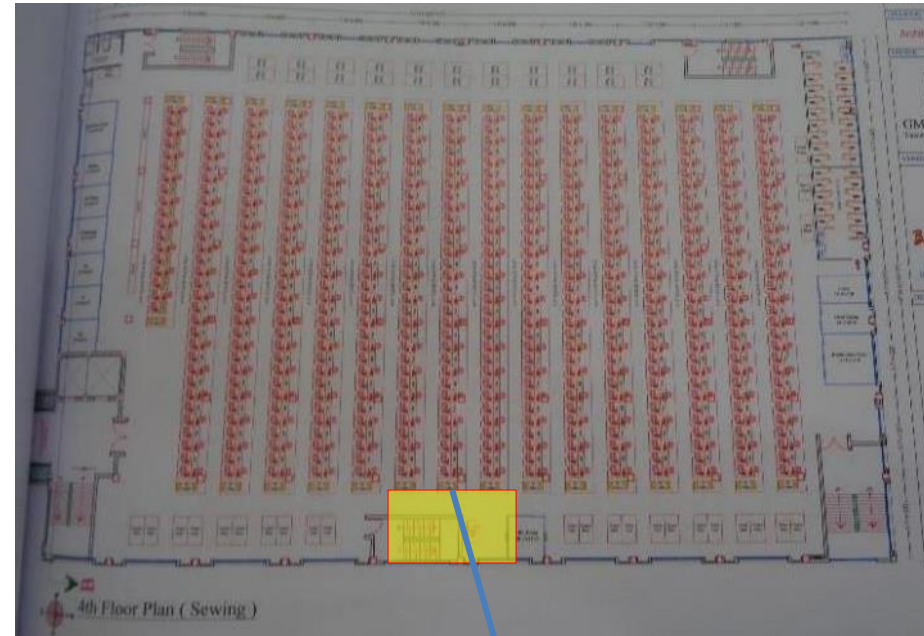
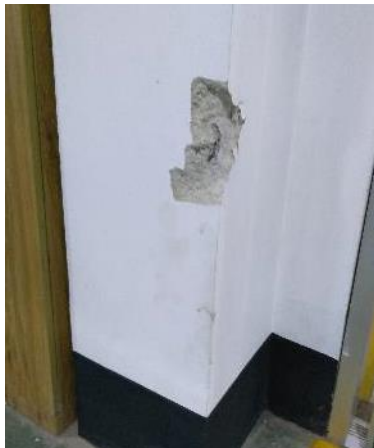
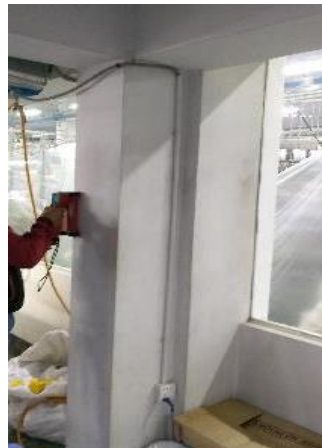
Additional column confirmed by scanning

Mezzanine floor is being supported by some additional columns. No drawings details were found for the mezzanine floor.

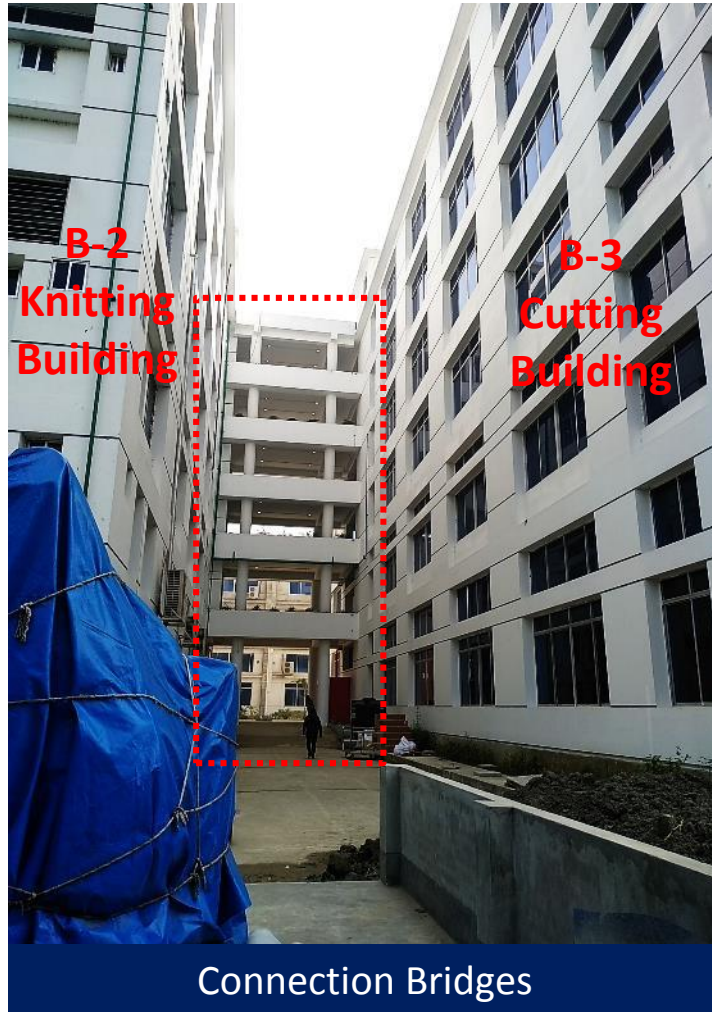
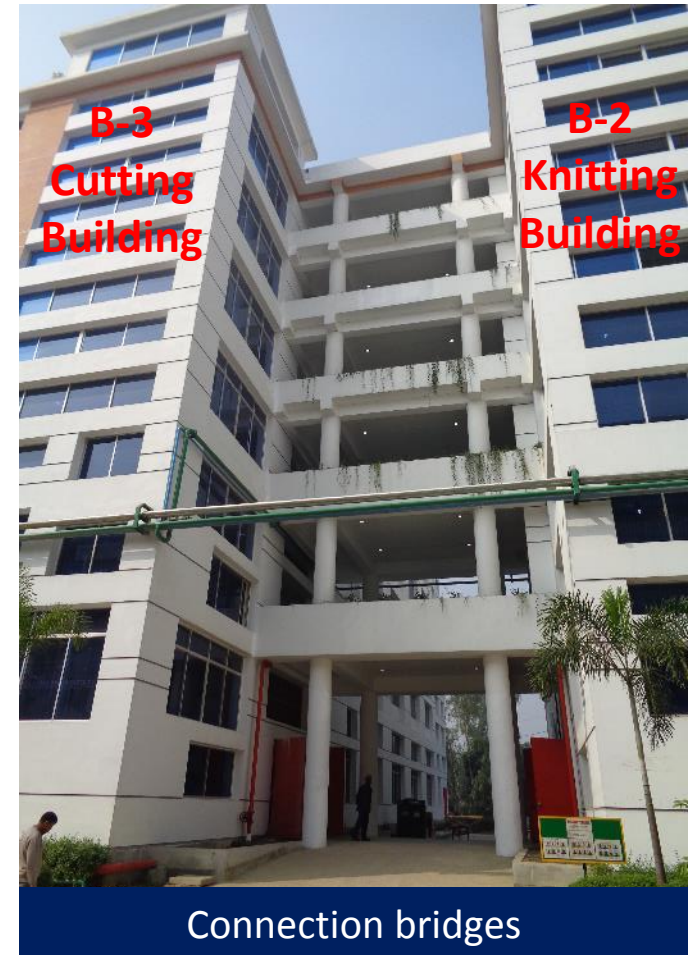
Connecting bridges were found between B-2 (Knitting Building) and B-3 (Cutting Building) at different floor levels. The connection bridges are structurally separated from both buildings. Factory engineer is required to prepare as-built drawings.

| Item No. | Observation | Recommended Action Plan | Recommended Timeline |
|---|---|---|---|
| 2 | Lack of as-built drawing of Connection bridges between B-2 and B-3 | The factory engineer is required to prepare as-built drawings for the connecting bridges. | 6-weeks |

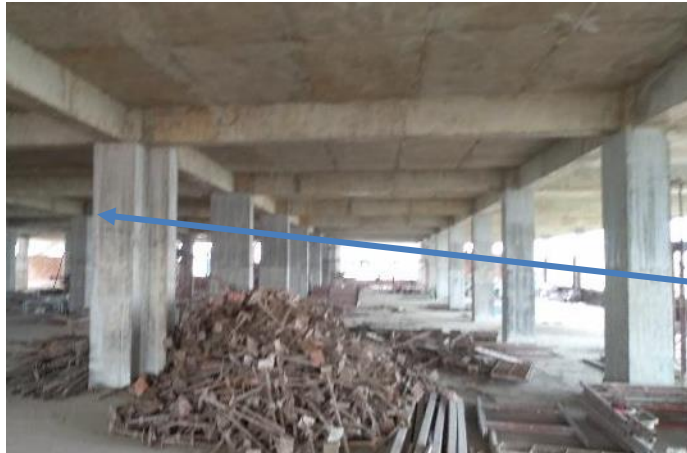
Some L-shape columns were found in Grey Fabric Store building. The size and number of rebar of these column were not matched with column schedule.

| Item No. | Observation | Recommended Action Plan | Recommended Timeline |
|---|---|---|---|
| 3 | Discrepancies in as-built structural drawings. (B-4) | The building engineer to check the structure, collect information of L-shaped column and revised as-built architectural documentations. | 6-weeks |

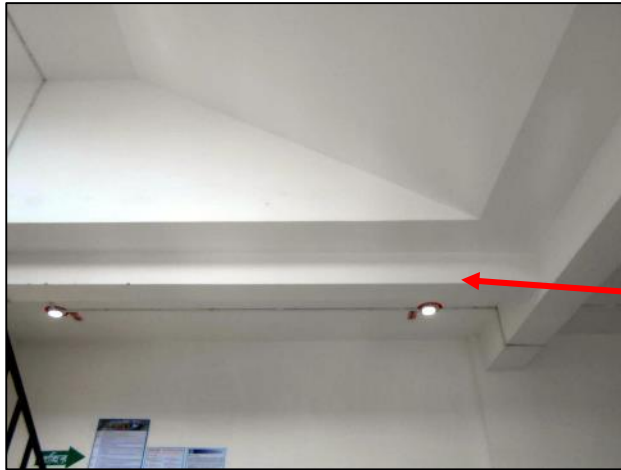
Extra beam on stair

Extra beam was found on the south west portion between grid 07-08 and A-B. the measurement of the beam found to be 305 X 355 mm (d/s). This beam was found only on 1<sup>st</sup> floor.

| Item No. | Observation | Recommended Action Plan | Recommended Timeline |
|---|---|---|---|
| 4 | Discrepancies between as-built structural drawings and onsite condition. (B-5) | The building engineer to check the structure, collect information of missing beam and revised as-built drawings. | 6-weeks |

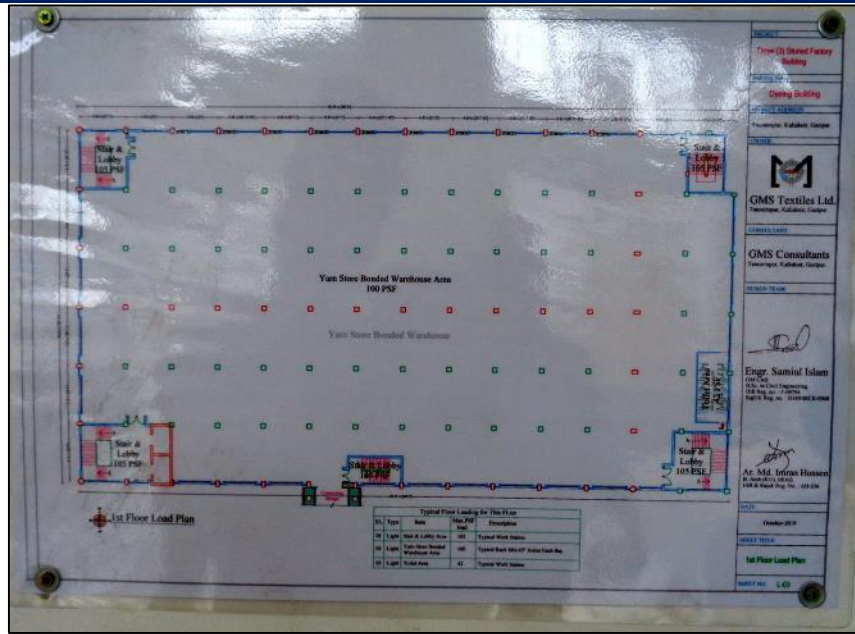
The load plan indicates the maximum allowable live load is 100 Psf (5 kPa). Though no calculation was provided to claim the rationality of using this load plan. No load height marking was observed.

Load plan posted on different floors

| Item No. | Observation | Recommended Action Plan | Recommended Timeline |
|---|---|---|---|
| 5 | Enforce load management program. (B-5) | The building engineer to post floor load plan on each floor and indicate load restriction height marking on the storage areas. | 6-weeks |

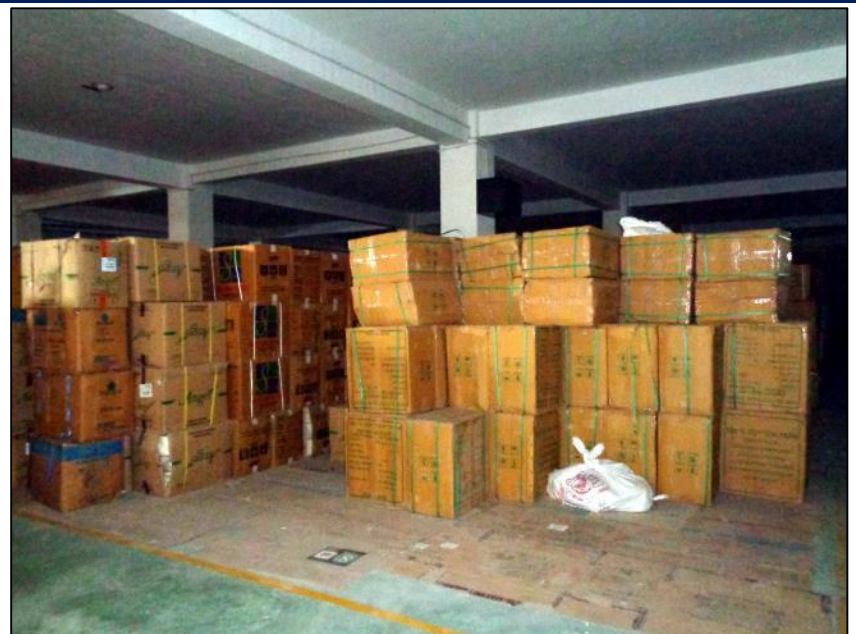
Observed loading on 1<sup>st</sup> floor.

| Item No. | Observation | Recommended Action Plan | Recommended Timeline |
|---|---|---|---|
| 6 | Enforce load management program. (B-5) | Monitor loading so that the load in panel does not exceed the allowable limit. | 6-weeks |

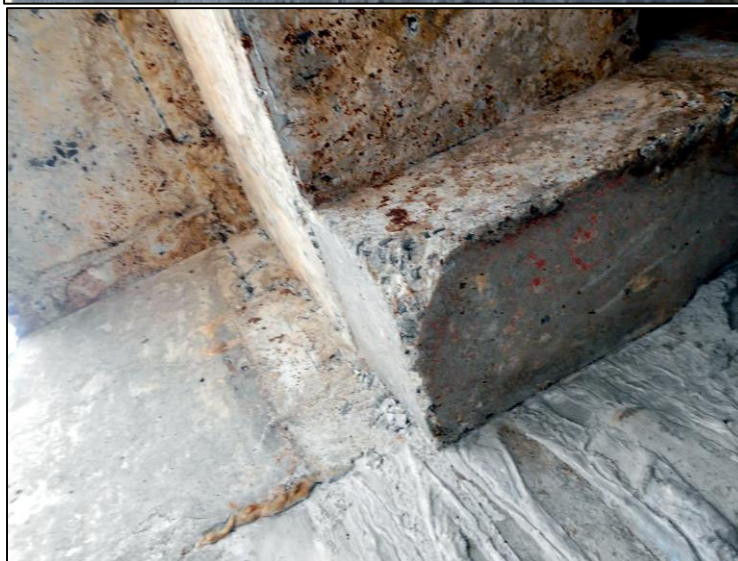
Column-Beam Connection

As per the drawing, RB02 was supposed to be connected to column with the edge. There was 125 mm offset found in RB02, which rise question of how the rebar of RB02 is joined with Column. The connection adequacy is required to be verified.

| Item No. | Observation | Recommended Action Plan | Recommended Timeline |
|---|---|---|---|
| 7 | Beam Offset from Column-Beam Connection. (B-6) | The beam-column connection adequacy check is required to be verified emphasizing on how the rebar from beam is connected to column. | 6-weeks |
| 8 | Beam Offset from Column-Beam Connection. (B-6) | Carry out remedial works if required. | 6-months |

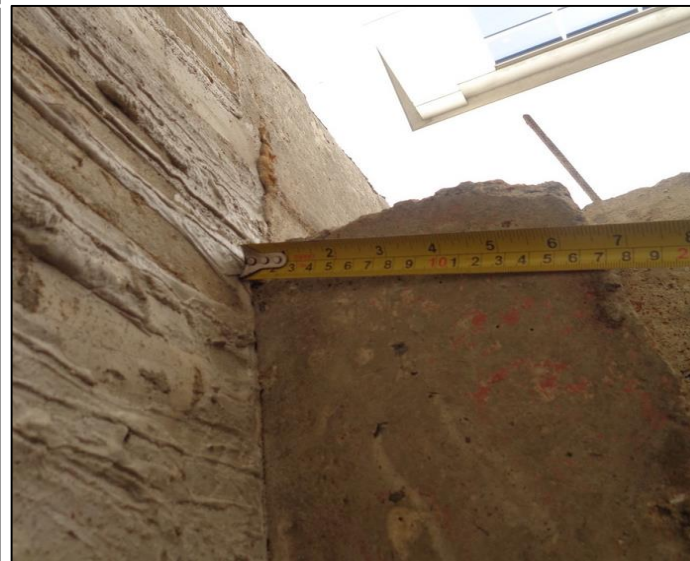
Offset around 125 mm

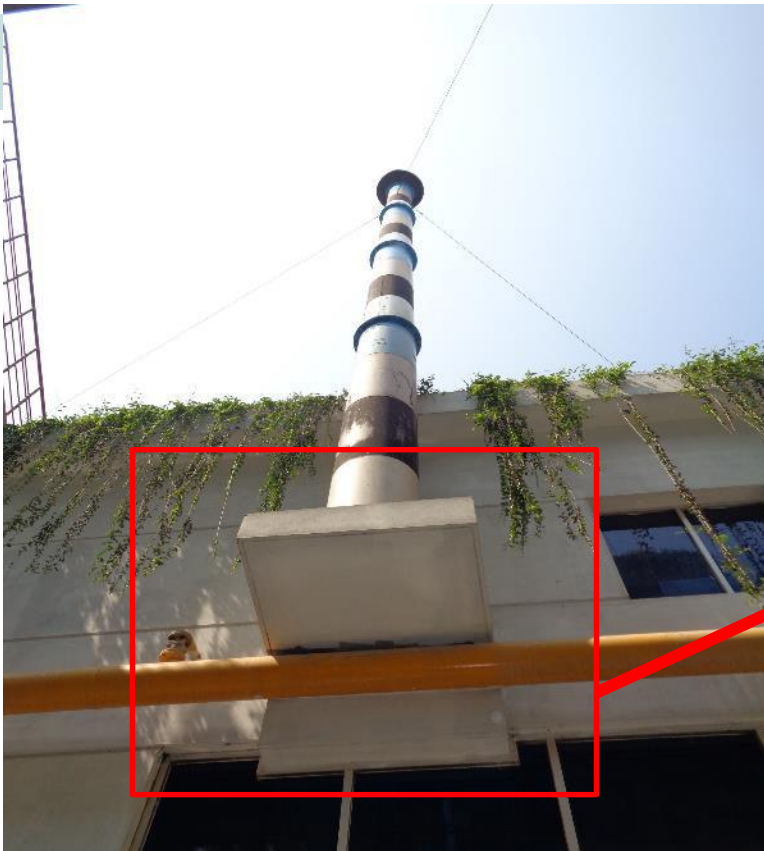
**Tie beam and corbel appeared to be overstressed due to heavily loaded chimney**

Chimney resting on corbel (east side)

Factory is required to carryout adequacy check of corbel and tie beam and implement any remediation work as required.

| Item No. | Observation | Recommended Action Plan | Recommended Timeline |
|---|---|---|---|
| 9 | Tie beam and corbel appeared to be overstressed due to heavily loaded chimney (B-9) | The factory is required to carryout adequacy check of corbel and tie beam. | 6-weeks |
| 10 | Tie beam and corbel appeared to be overstressed due to heavily loaded chimney (B-9) | Carry out any remedial works where necessary. | 6-months |

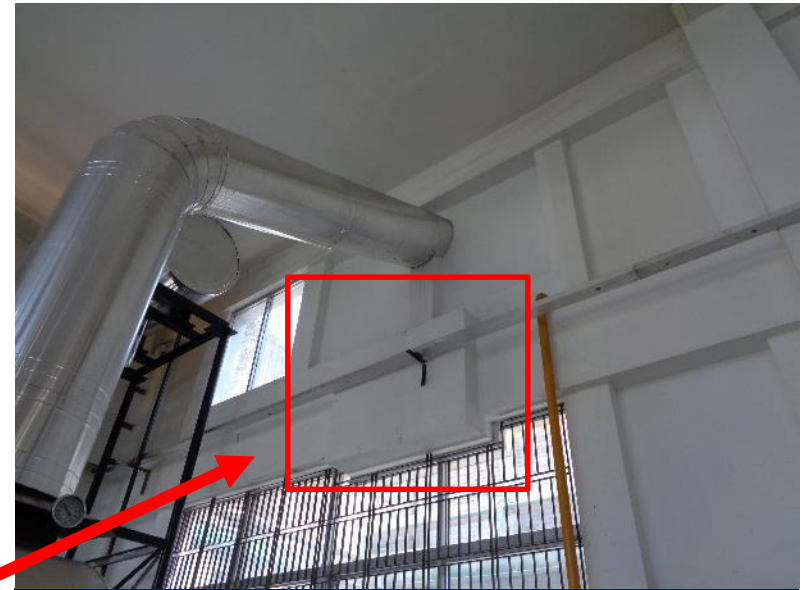
Corbel ultimately supported on tie beam which is producing overturning moment

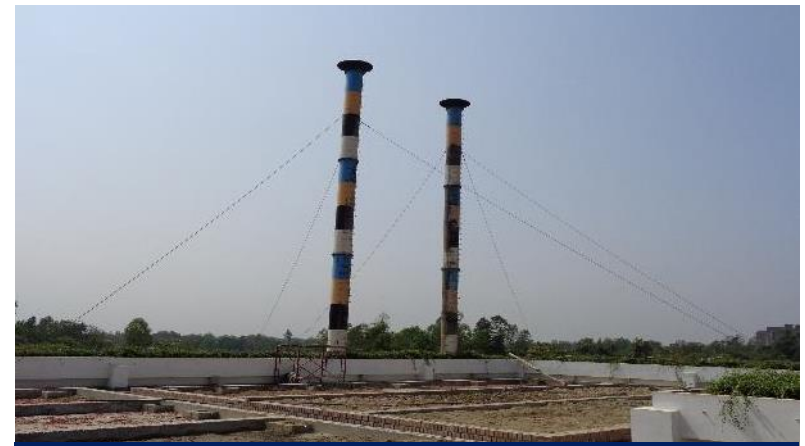
Chimney resting on corbel (south-west side)

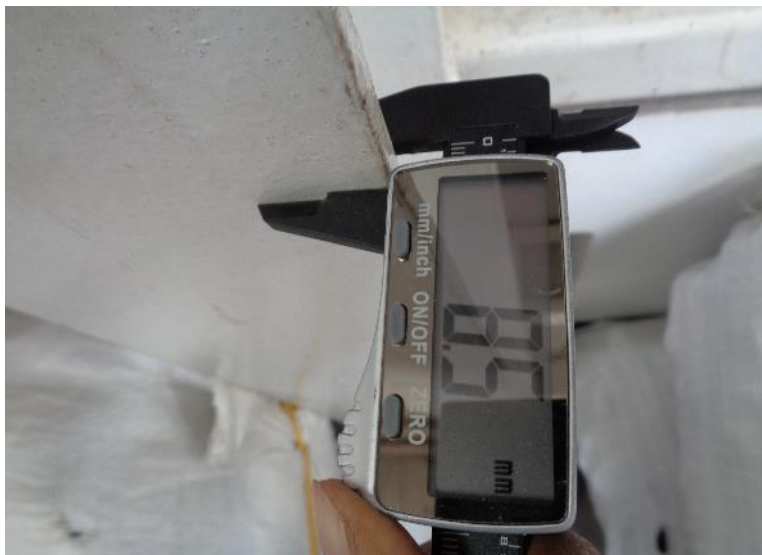
Flange thickness found 8.5 mm with coating for all internal columns

The factory engineer is required to produce accurate as-built structural drawings.

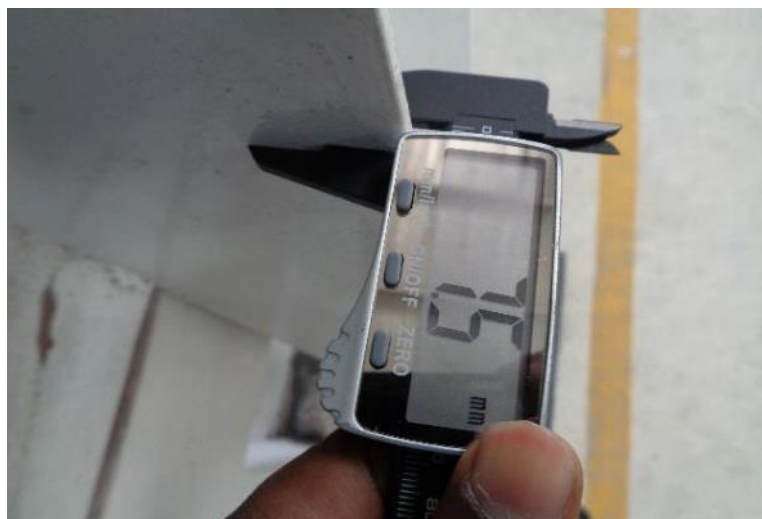
Flange thickness found 7.5 mm with coating for all periphery columns

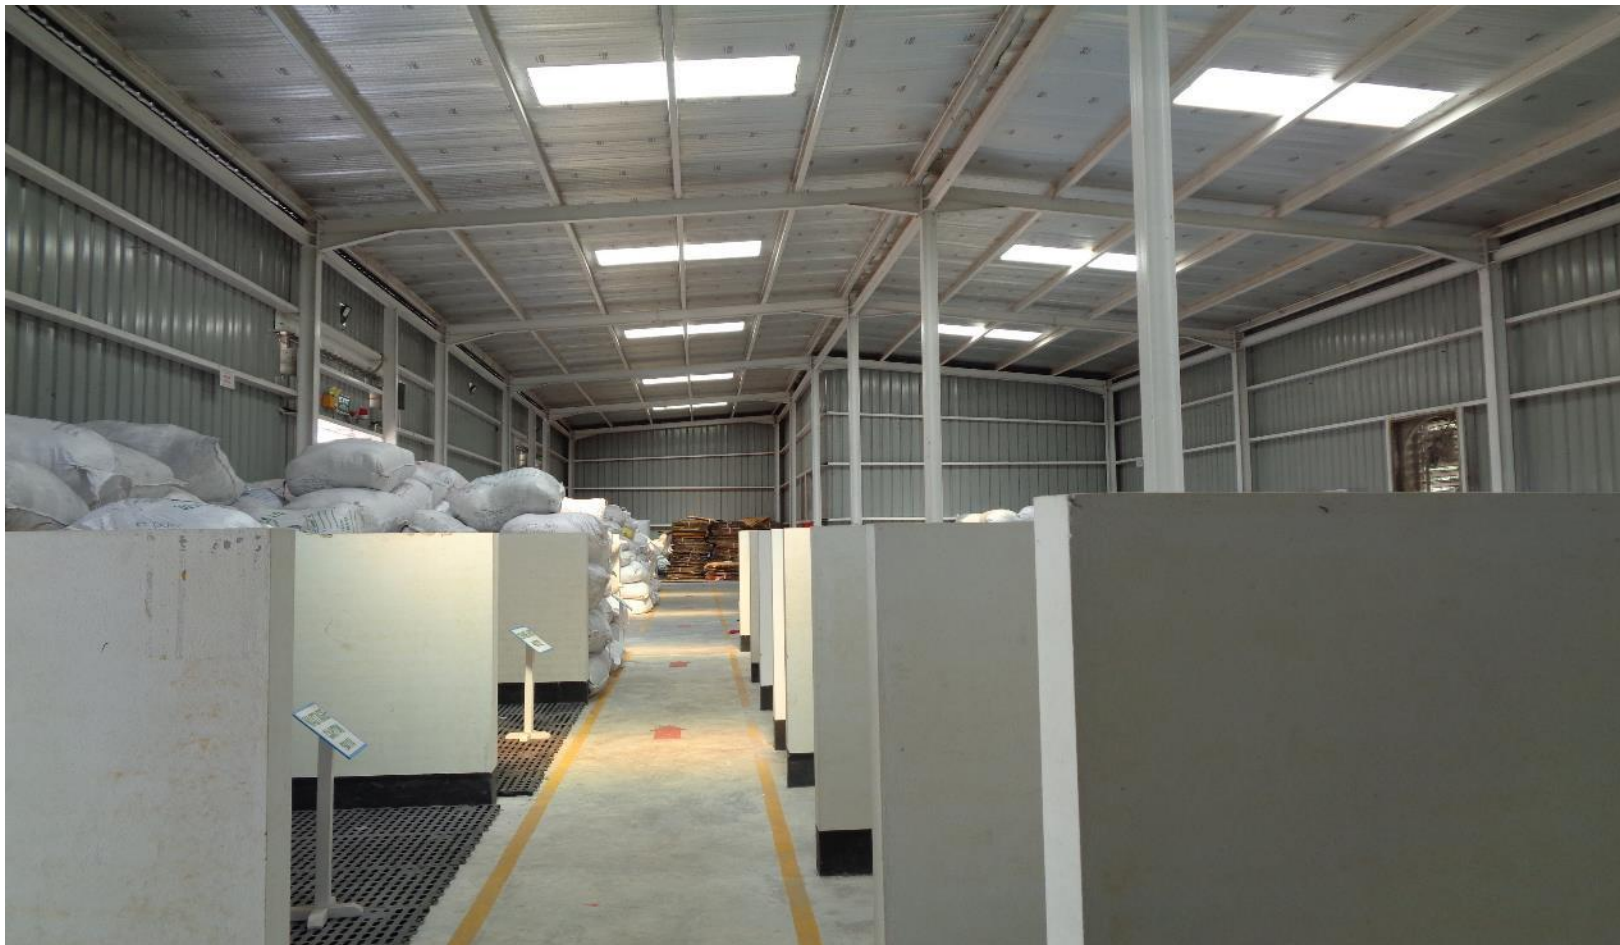
Compression strut provided along long direction without any bracing/tension member.

Horizontal and vertical bracing at roof and wall was not provided to complete the lateral stability system. The factory engineer is required to design and install the necessary bracings for lateral stability of the structure.

| Item No. | Observation | Recommended Action Plan | Recommended Timeline |
|---|---|---|---|
| 12 | Lack of lateral stability (B-10: Wastage Go-down) | The factory engineer to perform engineering assessment (EA) to confirm the lateral stability of the structure. | 6-weeks |
| 13 | Lack of lateral stability (B-10: Wastage Go-down) | Implement remedial works as per recommendation of EA. | 6-months |

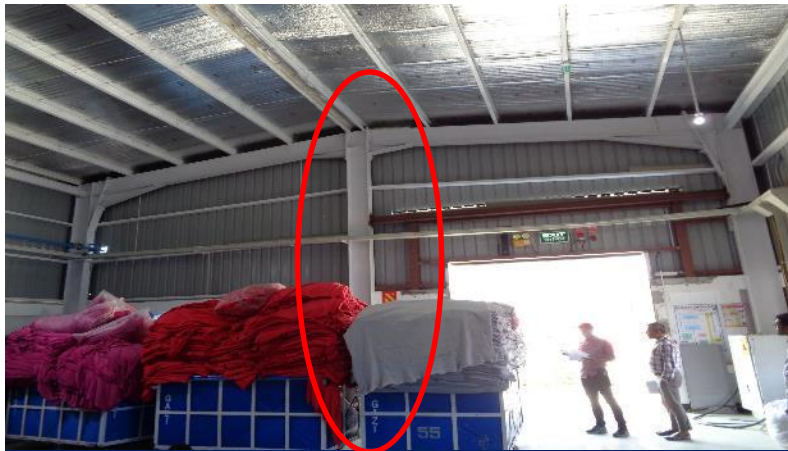
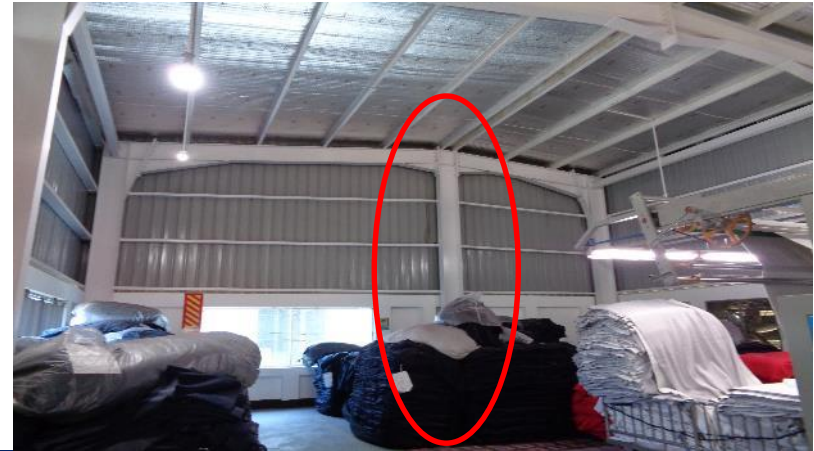
Marked steel columns at two end grids are not shown in provided drawing

| Item No. | Observation | Recommended Action Plan | Recommended Timeline |
|---|---|---|---|
| 14 | Inconsistency in provided drawing (B-11: Raising Shed) | Factory is required to produce accurate as-built drawing with proper connection details. | 6-weeks |

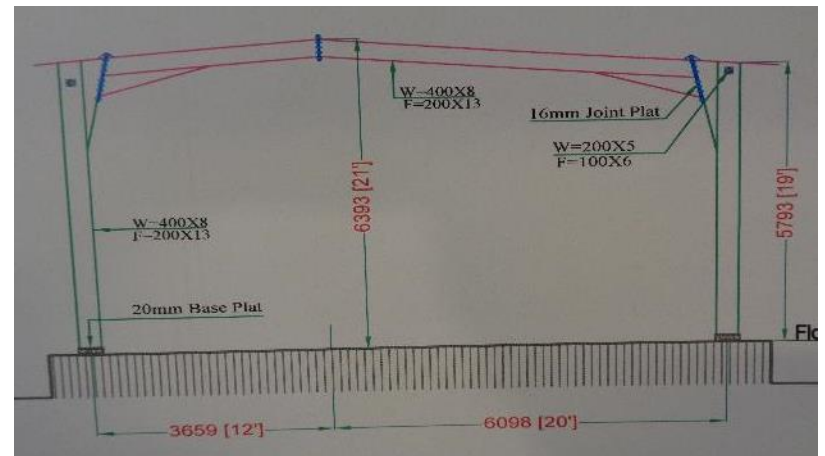
Connection details of all connection are not shown in provided drawing  
The factory is required to produce accurate as-built drawing with proper connection detail.

No connection detail shown in drawing

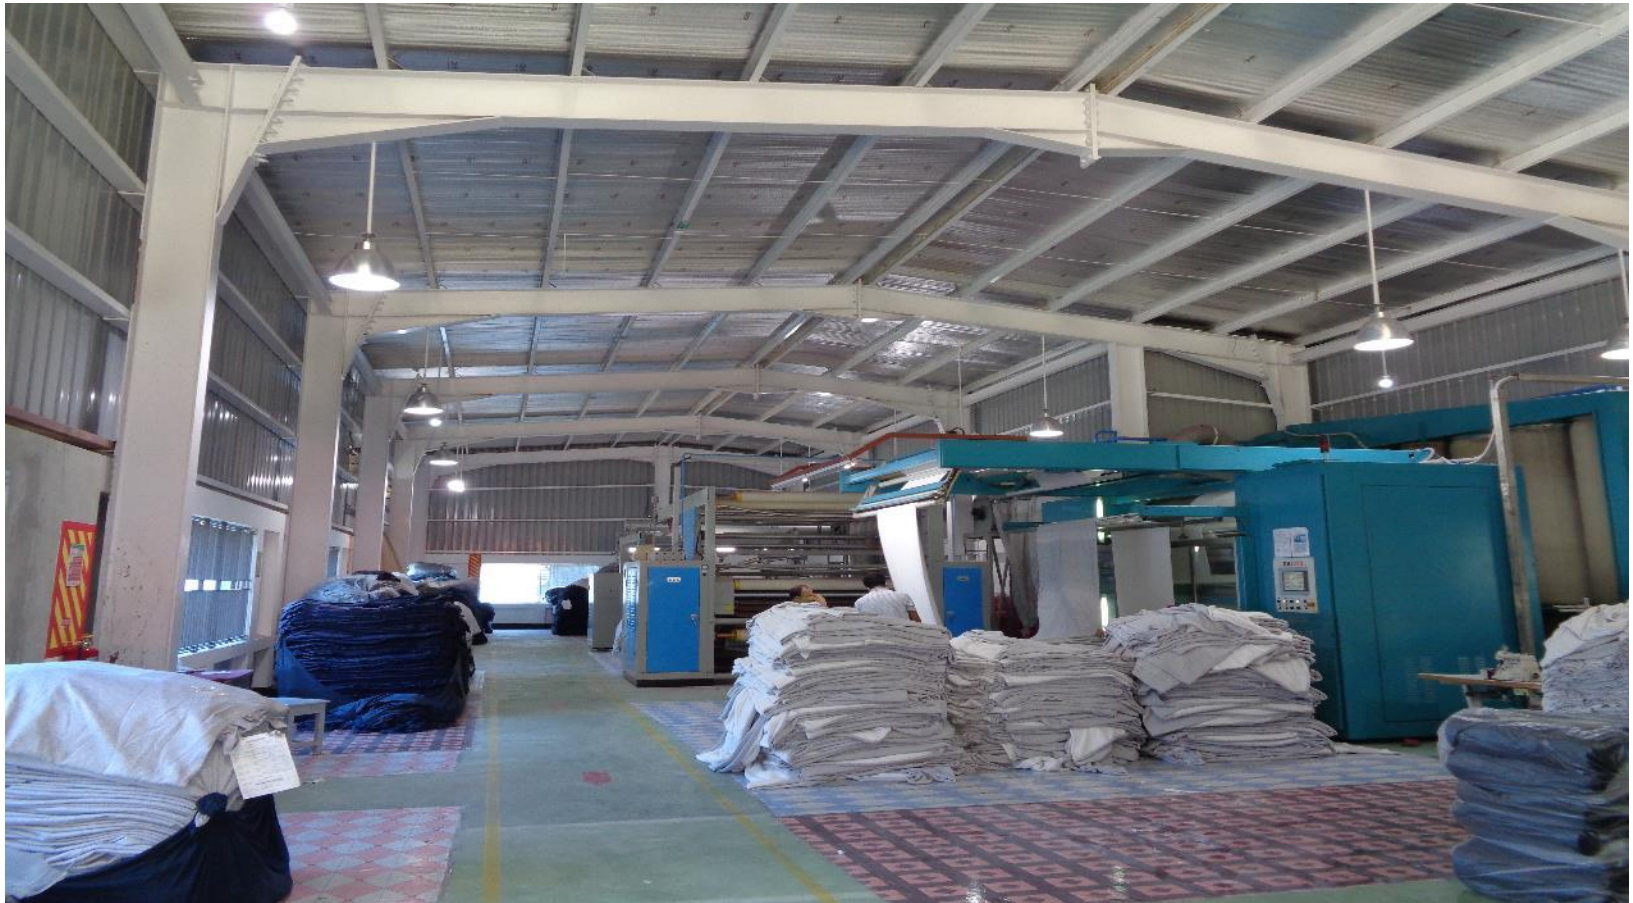
Compression strut provided along long direction without any bracing/tension member.

Horizontal and vertical bracing at roof and wall was not provided to complete the lateral stability system. The factory engineer is required to design and install the necessary bracings for lateral stability of the structure.

| Item No. | Observation | Recommended Action Plan | Recommended Timeline |
|---|---|---|---|
| 15 | Insufficient lateral stability system (B-11: Raising Shed) | The factory engineer to perform engineering assessment (EA) to confirm the lateral stability of the structure. | 6-weeks |
| 16 | Insufficient lateral stability system (B-11: Raising Shed) | Implement remedial works as per recommendation of EA. | 6-months |

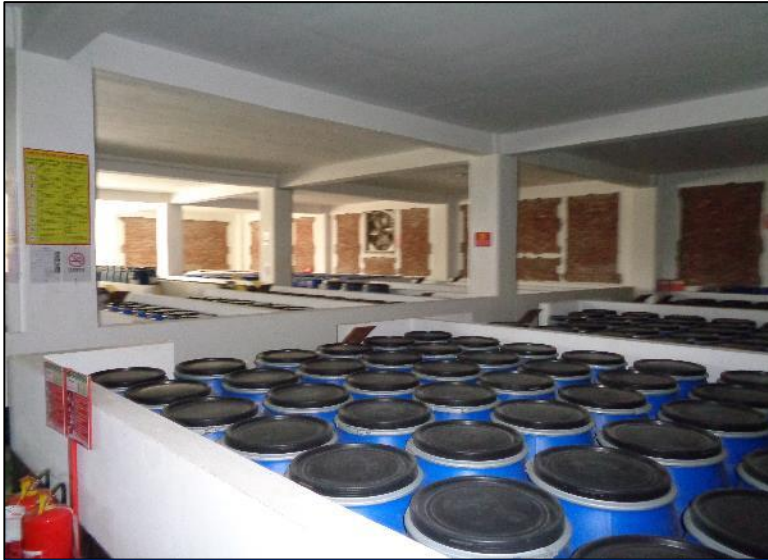
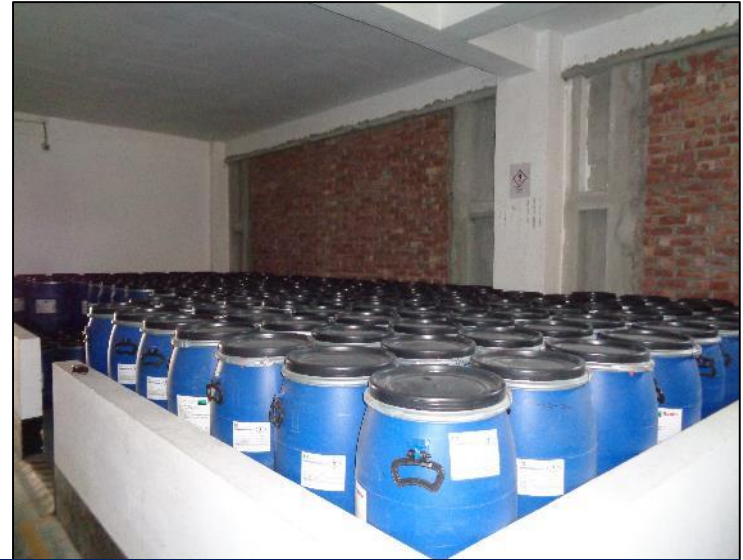
Excessive Loading on the ground floor and 1<sup>st</sup> floor

There was no floor loading plan posted on the floors. During inspection loading was observed on ground floor 3.3 kPa (69 psf) and 1<sup>st</sup> floor 5.5 kPa (116 psf).

| Item No. | Observation | Recommended Action Plan | Recommended Timeline |
|---|---|---|---|
| 18 | Loading on 1st floor and ground floor (B-12: WTP & Store Building) | Produce and actively manage load plans for all floor plates considering column and floor capacity. | 6-weeks |
| 19 | Loading on 1st floor and ground floor (B-12: WTP & Store Building) | Continue to implement floor load plan. | 6-months |
