# **FIRE SAFETY INSPECTION REPORT**

## **BAXTER BRENTON (BD) CLOTHING MFG.**

**FS SFB-07 (1ST FLOOR), DEPZ OLD ZONE,  
GONOKBARI, ASHULIA, SAVAR DHAKA**

May 7, 2014

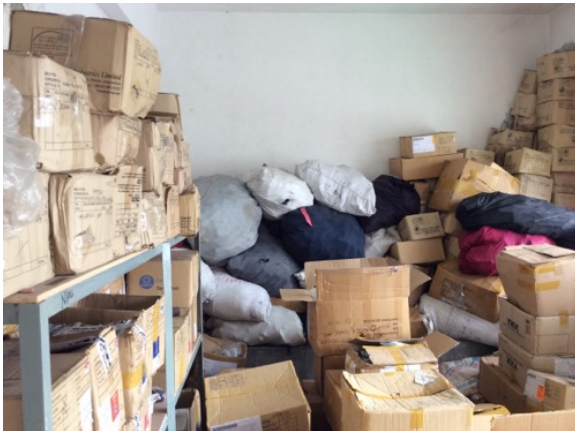
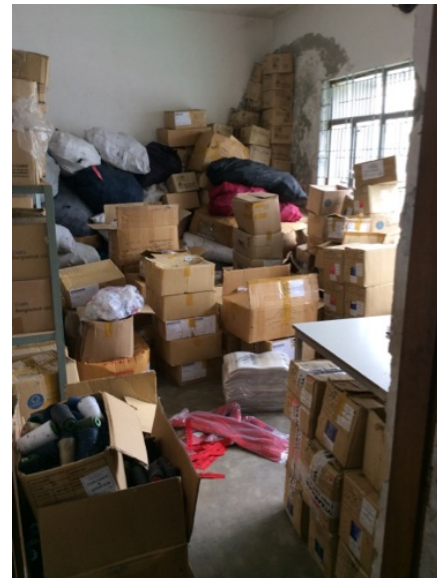
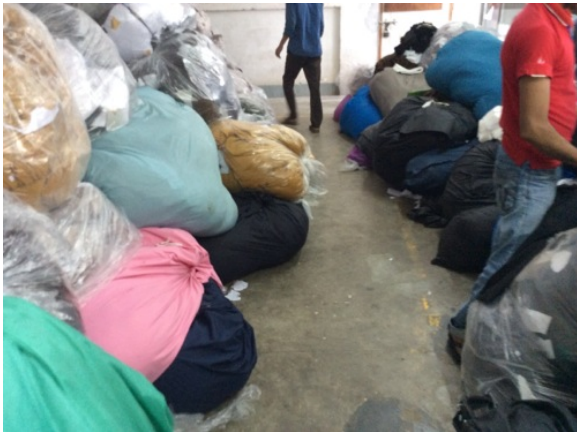
| No. | Category | Finding | Recommendation | Remediation Timeframe |
|---|---|---|---|---|
| F-1 | Fire Rated Construction | Areas used for combustible storage are not separated by fire-rated construction.<br>Location: On first and second floor | Provide dedicated storage rooms separated by minimum 1-hr fire-rated construction. | Immediate |

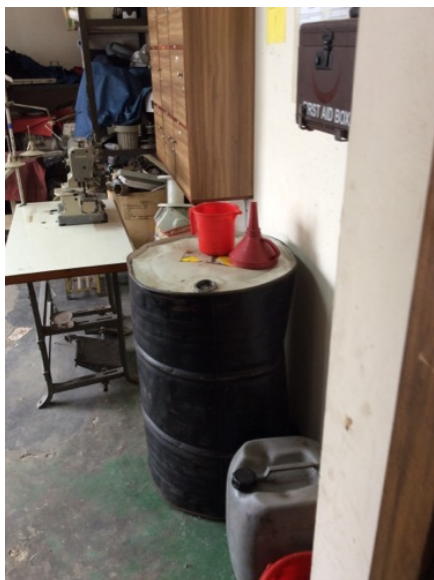
| F-2 | Fire Rated Construction | Flamable storage area is not separated by fire-rated construction on openings, non-rated doors. | Separate the hazardous materials / flammable liquid storage room by a minimum 2-hr fire-rated construction. Seal and/or protected all openings to maintain the required fire separations. | Within 3 months |

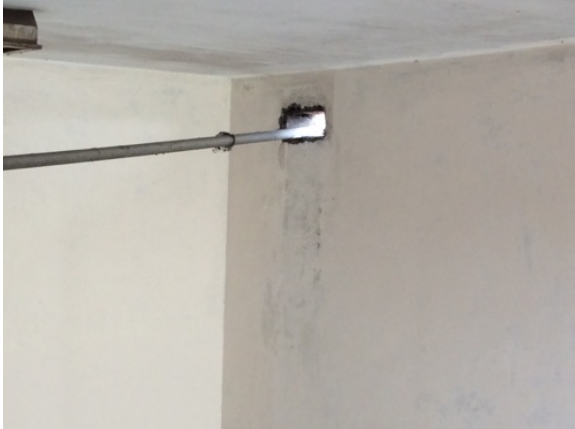
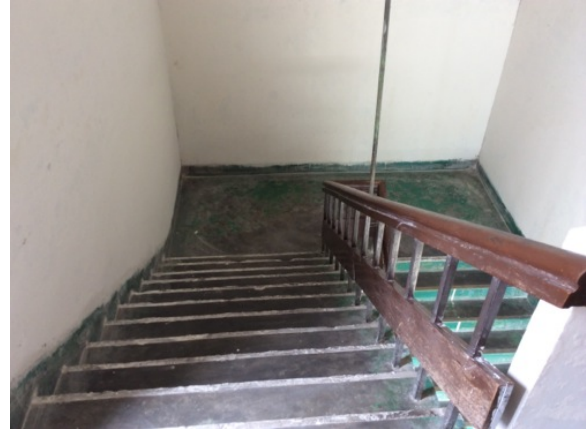
| F-3 | Fire Rated Construction | Unsealed stair penetrations, opening is located in exit stair enclosures al roof area pipe running through wall. | Seal all penetrations and openings in exit stair enclosure walls to maintain the fire separation. | Within 3 months |

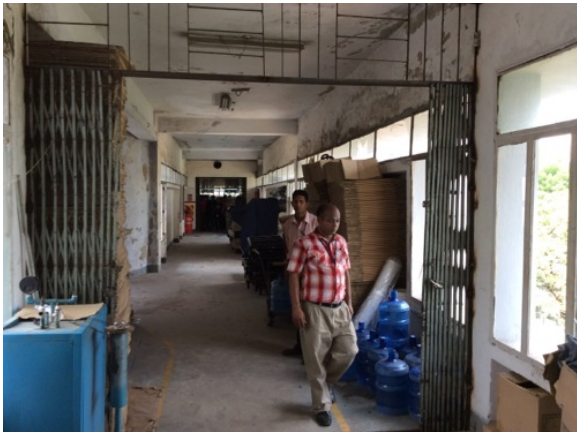
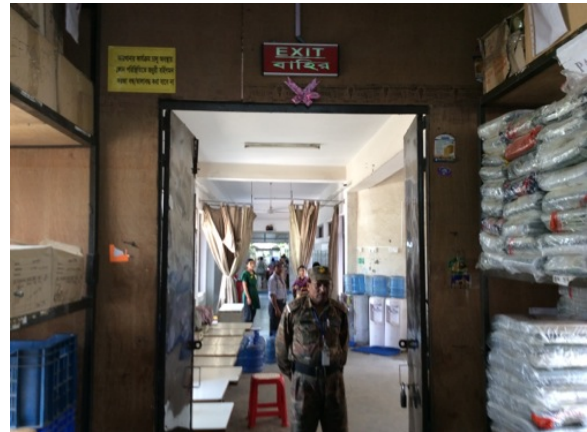
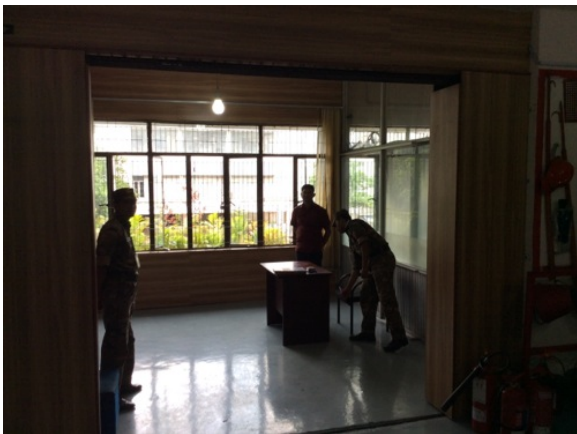
| F-4 | Egress | Egress doors / gates with locking features are provided at building exits, exit stairs, along egress routes, exit discharge. All gates and doors were open and unlocked during inspection. | Remove locking features from all egress doors / gates.<br><br>If locks are required for security reasons, utilize special door locking features complying with NFPA 101. | Immediate |

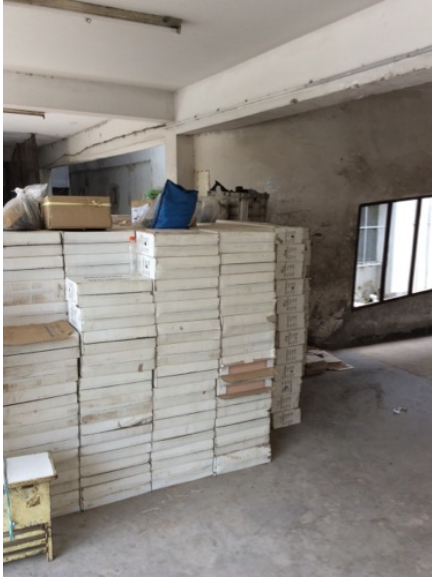
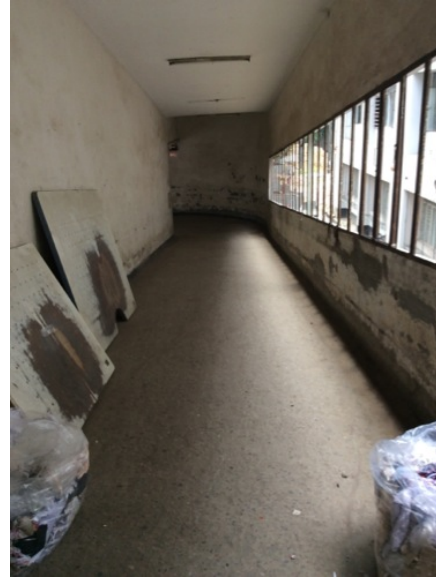
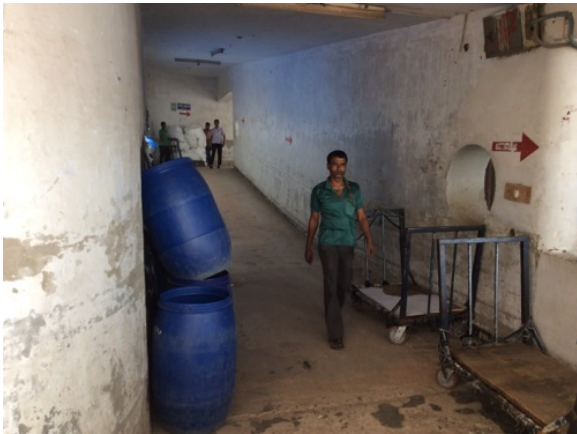
F-5

Storage was located in the exit ramp.

Remove all storage from exit ramp.

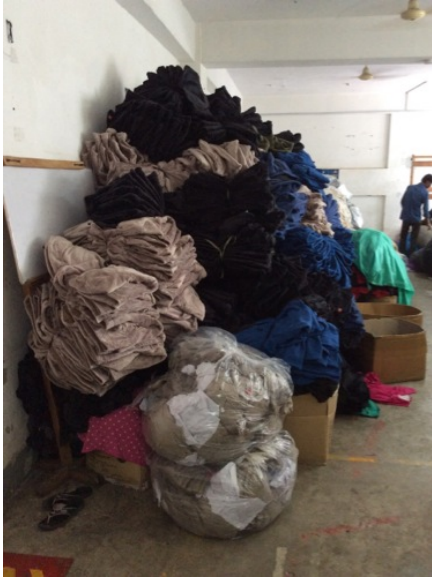
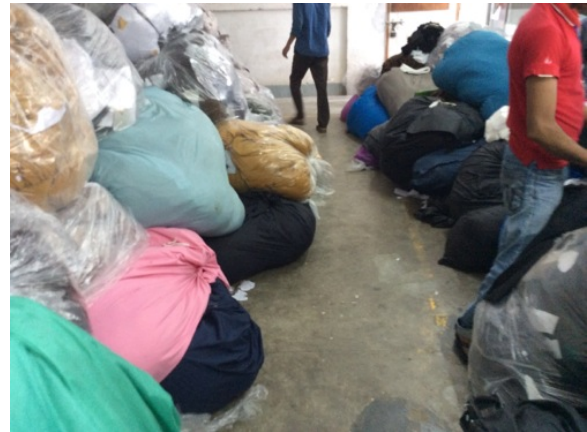
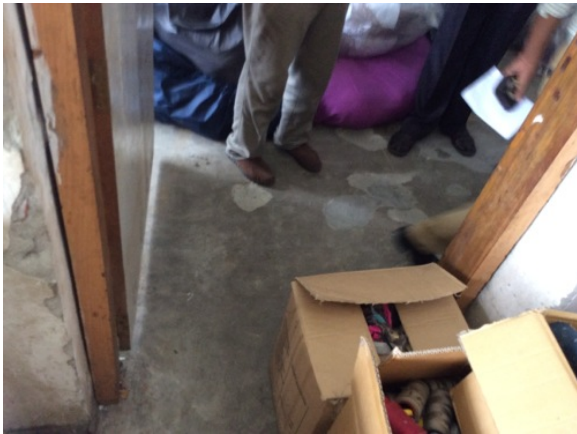
| F-6 | Egress | Storage was located in the egress path.<br>Location: On first floor. | Keep egress paths and stairs clear of storage. | Immediate |

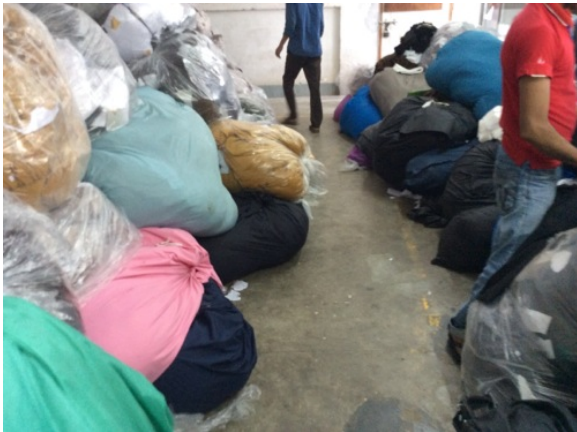
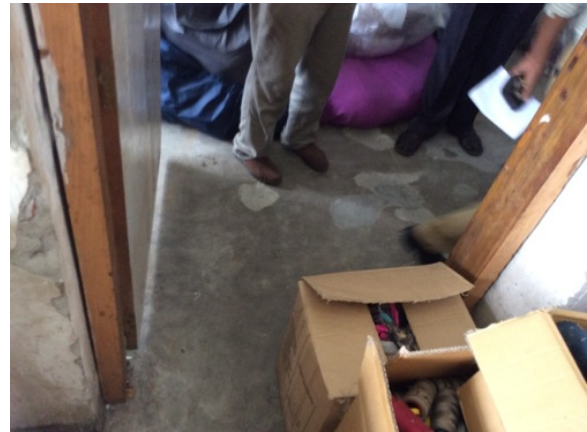
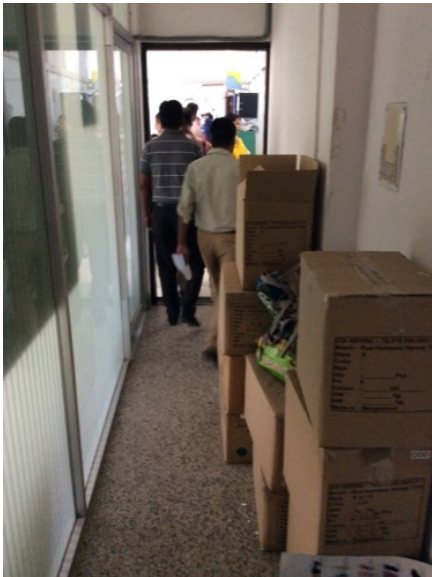
| F-7 | Egress | The width of egress aisles is less than 36-in.<br>Location: On the second floor. | Provide minimum aisle widths of 36-in. | Within 3 months |

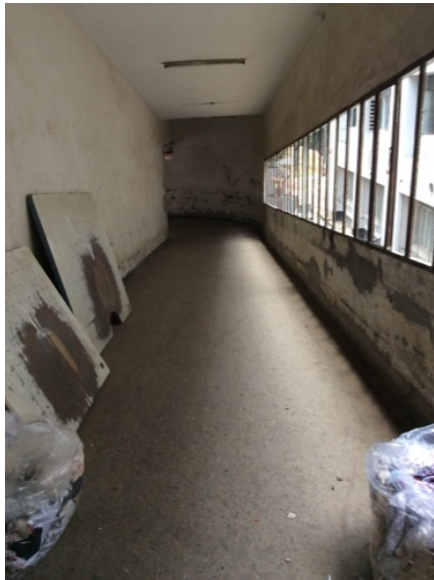
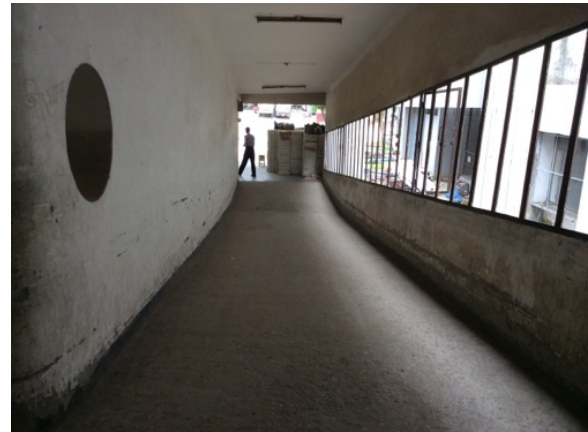
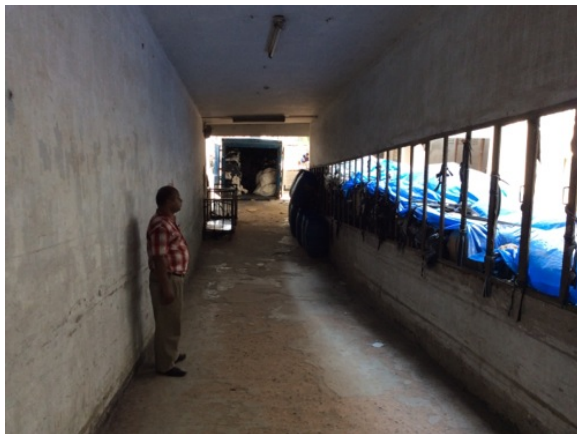
| F-8 | Egress | Handrails are not provided in the exit ramp. | Provide handrails on at least one side of exit ramp. | Within 3 months |

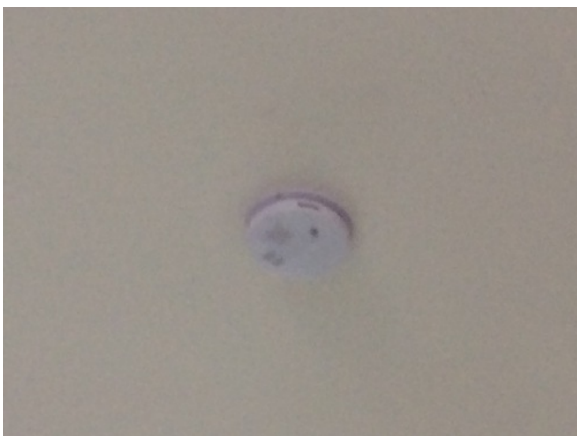
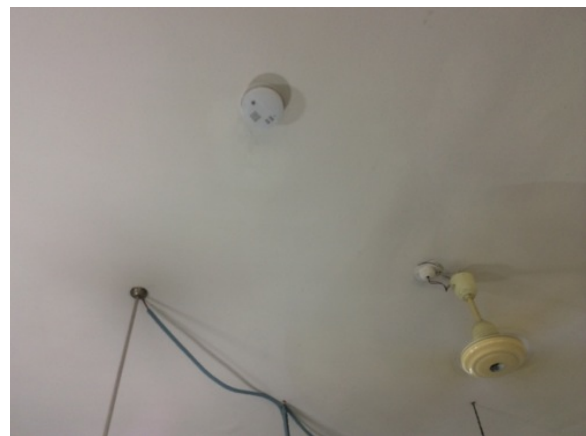
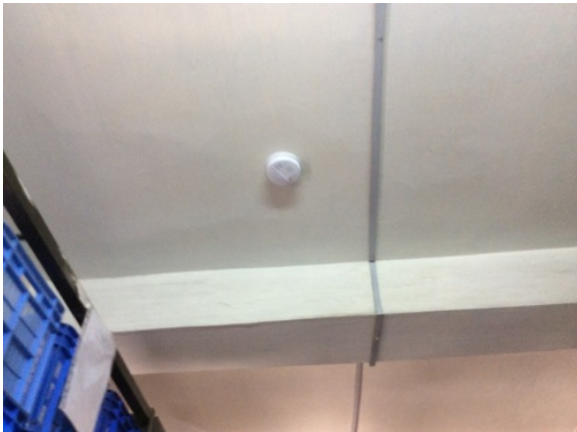
| F-12 | Fire Protection | The building is equipped with single-station smoke alarms. Smoke alarm activation sounds only a local alarm and does not provide automatic fire alarm notification of occupants. | Remove single-station smoke alarms. Provide automatic smoke detection throughout the accordance with NFPA 72. | Within 6 months |

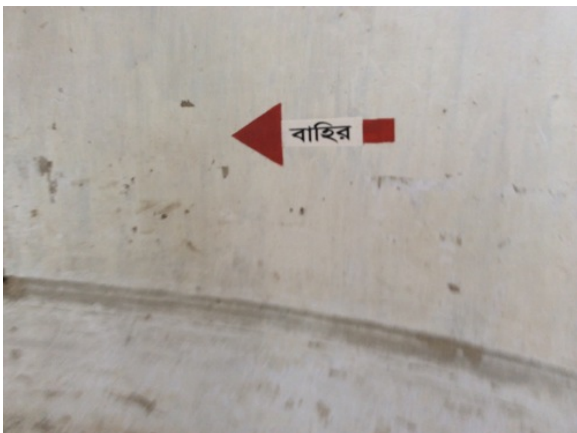
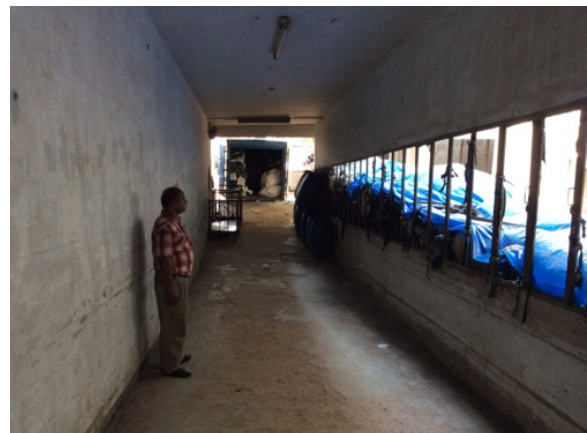
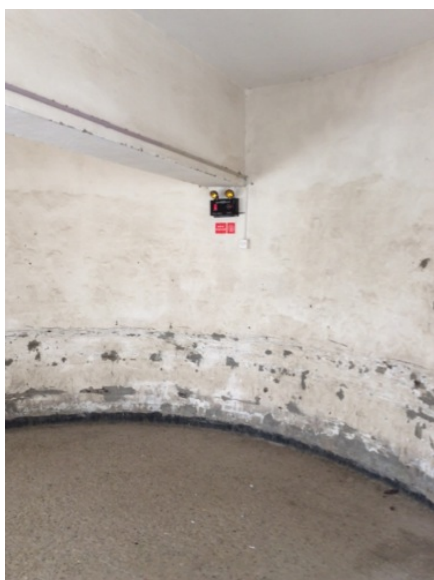
| F-13 | Egress Lighting | Exit sign not provided at both exit ramps. | Provide exit signs above all exits to the exterior and all doors to the exit stairs ramps. | Within 1 month |

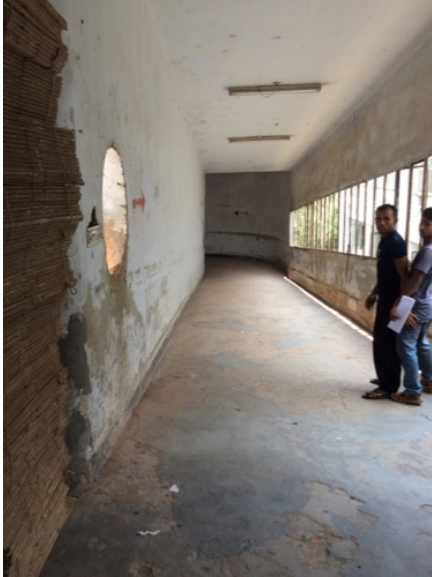
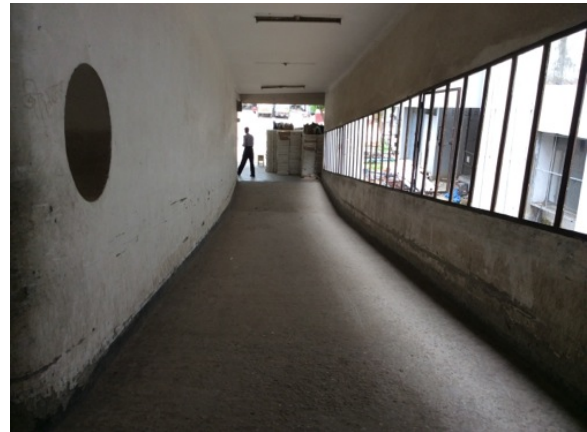
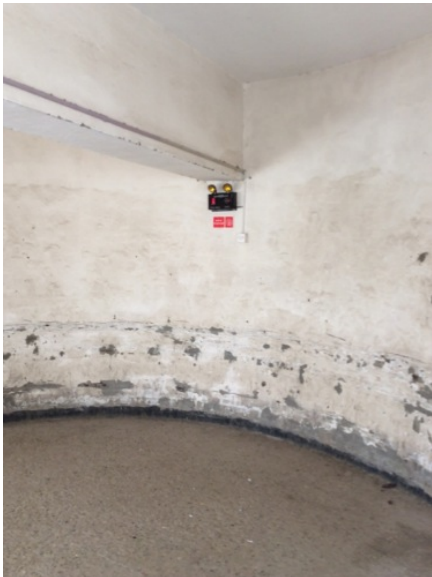
| F-15 | Egress Lighting | Based on the number and location of emergency lights observed, adequate illumination levels are not anticipated along egress routes. Missing in ramp exits and factory floor. | Test the emergency lighting system on each floor and provide additional emergency fixtures to provide adequate illumination along the means of egress. Provide a minimum illumination of 10 lux at the floor level within exit stairs and exit discharge paths and minimum 2.5 lux along exit access aisles. | Within 3 months |

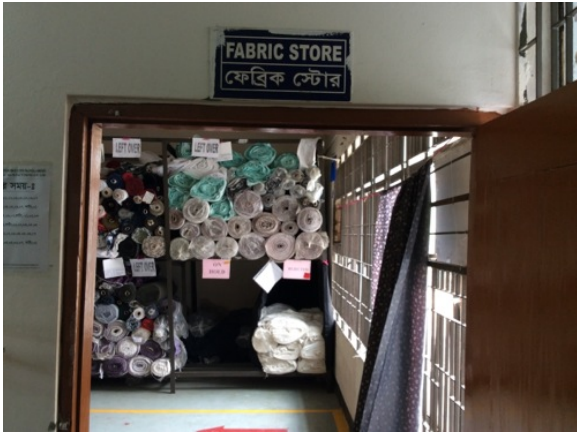
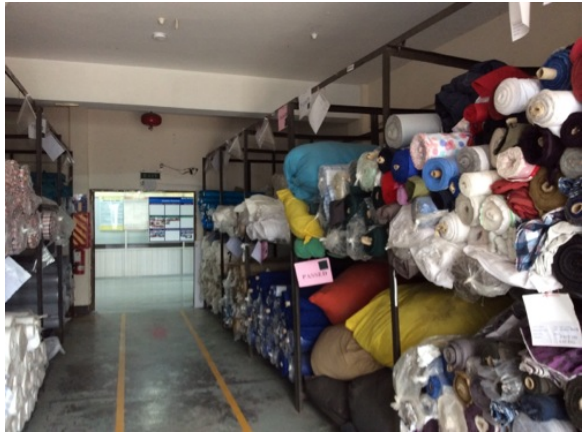
| No. | Category | Finding | Recommendation | Remediation Timeframe |
|---|---|---|---|---|
| F-1 | Fire Rated Construction | Areas used for combustible storage are not separated by fire-rated construction.<br>Location: First floor | Provide dedicated storage rooms separated by minimum 1-hr fire-rated construction. | Within 3 months |

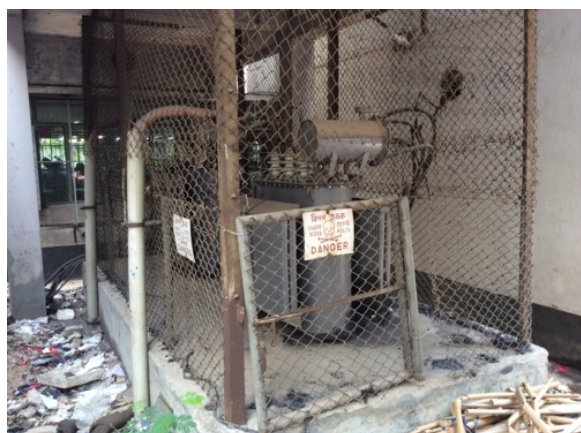
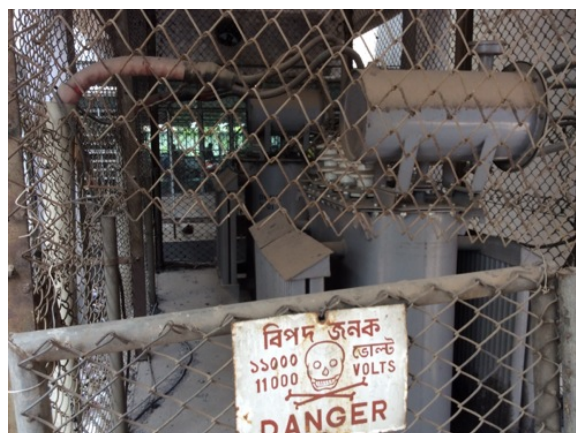
| No. | Category | Finding | Recommendation | Remediation Timeframe |
|---|---|---|---|---|
| F-2 | Fire Rated Construction | The transformer is not separated by fire-rated construction (openings, non-rated doors, penetrations). Location: Westside of the exterior of building. | Separate the transformer by a minimum 2-hr fire-rated construction. Seal and/or protected all openings to maintain the required fire separations | Within 3 months |

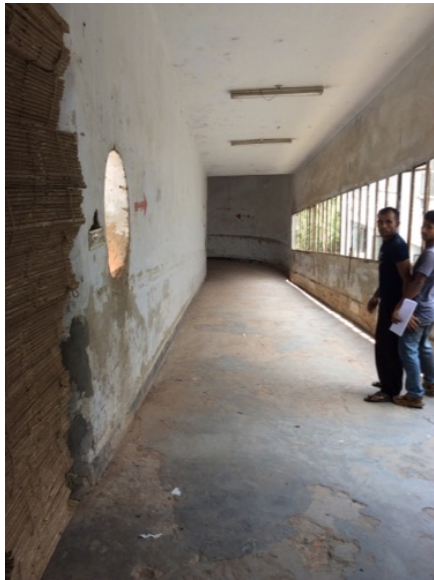
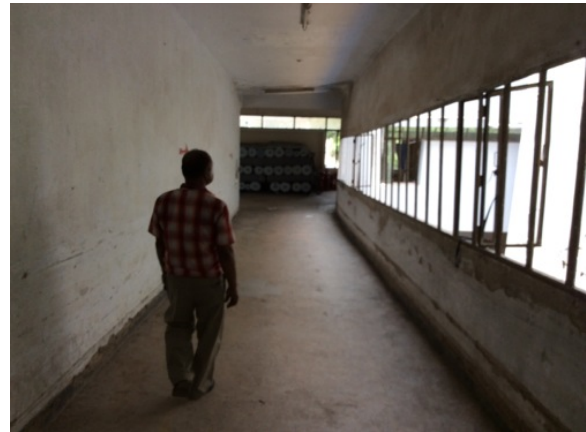
| F-4 | Egress | <p>Handrails are not provided in the exit ramp.</p> | <p>Provide handrails on at least one side of exit ramp.</p> | <p>Within 3 months</p> |

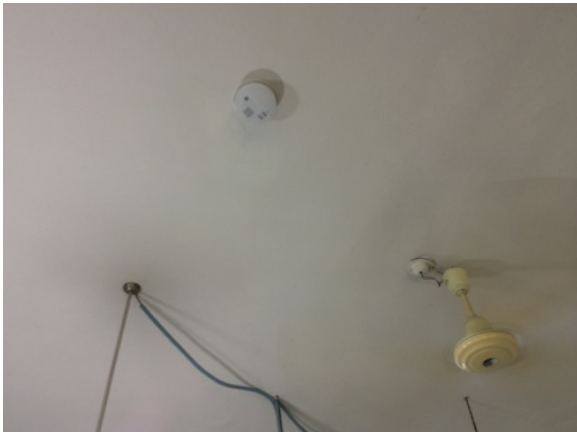
| F-6 | Fire Protection | Activation of the fire alarm system by a manual fire alarm station provides automatic occupant notification only on the floor of alarm and not throughout the building. Location: First floor. | Remove single-station smoke alarms. Provide automatic smoke detection throughout the accordance with NFPA 72. | Within 1 months |
