# INITIAL STRUCTURAL INTEGRITY ASSESSMENT REPORT (SIAR)

Factory Name: **Kenpark Bangladesh Apparel (Pvt) Limited (K-5)**  
Address: **Plot #14/23, Sector #2 Karnaphuli Export Processing  
Zone Chittagong Chittagong Bangladesh**  
Assessor: **Emkay Enterprises LTD**  
Date: **26 Feb 2014**

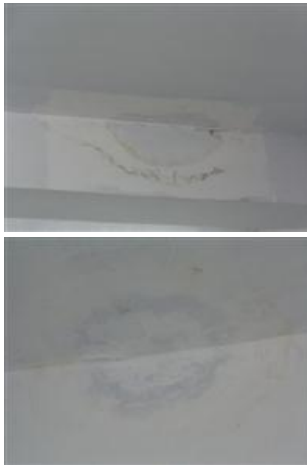
| Description: | Dampness and efflorescence were observed in the soffit of the slab and beam surfaces at the ground floor of Building-2 (Production Building-B). | |

| Suggested Plan of Action: | Under guidance from a qualified structural engineer, address all areas of needed maintenance by correcting the identified issues. | |
