# **FIRE SAFETY INSPECTION REPORT**

## **ENVOY FASHION LTD.**

**DIAKHALI, YEARPUR, JAMGORA, SAVAR, DHAKA.**

March 30, 2014

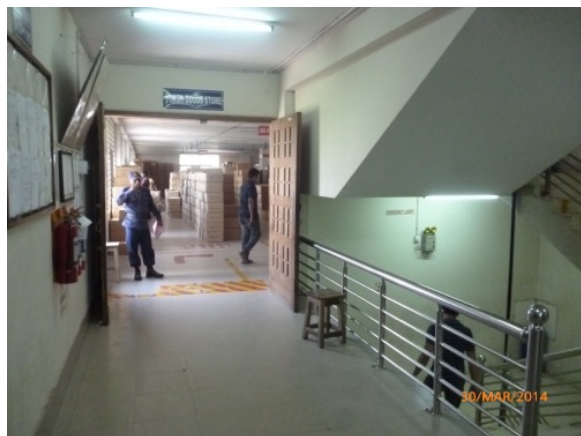
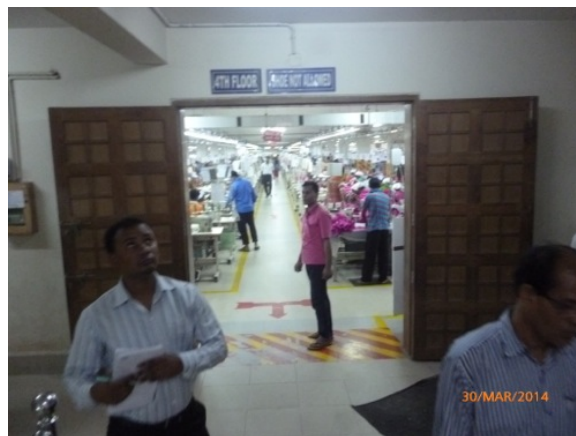
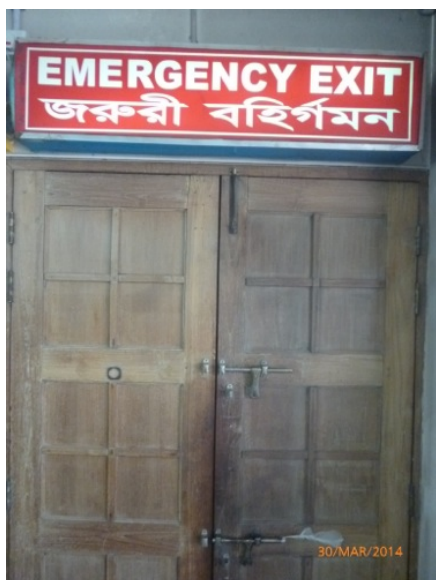
| F-3 | Fire Rated Construction | The exit stairs are not separated from work areas on each floor by fire-rated construction. | Provide minimum 1.5-hr fire rated doors and seal all unprotected openings to separate the exit stairs from work areas and other building spaces on all floor levels. Ensure that the fire doors are self-closing and positive latching and that they are provided with fire exit (panic) hardware where serving production floors. | Within 3 months |

| | | | If fire doors are required to be held open for functional reasons, provide automatic-closing devices tied to the fire alarm system. | |

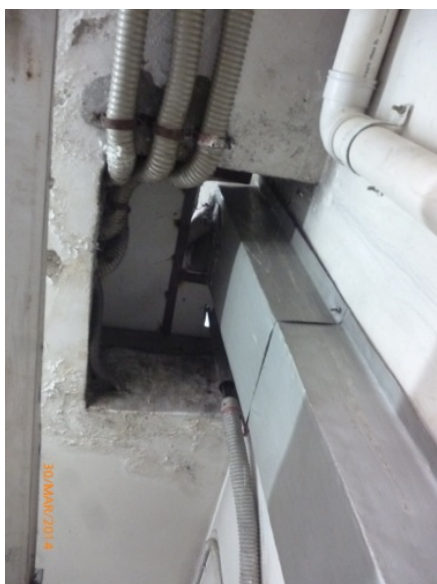
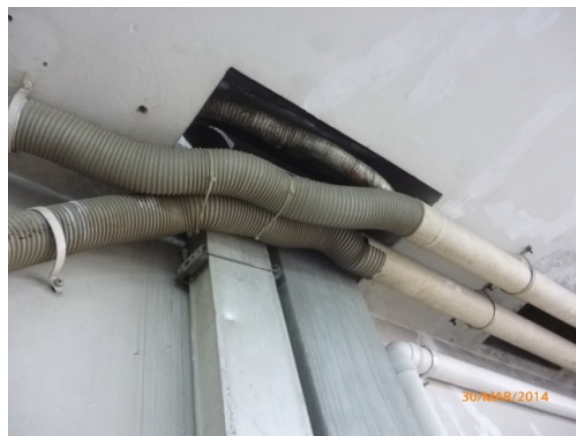
| F-4 | Fire Rated Construction | Unsealed penetrations and openings are located in the fire-rated floor/ceiling assemblies. | Provide a minimum 2-hr fire-rated shaft to separate the utility risers from each floor level. | Within 3 months |

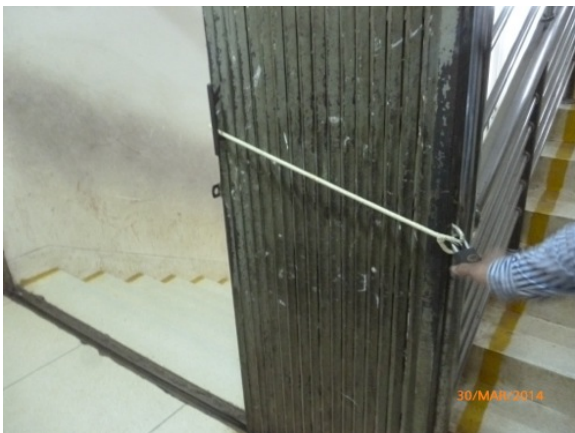
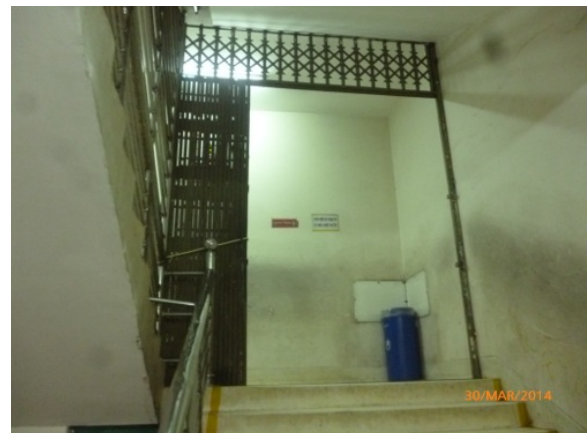
| F-5 | Egress | <p>Egress doors and gates with locking features are provided at building exits, exit stairs and exit discharge.</p> <p>All gates and doors were open and unlocked during the inspection.</p> | <p>Remove locking features from all egress doors / gates.</p> <p>If locks are required for security reasons, utilize special door locking features complying with NFPA 101.</p> | Immediate |

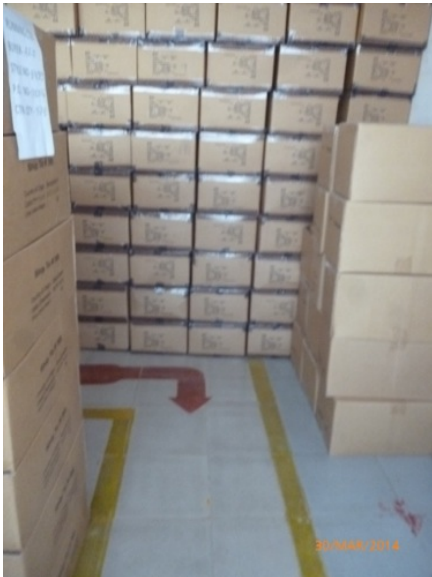
| F-6 | Egress | Storage was located in the exit stair at 5th floor finished goods store. | Remove all storage from exit stairs and egress paths. | Immediate |

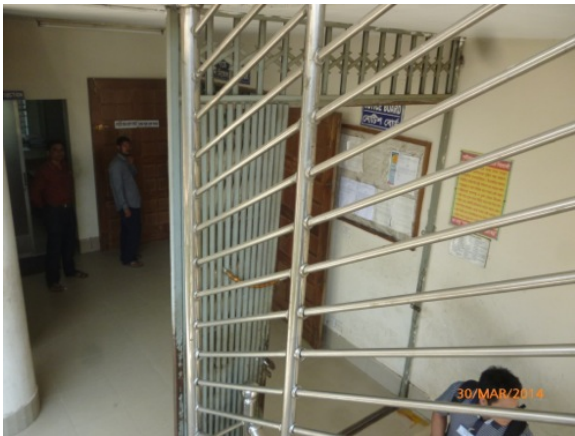
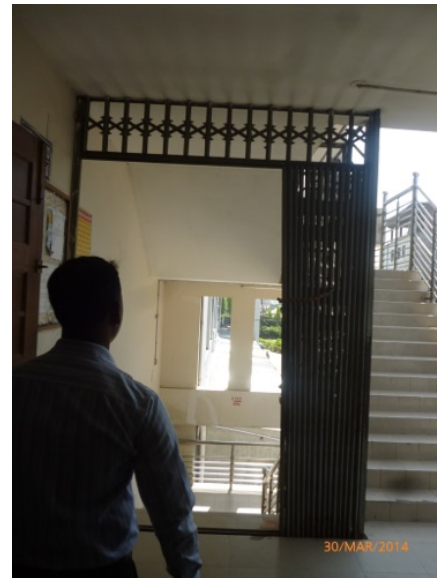
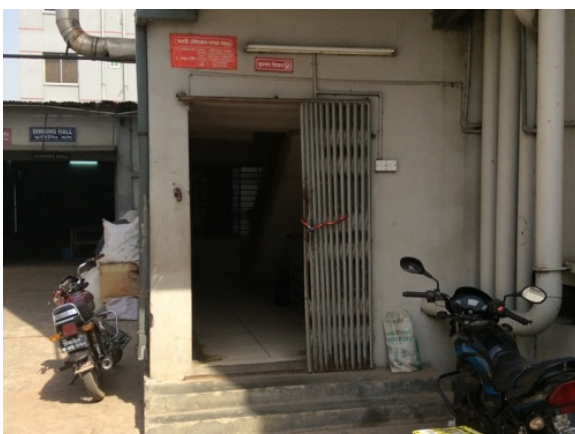
| F-8 | Egress | Collapsible gates and sliding doors are provided at building exits, exit stairs and exit discharge. | Replace all gates and sliding doors along the means of egress with side-hinged, swinging egress doors.<br><br>If locks are required for security reasons, utilize special door locking features complying with NFPA 101. | Within 1 month |

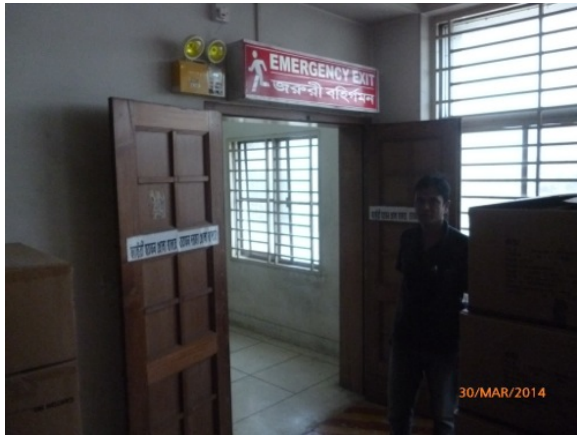
| F-9 | Egress | West exit stairwell doors serving 50 or more occupants does not swing in the direction of egress travel. | Modify the egress door to swing in the direction of egress travel. | Within 3 months |

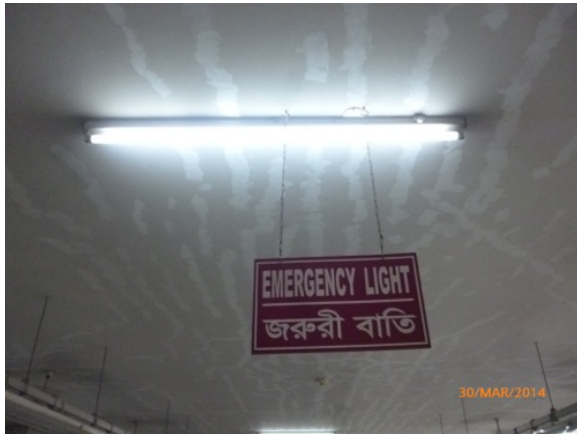
| F-11 | Egress Lighting | Manual on-off switch is provided for emergency lighting and exit signage units. | Remove manual on/off switches from emergency lighting and exit signage units to prevent them from being switched off. | Within 1 month |
