# **FIRE SAFETY INSPECTION REPORT**

**SB STYLE COMPOSITE LTD.  
DELPARA, FATULLAH, NARAYANGANJ**

**ACCORD**  
on Fire and Building Safety in Bangladesh

May 20, 2014

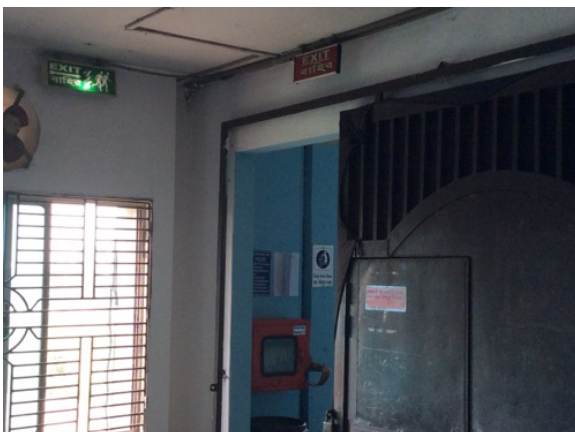
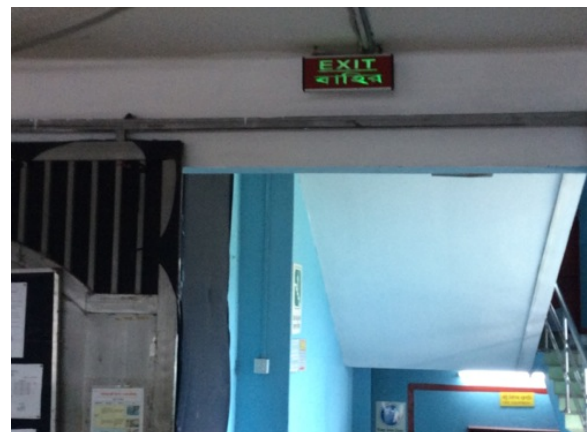
| No. | Category | Finding | Recommendation | Remediation Timeframe |
|---|---|---|---|---|
| F-1 | Fire Rated Construction | The exit stairs are not separated from work areas, on each floor by fire-rated construction. | <p>Provide minimum 1.5-hr fire rated doors and seal all unprotected openings to separate the exit stairs from work areas and other building spaces on all floor levels. Ensure that the fire doors are self-closing and positive latching and that they are provided with fire exit (panic) hardware where serving production floors.</p> <p>If fire doors are required to be held open for functional reasons, provide automatic-closing devices tied to the fire alarm system.</p> | Within 3 months |

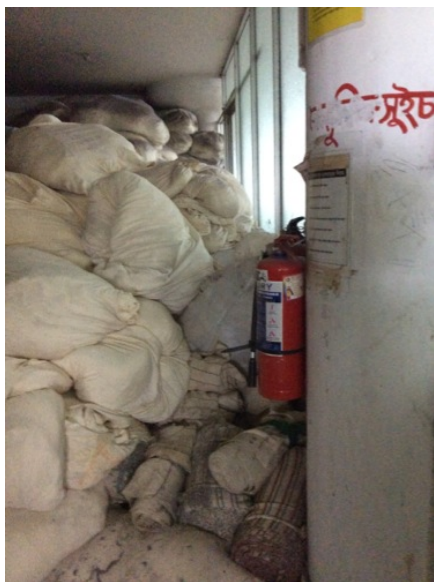
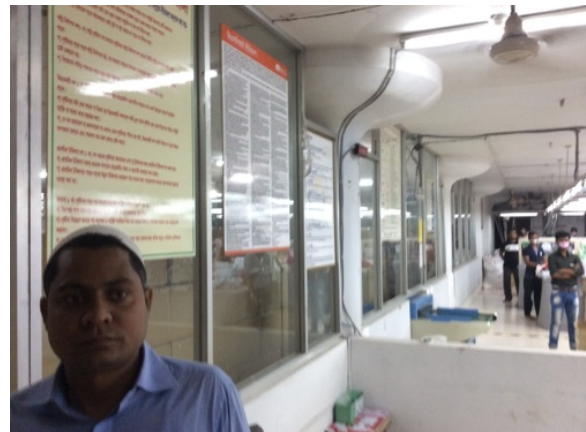
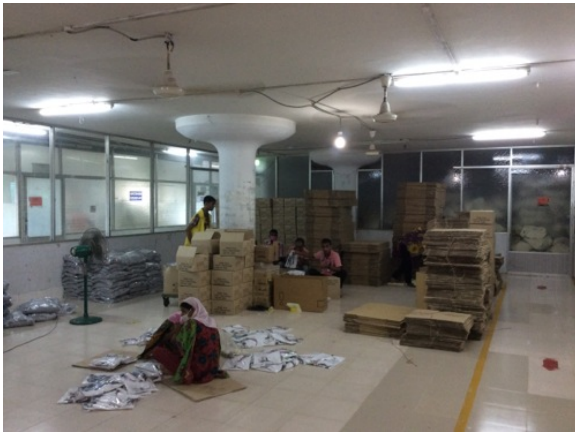
| F-2 | Fire Rated Construction | Areas used for combustible storage at the 2nd floor are not separated by fire-rated construction. | <p>Provide dedicated storage rooms separated by minimum 1-hr fire-rated construction.</p> <p>Where separate storage rooms are not feasible, provide defined storage areas and limit the storage arrangement as follows:</p> <ul style="list-style-type: none"><li>- Maximum height of 2.4m and maximum area of 23m<sup>2</sup></li><li>- If sprinkler protected: maximum height of 3.66m and maximum area of 93m<sup>2</sup></li></ul> <p>Separate areas of unenclosed combustible storage by a minimum clear distance of 3m.</p> | Within 3 months |

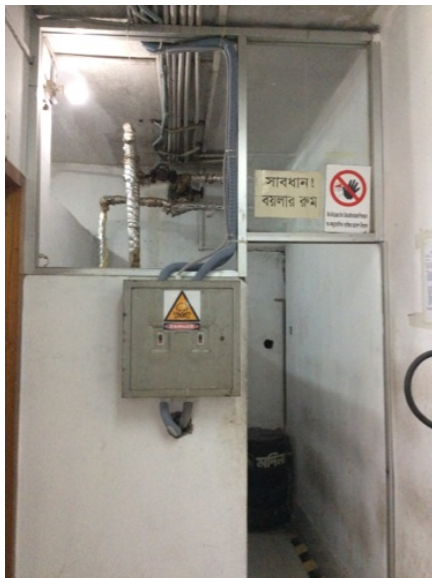
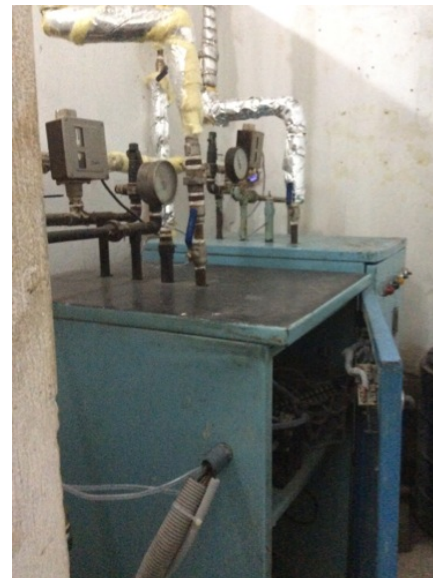
| F-3 | Fire Rated Construction | <p>The boiler room is not separated by fire-rated construction.</p> <p>Electrical boiler was located at the 2nd floor without proper fire-rated separation.</p> | <p>Separate the boiler room by a minimum 1-hr fire-rated construction. Seal and/or protected all openings to maintain the required fire separations</p> | Within 3 months |

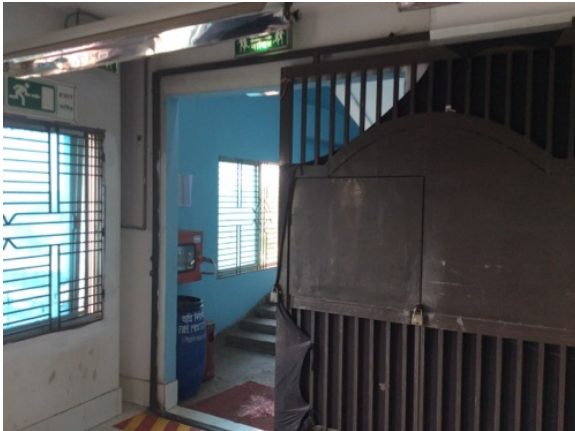
| F-4 | Egress | Egress gates with locking features are provided at most building exit stairs.<br><br>All lockable openings were open and unlocked during the inspection. | Remove locking features from all egress gates.<br><br>If locks are required for security reasons, utilize special door locking features complying with NFPA 101. | Immediate |

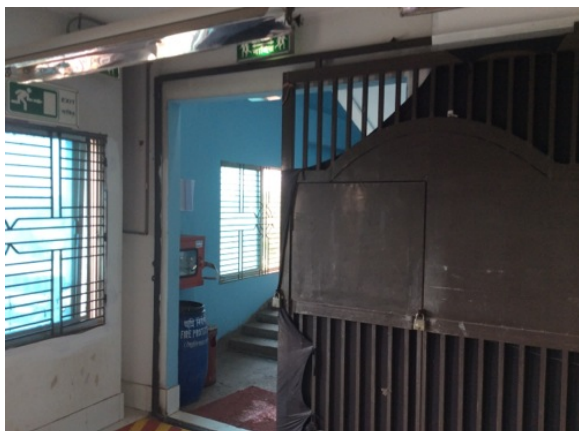
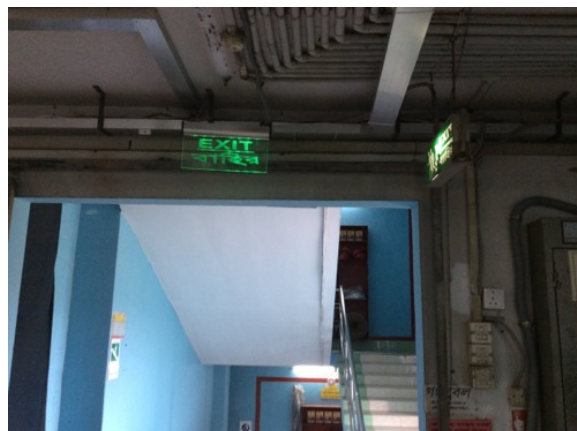
| F-5 | Egress | Sliding gates are provided at both exit stairs. | Replace all gates along the means of egress with side-hinged, swinging egress doors.<br><br>If locks are required for security reasons, utilize special door locking features complying with NFPA 101. | Within 1 month |

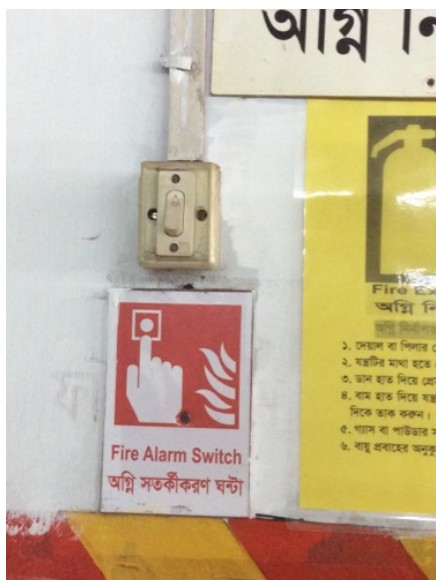
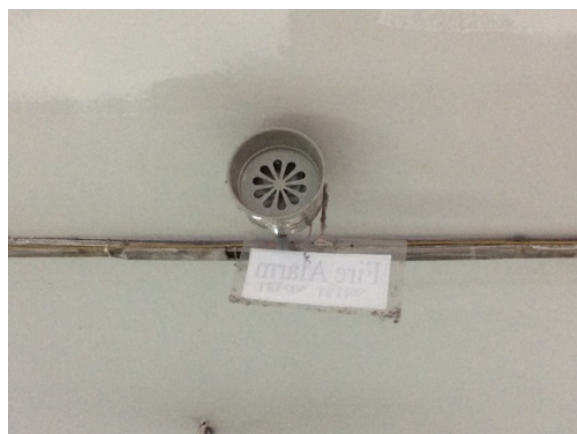
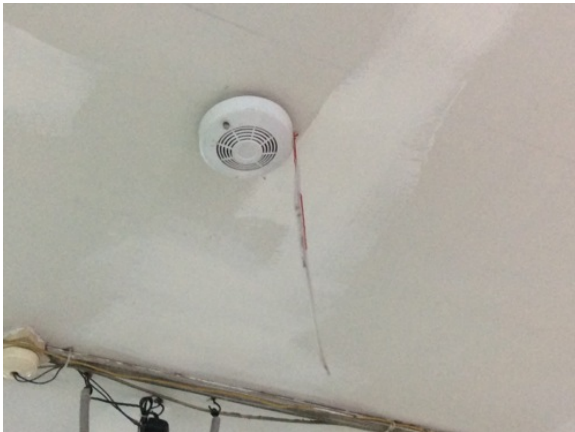
| F-6 | Fire Protection | The fire alarm system is antiquated, not a listed system, and does not provide alarm and notification features consistent with acceptable standards. | Replace the fire alarm system with a new, listed addressable fire alarm system in accordance with NFPA 72. | Design within 4 months, install within 9 months |

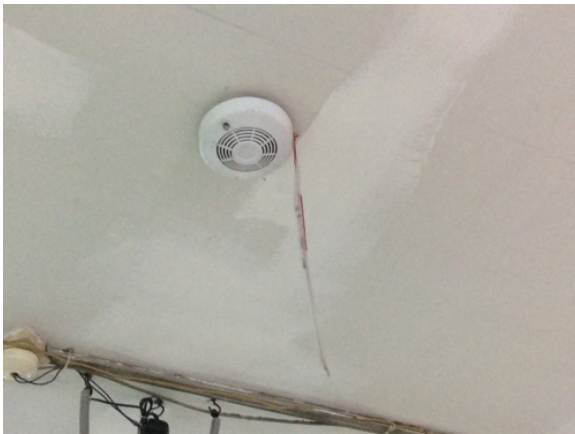
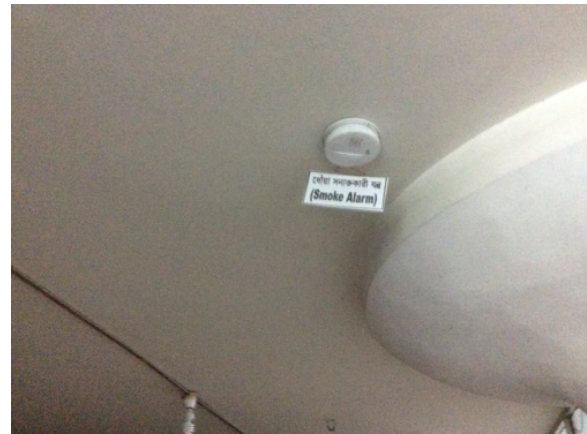
| F-8 | Fire Protection | The building is equipped with single-station smoke alarms. Smoke alarm activation sounds only a local alarm and does not provide automatic fire alarm notification of occupants. | Replace the single-station smoke alarms. Provide automatic smoke detection throughout the building in accordance with NFPA 72. | Within 6 months |

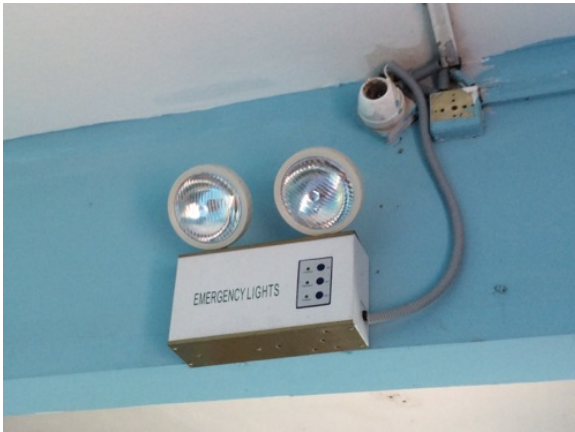
| F-9 | Egress Lighting | Inspection, testing, and maintenance records for the emergency lighting system were not available. | Inspect, test and maintain the emergency lighting system in accordance with The ACCORD standard. Keep written records on-site. | Within 3 months |
