# **FIRE SAFETY INSPECTION REPORT**

## **GARTEX GARMENTS LTD.**

**ACCORD**  
on Fire and Building Safety in Bangladesh

May 22, 2014

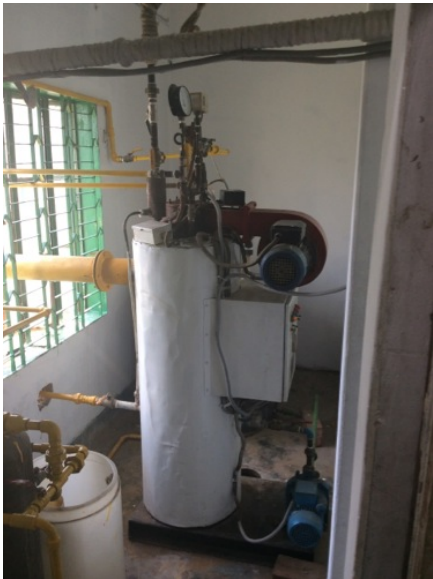
| No. | Category | Finding | Recommendation | Remediation Timeframe |
|---|---|---|---|---|
| F-1 | Fire Rated Construction | The boiler and generator room is not separated by fire-rated construction (openings, non-rated doors, penetrations) located on the second floor open to sewing productions and generator at close proximity to main rear of building egress routes. | Separate the boiler and generator room by a minimum 2-hr fire-rated construction. Seal and/or protected all openings to maintain the required fire separations | Within 3 months |

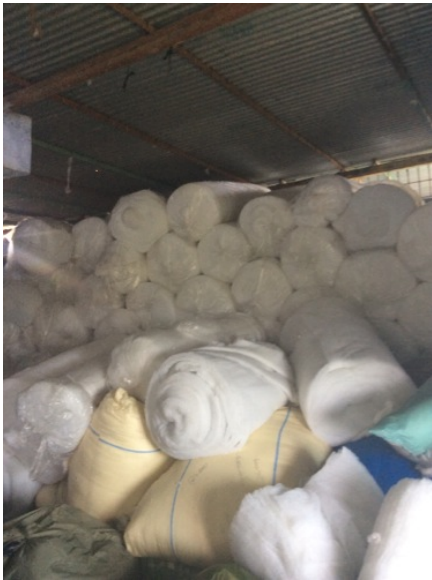
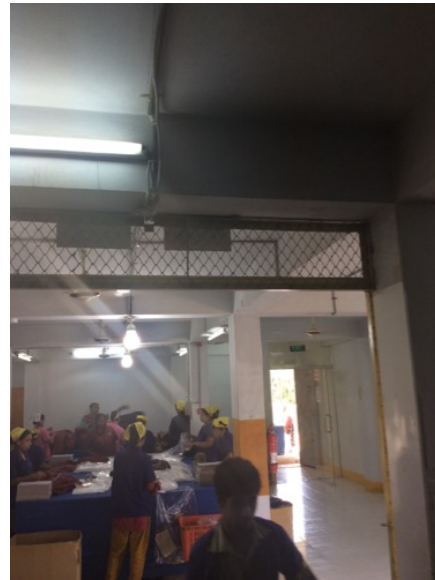
| No. | Category | Finding | Recommendation | Remediation Timeframe |
|---|---|---|---|---|
| F-2 | Fire Rated Construction | Areas used for combustible storage are not separated by fire-rated construction and open to egress paths on the ground and third floor dining area. | Provide dedicated storage rooms separated by minimum 1-hr fire-rated construction. | Within 3 months |

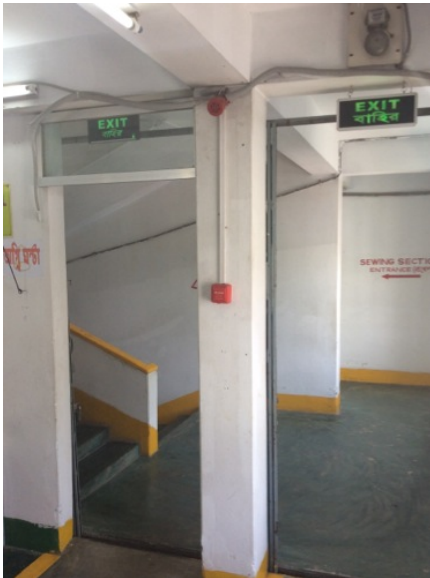
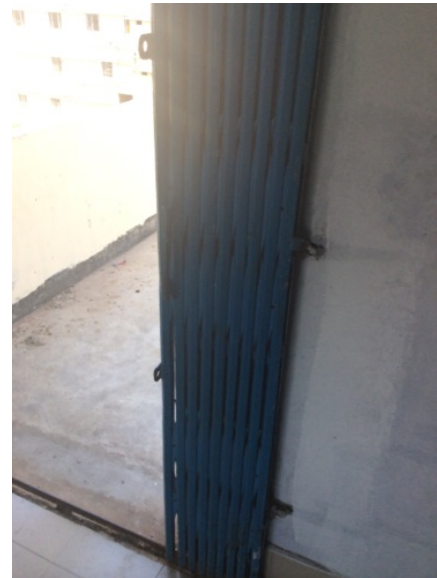
| F-3 | Fire Rated Construction | The exit stairs are not separated from work areas, other spaces on each floor by fire-rated construction throughout the factory building. | <p>Provide minimum 1.5-hr fire rated doors and seal all unprotected openings to separate the exit stairs from work areas and other building spaces on all floor levels. Ensure that the fire doors are self-closing and positive latching and that they are provided with fire exit (panic) hardware where serving production floors.</p> <p>If fire doors are required to be held open for functional reasons, provide automatic-closing devices tied to the fire alarm system.</p> | Within 3 months |

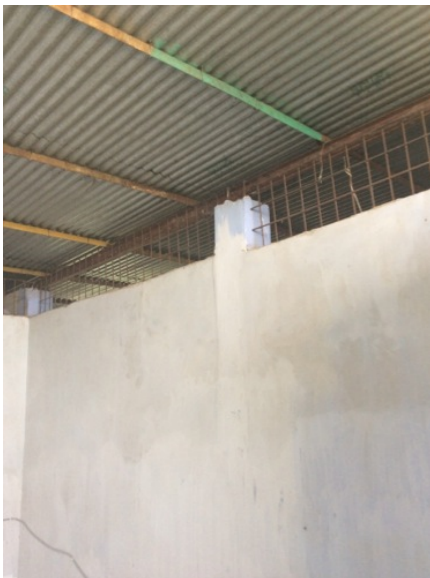
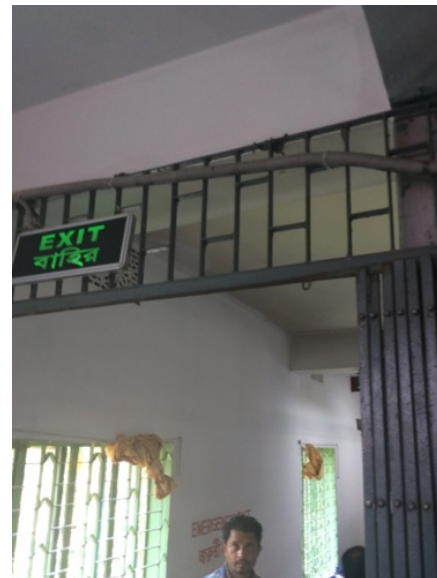
| F-4 | Fire Rated Construction | Unsealed penetrations and openings are located in exit stair enclosures, most notably the West most facing stair on the third floor open to both storage spaces. | Seal all penetrations and openings in exit stair enclosure walls to maintain the fire separation. | Within 3 months |

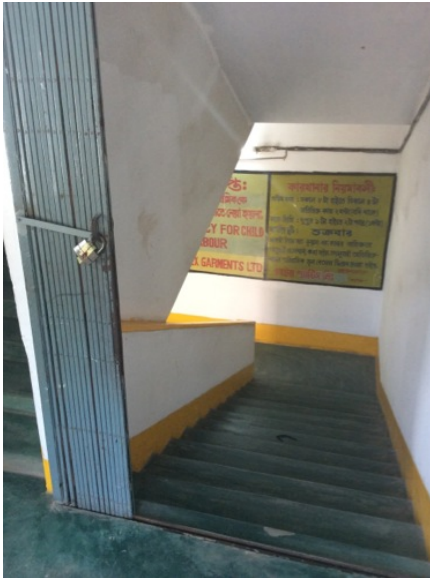
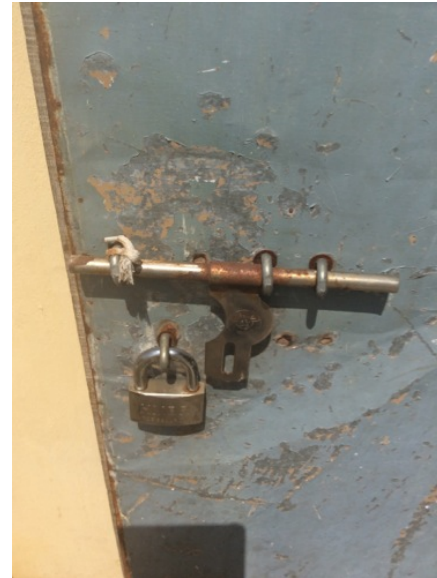
| F-5 | Egress | Egress doors and gates with locking features are provided at building exits, exit stairs, along egress routes and main exit discharge. All gates and doors were open and unlocked during the inspection. | Remove locking features from all egress doors / gates.<br><br>If locks are required for security reasons, utilize special door locking features complying with NFPA 101. | Immediate |

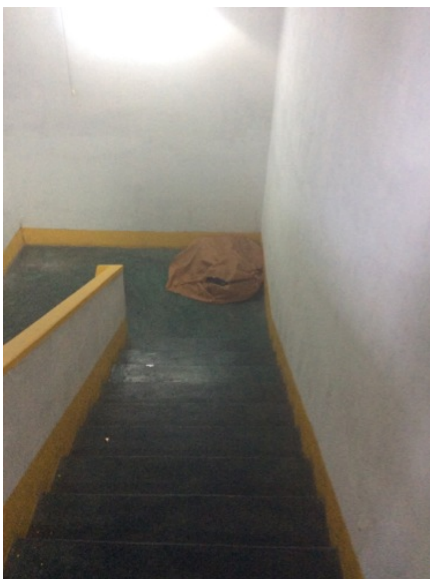
| F-6 | Egress | Storage was located in the South East facing exit stair. | Remove all storage from exit stairs and egress paths. | Immediate |

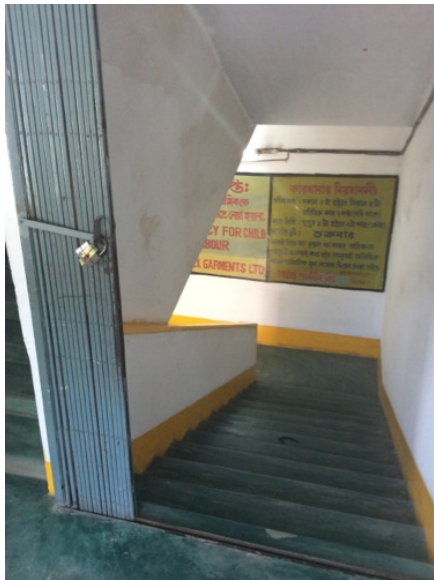
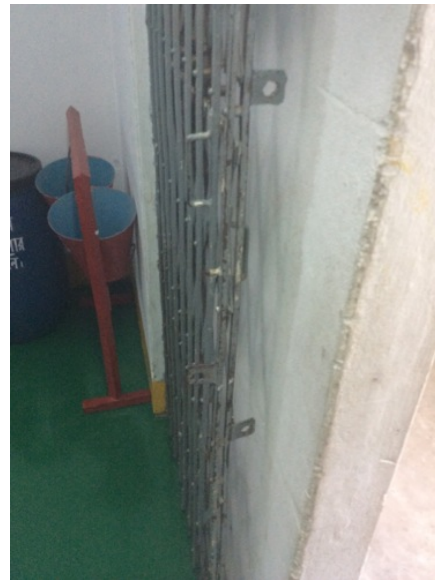
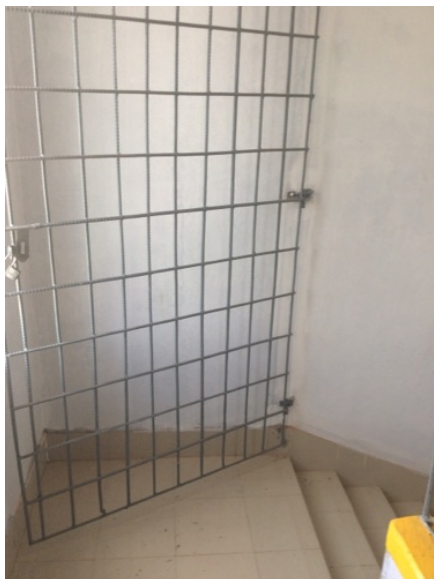
| F-7 | Egress | Collapsible gates and sliding doors are provided at building exits, exit stairs, along egress routes and main exit discharge throughout the factory building. | <p>Replace all gates / sliding doors along the means of egress with side-hinged, swinging egress doors.</p> <p>If locks are required for security reasons, utilize special door locking features complying with NFPA 101.</p> | Within 1 month |

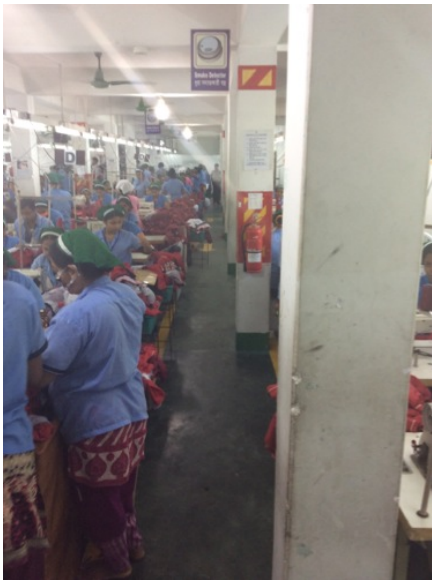
| F-8 | Egress | The width of egress aisles is less than 36-in on a number of floors throughout the factory at random locations i.e second floor sewing section. | Provide minimum aisle widths of 36-in. | Within 3 months |

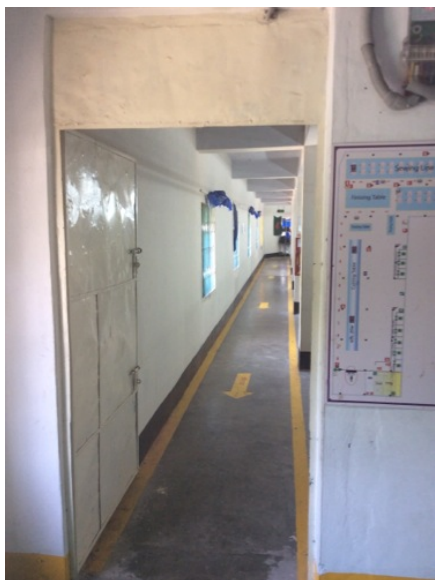
| F-9 | Egress | Exit stair doors and egress doors serving 50 or more occupants does not swing in the direction of egress travel, noted on the third floor exit stair door and first and second egress doors throughout floor plate. | Modify the egress door to swing in the direction of egress travel. | Within 3 months |

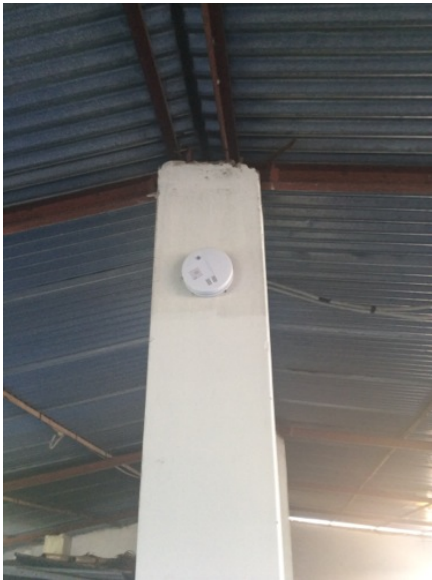
| F-12 | Fire Protection | The building is equipped with single-station smoke alarms. Smoke alarm activation sounds only a local alarm and does not provide automatic fire alarm notification of occupants. | Remove single-station smoke alarms. Provide automatic smoke detection throughout the building in accordance with NFPA 72. | Within 6 months |

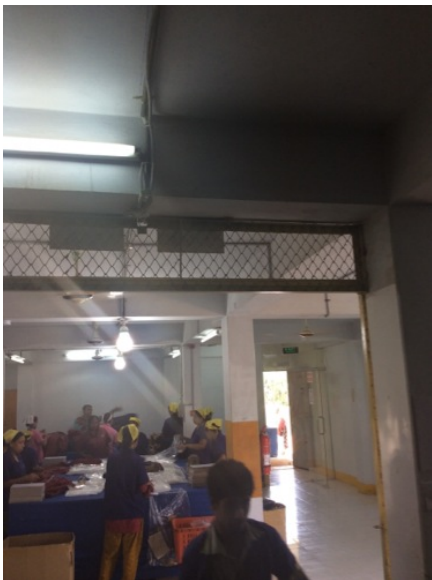
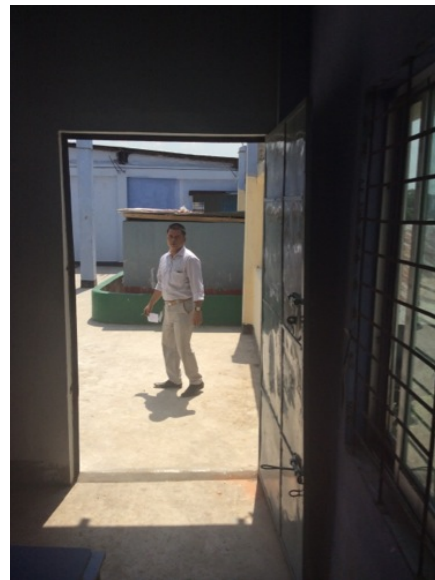
| F-13 | Egress Lighting | Exit sign not provided above a number of exit routes on the ground, first and third floor. | Provide exit signs above all exits to the exterior and all doors to the exit stairs. | Within 1 month |

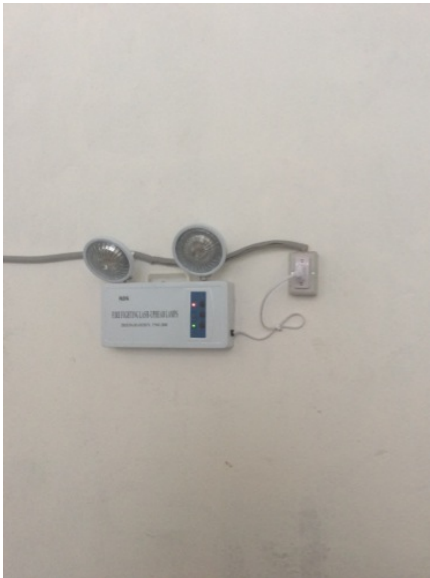
| F-14 | Egress Lighting | Manual on-off switch is provided for emergency battery backup lighting units throughout all the stairwells. | Remove manual on/off switches from emergency lighting units to prevent them from being switched off. | Within 1 month |
