# Sonia Sweaters Ltd. (9932)

604, Kondolbagh Taibpur, Ashulia Road, Savar

28.April.2014

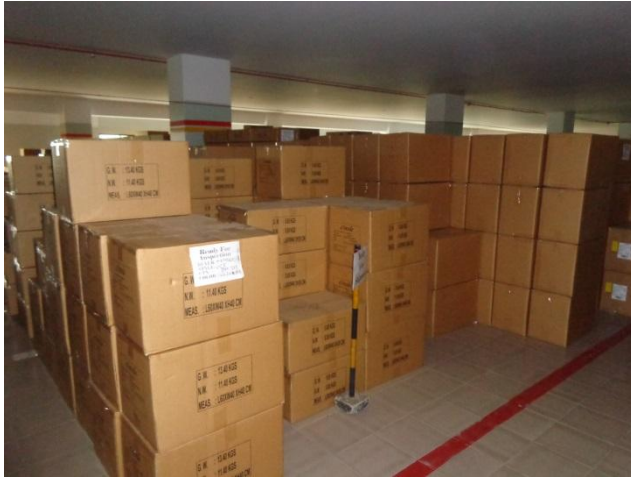
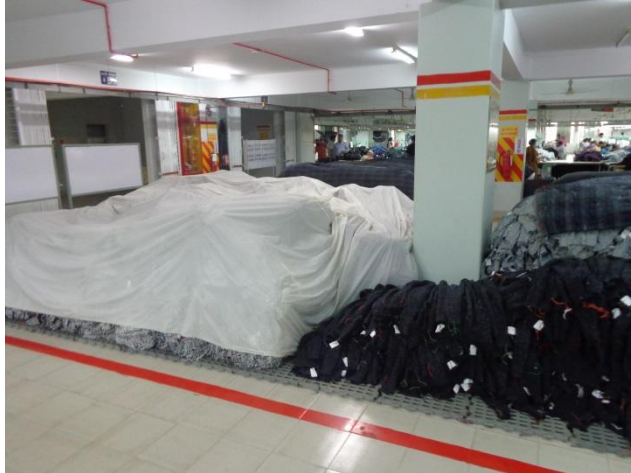
Main building –

The number of re-bars in columns does not match the construction documentation; loading to be reduced to allowable stress levels.

Built in 2002 with stone chip concrete

Columns do not reflect information provided on structural drawings which indicated 500mm x760mm with 32 number 25mm dia re-bars.

We surveyed 500 mm x 760mm columns. Two columns were Ferro-scanned and showed 20 bars which is less than the amount of rebar shown on the construction documents.

Loading on typical column reflects approx 2.0kPa, expect for 1 floor of storage. For certain gridlines, we found that there was ponctual heavy stacking of fabric.

The Managing Director was advised at the closing meeting to not store any material on the floors. Further action is required to reduce stress (Action section)

**ITEM 1:** Concrete stress due to current loading is greater than allowed.

Concrete stress due to current loading is greater than allowed.

- Verify in-situ stress and material properties by testing 100mm dia. concrete cores of at least 4 columns.
- Commence Detailed Engineering Assessment.

- Act upon all of the recommendations of the DEA.

- Produce and actively manage a loading plan for all floor plates within the factory giving consideration to floor capacity and column capacity.

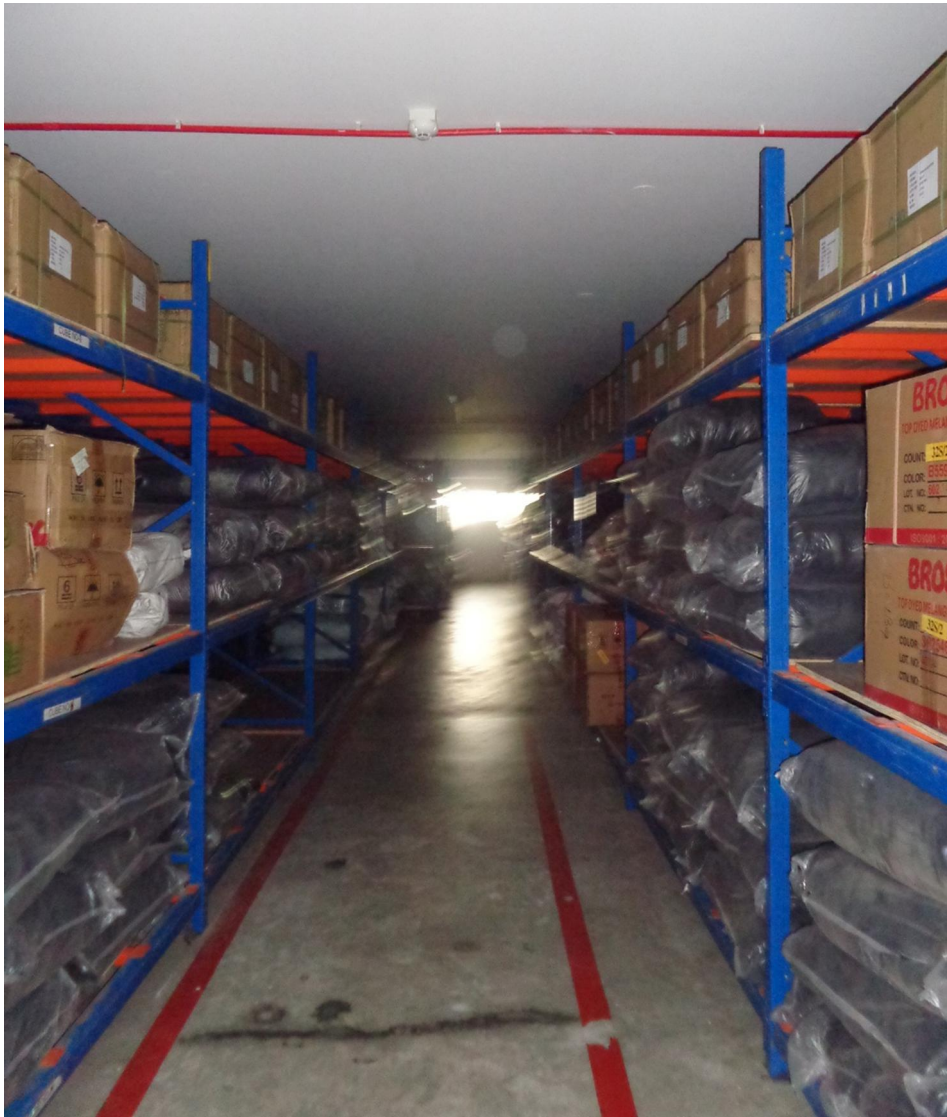
Punching shear concern for 8” thick flat slab with storage.

Taking in account low concrete resistance, we have reasonable doubt that an 8in. flat slab system may have adequate strength for storage loading, especially in unbalanced loading situations where concrete stress is amplified.

**ITEM 2:** Punching shear concern for 8” flat slab with storage.

Punching shear concern for 8" flat slab with storage

- Include punching shear verification with updated concrete strength information in the Detailed Engineering Assessment.

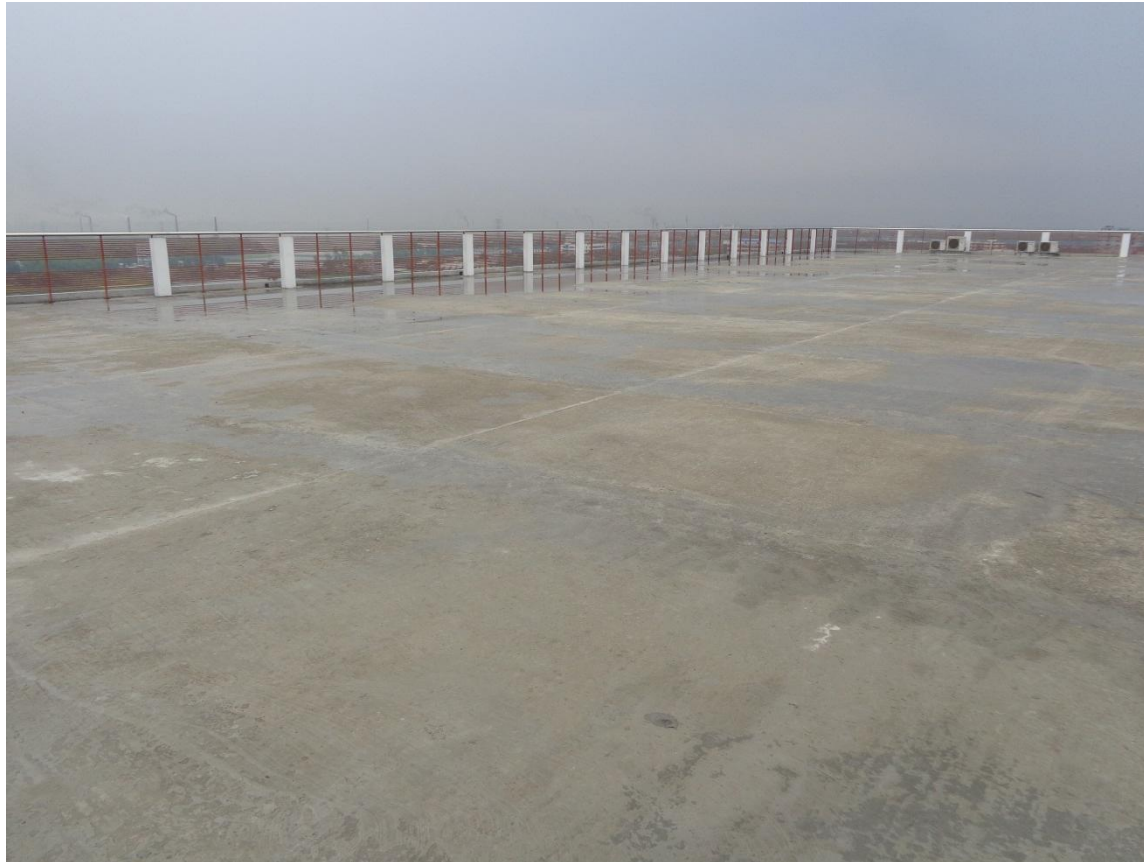
No waterproofing at roof level

No waterproofing membrane was visible on the roof of the building. This means that any cracks in the surface finishes on the roof will allow water to seep into the concrete slab beneath the finishes, and cause long-term soaking of the slab. The same applies to all water tanks at roof level.

**ITEM 3:** No waterproofing at roof level.

No waterproofing at roof

- Apply a new waterproofing membrane at roof level.

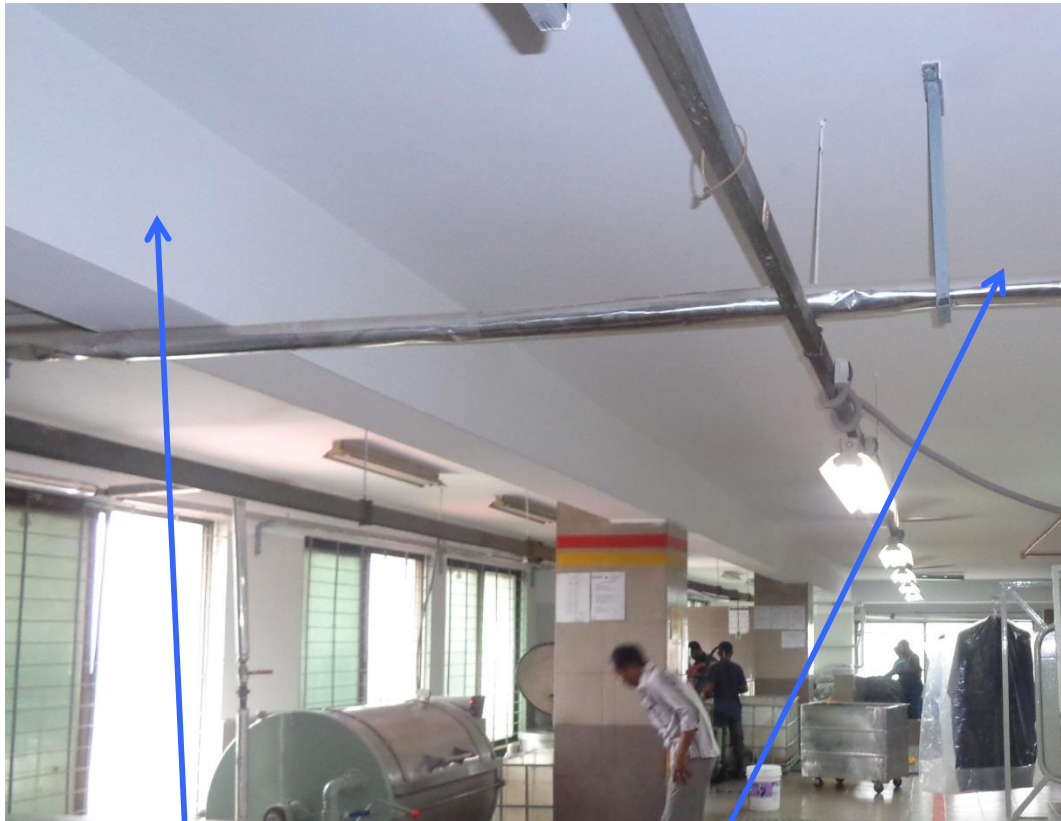
Typical  
Continuous  
Beams All-Around

Ground to 4th Floor – Interior bays have continuous beams in all directions  
4th Floor and Above – Interior bays have a flat slab system only.

Sway stability of building could only probably be expected from rigid frame system (beam and column connections) found at the periphery of the building although no ductile detailing is provided on the structural plans. Furthermore, with columns overstressed in compression, they have no reserve for moment frame use. Masonry infill panels are unrestrained and cannot be considered.

We require that these items be investigated as part of a Detailed Engineering Assessment
