# HASAN TANVIR FASHION WEARS LTD (11229)

397 Chandona Chowrasta Joydevpur Road Gazipur - 1702

23.MARCH.2014

## Identified Priority 3 Concerns

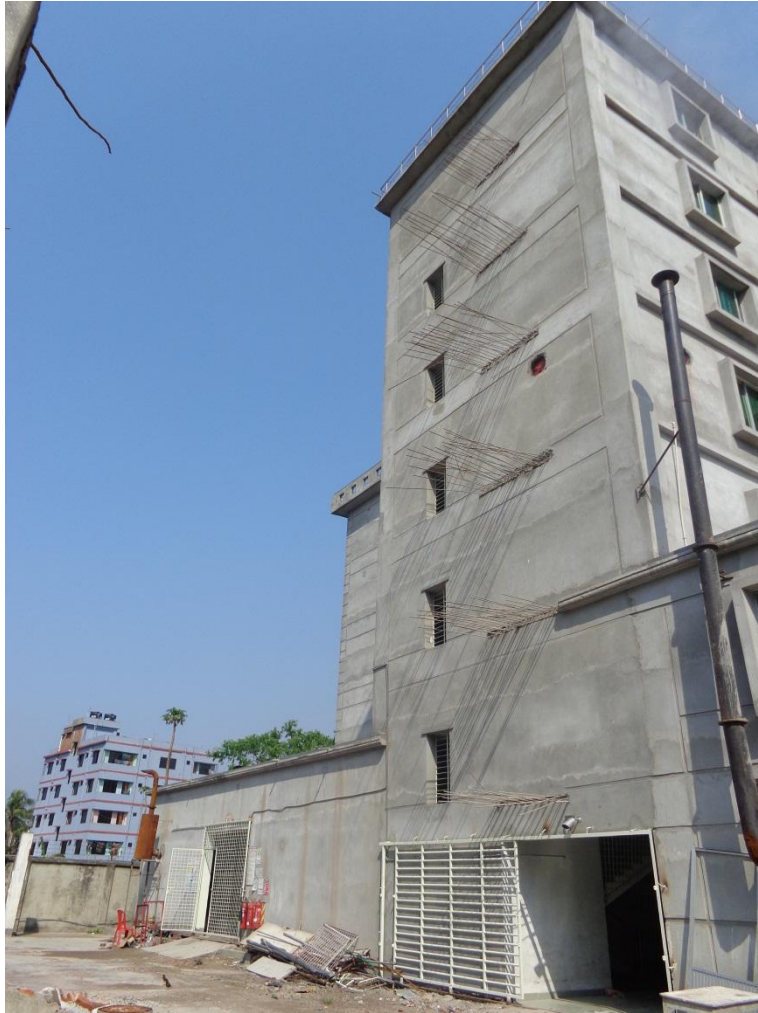
**Future walkways**

Rebars were left in place to accommodate walkways to future adjacent building. Building engineer to validate beams and column capacity before construction.

- Building engineer to validate existing structure capacity before construction of the walkways

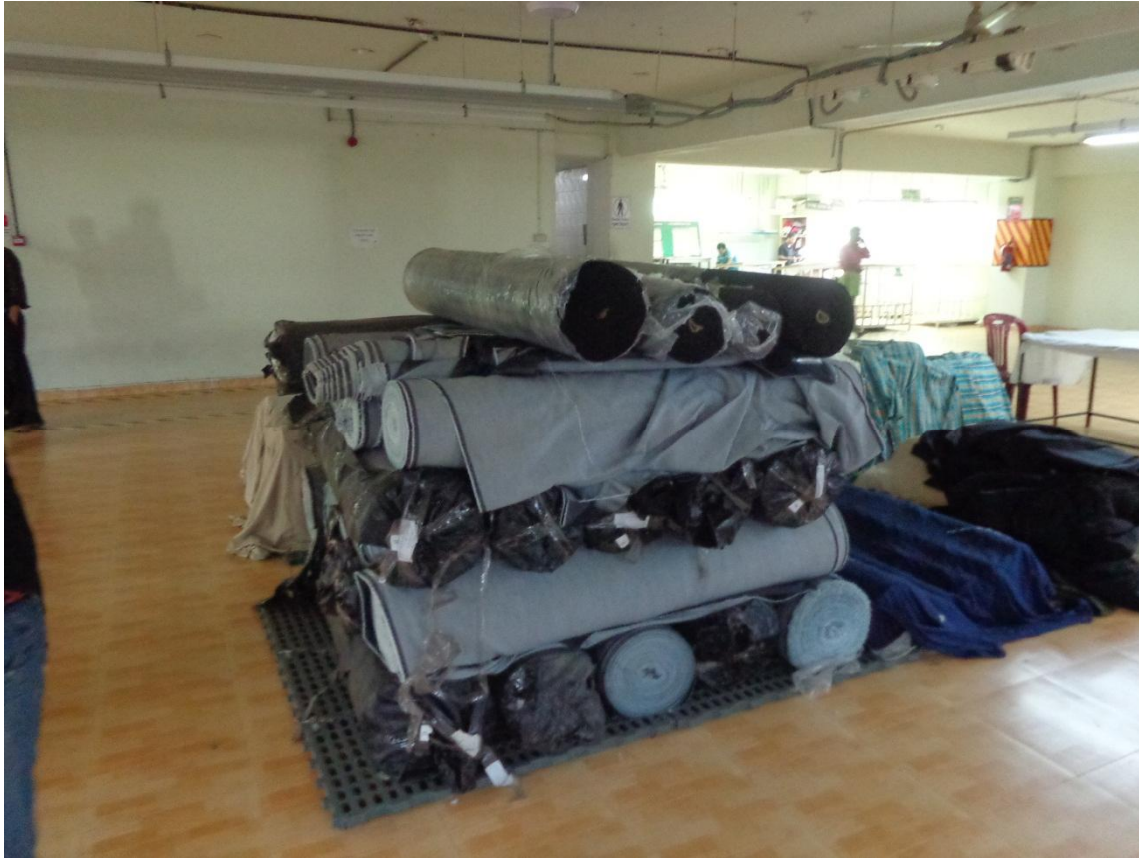
No loading plan in place on the upper floors to insure full compliance with specified design loads

- Produce and actively manage a loading plan, ensuring maximum height of storage is adhered to in the long-term.

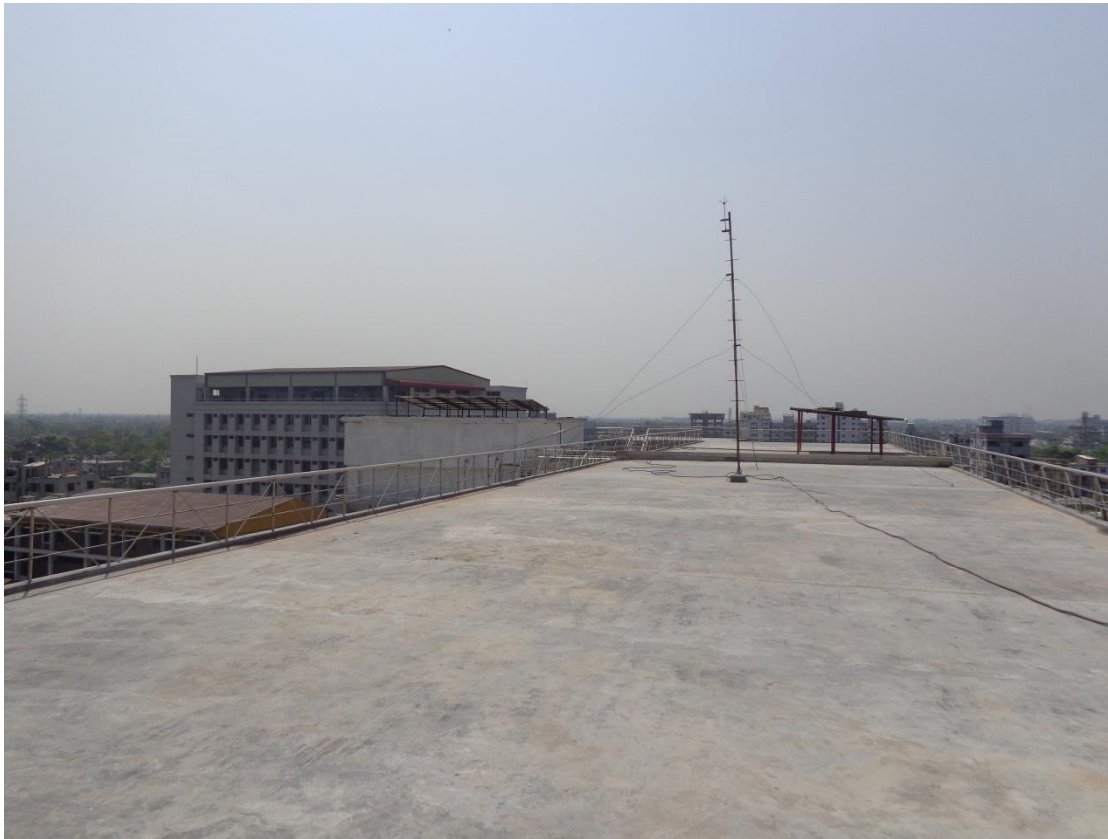
No waterproofing membrane was visible on the roof of the building. This means that any cracks in the surface finishes on the roof will allow water to seep into the concrete slab beneath the finishes, and cause long-term soaking of the slab.

**Roof Floor does not appear to have any waterproof membrane to protect lower floor from water damage**

- Consider applying a new waterproofing membrane.
