# **FIRE SAFETY INSPECTION REPORT**

**JEANS 2000 LTD.  
PLOT # 67, SECTOR #7, CEPZ**

**ACCORD**  
on Fire and Building Safety in Bangladesh

May 15, 2014

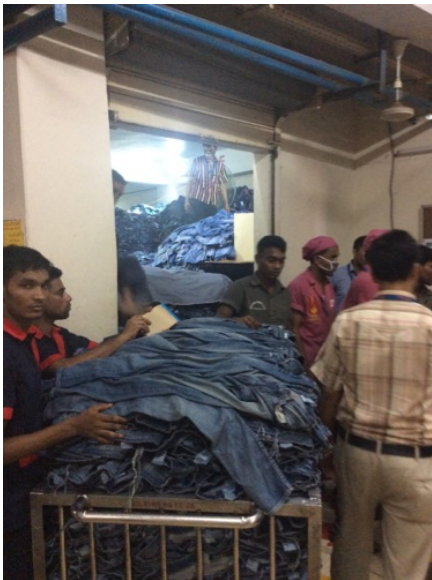
| No. | Category | Finding | Recommendation | Remediation Timeframe |
|---|---|---|---|---|
| F-1 | Fire Rated Construction | Storage rooms used for combustible storage are not separated by fire-rated construction. | Provide dedicated storage rooms separated by minimum 1-hr fire-rated construction. | Within 3 months |

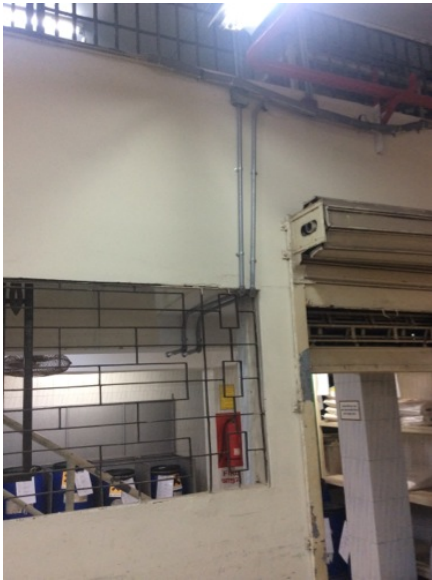
| F-3 | Fire Rated Construction | <p>Hazardous materials / flammable liquid storage area is not separated by fire-rated construction.</p> <p>Additionally, flammables and oxidizers were not adequately separated.</p> | <p>Separate the hazardous materials / flammable liquid storage room by a minimum 2-hr fire-rated construction. Seal and/or protected all openings to maintain the required fire separations.</p> <p>Separate all flammables from oxidizers by a minimum of 20 feet.</p> | Within 3 months |

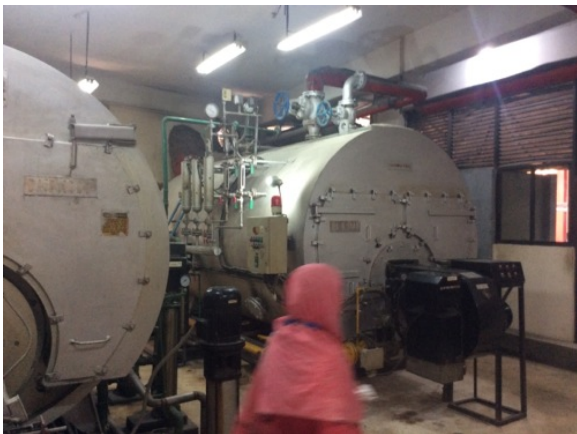
| F-4 | Fire Rated Construction | The boiler, generator, and transformer rooms are not separated by fire-rated construction from an egress path. | Separate the boiler, generator, and transformer rooms by a minimum 2-hr fire-rated construction. Seal and/or protected all openings to maintain the required fire separations | Within 3 months |

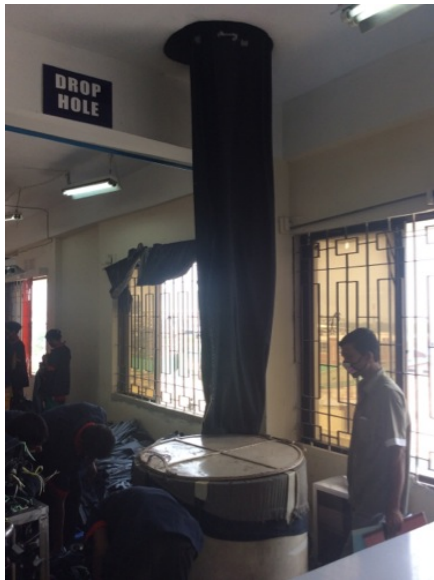
| F-5 | Fire Rated Construction | Unsealed penetrations and openings are located in the fire-rated floor/ceiling assemblies, specifically the clothing drop between floors 4, 5, and 6. | Provide a minimum 2-hr fire-rated protection to the penetration<br><br>or<br><br>Seal all penetrations and openings in floor/ceiling assemblies to maintain the fire separation. | Within 3 months |

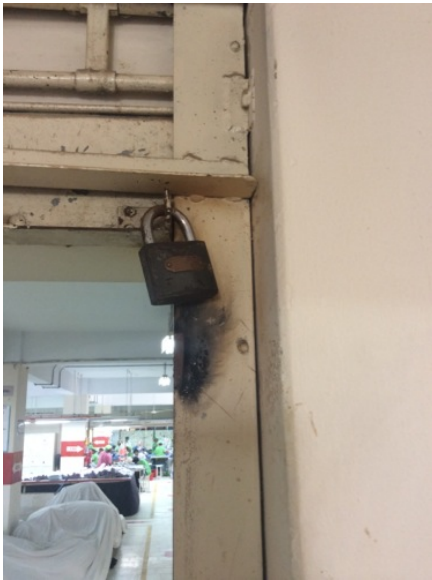
| F-6 | Egress | Egress gates with locking features are provided at exit stairs throughout the building. | Remove locking features from all egress gates.<br><br>If locks are required for security reasons, utilize special door locking features complying with NFPA 101. | Immediate |

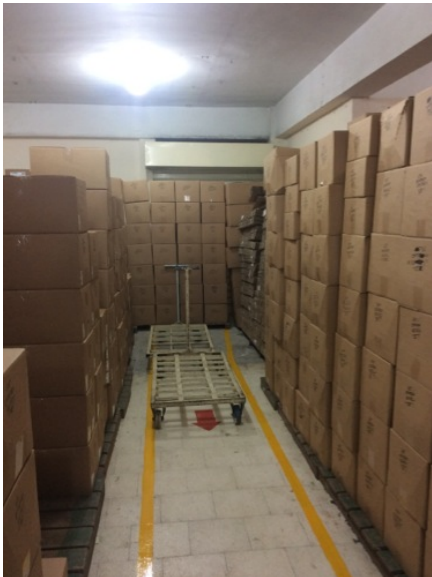
| F-7 | Egress | Storage was located in the egress path in the floor 5 store. | Keep egress paths and stairs clear of storage. | Immediate |

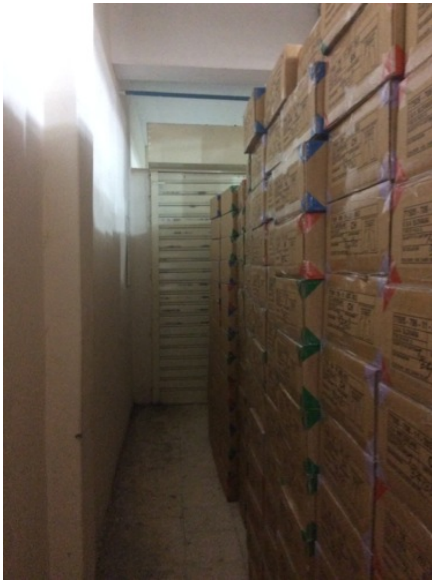
| F-8 | Egress | The width of egress aisles is less than 36-inches in the floor 5 store. | Provide minimum aisle widths of 36-in. | Within 3 months |

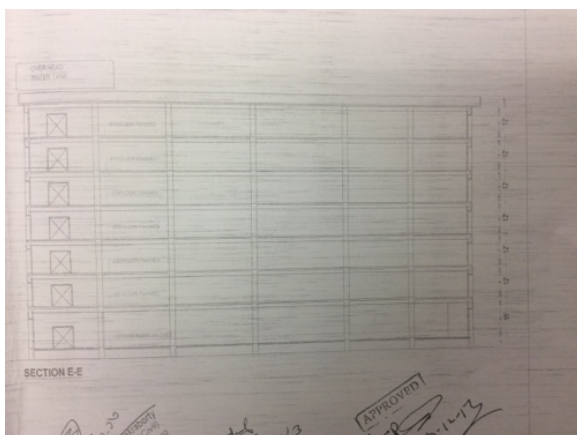
| F-9 | Fire Protection | The high-rise building has an occupied floor greater than 23m (75 ft) and is not provided with automatic sprinkler protection. The large occupant loads, heavy fuel loading, and anticipated extended egress times warrant sprinkler protection. | Provide automatic sprinkler protection throughout the building in accordance with NFPA 13. | Design within 6 months, install within 12 months |

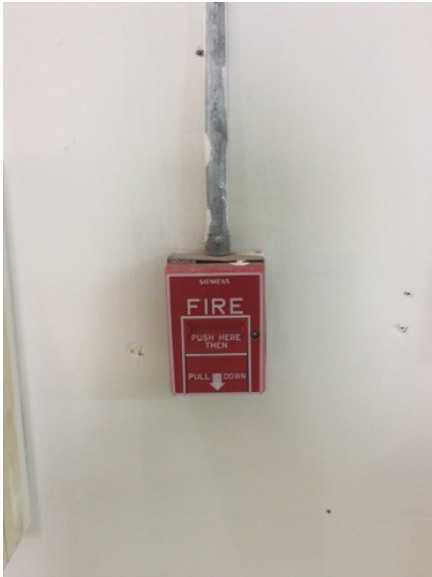
| F-10 | Fire Protection | Inspection, testing, and maintenance for the fire alarm system it was not in accordance with NFPA 72. | Inspect, test and maintain the fire alarm system, and keep written records on-site, in accordance with NFPA 72. | Within 3 months |

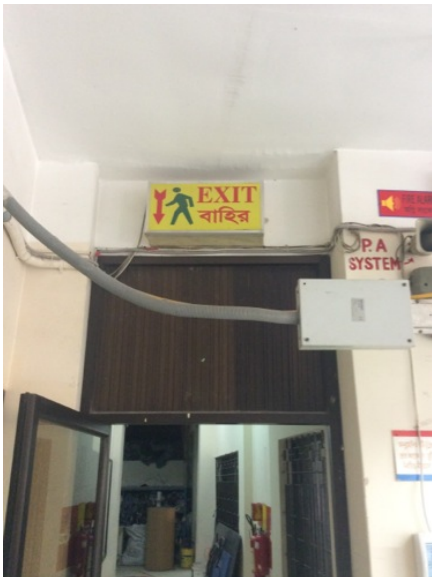
| F-11 | Egress Lighting | Exit signage not illuminated (burned out, broken, etc.) in multiple locations. | Regularly inspect all exit signage and replace/install lights as needed to illuminate signs. | Within 1 month |
