# INITIAL STRUCTURAL INTEGRITY ASSESSMENT REPORT (SIAR)

Factory Name: **Jinnat Knitwears Ltd (Phase-2)**  
Address: **Dhanua, Shreepur, Gazipur Bangladesh**  
Assessor: **EIMS**  
Date: **24 Jul 2018**

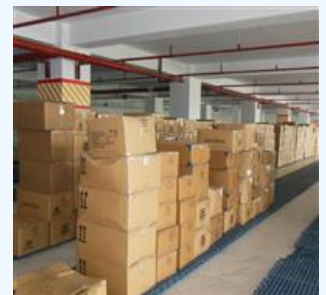
| Description: | Load marking was not indicated for storage of work. |
| Source of Findings: | Photograph: No load marking in storage area of Building-1., Visual Assessment: Site visit on 17, May 2018. |

| Suggested Plan of Action: | Provide signage or the appropriate markings at all areas used for storage to indicate the acceptable loading limits detailed in the Load Plan. | |
