# Metro Knitting & Dyeing Mills Ltd. (9510)

Mouza-Basaid, S.A.-202, R.S.-909, Charabag, Ashulia, Dhaka

23.MARCH.2014

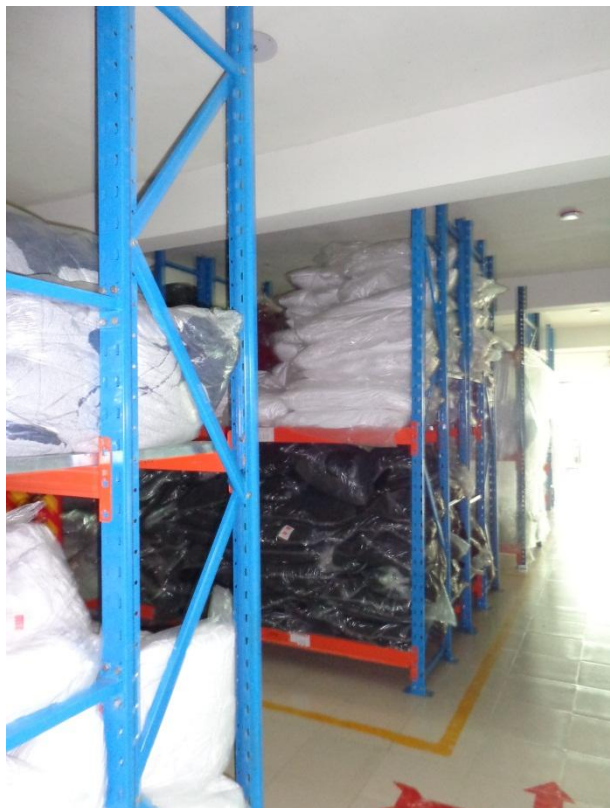
Storage levels appeared slightly higher than allowable in localized areas distributed throughout the complex.

**ITEM 1: (Priority 2) Generally slab loadings were acceptable. However, moderately high storage loadings were observed at localized areas throughout the complex.**

- Factory engineer to develop and actively monitor a loading plan for all floor plates within the factory giving consideration to slab, column and foundation capacity.

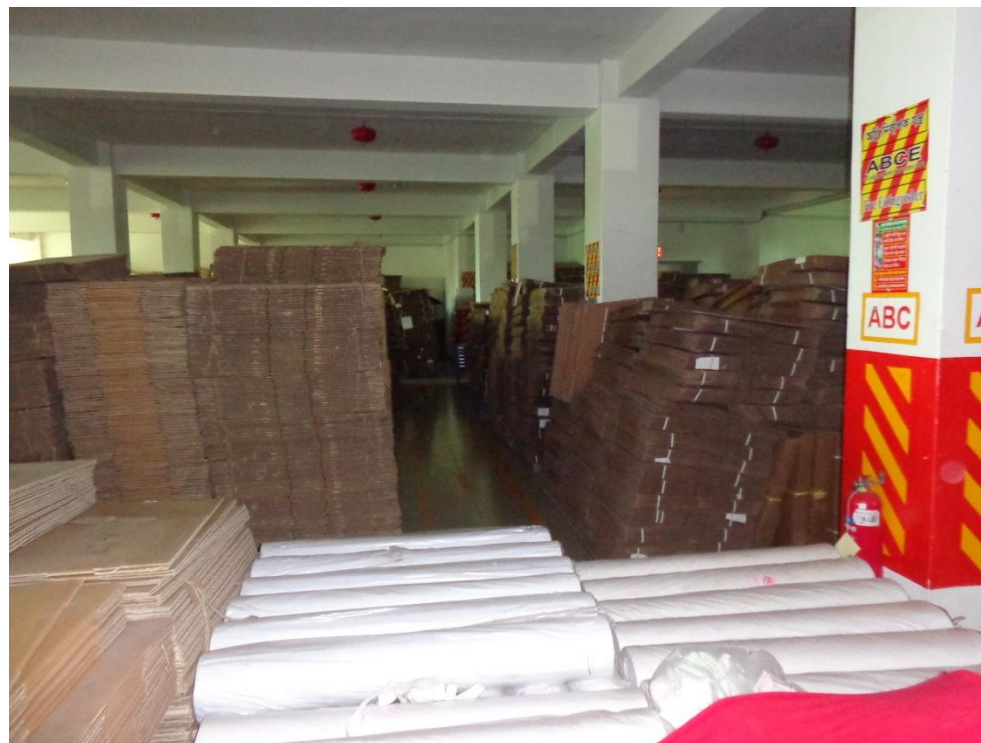
## High Levels of Local Storage

Storage above allowable live loads within building A
