FIRE SAFETY INSPECTION REPORT

MOONLIGHT GARMENTS K.B. BAZAR, TARGACH,GAZIPUR, BANGLADESH

ACC   **RD**
on Fire and Building Safety in Bangladesh

March 23, 2014

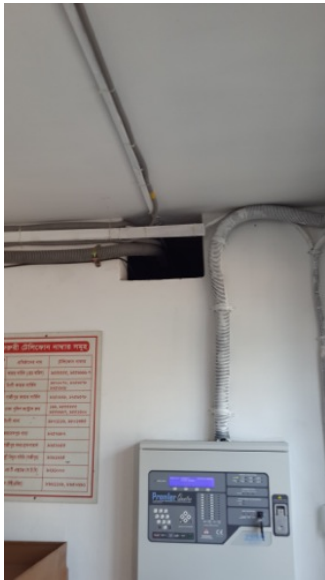
| No. | Category | Finding | Recommendation | Remediation Timeframe |
|---|---|---|--|---|
| F-1 | Fire Rated Construction | Unsealed ceiling penetrations located in the fire command room above the fire alarm control panel. Penetration leads to storage room. | Provide a minimum 2-hr fire-rated shaft to separate the utility risers from each floor level. Seal all penetrations and openings in floor/ceiling assemblies to maintain the fire separation. | Within 1 month |

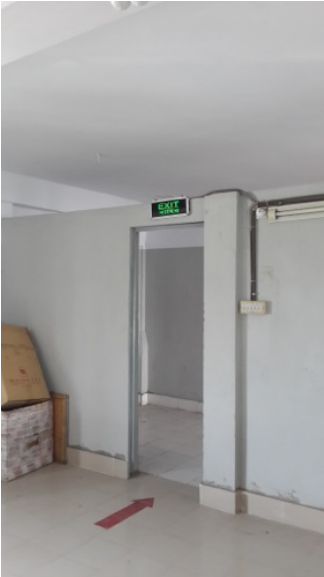
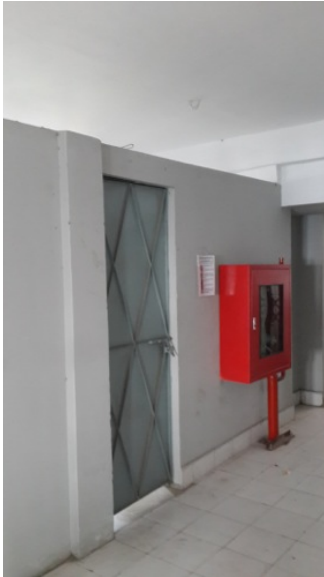
| F-2 | Fire Rated Construction | <p>Unsealed penetrations and openings are located in exit stair enclosures. Storage rooms were located in the exit stairwells Specifically in the east stairwell sixth floor. Storage rooms were not fully sealed and compromises the stairwell exiting system.</p> | <p>Seal all penetrations and openings in exit stair enclosure walls to maintain the fire separation.</p> | <p>Within 3 months</p> |

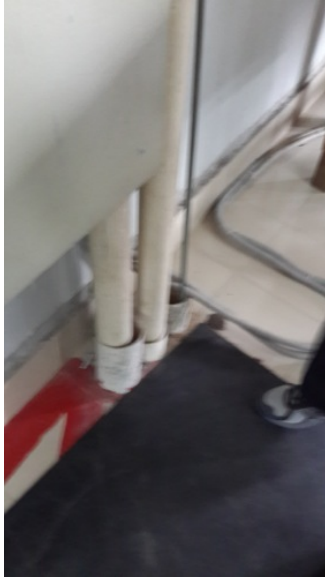
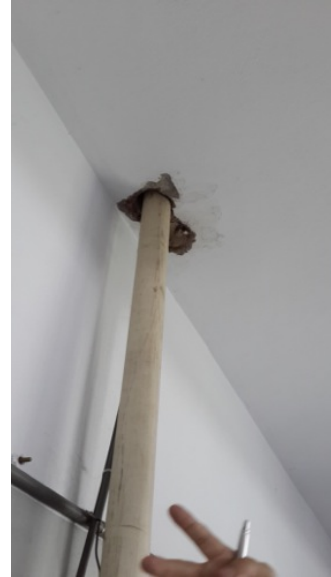
| F-3 | Fire Rated Construction | <p>Unsealed penetrations and openings are located in the fire-rated floor/ceiling assemblies. Specifically located at the M/C Bond room and reflected on all floors, penetrations were seen due to electrical wiring.</p> | <p>Provide a minimum 2-hr fire-rated shaft to separate the utility risers from each floor level.</p> | <p>Within 3 months</p> |

| | | <p>Seal all penetrations and openings in floor/ceiling assemblies to maintain the fire separation.</p> | | |

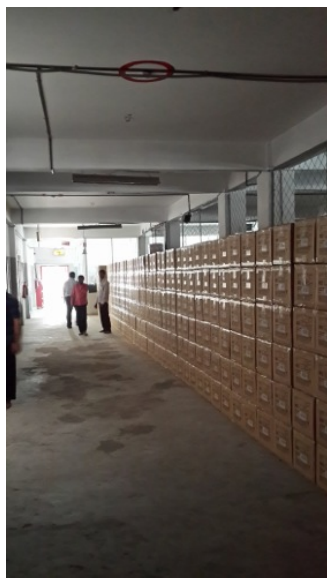
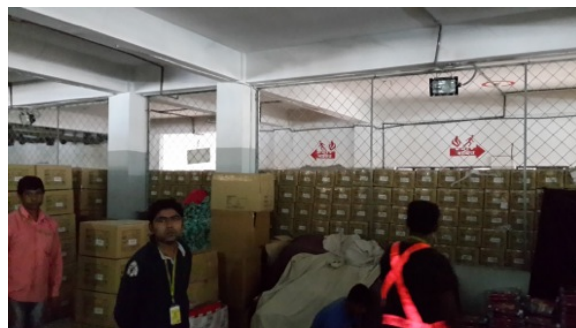
| F-4 | Fire Rated Construction | <p>Areas used for combustible storage are not separated by fire-rated construction.</p> <p>Excess stored boxes were staged outside of storage rooms.</p> <p>However all boxes/storage whether they are rotating storage or not, should be stored inside a proper storage facility/room.</p> | <p>Provide dedicated storage rooms separated by minimum 1-hr fire-rated construction.</p> <p>Where separate storage rooms are not feasible, provide defined storage areas and limit the storage arrangement as follows:</p> <ul style="list-style-type: none"> - Maximum height of 2.4m and maximum area of 23m² - If sprinkler protected: maximum height of 3.66m and maximum area of 93m² <p>Separate areas of unenclosed combustible storage by a minimum clear distance of 3m.</p> | Within 3 months |

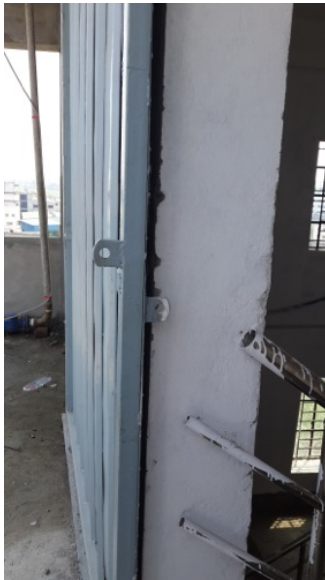
| F-5 | Egress | <p>Egress doors / gates with locking features are provided at building exits, exit stairs, along egress routes, and exit discharge. While most doors in building were fire rated type with panic hardware, some were not. Specifically located on the sixth floor (unoccupied/temporary dining) exit doorways were lockable by pad lock.</p> | <p>Remove locking features from all egress doors / gates.</p> <p>If locks are required for security reasons, utilize special door locking features complying with NFPA 101.</p> | Immediate |

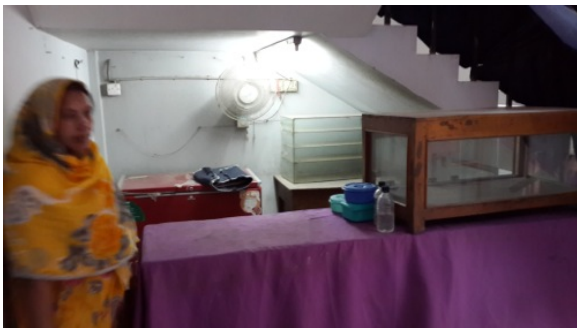
| F-6 | Egress | Located in the south stairwell on ground floor, a snack/drink shop was placed at the bottom of the stairwell. | Remove all storage from exit stairs and egress paths. | Immediate |

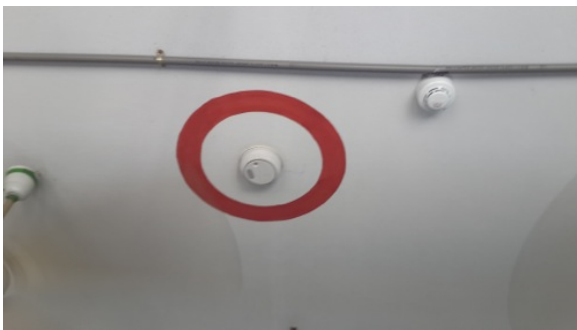
| F-7 | Fire Protection | In addition to having addressable smoke detectors tied into the fire alarm system, the building is also equipped with single-station smoke alarms. Smoke alarm activation sounds only a local alarm and does not provide automatic fire alarm notification of occupants. | Remove the single-station smoke alarms. | Immediate |

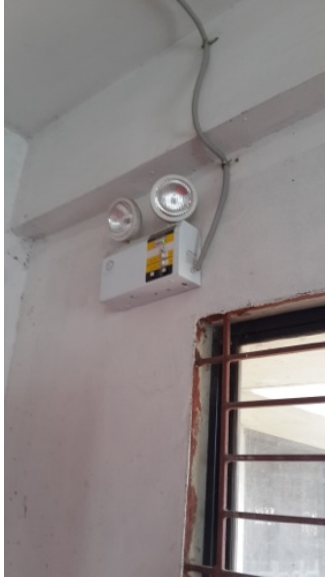
| F-9 | Egress Lighting | Manual on-off switch is provided for emergency lighting units. This was reflected on multiple floors throughout the building. | Remove manual on/off switches from emergency lighting units to prevent them from being switched off. | Within 1 month |
