# Dekko Garments Ltd

Nayanpur, Mawna, Sreepur, Gazipur.

08<sup>th</sup> April 2019

# Observation

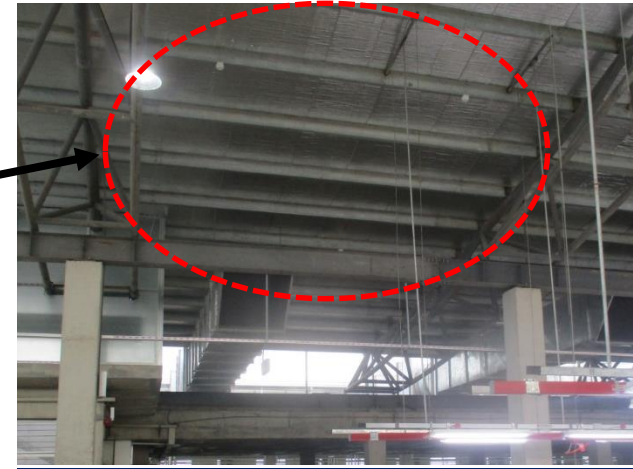
On the marked location, horizontal bracing was not observed

At one location horizontal bracing was not found on site. At some splice locations of beam on top floor bolt was found missing. Factory is required to install the missing elements as shown in the as-built drawings.

Item No.	Observation	Recommended Action Plan	Recommended Timeline
1	(Main Production building) Missing bolts and horizontal cable bracings	Factory is required to install the missing elements as shown in the as-built drawing.	6-weeks
2	(Main Production building) Significant gap in steel beam and RC column joint at several locations	Identify all the locations and carryout suitable remedial works where necessary.	6-weeks
3	(Main Production building) Insufficient information in drawings	Factory Engineer to survey the whole structure and update a full set of “as-constructed” drawings.	6-weeks

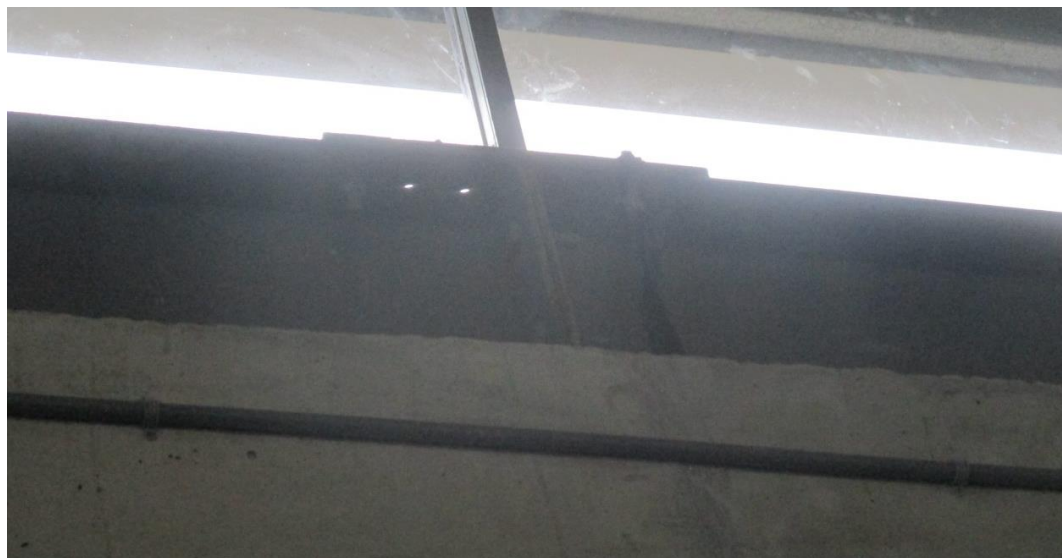
Bolt missing at some splice locations of beam on top floor

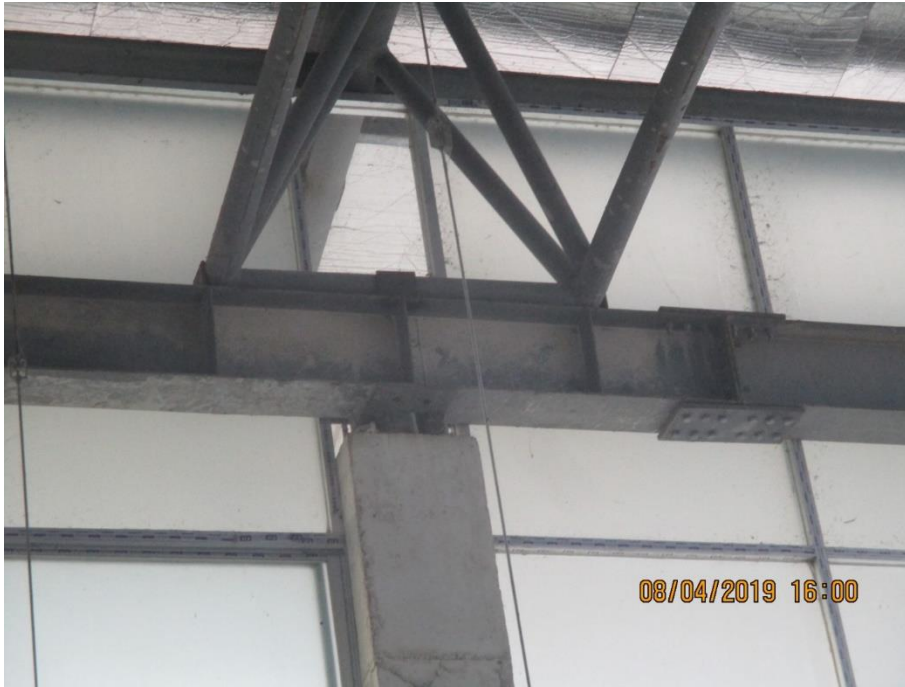
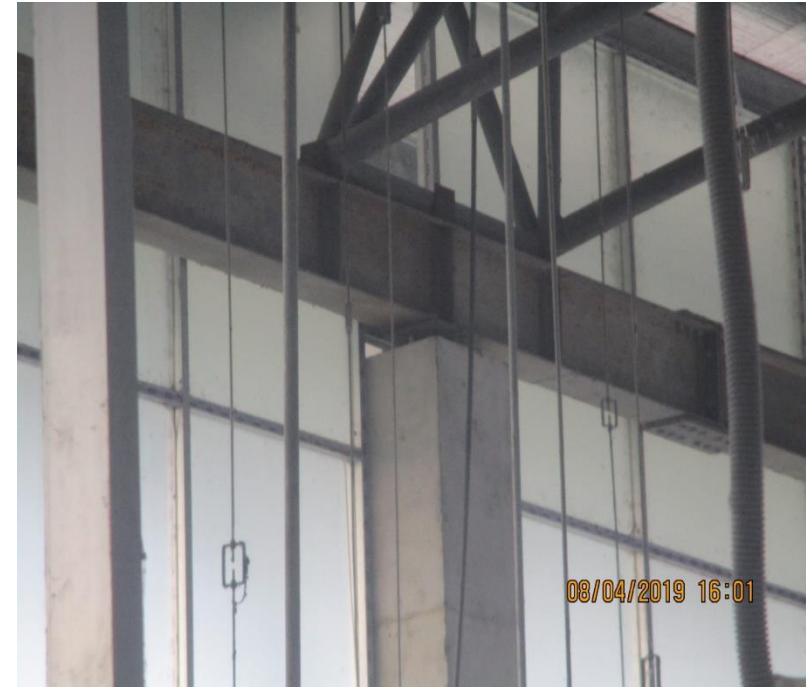
**Significant gap in steel beam and RC  
column joint at several locations**

Significant gaps were found at top floor steel beam to RC column joint. Factory engineer is required to carry out suitable remedial works.

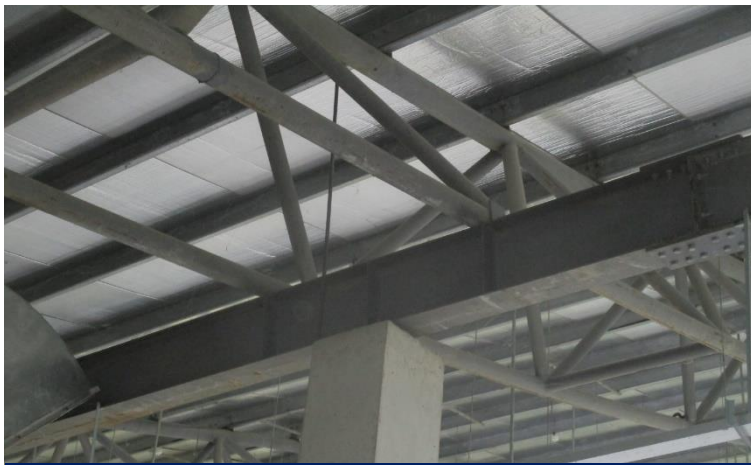
No RC column-steel beam connection detail and sectional detail of steel beam were provided in the as-built drawing.

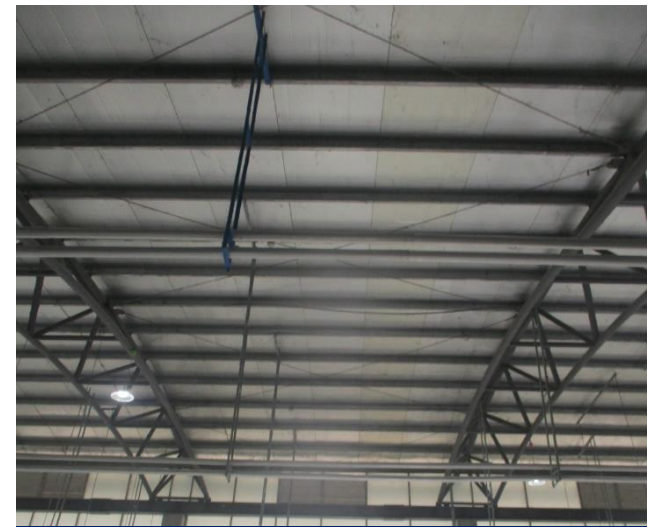
The dimension was not given for horizontal cable bracing.

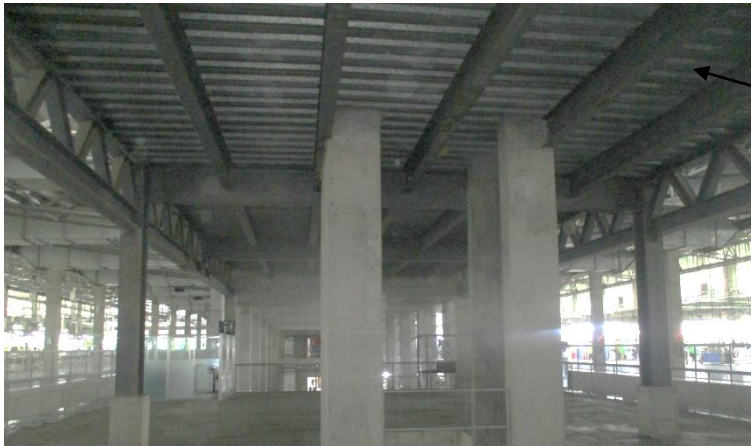
No connection detail was found in drawing for the steel roof structure around the lift.
