# **FIRE SAFETY INSPECTION REPORT**

**PIMKIE APPARELS LTD.**

**PLOT # 328, BLOCK # F, TONGI, INDUSTRIAL AREA**

May 25, 2014

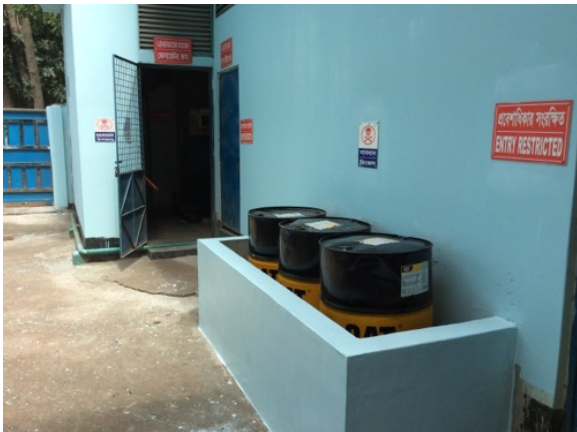
| No. | Category | Finding | Recommendation | Remediation Timeframe |
|---|---|---|---|---|
| F-1 | Fire Rated Construction | Combustible liquid (diesel drum) storage area is not separated by fire-rated construction (openings). | Separate the flammable liquid storage room by a minimum 2-hr fire-rated construction. Seal and/or protected all openings to maintain the required fire separations. | Within 3 months |

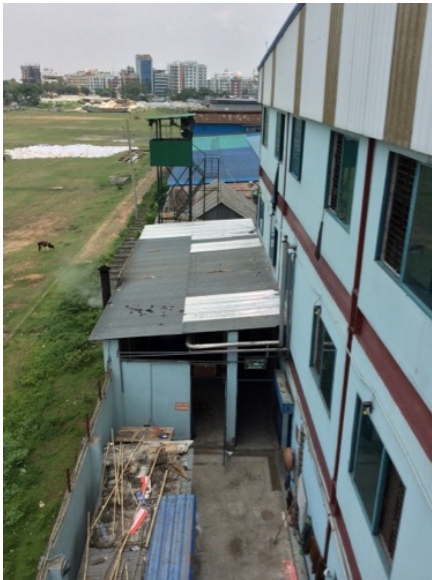
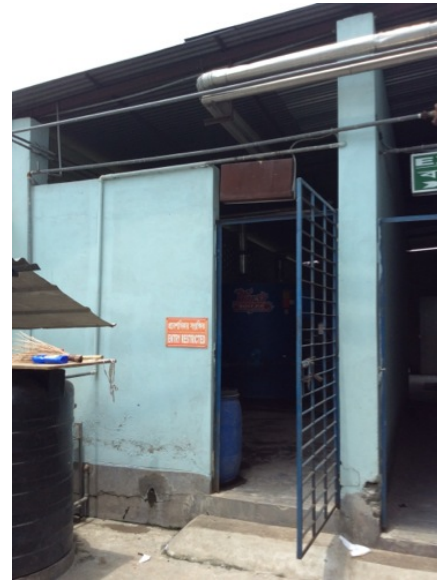
| No. | Category | Finding | Recommendation | Remediation Timeframe |
|---|---|---|---|---|
| F-2 | Fire Rated Construction | The boiler room is not separated by fire-rated construction from egress path (openings, non-rated doors, penetrations). | Separate the boiler room by a minimum 2-hr fire-rated construction. Seal and/or protected all openings to maintain the required fire separations | Within 3 months |

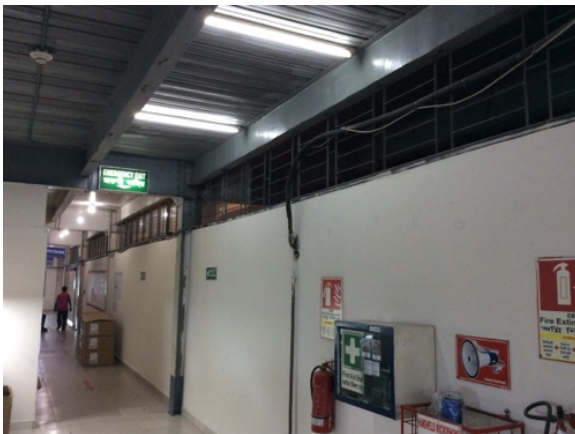
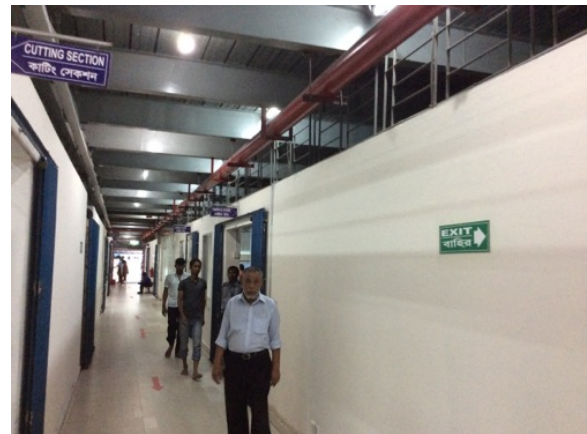
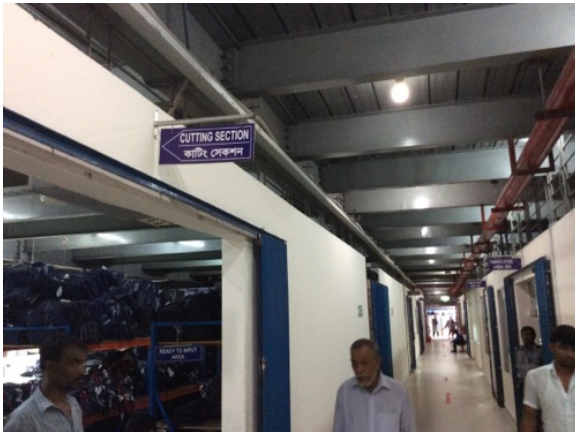
| F-3 | Fire Rated Construction | Rooms used for combustible storage on the ground and 1st floors are not separated by fire-rated construction. | Provide dedicated storage rooms separated by minimum 1-hr fire-rated construction. | Within 3 months |

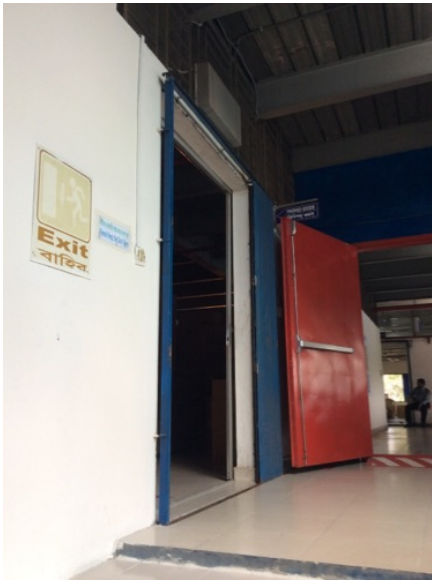
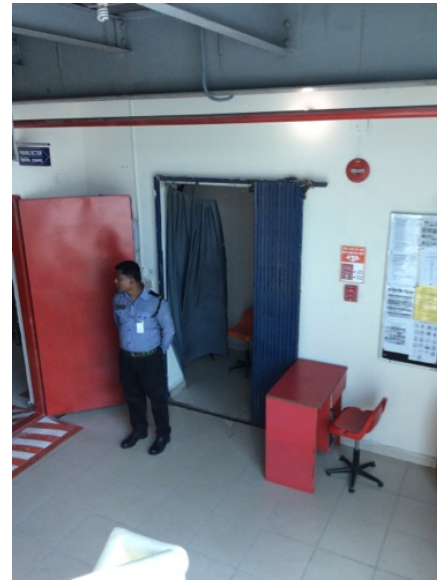
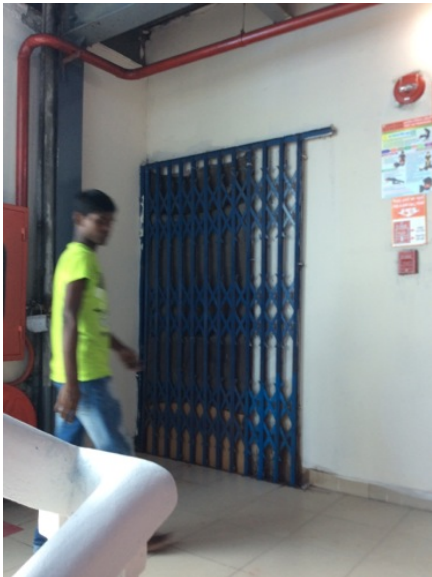
| F-4 | Fire Rated Construction | All exit stairs are not separated from work areas on each floor by fire-rated construction. | <p>Provide minimum 1.5-hr fire rated doors and seal all unprotected openings to separate the exit stairs from work areas and other building spaces on all floor levels. Ensure that the fire doors are self-closing and positive latching and that they are provided with fire exit (panic) hardware where serving production floors.</p> <p>If fire doors are required to be held open for functional reasons, provide automatic-closing devices tied to the fire alarm system.</p> | Within 3 months |

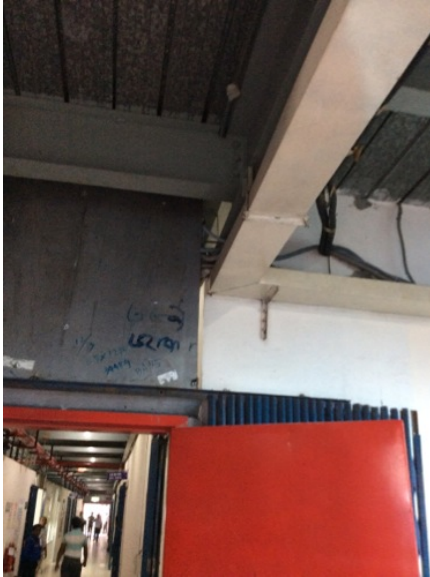
| F-5 | Fire Rated Construction | Unsealed penetrations are located in the west exit stair enclosure. | Seal all penetrations and openings in exit stair enclosure walls to maintain the fire separation. | Within 3 months |

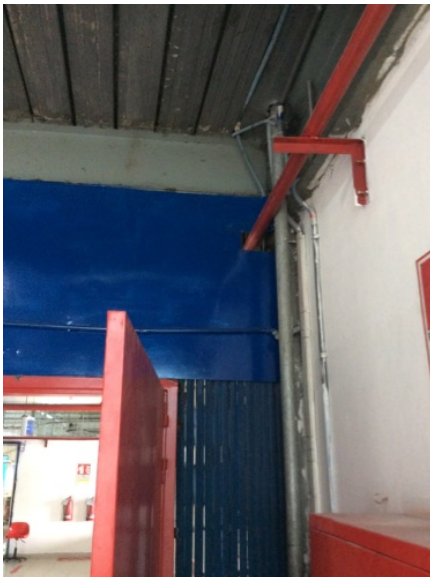
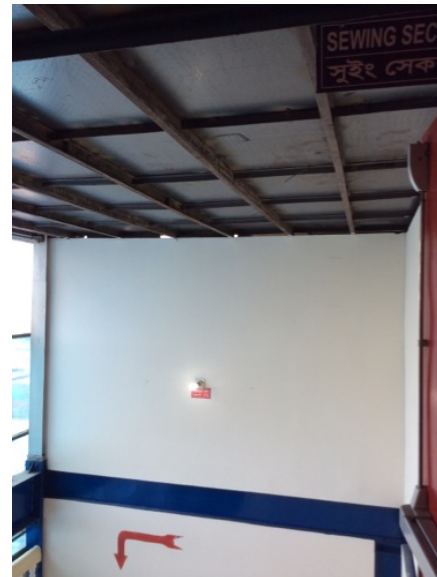
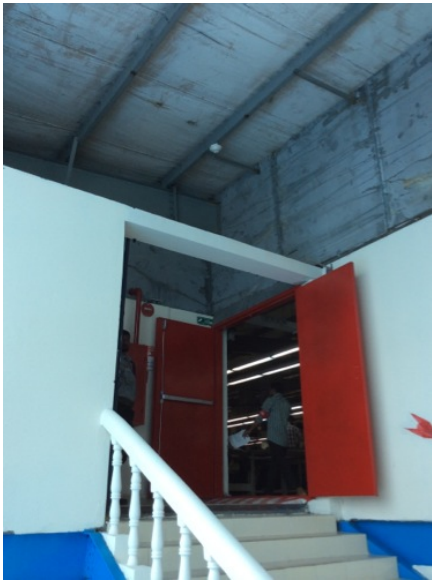
| F-6 | Fire Rated Construction | The exit stairs are not separated from work areas on each floor by fire-rated construction. | Provide fire-rated construction for all unprotected openings to separate the exit stairwells from work areas on all floor levels. | Within 3 months |

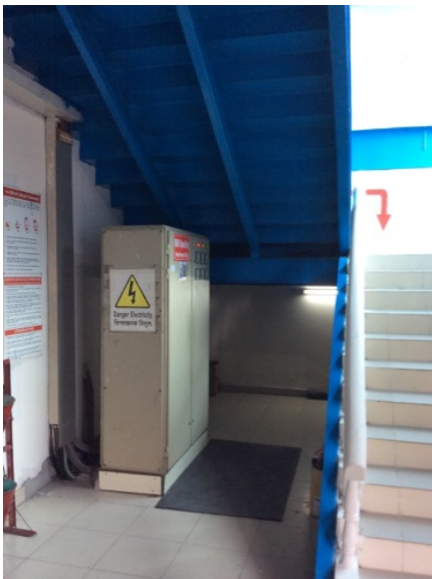
| F-7 | Fire Rated Construction | Electric appliances are located in the west exit stair on the ground floor. | Remove or relocate the electric appliances to the exterior of the exit stair. | Within 3 months |

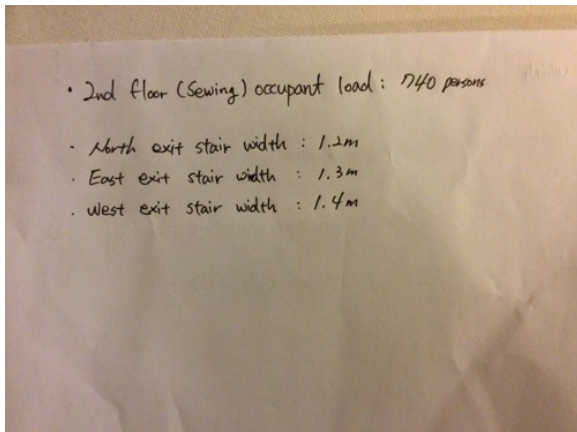
| F-8 | Egress | Exit capacity is not adequate for the occupant load of the 2nd floor. The occupant load for the 2nd floor is 740 persons, however these exceed the egress capacity provided which is 487 persons. | Immediate, reduce occupant load to not more than available exit capacity. If possible, add additional exits in the future to increase exit capacity. | Immediate |

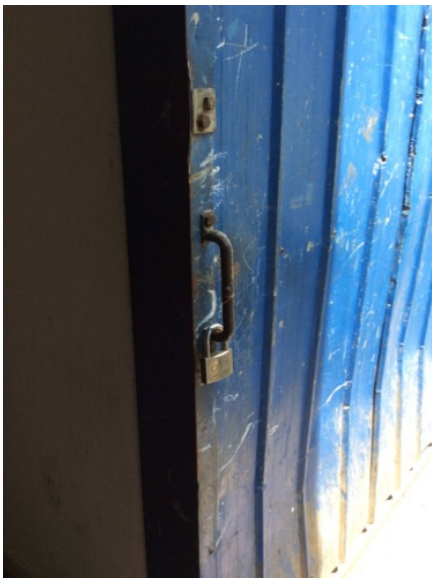
| F-9 | Egress | Egress gates with locking features are provided at exit discharge. | Remove locking features from all egress gates.<br><br>If locks are required for security reasons, utilize special door locking features complying with NFPA 101. | Immediate |

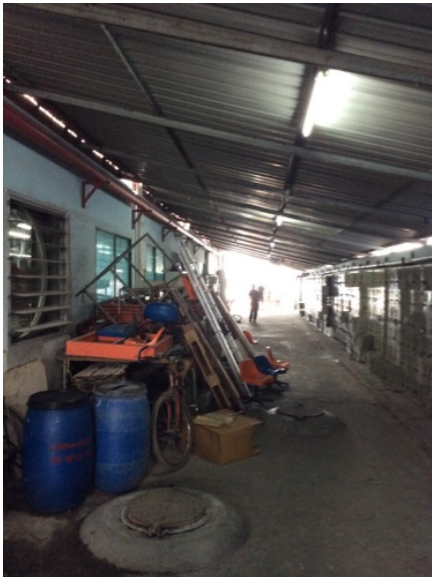
| F-11 | Egress | Storage was located in the east side egress path on the ground floor. | Keep egress paths clear of storage. | Immediate |
