# **FIRE SAFETY INSPECTION REPORT**

**RUSSEL GARMENTS BD 1**  
**OSMAN TOWER, 56/1, S.M. MALEH ROAD,**  
**NARAYANGANJ**

**ACCORD**  
on Fire and Building Safety in Bangladesh

April 29, 2014

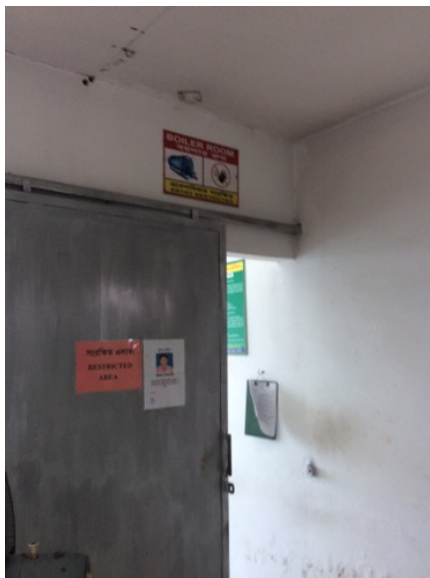
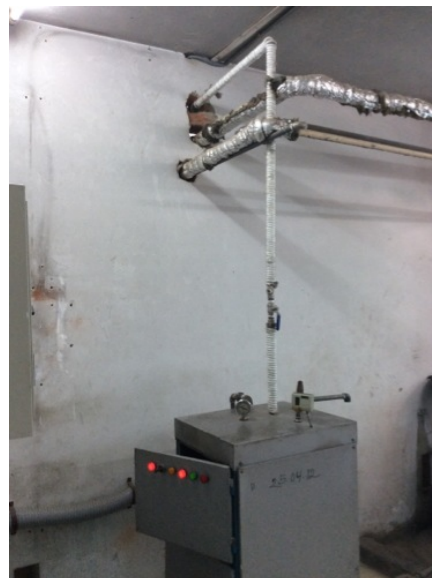
| No. | Category | Finding | Recommendation | Remediation Timeframe |
|---|---|---|---|---|
| F-1 | Fire Rated Construction | The boiler rooms on the 1st, 4th, 5th, and 7th floor are not separated by fire-rated construction (non-rated doors, and penetrations). | Separate the boiler rooms by a minimum 2-hr fire-rated construction. Seal and/or protected all openings to maintain the required fire separations | Within 3 months |

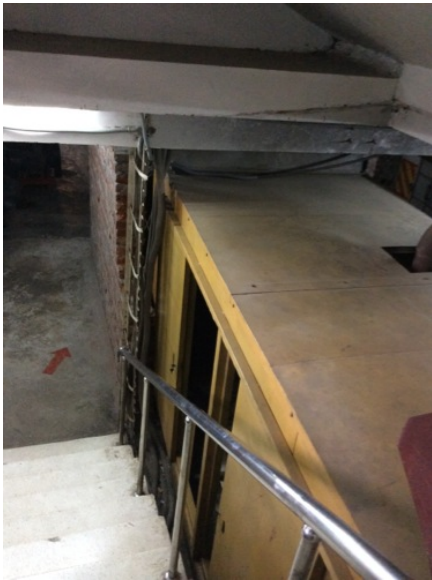
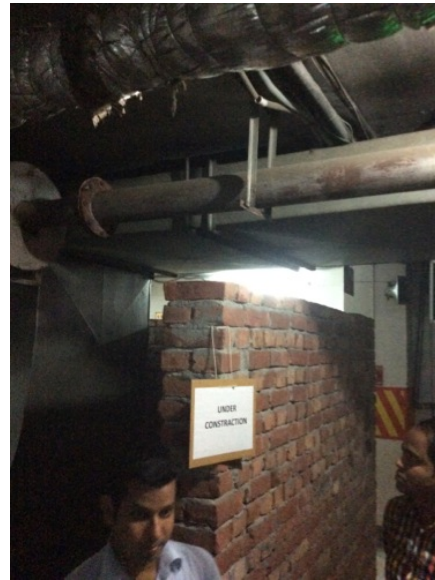
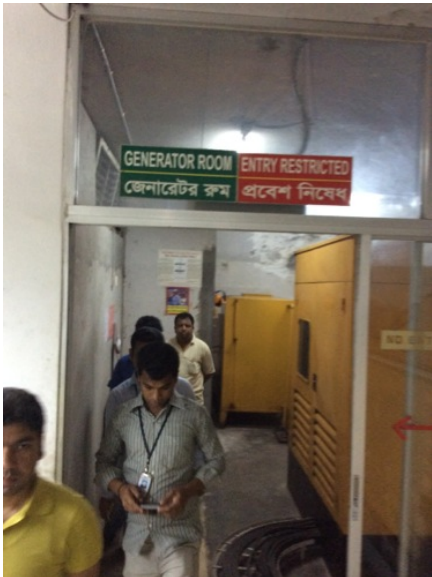
| No. | Category | Finding | Recommendation | Remediation Timeframe |
|---|---|---|---|---|
| F-2 | Fire Rated Construction | The generator rooms on the ground and basement floor are not separated by fire-rated construction (openings, non-rated doors, and penetrations). | Separate the generator rooms by a minimum 2-hr fire-rated construction. Seal and/or protected all openings to maintain the required fire separations | Within 3 months |

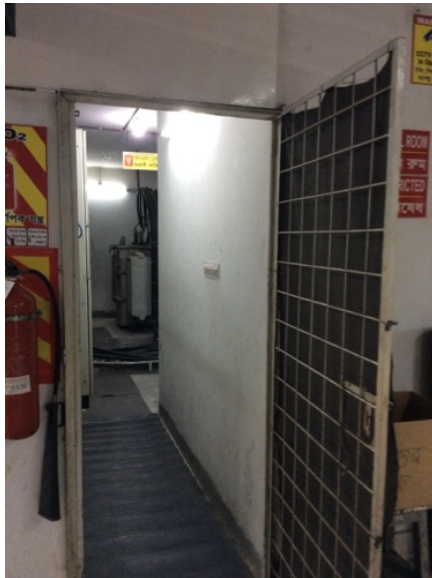
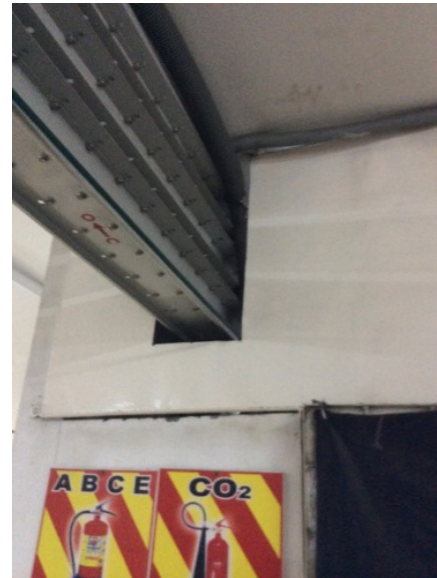
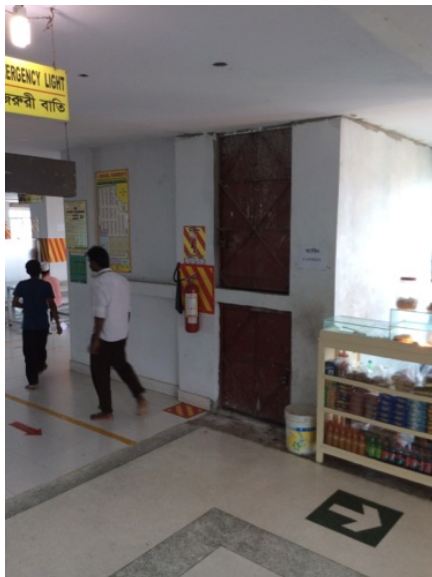
| F-3 | Fire Rated Construction | The transformer room on the ground floor and EMR room on the 6th floor are not separated by fire-rated construction (non-rated doors, penetrations). | Separate the transformer and EMR room by a minimum 2-hr fire-rated construction. Seal and/or protected all openings to maintain the required fire separations | Within 3 months |

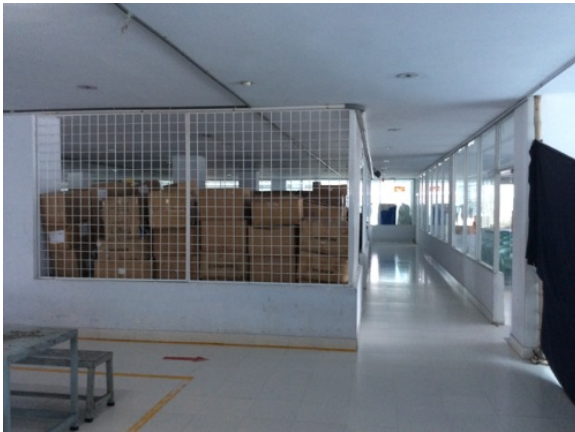
| F-4 | Fire Rated Construction | Rooms used for combustible storage on the 6th floor are not separated by fire-rated construction. | Provide dedicated storage rooms separated by minimum 1-hr fire-rated construction. | Within 3 months |

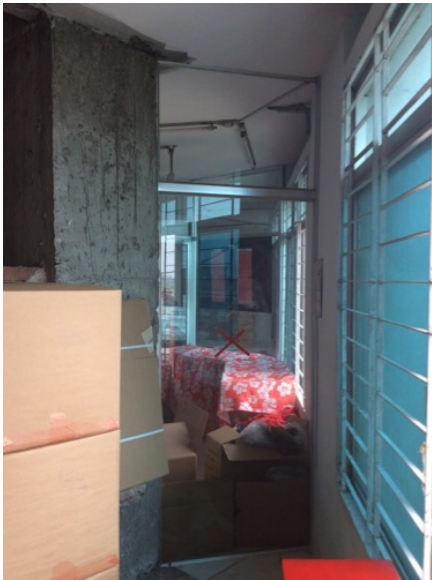
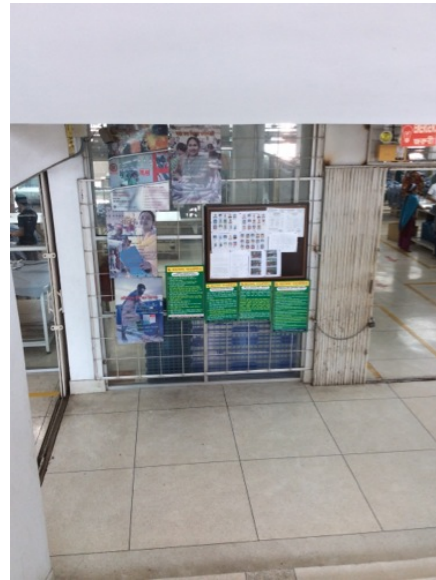
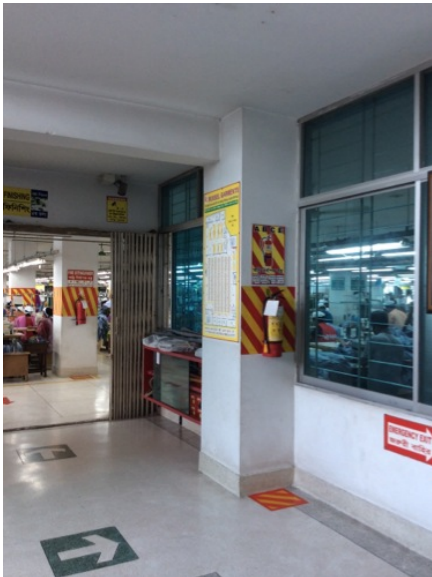
| F-5 | Fire Rated Construction | The exit stairs are not separated from work areas on each floor by fire-rated construction. | <p>Provide minimum 1.5-hr fire rated doors and seal all unprotected openings to separate the exit stairs from work areas on all floor levels. Ensure that the fire doors are self-closing and positive latching and that they are provided with fire exit (panic) hardware where serving production floors.</p> <p>If fire doors are required to be held open for functional reasons, provide automatic-closing devices tied to the fire alarm system.</p> | Within 3 months |

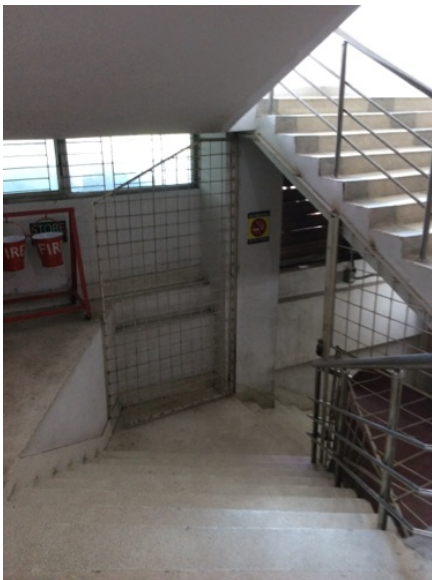
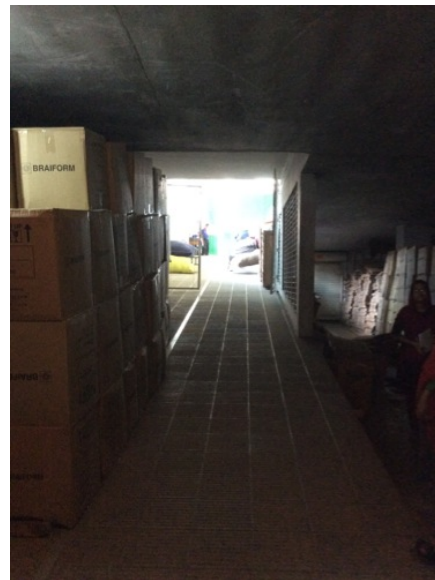
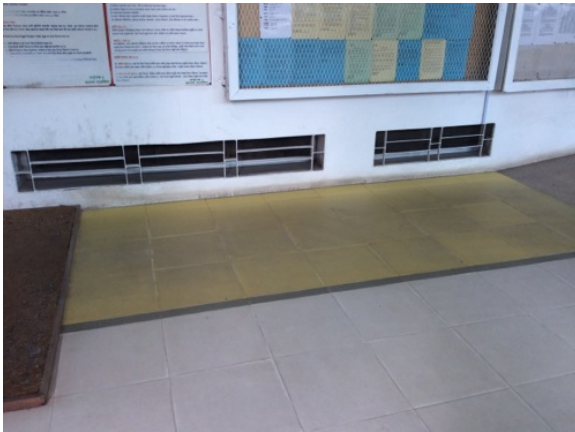
| F-6 | Fire Rated Construction | The exit stairs are not separated from storage on basement floor by fire-rated construction. | Provide minimum 1.5-hr fire rated doors and seal all unprotected openings to separate the exit stairs from work areas and other building spaces on all floor levels. Ensure that the fire doors are self-closing and positive latching and that they are provided with fire exit (panic) hardware where serving production floors. | Within 3 months |

If fire doors are required to be held open for functional reasons, provide automatic-closing devices tied to the fire alarm system.

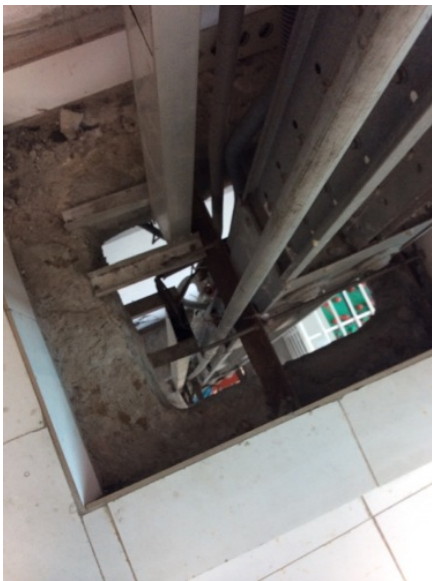
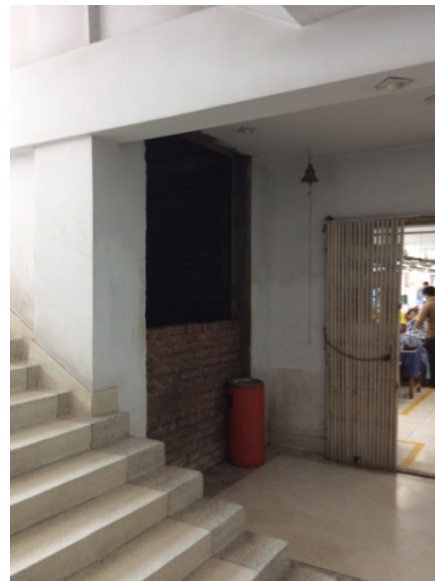
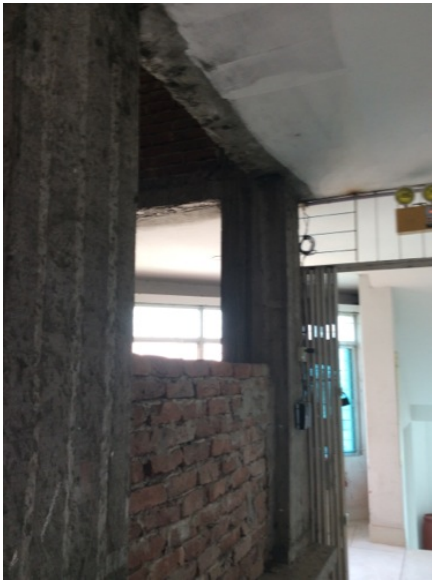
| F-7 | Fire Rated Construction | Unsealed penetrations and openings are located in the fire-rated floor/ceiling assemblies on each floor. | Provide a minimum 2-hr fire-rated shaft to separate the utility risers and the elevator shafts from each floor level.<br><br>Seal all penetrations and openings in floor/ceiling assemblies to maintain the fire separation. | Within 3 months |

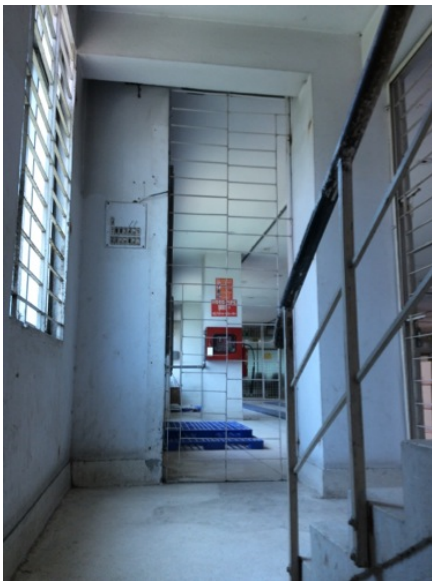
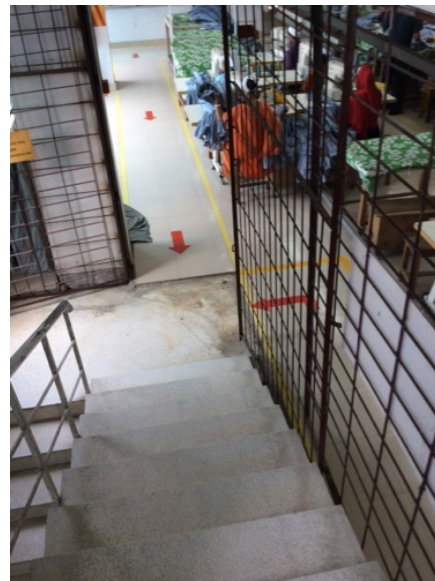
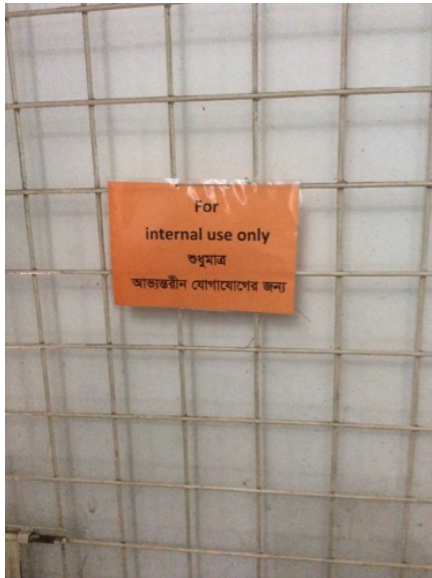
| F-8 | Fire Rated Construction | Unsealed penetrations and openings are located in the fire-rated floor/ceiling assemblies on each floor. | Provide a minimum 2-hr fire-rated shaft to separate the communicating stairs from each floor level.<br><br>Seal all penetrations and openings in floor/ceiling assemblies to maintain the fire separation. | Within 3 months |

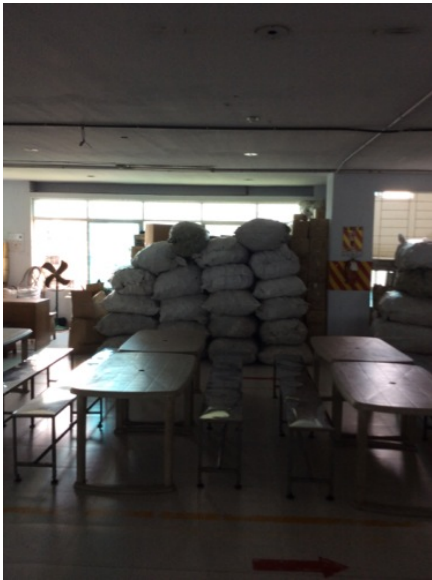
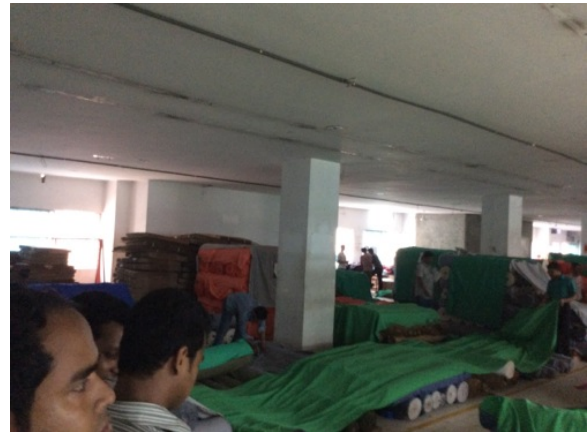
| F-9 | Fire Rated Construction | Areas used for combustible storage on the 1st and 6th floors are not separated by fire-rated construction. | <p>Provide dedicated storage rooms separated by minimum 1-hr fire-rated construction.</p> <p>Where separate storage rooms are not feasible, provide defined storage areas and limit the storage arrangement as follows:</p> <ul style="list-style-type: none"> <li>- Maximum height of 2.4m and maximum area of 23m<sup>2</sup></li> <li>- If sprinkler protected: maximum height of 3.66m and maximum area of 93m<sup>2</sup></li> </ul> <p>Separate areas of unenclosed combustible storage by a minimum clear distance of 3m.</p> | Within 3 months |

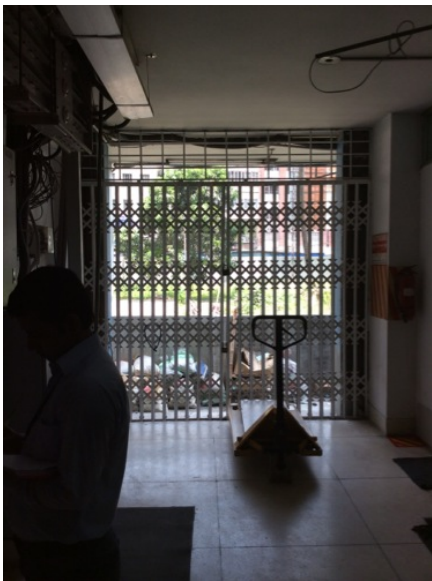
| F-11 | Egress | Collapsible gate is provided at building exit. | <p>Replace all gate along the means of egress with side-hinged, swinging egress doors.</p> <p>If locks are required for security reasons, utilize special door locking features complying with NFPA 101.</p> | Within 1 month |

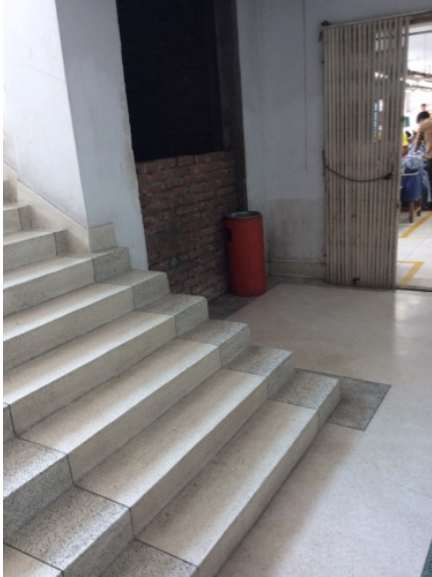
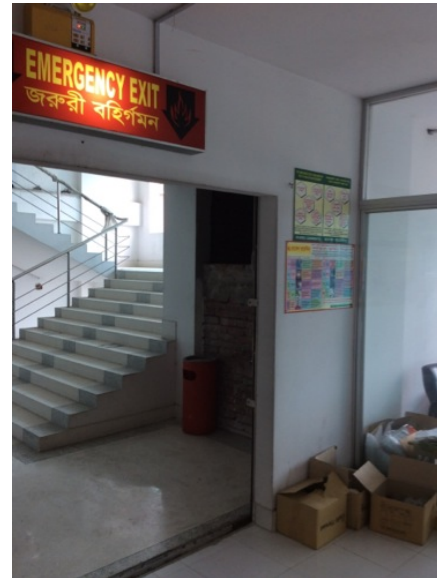
| F-12 | Egress | Handrails are not provided in the northwest exit stair. | Provide handrails on each floor. | Within 3 months |

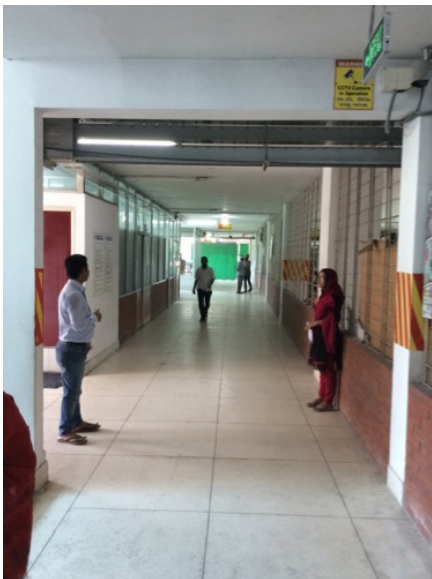
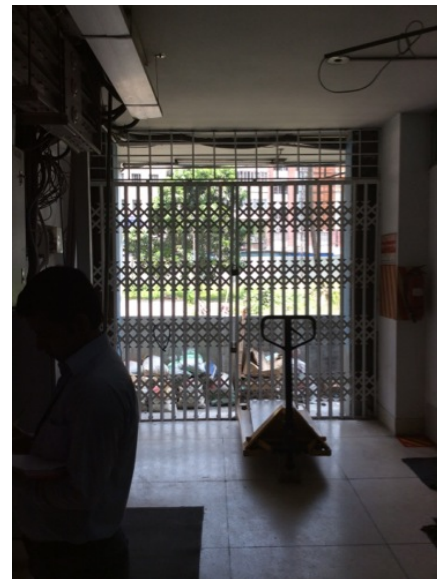
| F-13 | Egress | Southeast exit stair discharge inside the building on the ground floor. | Modify stair to discharge directly outside or Provide 2-hr fire-rated exit passageway leading directly outside (vestibules to separate any storage areas) or Provide sprinkler protection for discharge floor in accordance with NFPA 13. | Within 6 months |

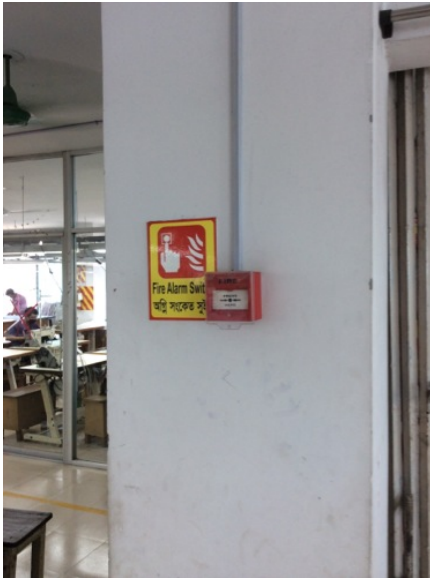
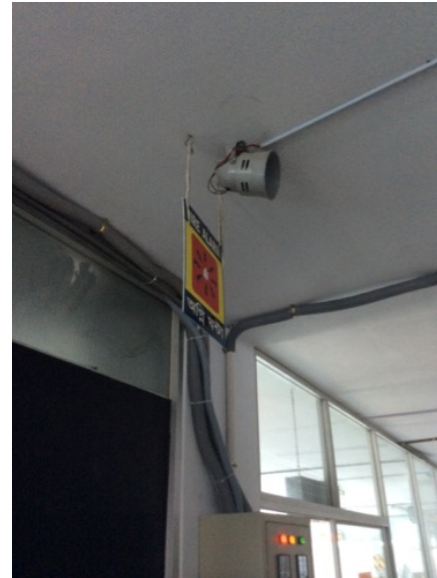
| F-14 | Fire Protection | The fire alarm system is antiquated, not a listed system, and does not provide alarm and notification features consistent with acceptable standards. | Replace the fire alarm system with a new, listed addressable fire alarm system in accordance with NFPA 72. | Design within 4 months, install within 9 months |

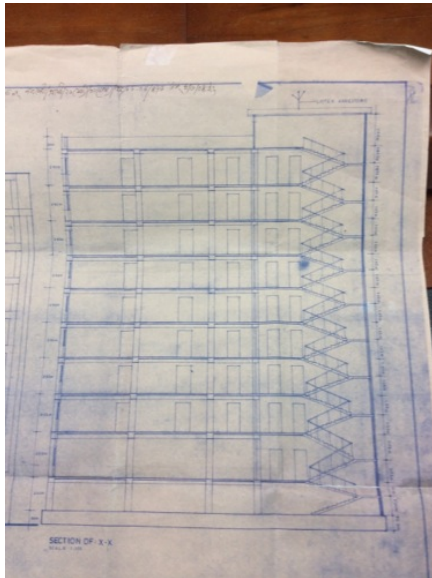
| F-15 | Fire Protection | The high-rise building has an occupied floor greater than 23m (75 ft) and is not provided with automatic sprinkler protection. The large occupant loads, heavy fuel loading, and anticipated extended egress times warrant sprinkler protection. | Provide automatic sprinkler protection throughout the building in accordance with NFPA 13. | Design within 6 months, install within 12 months |
